Re: Dangerous Waste Compliance Inspection on April 28, 2016 at Plutonium-Uranium Extraction (PUREX) Plant and Storage Tunnels, RCRA Site ID: WA7890008967, NWP Compliance Index No. 16.559

**Washington Department of Ecology
Nuclear Waste Program
Compliance Report**

Site: Plutonium-Uranium Extraction (PUREX) Plant and Storage Tunnels
RCRA Site ID: WA7890008967
Inspection Date: April 28, 2016
Site Contacts: Joel F. Williams Jr. CH2M HILL Plateau Remediation Company (CHPRC)
Phone: (509) 376-4782 **FAX:** (509) 372-2828
Site Location: Hanford Site
Benton County, WA
At This Site Since: 1943 **NAICS#:** 924110, 56221, 54171
Current Site Status: Closure Unit Group 25 and Operating Unit Group 2

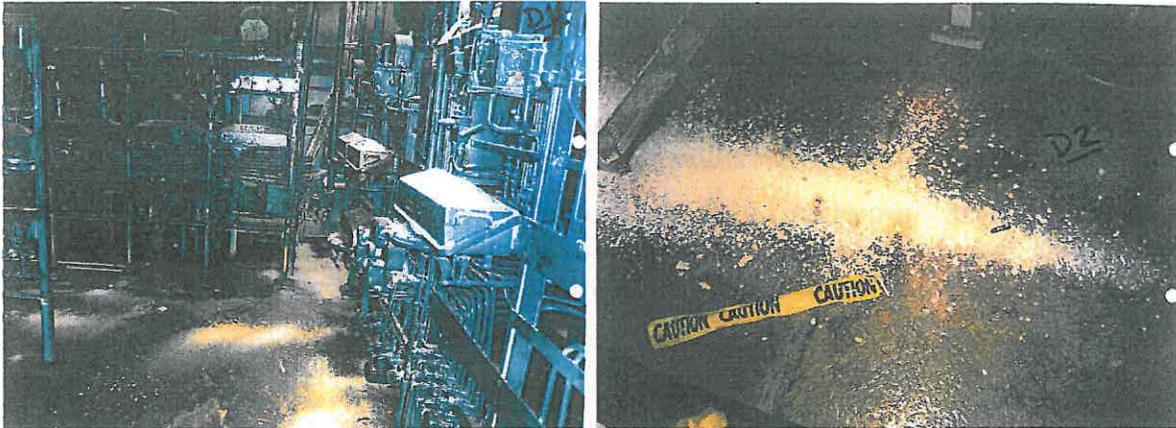
Photo D-1 and D-2: 2015 Surveillance of PUREX Plant (Surveillance Path 3 and Path 4).

White powder by col. 26 and in white Rm see pic D-1, D-2 & D-3

On July 11, 2016, I asked what repair or remedial action was taken for the white powder observed (See Photo D-1). I received the following response on August 18, 2016.

DOE-RL/CHRPC will continue to monitor structural integrity. Additional investigation / data may be needed to determine if the white powder poses a hazard that requires additional

Additional investigation/data may be needed to determine if the white powder poses a hazard that requires additional action. Workplace air monitoring will be performed during the 2016 surveillance in the vicinity of the white powder to evaluate the need for additional controls to protect workers.

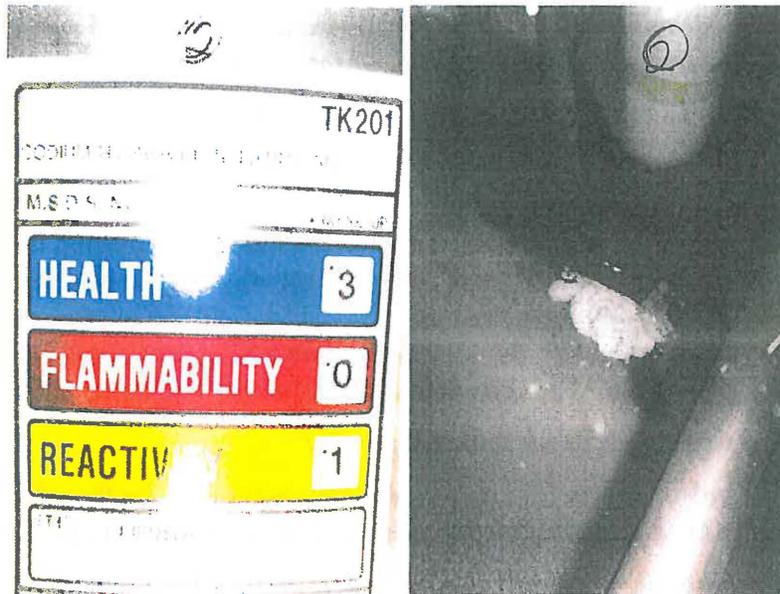
Photo 2: 2015 Surveillance of PUREX Plant (Surveillance Path 7), four photos marked with a 2.

Brown stain on the floor (Picture 1) most likely from Tank 204-Sugar Tank

White Powder on the floor. This looks to be a new accumulation, from a valve off of Tank 200 – Sodium Hydroxide Solution 50% (Picture 2)

Additional investigation/data may be needed to determine if the white powder poses a hazard that requires additional action. Workplace air monitoring will be performed during the 2016 surveillance in the vicinity of the white powder to evaluate the need for additional controls to protect workers.

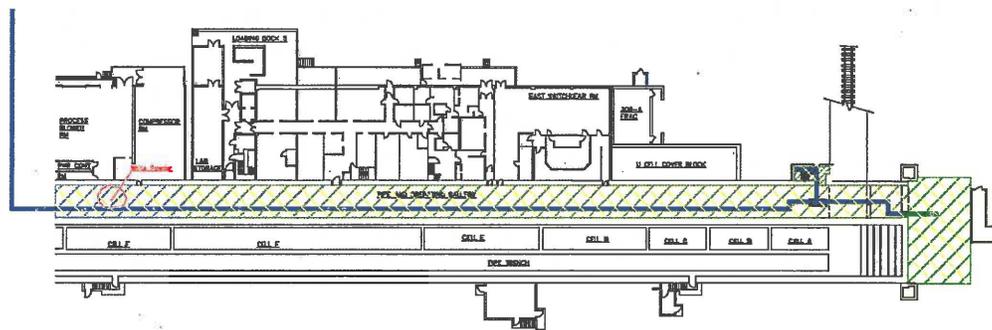
Excerpt 1: PUREX Surveillance Path 3

I observed a legend on the PUREX Path 3 drawing, which states yellow is a radiation area and green is a beryllium area. I also observed on the PUREX Path 3 drawing that the red marking is the location of the white powder, which appears to be in both a radiation area and beryllium area.

Surveillance path 3 is of the pipe and operating gallery along the north side of the PUREX canyon. The pipe and operating (P&O) gallery contains deactivated instrument racks, electrical motor controls, steam and cooling water supply lines, and the piping and associated valves for transferring nonradioactive solutions that served the in-cell equipment. Hazardous materials and wastes were removed in accordance with the end point criteria and materials remaining in the P&O Gallery are identified in Appendix A of the PUREX S&M Plan. These sources do not provide any indication that the white powder (if determined to be a solid waste) would designate as a dangerous waste. The powder is in a safe and stable condition within the confines of the robust canyon structure of PUREX and does not constitute a threat to human health and the environment. In accordance with agreements established under the TPA, disposition of this material will be addressed during the CERCLA remedial action unless hazards to workers or the environment mandate an earlier removal action. The only sampling that will be performed is industrial hygiene air sampling as identified in the Item 1 DOE-RL/CHPRC Response Attachment. Path 3 S&M annual inspection is not within a treatment, storage, or disposal (TSD) boundary as identified in the PUREX Part A Form, dated October 1, 2008. Attached is a copy of the PUREX Part A, Rev 12, page 8 of 12 that identifies the TSD boundaries. Path 3 is located in a radiological and beryllium contaminated controlled area and for ALARA concerns the procedure requires that the inspection teams stay within the designated pathway to minimum the exposure to radioactive and beryllium contamination. Path 3 is a highly congested area with equipment and piping and difficult to maneuver during the inspection.

DOE-RL/CHPRC believes that the white powder is not a threat to the human health and environment and removing the white powder could cause an ALARA issue by causing more contamination issues. Leaving the white powder in place better protects the human health and the environment. This path and white powder is to be dealt with under CERCLA.

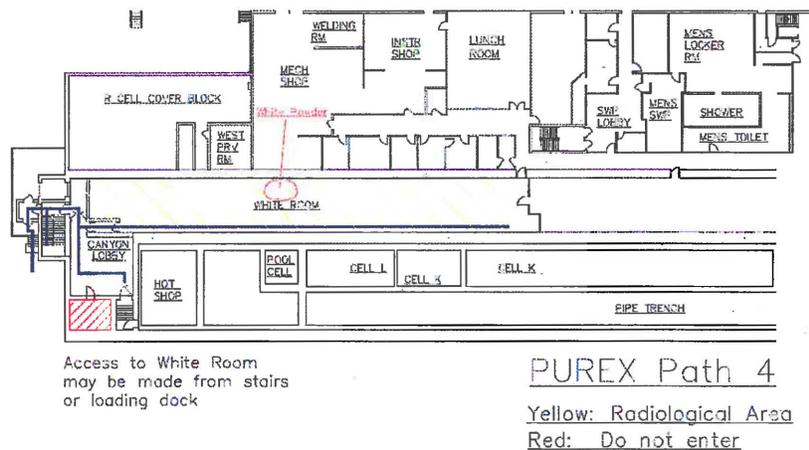
Excerpt 2: PUREX Surveillance Path 4

I observed on the PUREX Path 4 drawing that the red marking is the location of the white powder, which appears to be in a radiation area.

Surveillance path 4 is of the White Room which is at the west end of the P&O Gallery. Hazardous materials and wastes were removed in accordance with the end point criteria and materials remaining in the P&O Gallery are identified in Appendix A of the PUREX S&M Plan. These sources do not provide any indication that the white powder (if determined to be a solid waste) would designate as a dangerous waste. The powder is in a safe and stable condition within the confines of the robust canyon structure of PUREX and does not constitute a threat to human health and the environment. In accordance with agreements established under the TPA, disposition of this material will be addressed during the CERCLA remedial action unless hazards to workers or the environment mandate an earlier removal action. The White Room has additional access controls because of radiological contamination. The only sampling that will be performed is industrial hygiene air sampling as identified in the Item 1 DOE-RL/CHPRC Response Attachment. Path 4 S&M annual inspection is not within a treatment, storage, or disposal (TSD) boundary as identified in the PUREX Part A Form, dated October 1, 2008 (refer to Item 2 DOE-RL/CHPRC Response, provides copy of the PUREX Part A, Rev 12, page 8 of 12 that identifies the TSD boundaries). Path 4 is located in a radiological contaminated controlled area and for ALARA concerns the procedure requires that the inspection teams stay within the designated pathway to minimum the exposure to radioactive contamination. Path 4 is a highly congested area with equipment and piping and difficult to maneuver during the inspection. Due to an incident back in the late 1950's, there was a spill of plutonium that distributed over a large surface area. Numerous coats of paint covered by a polymeric barrier system

has been place on the floor fixing the contamination. DOE-RL/CHPRC believe that the white powder is not a threat to the human health and environment and removing the white powder could cause an ALARA issue by causing more contamination issues. Leaving the powder in place better protects human health and the environment. This path and white powder is to be dealt with under CERCLA.

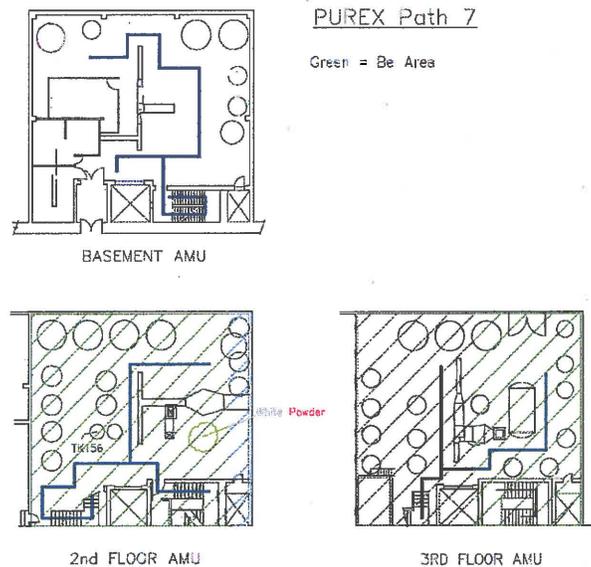
Excerpt 2: PUREX Surveillance Path 4

I observed on the PUREX Path 7 drawing that the red marking is the location of the white powder, which appears to be in a beryllium area.

Surveillance path 7 is of the Aqueous Makeup Unit (AMU) and involves entries on the basement, 2nd floor, and 3rd floor. Tank 156 in the AMU was used for nitric acid storage and is identified in the PUREX Part A (refer to Item 2DOE-RL/CHPRC Response provides copy of the PUREX Part A, Rev 12, page 8 of 12 that identifies the TSD boundary). The remainder of the AMU is not within the TSD boundary. Tank 156 was flushed and sampled to confirm that residues were below dangerous waste regulatory limits. Hazardous materials and wastes were removed in accordance with the end point criteria and materials remaining in the AMU are identified in Appendix A of the PUREX S&M Plan. These sources do not provide any indication that the white powder (if determined to be a solid waste) would designate as a dangerous waste. The only sampling that will be performed is industrial hygiene air sampling as identified in the Item 1 DOE-RL/CHPRC Response Attachment. Path 7 is located in a radiological and beryllium contamination controlled area. For ALARA concerns the procedure requires that the inspection teams stay within the designated pathway to minimize the exposure to radioactive and beryllium contamination. Path 7 is a highly congested area with equipment and piping and difficult to maneuver during the inspection.

DOE-RL/CHPRC believes that the white powder is not a threat to the human health and the environment and removing the white powder could cause an ALARA issue by causing more contamination issues. Leaving the powder in place better protects the human health and the environment. This path and white powder is to be dealt with under CERCLA.
