STATE OF WASHINGTON
DEPARTMENT OF ECOLOGY

16-NWP-197

Re: Dangerous Waste Compliance Inspection on June 7, 8, and June 9, 2016, at United States Department of Energy Hanford Site, RCRA Site ID: WA7890008967, NWP Compliance Index Nos. 16.562 through 16.574

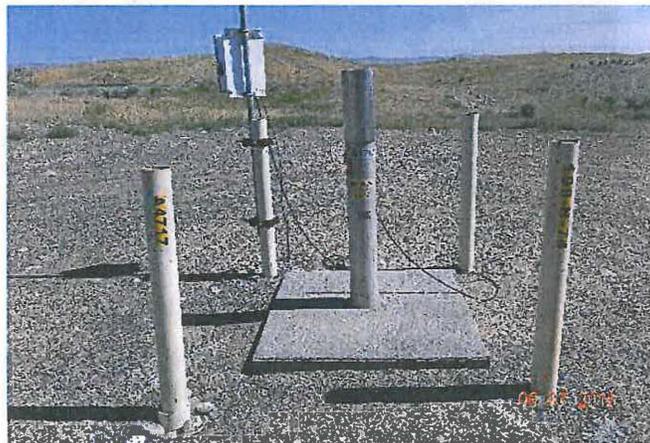
Photo #DSC01272, Up-Gradient Well No. 199-N-74 for 1325-N

At 10:15 a.m. we arrived at groundwater Well 199-N-74 for 1325-N. I observed the following on the Up-Gradient Well 199-N-74:

- The well had a Washington State well identification tag on the well casing that was visible above the land surface with unique well identification number BIV 654.
- The well had a cap that was locked on top of the casing.
- The well was protected from damage by four metal posts. The posts were over three inches in diameter, over three feet above the land surface, and were over two feet away from the well casing.
- The well protection measures appeared to not be damaged.

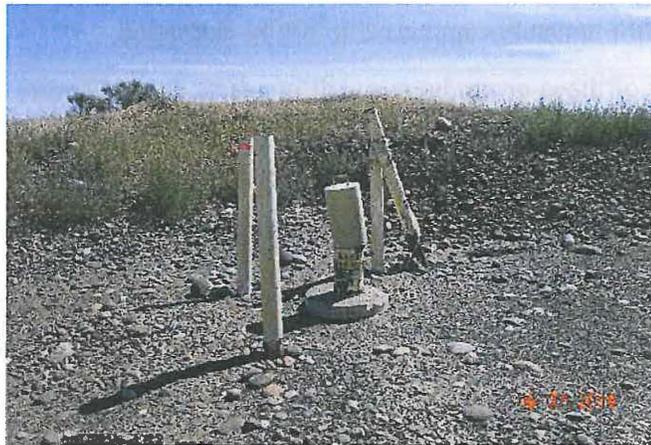
Photo #DSC01273, Up-Gradient Well No. 199-N-32 for 1325-N

I observed the following on the Down-Gradient Well 199-N-32 for 1325-N:

- The well had a Washington State well identification tag on the well casing that was visible above the land surface with unique well identification number BIV 662.
- The well had a cap that was locked on top of the casing.
- The well was protected from damage by three metal posts. The posts were over three inches in diameter, over three feet above the land surface, and were over two feet away from the well casing.
- A fourth well post protection measure appeared to be removed from its previous location and was leaning against one of the other protective posts. I observed that the concrete around the casing was slightly chipped, but otherwise intact.
- The well was equipped with an Automatic Water Level Network (AWLN).

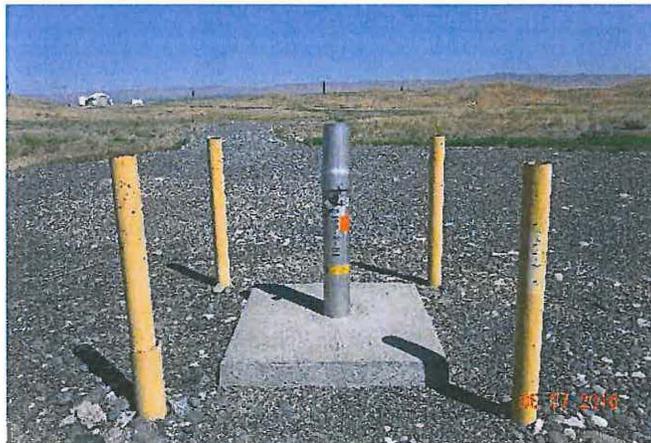
Photo #DSC01274, Down Gradient Well No. 199-N-81 for 1325-N

I observed the following on the Down-Gradient Well 199-N-81 for 1325-N:

- The well had a Washington State well identification tag on the well casing that was visible above the land surface with unique well identification number BIV 665.
- The well had a cap that was locked on top of the casing.
- The well was protected from damage by four metal posts. The posts were over three inches in diameter, over three feet above the land surface, and were over two feet away from the well casing.
- The well protection measures appeared to not be damaged.

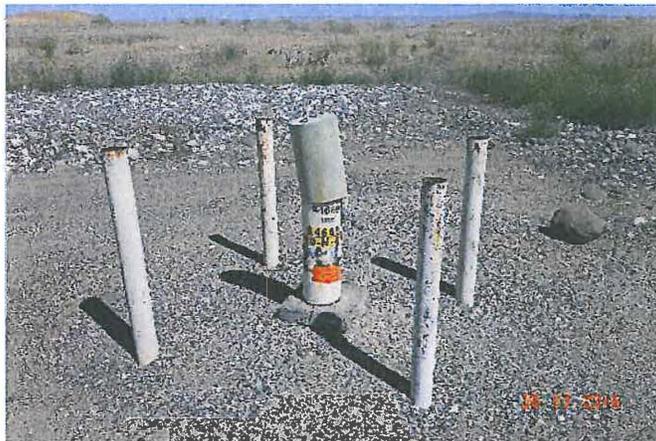
Photo #DSC01275, Down-Gradient Well No. 199-N-41 for 1325-N

I observed the following on the Down-Gradient Well 199-N-41 for 1325-N:

- The well had a Washington State well identification tag on the well casing that was visible above the land surface with unique well identification number BIV 663.
- The well had a cap that was locked on top of the casing.
- The well was protected from damage by four metal posts. The posts were over three inches in diameter, over three feet above the land surface, and were over two feet away from the well casing.
- I observed a small crack in the concrete pad protective measure and approximately 10 percent coverage of rust on the protective posts.

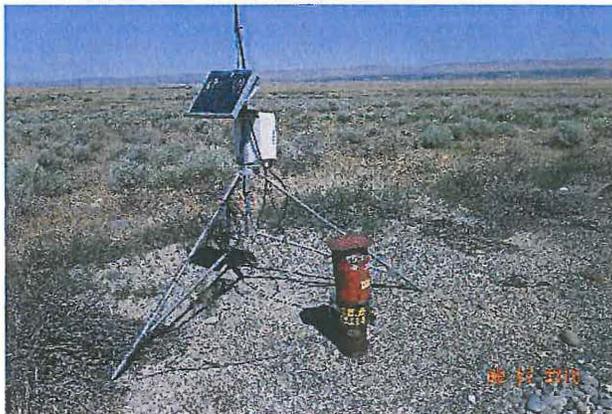
Photo #DSC01276, Down-Gradient Well No. 199-N-2 for 1301-N

At 10:50 a.m. we arrived at groundwater Well 199-N-2 for 1301-N. I observed the following on the Down-Gradient Well 199-N-2:

- The well had a Washington State well identification tag on the well casing that was visible above the land surface with unique well identification number BIV 667.
- The well had a cap that was locked on top of the casing.
- The well had no protective measures.
- The well was equipped with an Automatic Water Level Network (AWLN)

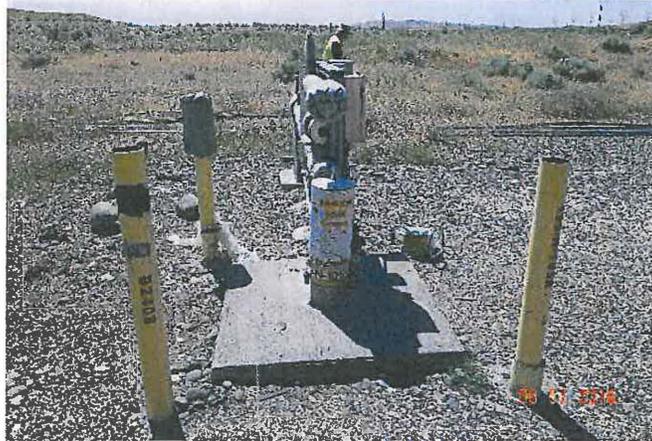
Photo #DSC01277, Down-Gradient Well No. 199-N-105A for 1301-N

I observed the following on the Down-Gradient Well 199-N-105A at 1301-N:

- The well had a Washington State well identification tag on the well casing that was visible above the land surface with unique well identification number BIV 666.
- The well had a cap that was locked on top of the casing.
- The well was protected from damage by three metal posts. The posts were over three inches in diameter, over three feet above the land surface, and were over two feet away from the well casing.
- The well protection measures appeared to not be damaged.

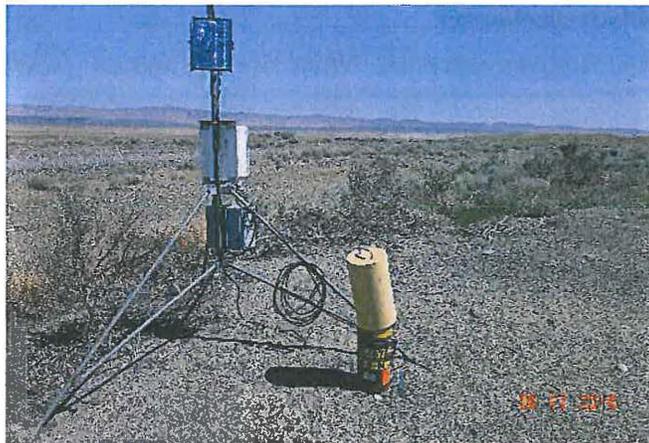
Photo #DSC01278, Down-Gradient Well No. 199-N-3 for 1301-N

I observed the following on the Down-Gradient Well 199-N-3 at 1301-N:

- The well had a Washington State well identification tag on the well casing that was visible above the land surface with unique well identification number BIV 668.
- The well had a cap that was locked on top of the casing.
- The well had no protective measures.
- The well was equipped with an Automatic Water Level Network (AWLN)
- The outer well casing of the well had a small hole in it.

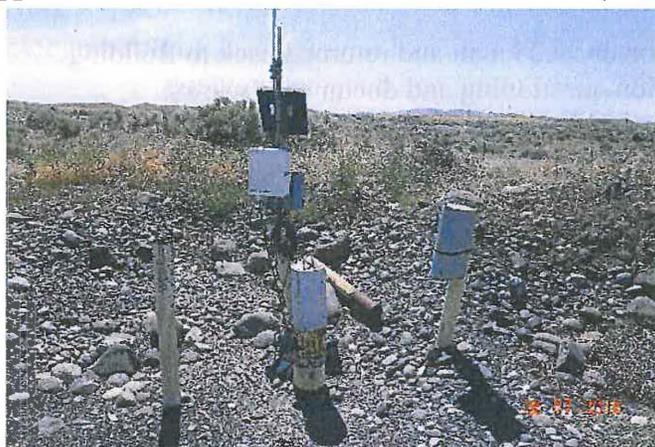
Photo #DSC01279, Down-Gradient Well No. 199-N-34 for 1301-N

I observed the following on the up-gradient Well 199-N-34 for the 1301-N:

- The well had a Washington State well identification tag on the well casing that was visible above the land surface with unique well identification number BIV 664.
- The well had a cap that was locked on top of the casing.
- The well was protected from damage by three metal posts. The posts were over three inches in diameter, over three feet above the land surface, were over two feet away from the well casing, and were in a triangular array that was not completely around the casing.
- A fourth well post protection measure appeared to be removed from its previous location and was laying on the ground.
- The well did not have a concrete pad around the casing.
- The well was equipped with an Automatic Water Level Network (AWLN)

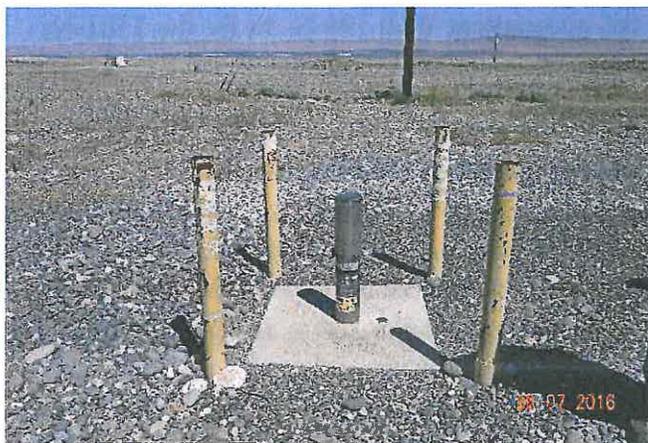
Photo #DSC01280, Down-gradient Well No. 199-N-57 for 1301-N

I observed the following on the down-gradient Well 199-N-57 for the 1301-N:

- The well had a Washington State well identification tag on the well casing that was visible above the land surface with unique well identification number BIV 660.
- The well had a cap that was locked on top of the casing.
- The well was protected from damage by four metal posts. The posts were over three inches in diameter, over three feet above the land surface, and were over two feet away from the well casing.
- The well protection measures appeared to not be damaged; however I observed approximately 10 percent coverage of rust on the protective posts.

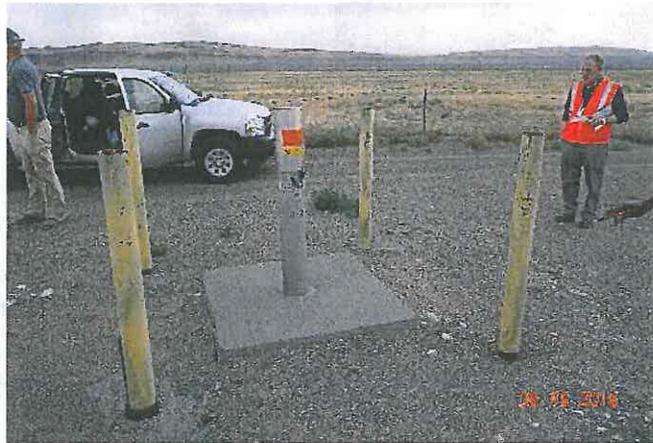
Photo #DSC01293, Up-Gradient Well 299-E34-8 for 216-B-63 Trench

I observed the following on the Up-Gradient Well 299-E34-8:

- The well did not have a Washington State identification tag with unique well identification number on the well casing that was visible above the land surface.
- The well had a cap that was locked on top of the casing.
- The well was protected from damage by four metal posts. The posts were over three inches in diameter, over three feet above the land surface, and were over two feet away from the well casing.
- The well protection measures appeared to not be damaged.

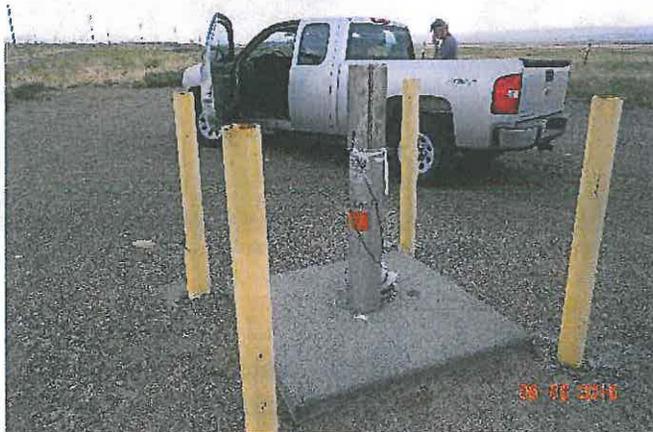
Photo #DSC01294, Up-Gradient Well 299-E34-12 for 216-B-63 Trench

I observed the following on the Up-Gradient Well 299-E34-12 for 216-B-63 Trench:

- The well did not have a Washington State identification tag with unique well identification number on the well casing that was visible above the land surface.
- The well had a cap that was locked on top of the casing.
- The well was protected from damage by four metal posts. The posts were over three inches in diameter, over three feet above the land surface, and were over two feet away from the well casing.
- The well protection measures appeared to not be damaged.

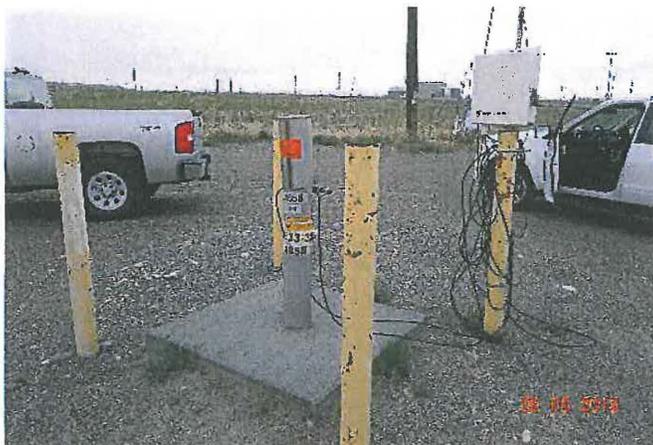
Photo #DSC01295, Up-Gradient Well 299-E33-33 for 216-B-63 Trench

I observed the following on the Up-Gradient Well 299-E33-33 for 216-B-63 Trench:

- The well did not have a Washington State identification tag with unique well identification number on the well casing that was visible above the land surface.
- The well had a cap that was locked on top of the casing.
- The well was protected from damage by four metal posts. The posts were over three inches in diameter, over three feet above the land surface, and were over two feet away from the well casing.
- The well protection measures appeared to not be damaged; however I observed approximately 10 percent coverage of rust on the protective posts.

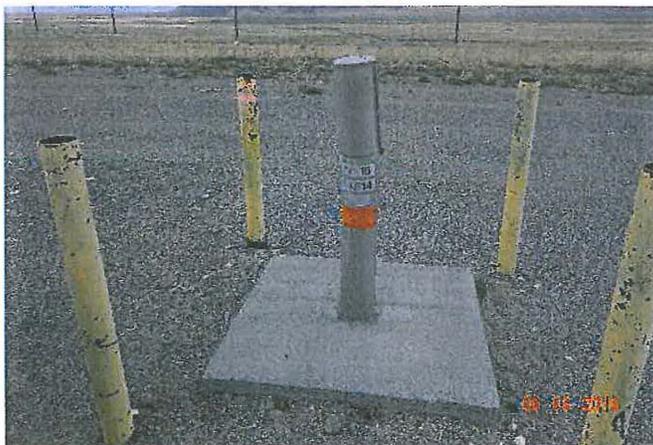
Photo #DSC01296, Down-Gradient Well 299-E27-16 for 216-B-63 Trench

I observed the following on the Down-Gradient Well 299-E27-16 for 216-B-63 Trench:

- The well did not have a Washington State identification tag with unique well identification number on the well casing that was visible above the land surface.
- The well had a cap that was locked on top of the casing.
- The well was protected from damage by four metal posts. The posts were over three inches in diameter, over three feet above the land surface, and were over two feet away from the well casing.
- The well protection measures appeared to not be damaged; however I observed approximately 10 percent coverage of rust on the protective posts.

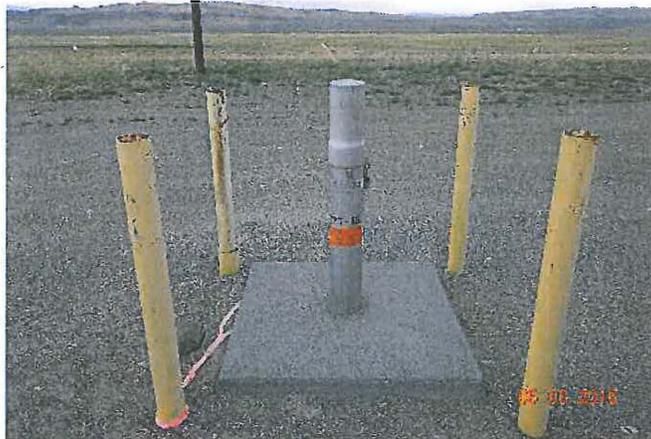
Photo #DSC01297, Down-Gradient Well 299-E27-18 for 216-B-63 Trench

I observed the following on the Down-Gradient Well 299-E27-18 for 216-B-63 Trench:

- The well did not have a Washington State identification tag with unique well identification number on the well casing that was visible above the land surface.
- The well had a cap that was locked on top of the casing.
- The well was protected from damage by four metal posts. The posts were over three inches in diameter, over three feet above the land surface, and were over two feet away from the well casing.
- The well protection measures appeared to not be damaged.

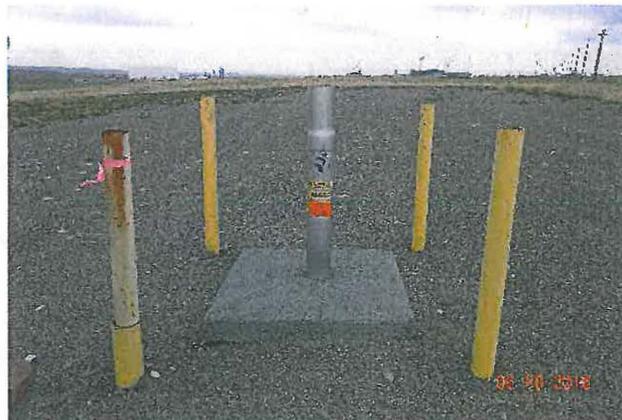
Photo #DSC01298, Down-Gradient Well 299-E27-19 for 216-B-63 Trench

I observed the following on the Down-Gradient Well 299-E27-19 for 216-B-63 Trench:

- The well did not have a Washington State identification tag with unique well identification number on the well casing that was visible above the land surface.
- The well had a cap that was locked on top of the casing.
- The well was protected from damage by four metal posts. The posts were over three inches in diameter, over three feet above the land surface, and were over two feet away from the well casing.
- The well protection measures appeared to not be damaged; however I observed approximately 20 percent coverage of rust on one of the protective posts.

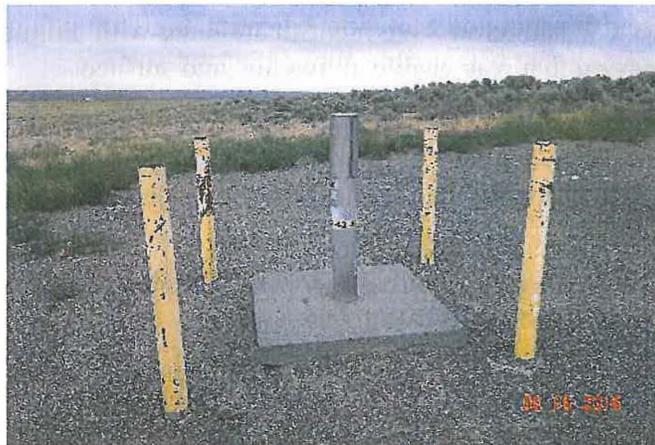
Photo #DSC01299, Down-Gradient Well 699-43-45 for 216-B-3 Main Pond

At 1:59 p.m. we arrived at groundwater Well 699-43-45 for 216-B-3 Main Pond. I observed the following on the Down-Gradient Well 699-43-45:

- The well did not have a Washington State identification tag with unique well identification number on the well casing that was visible above the land surface.
- The well had a cap that was locked on top of the casing.
- The well was protected from damage by four metal posts. The posts were over three inches in diameter, over three feet above the land surface, and were over two feet away from the well casing.
- The well protection measures appeared to not be damaged; however I observed approximately 20 percent coverage of rust on one of the protective posts.

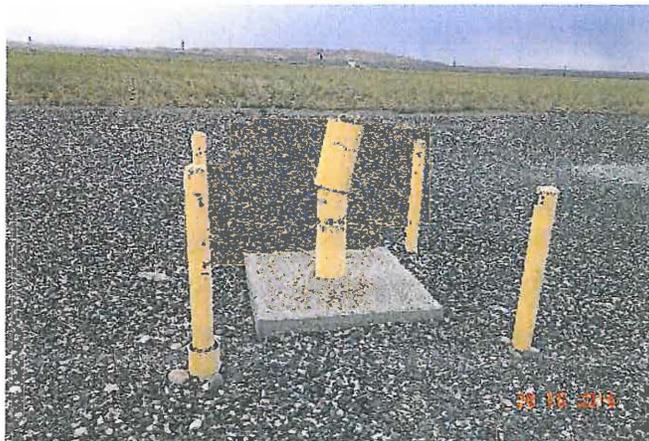
Photo #DSC01300, Down-Gradient Well 699-43-44 for 216-B-3 Main Pond

I observed the following on the Down-Gradient Well 699-43-44 for 216-B-3 Main Pond:

- The well had a Washington State well identification tag on the well casing that was visible above the land surface with unique well identification number AAO 451.
- The well had a cap that was locked on top of the casing.
- The well was protected from damage by four metal posts. The posts were over three inches in diameter, over three feet above the land surface, and were over two feet away from the well casing.
- The well protection measures appeared to not be damaged.

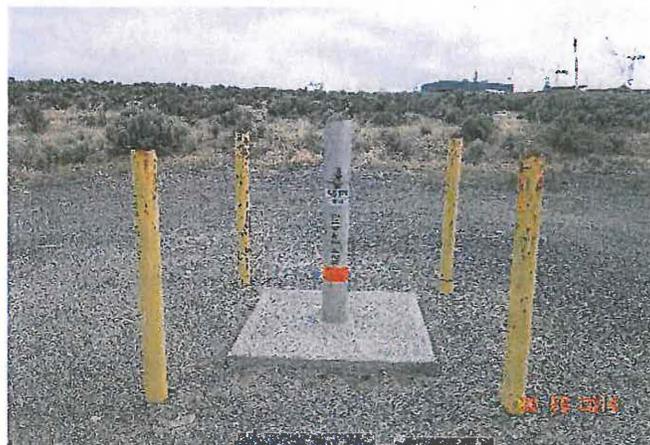
Photo #DSC01301, Down-Gradient Well 699-42-42B for 216-B-3 Main Pond

I observed the following on the Down-Gradient Well 699-42-42B:

- The well did not have a Washington State identification tag with unique well identification number on the well casing that was visible above the land surface.
- The well had a cap that was locked on top of the casing.
- The well was protected from damage by four metal posts. The posts were over three inches in diameter, over three feet above the land surface, and were over two feet away from the well casing.
- The well protection measures appeared to not be damaged; however I observed approximately 10 percent coverage of rust on the protective posts.

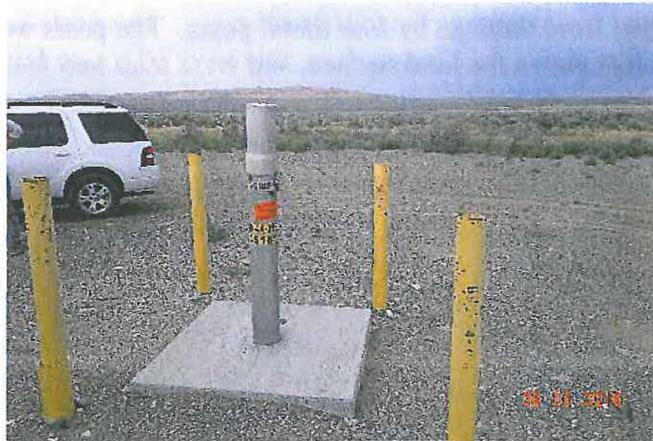
Photo #DSC01302, Up-Gradient Well 699-44-39B for 216-B-3 Main Pond

I observed the following on the Up-Gradient Well 699-44-39B:

- The well did not have a Washington State identification tag with unique well identification number on the well casing that was visible above the land surface.
- The well had a cap that was locked on top of the casing.
- The well was protected from damage by four metal posts. The posts were over three inches in diameter, over three feet above the land surface, and were over two feet away from the well casing.
- The well protection measures appeared to not be damaged.

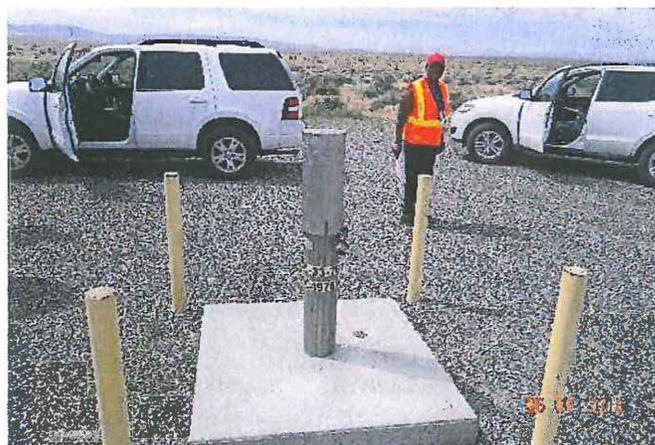
Photo #DSC01303, Up-Gradient Well 699-33-76 for 216-S-10 Pond and Ditch

At 2:46 p.m., we arrived at groundwater Well 699-33-76 for 216-S-10 Pond and Ditch. I observed the following on the Up-Gradient Well 699-33-76:

- The well had a Washington State well identification tag on the well casing that was visible above the land surface with unique well identification number BAL 354.
- The well had a cap that was locked on top of the casing.
- The well was protected from damage by four metal posts. The posts were over three inches in diameter, over three feet above the land surface, and were over two feet away from the well casing.
- The well protection measures appeared to not be damaged.

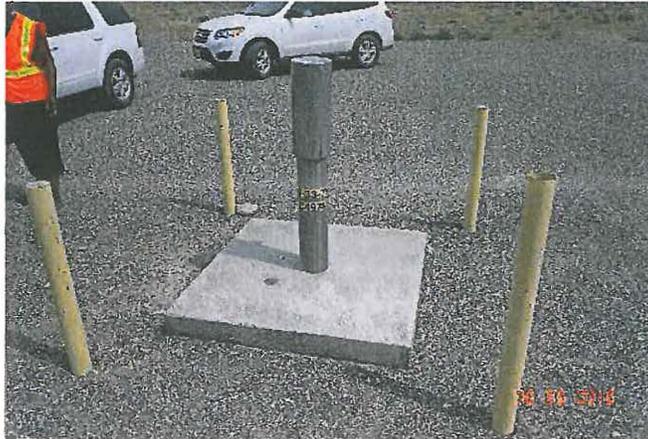
Photo #DSC01304, Down-Gradient Well 699-33-75 for 216-S-10 Pond and Ditch

I observed the following on the Down-Gradient Well 699-33-75:

- The well was protected from damage by four metal posts. The posts were over three inches in diameter, over three feet above the land surface, and were over two feet away from the well casing.
- The well protection measures appeared to not be damaged.

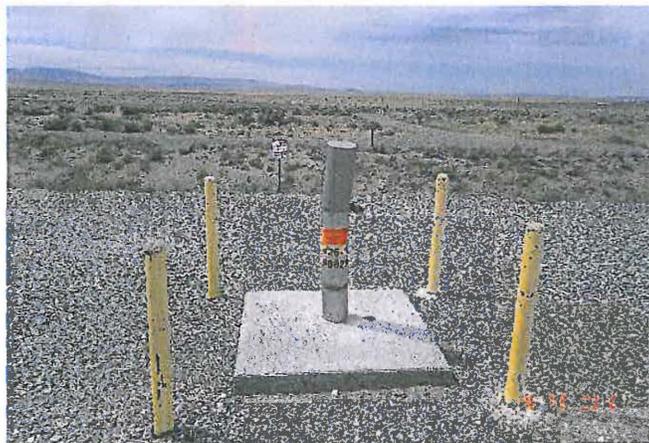
Photo #DSC01305, Down-Gradient Well 299-W26-14 for 216-S-10 Pond and Ditch

During my inspection of Well 299-W26-14, Mr. Hildebrand told me he just received a phone call that they had confirmed exceedances of specific conductance for 1325-N and 1324 N and 1324-NA. He explained he wanted me to know right now, as the previous day he told me they did not have any known exceedances for those units. I observed the following on the Down-Gradient Well 299-W26-14:

- The well had a Washington State well identification tag on the well casing that was visible above the land surface with unique well identification number AHK 590.
- The well had a cap that was locked on top of the casing.
- The well was protected from damage by four metal posts. The posts were over three inches in diameter, over three feet above the land surface, and were over two feet away from the well casing.
- The well protection measures appeared to not be damaged.

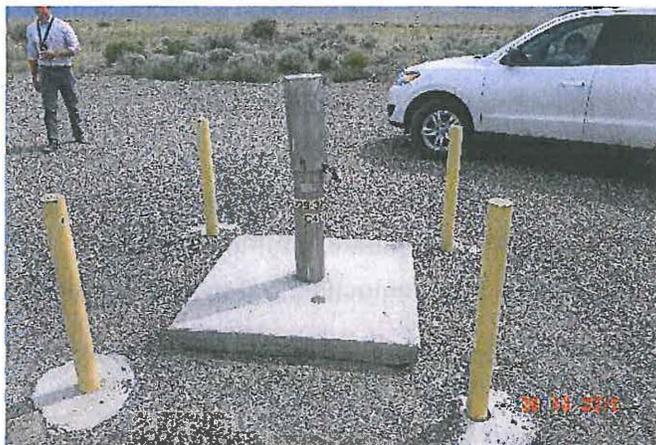
Photo #DSC01306, Down-Gradient Well 699-32-76 for 216-S-10 Pond and Ditch

I observed the following on the Down-Gradient Well 699-32-76:

- The well had a Washington State well identification tag on the well casing that was visible above the land surface with unique well identification number BAL 351.
- The well had a cap that was locked on top of the casing.
- The well was protected from damage by four metal posts. The posts were over three inches in diameter, over three feet above the land surface, and were over two feet away from the well casing.
- The well protection measures appeared to not be damaged.

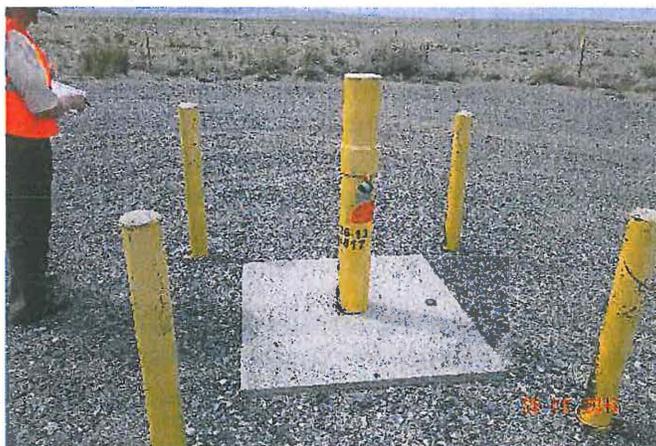
Photo #DSC01307, Down-Gradient Well 699-32-76 for 216-S-10 Pond and Ditch

I observed the following on the Down-Gradient Well 299-W26-13:

- The well had a Washington State well identification tag on the well casing that was visible above the land surface with unique well identification number AAO 459.
- The well had a cap that was locked on top of the casing.
- The well was protected from damage by four metal posts. The posts were over three inches in diameter, over three feet above the land surface, and were over two feet away from the well casing.
- The well protection measures appeared to not be damaged.

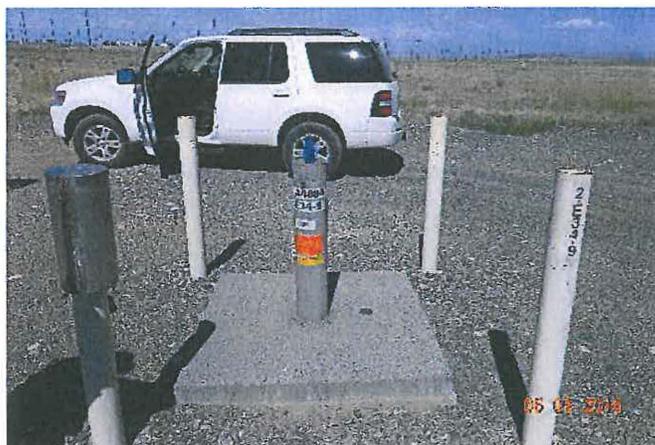
Photo #DSC01308, Cross-Gradient Well 299-E34-9 for Low Level Burial Grounds Green Islands

At 10:23 a.m. we arrived at groundwater Well 299-E34-9 for Low Level Burial Grounds Green Islands. I observed the following on the Cross-Gradient Well 299-E34-9:

- The well did not have a Washington State identification tag with unique well identification number on the well casing that was visible above the land surface.
- The well had a cap that was not locked or on top of the casing.
- The well was protected from damage by four metal posts. The posts were over three inches in diameter, over three feet above the land surface, and were over two feet away from the well casing.
- The well protection measures appeared to not be damaged.

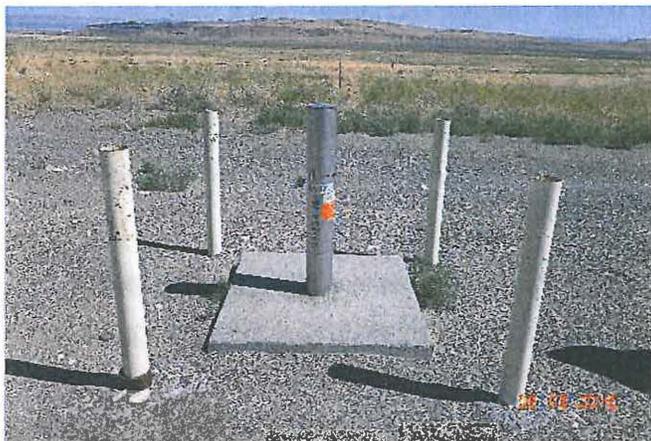
Photo #DSC01309, Cross-Gradient Well 299-E34-10 for Low Level Burial Grounds Green Islands

I observed the following on the Cross-Gradient Well 299-E34-10:

- The well was protected from damage by four metal posts. The posts were over three inches in diameter, over three feet above the land surface, and were over two feet away from the well casing.
- The well protection measures appeared to not be damaged.

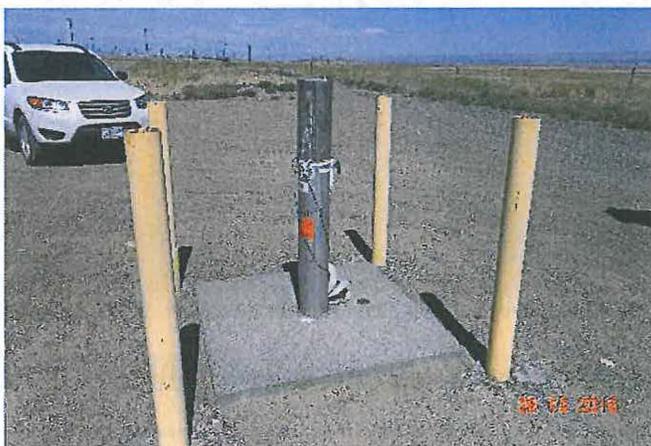
Photo #DSC01310, Cross-Gradient Well 299-E34-12 for Low Level Burial Grounds Green Islands

I observed the following on the Cross-Gradient Well 299-E34-12:

- The well did not have a Washington State identification tag with unique well identification number on the well casing that was visible above the land surface.
- The well had a cap that was locked on top of the casing.
- The well was protected from damage by four metal posts. The posts were over three inches in diameter, over three feet above the land surface, and were over two feet away from the well casing.
- The well protection measures appeared to not be damaged.

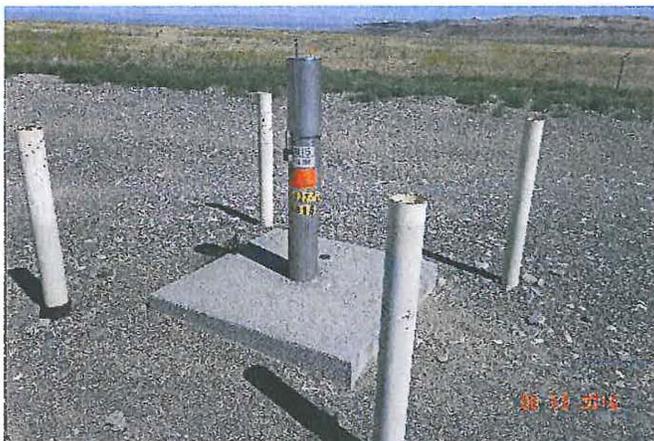
Photo #DSC01311, Cross-Gradient Well 299-E27-17 for Low Level Burial Grounds Green Islands

I observed the following on the Cross-Gradient Well 299-E27-17:

- The well was protected from damage by four metal posts. The posts were over three inches in diameter, over three feet above the land surface, and were over two feet away from the well casing.
- The well protection measures appeared to not be damaged.

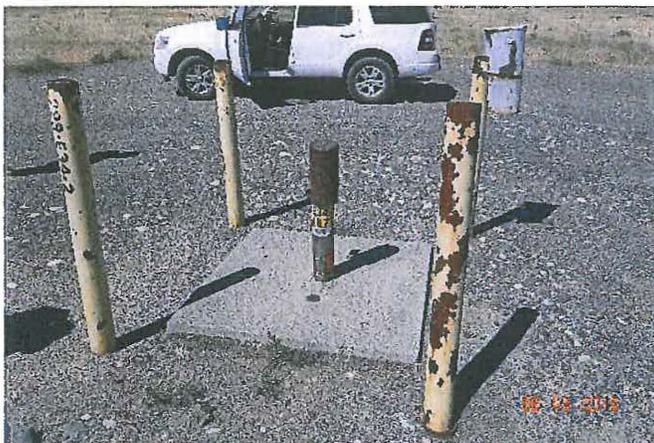
Photo #DSC01312, Up-Gradient Well 299-E34-2 for Low Level Burial Grounds Green Islands

I observed the following on the Up-Gradient Well 299-E34-2:

- The well did not have a Washington State identification tag with unique well identification number on the well casing that was visible above the land surface.
- The well had a cap that was locked on top of the casing.
- The well was protected from damage by four metal posts. The posts were over three inches in diameter, over three feet above the land surface, and were over two feet away from the well casing.
- The well protection measures appeared to not be damaged; however I observed approximately 40 percent coverage of rust on the protective posts.

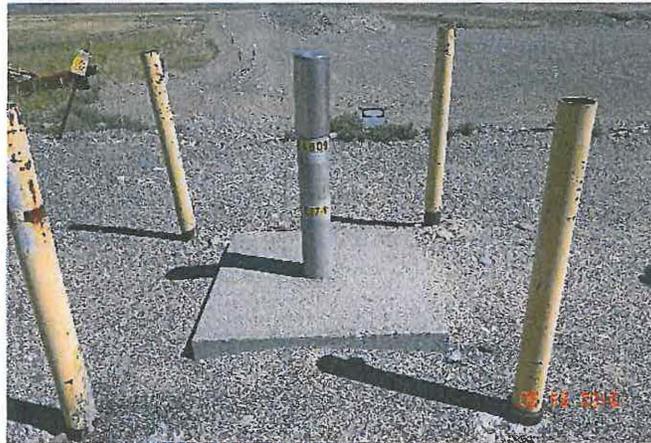
Photo #DSC01313, Cross-Gradient Well 299-E27-11 for Low Level Burial Grounds Green Islands

I observed the following on the Cross-Gradient Well 299-E27-11:

- The well did not have a Washington State identification tag with unique well identification number on the well casing that was visible above the land surface.
- The well had a cap that was locked on top of the casing.
- The well was protected from damage by four metal posts. The posts were over three inches in diameter, over three feet above the land surface, and were over two feet away from the well casing.
- The well protection measures appeared to not be damaged; however I observed approximately 10 percent coverage of rust on the protective posts.

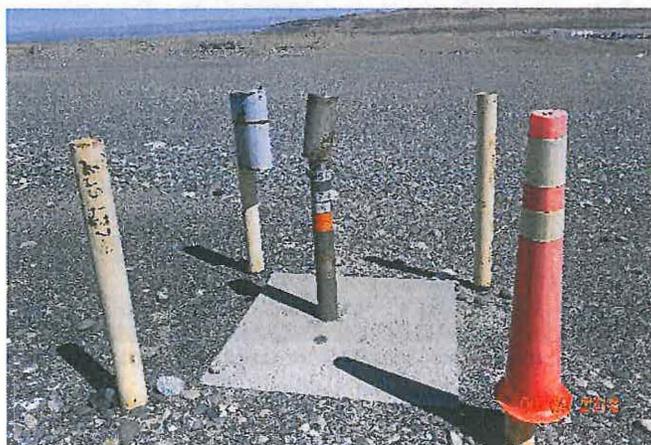
Photo #DSC01314, Down-Gradient Well 299-E27-8 for Low Level Burial Grounds Green Islands

I observed the following on the Down-Gradient Well 299-E27-8:

- The well did not have a Washington State identification tag with unique well identification number on the well casing that was visible above the land surface.
- The well had a cap that was locked on top of the casing.
- The well was protected from damage by four metal posts. The posts were over three inches in diameter, over three feet above the land surface, and were over two feet away from the well casing.
- The well protection measures appeared to not be damaged.

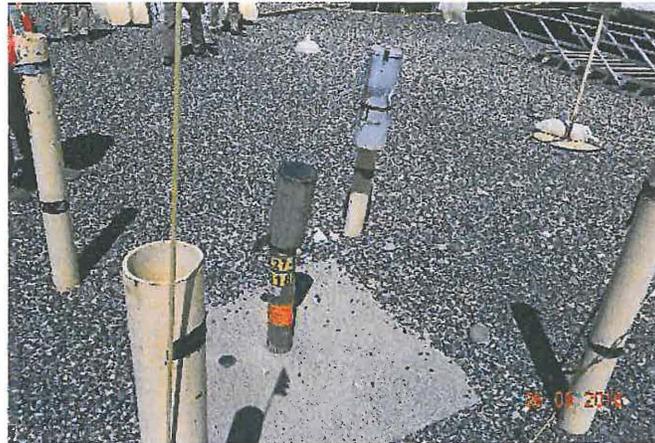
Photo #DSC01315, Down-Gradient Well 299-E27-9 for Low Level Burial Grounds Green Islands

I observed the following on the Down-Gradient Well 299-E27-9:

- The well did not have a Washington State identification tag with unique well identification number on the well casing that was visible above the land surface.
- The well had a cap that was locked on top of the casing.
- The well was protected from damage by four metal posts. The posts were over three inches in diameter, over three feet above the land surface, and were over two feet away from the well casing.
- The well protection measures appeared to not be damaged.

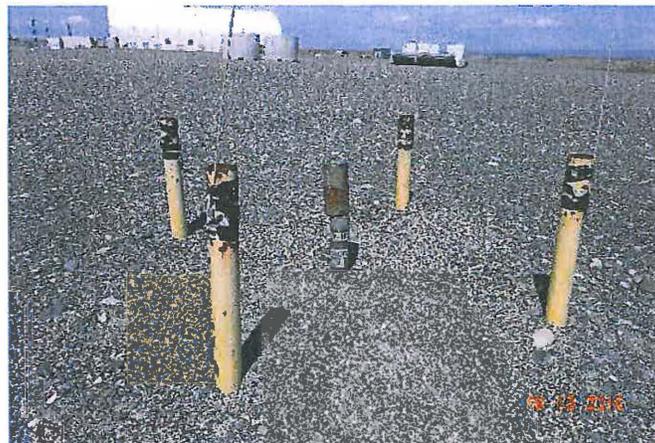
Photo #DSC01316, Down-Gradient Well 299-E27-10 for Low Level Burial Grounds Green Islands

I observed the following on the Down-Gradient Well 299-E27-10:

- The well did not have a Washington State identification tag with unique well identification number on the well casing that was visible above the land surface.
- The well had a cap that was locked on top of the casing.
- The well was protected from damage by four metal posts. The posts were over three inches in diameter, over three feet above the land surface, and were over two feet away from the well casing.
- The well protection measures appeared to not be damaged.

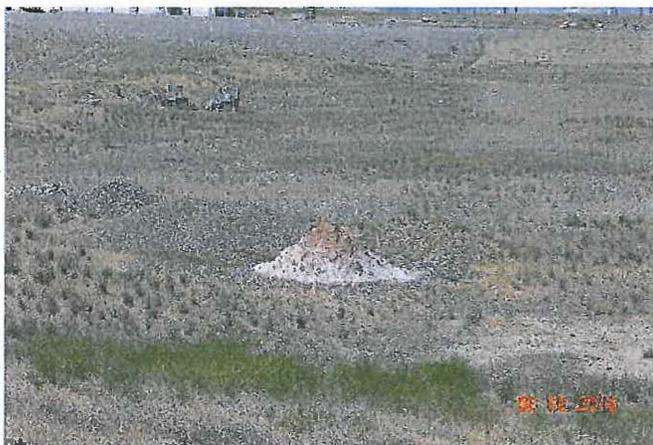
After inspecting the resource protection wells for the Low Level Burial Ground Green Islands Waste Management Area 2, we drove up onto the road just southeast from Trench 94. I observed an orange and white pile of unknown material in a pit to the south of Trench 94. I explained that I observed the pile during a previous inspection and I wanted to inquire about the material. Mr. Oldham said that this was Mission Support Alliance's pit and that the pile was likely road salt used in the winter. Mr. Williams called a contact at Mission Support Alliance, but was not able to get an answer during this field inspection. Mr. Williams told me that I could ask the question and request an answer in my documents request. We left at 11:07 a.m. and drove back to Building 2753E. At Building 2753E we regrouped and then drove to the Non-Radioactive Dangerous Waste Landfill.

Photo #DSC01317, Pile of unknown material to the southeast from Trench 94

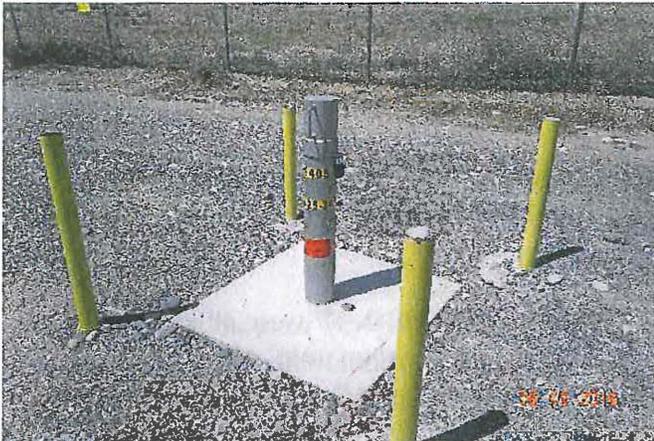
At 11:42 a.m., we arrived at groundwater Well 699-25-34F for the Non-Radioactive Dangerous Waste Landfill. I observed the following on Down-Gradient Well 699-25-34F:

- The well had a Washington State well identification tag on the well casing that was visible above the land surface with unique well identification number BJB 544.
- The well had a cap that was locked on top of the casing.
- The well was protected from damage by four metal posts. The posts were over three inches in diameter, over three feet above the land surface, and were over two feet away from the well casing.
- The well protection measures appeared to not be damaged.

Photo #DSC01318, New Down-Gradient Well 699-25-34F for NRDWL Photo #DSC01319, No Longer Used Down-Gradient Well 699-25-34A

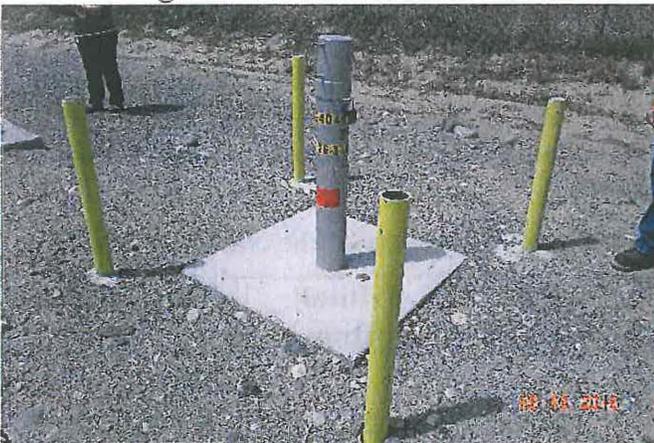
I observed the following on Down-Gradient Well 699-26-33A:

- The well had a Washington State well identification tag on the well casing that was visible above the land surface with unique well identification number BJB 546.
- The well had a cap that was locked on top of the casing.
- The well was protected from damage by four metal posts. The posts were over three inches in diameter, over three feet above the land surface, and were over two feet away from the well casing.
- The well protection measures appeared to not be damaged.

Photo #DSC01320, New Down-Gradient Well 699-26-33A for NRDWL Photo #DSC01321, No Longer Used Down-Gradient Well 699-26-33
