Washington Department of Ecology
Nuclear Waste Program
Compliance Report

Site: Waste Receiving and Processing Facility (WRAP)
RCRA Site ID: WA7890008967
Inspection Date: March 23, 2016
Site Contacts: Joel Williams, Regulatory Inspection Lead,
CH2M HILL Plateau Remediation Company (CHPRC)
Tony McKarns, Compliance
United States Department of Energy – Richland Office (USDOE-RL)
Phone: (509) 376-4782 **FAX:** N/A
Site Location: 200 West Area, Hanford Site
Benton County, Washington
At This Site Since: 1943 **NAICS#:** 56221, 924110, 54171
Current Site Status: Treatment, Storage, and Disposal Facility/Large Quantity Generator
Operating Unit Group # 7

Report Date: July 25, 2016
Index: #16.556
Report By: Nancy Ware

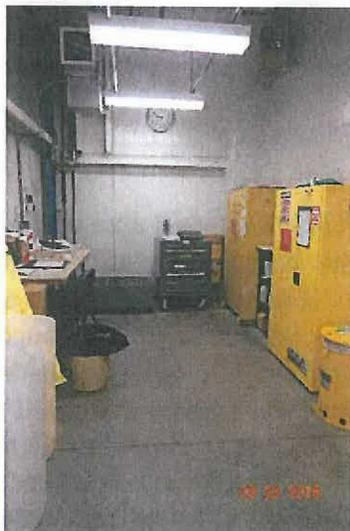
Photo # DSC01170, Building 2336W, Room 152

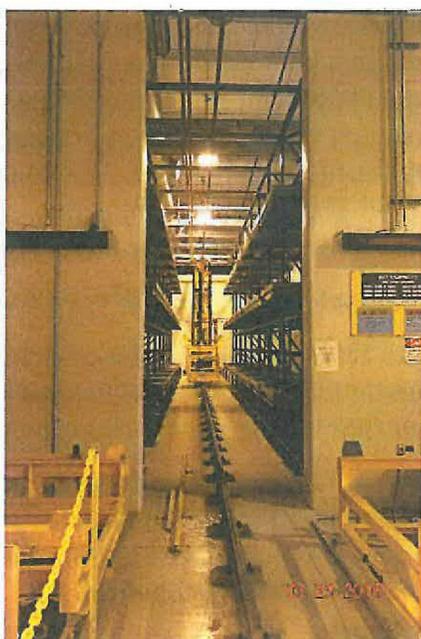
Photo # DSC01171, Automatic Drum Stacker

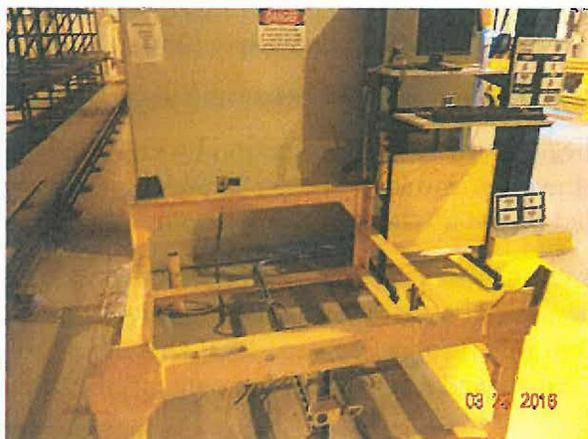
Photo # DSC01173, Pallet Stand for Container Inspections

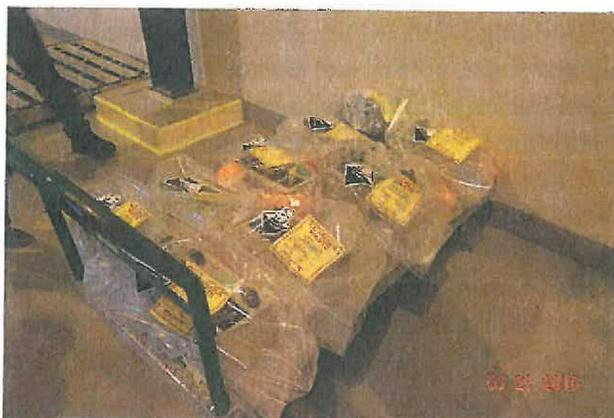
We walked around the corner to the left, and I observed nine plastic containers on a handcart. I observed that each container was a plastic bag, horse-tailed closed, and taped shut. I observed that the plastic bags contained batteries, and that the battery terminals had also been taped. I observed that each container was labeled as hazardous waste, corrosive, and had an accumulation start date of March 8, 2016. Mr. Mortensen told us that WRAP Operations had performed a maintenance campaign for the replacement of the uninterruptible power supply. He stated that ~60 batteries had been taken out of service during the campaign, and that they were able to recycle most of the batteries, with the exception of these nine lead-acid batteries. He said that containers were ordered to ship the batteries to an offsite TSD for treatment and disposal. Mr. Fulton added that the lead-acid batteries designated as D008 and WSC2 waste codes.

Photo # DSC01174, nine DW containers (lead-acid batteries)

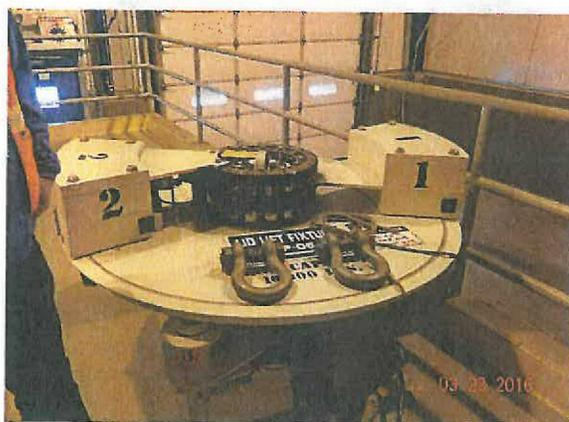
Photo # DSC01177, Automatic Center of Gravity Lifter

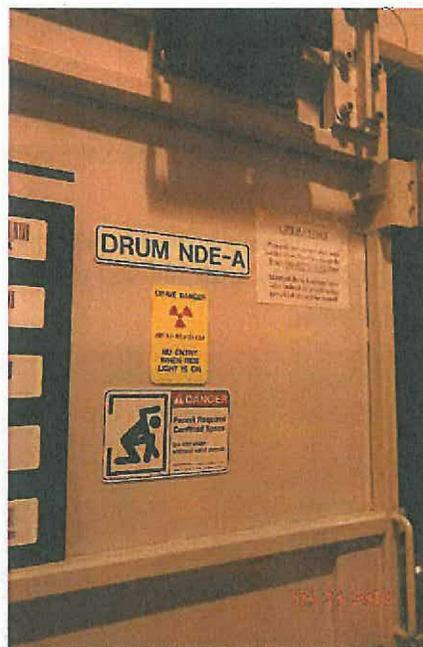
Photo # DSC01179, Drum X-Ray Machine (NDE)

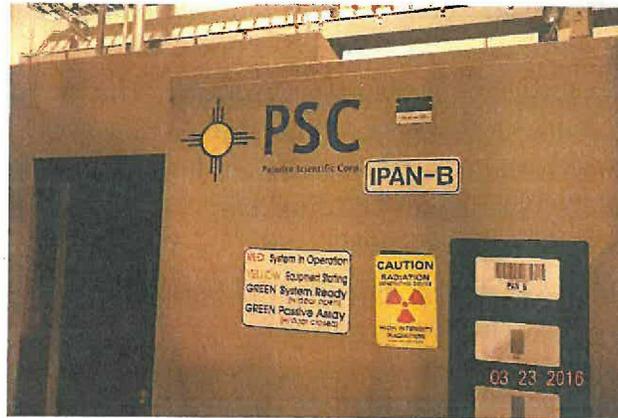
Photo # DSC01182, Image Passive Active Neutron Machine (NDA)

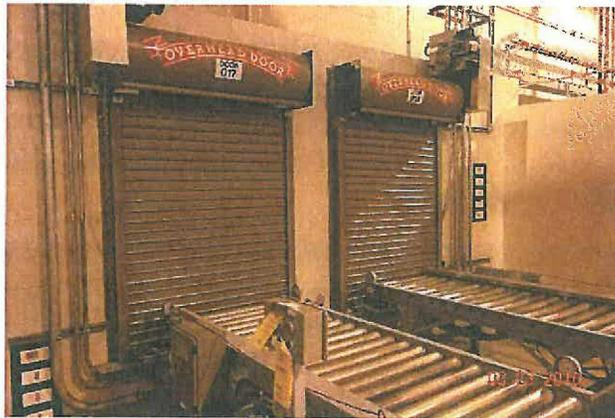
Photo # DSC01184, Conveyor Belts to Gloveboxes

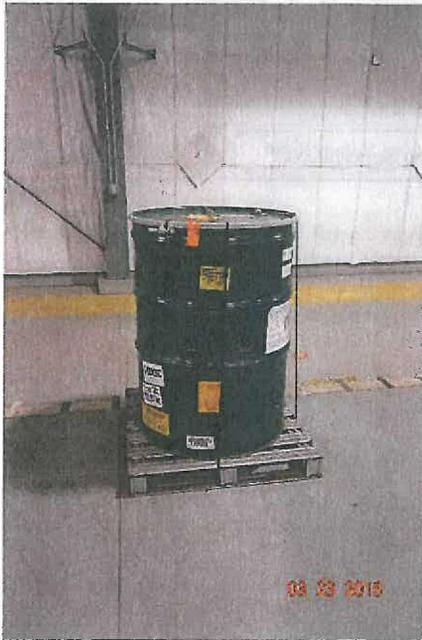
Photo # DSC01206, Container #0087221,
Hazardous Waste and Toxic

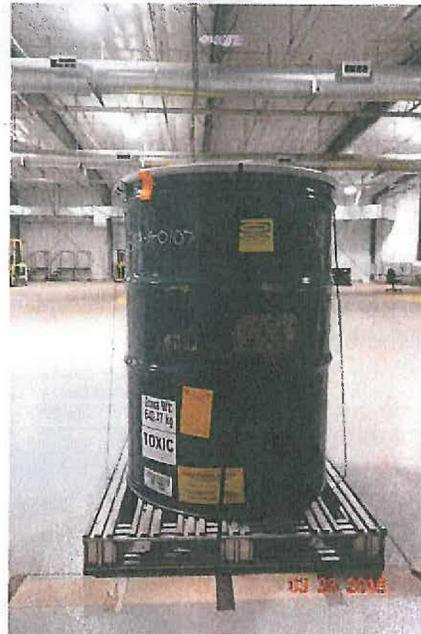
Photo # DSC01207, Container #0087223,
Hazardous Waste and Toxic

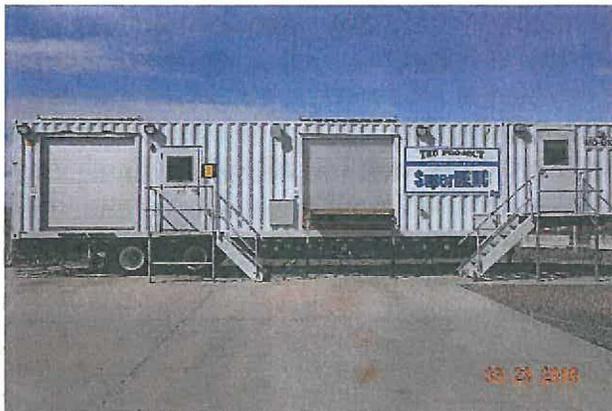
Photo # DSC01214, MO-610 Building SuperHENC

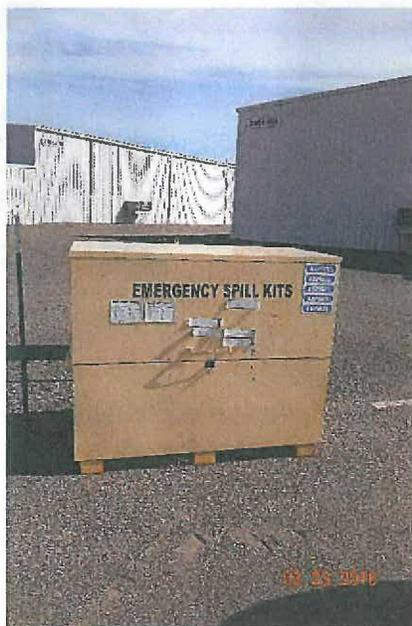
We walked back to the location of the emergency spill kits box, and I observed that the box was sealed when we arrived. Mr. Fulton broke the seal and opened the box. Inside the box I observed ropes, chains, absorbent, gloves, markers, shovels, spill pigs, and radiological posting signs. Mr. Fulton called an NCO to reseal the box.

Photo # DSC01199, Emergency Spill Kits Box
