RPP-ENV-37956, Rev. 2

# Hanford 241-A/AX Farm Leak Inventory Assessment Report

# **HANFORD 241-A AND 241-AX TANK FARMS LEAK INVENTORY ASSESSMENT REPORT**

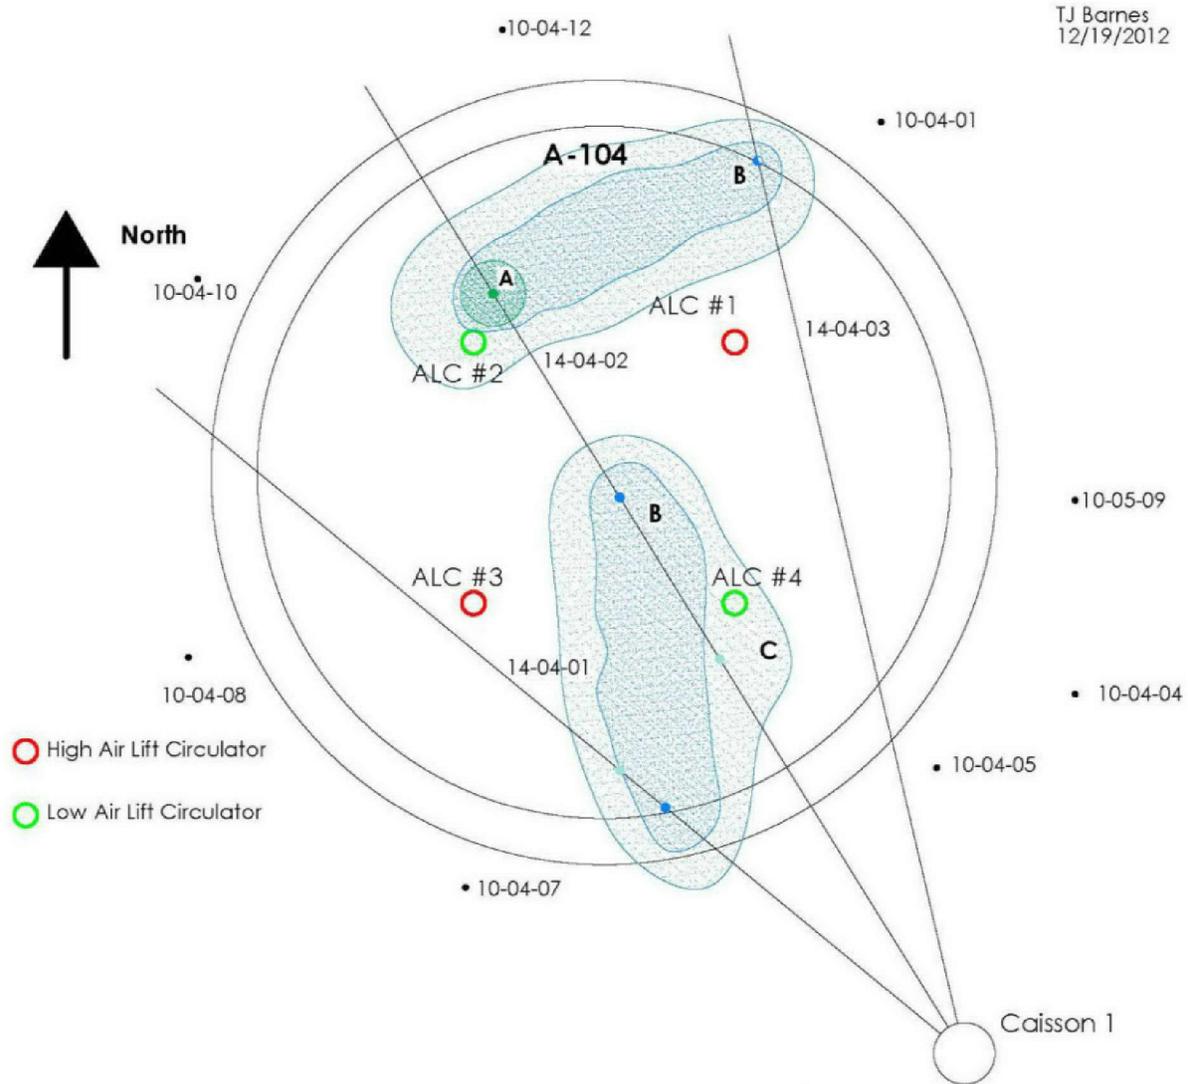
**Figure 4-1. Tank 241-A-104 Possible Leak Locations and Indicators**

A	B	C
<b>March 1975</b>	<b>April 1975</b>	<b>May 1975</b>
Radioactivity first detected in lateral 14-04-02 in March 1975 in the northern portion of tank A-104 shortly after the start of sluicing the tank in September 1974. The peak radioactivity was reported at 100 cpm in lateral 14-04-02 at approximately 94-ft from the caisson. No radioactivity was detected in the other laterals or drywells during this time.	A week after initial radioactivity was detected in lateral 14-04-02, counts continued to increase in the northern portion of the tank. Thus, sluicing was halted on April 7, 1975. On April 8, 1975, radioactivity was first detected in lateral 14-04-01 and an additional peak was recorded in lateral 14-04-02, both in the southern portion of the tank. On April 21, 1975, radioactivity was first reported in lateral 14-04-03 in the northern portion of the tank. Tank A-104 was declared a confirmed leaker and supernatant was pumped out of the tank from April 9 through April 19, 1975.	In May 1975, additional peaks were detected in lateral 14-04-02 along the southern edge of the tank. Radioactivity in site B continued to slowly increase through 1975. Radioactivity in lateral 14-04-03 slowly increased in May 1975 and then slowly declined. The tank A-104 liquid level was reported at 6.5-in at the end of April 1975 and radioactivity in the laterals appeared to stabilize by the end of 1975. No radioactivity was detected in the surrounding drywells.

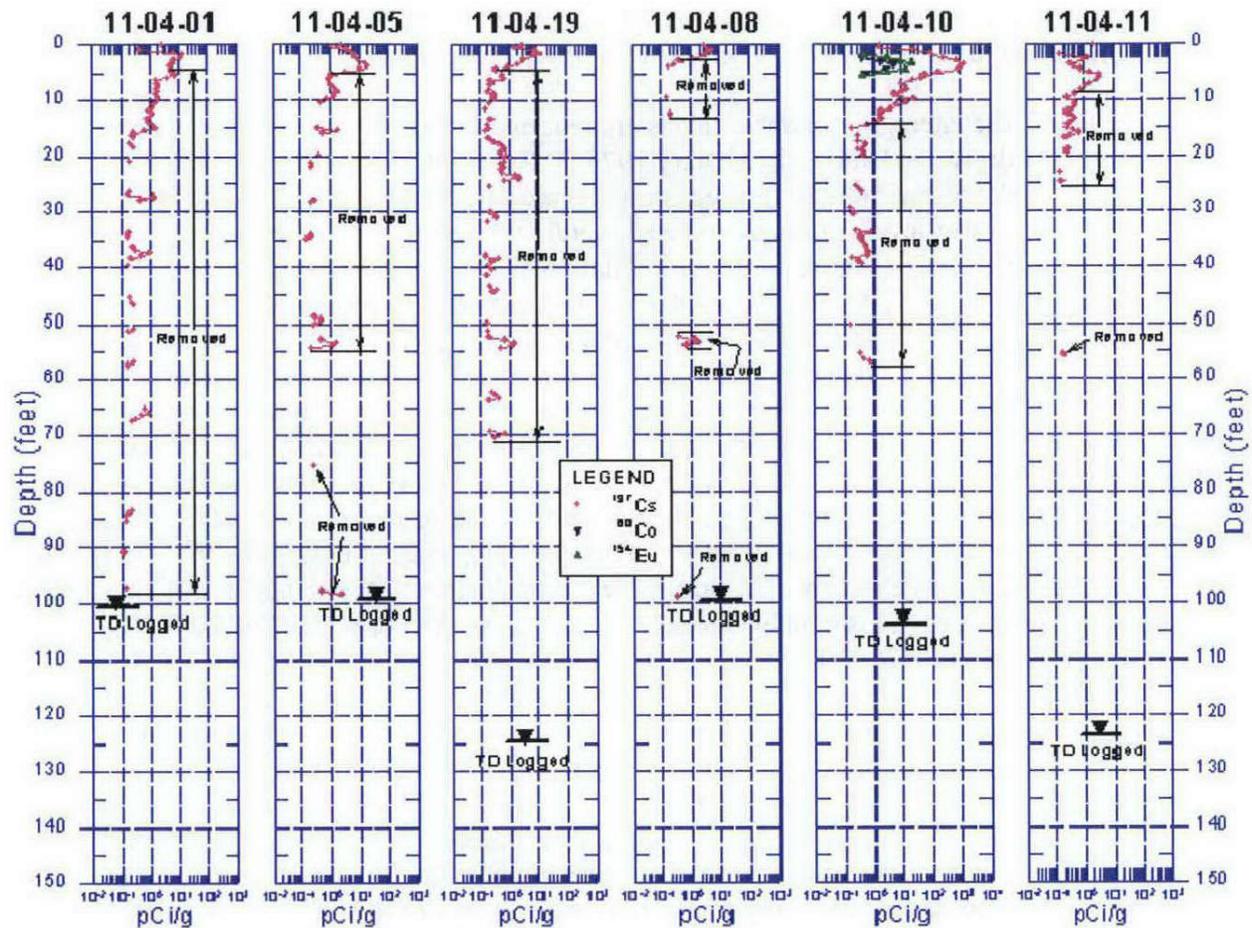
Figure 4-4. Spectral Gamma Log Data from AX-104 Drywells

- Two other drywells indicated elevated gross gamma contamination around tank AX-104. In drywell 11-04-08, elevated gross gamma measurements (up to 350 c/s) were measured in 1977 and 1978 between 60 and 65 ft bgs. A reduction by half within a year's time suggests that  $^{106}\text{Ru}$  was the primary contributor. Whether this observation indicates a continuation of waste migration from the same source affecting drywells 11-04-01 and 11-04-11 is not clear, though the timing and radiation levels are consistent with that hypothesis. On the other hand, no indications of elevated gross gamma activity were observed at drywell 11-04-10, which is located between drywell 11-04-08 and the other

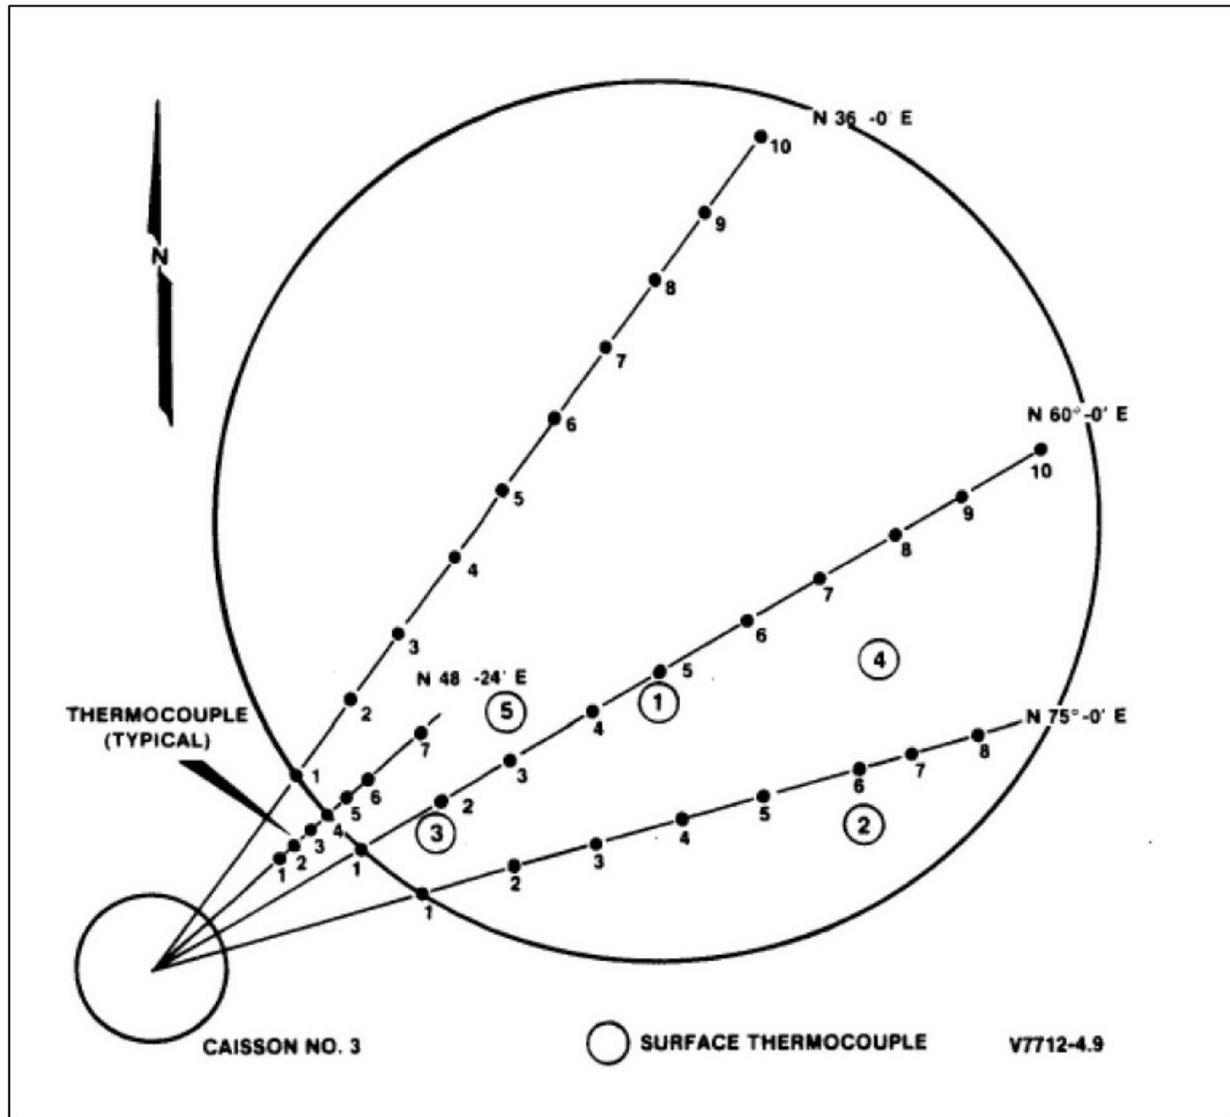
**Figure B3-7. Tank 241-A-105 Caisson #3 Temperature Laterals**

This indicates that the temperatures two feet under the tank were probably much higher in 1965 and 1966, which would have far exceeded the concrete temperature limit of 325 °F (RHO-CD-255, *Tank 105-A Stabilization Progress Report*). These thermocouples were no longer the hottest when the report was written in 1978, when the highest reading in lateral N 36°0'E was reported at thermocouple number 3 at 215 °F. Temperatures were later found to be higher beneath the bulged area of the tank and highest beneath the sludge pile above the liner. Figure B3-8 shows Surveillance Analysis Computer System temperatures for the laterals in Figure B3-7 from 1978 to 2014.

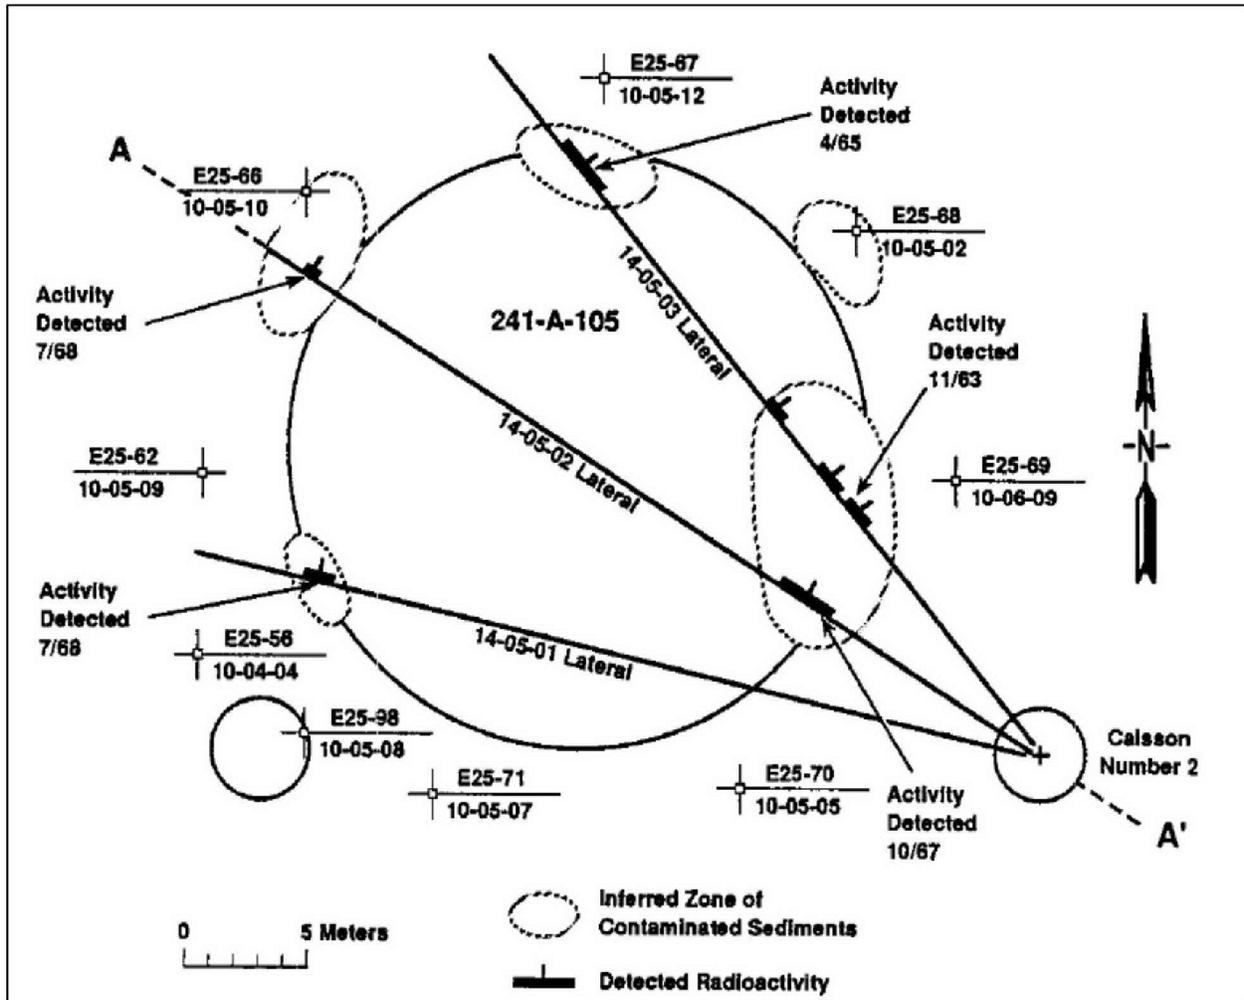
Figure B3-18. Location of Laterals and Gamma Activity for Tank 241-A-105

Note: The dates of lateral radioactivity increases and stabilization during August 1968 conflict between document WHC-MR-0264, *Tank 241-A-105 Leak Assessment* and WHC-EP-0412, *Fate and Transport of Constituents Leaked from Tank 241-A-105* and Interoffice Memorandum 7G420-06-004, "Estimation of Tank 241-A-105 Supernatant Cesium-137 Concentration During Sluicing in August 1968."
