Subject: Scanning Electron Microscopy for Sample from Purex A-006 Air Filter, Rev. 1

W603042 CHPRC Charred Filter

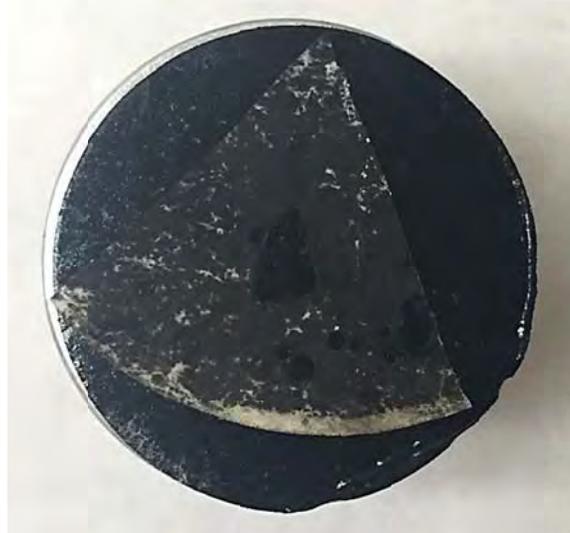
Figure 1. Quarter of the filter mounted on carbon tape.

The material received was made of an air filter, charred with visible holes. The filter was cut in half to be mountable on a 1" SEM stub. Carbon tape was used to mount the material and the stub was gold coated.

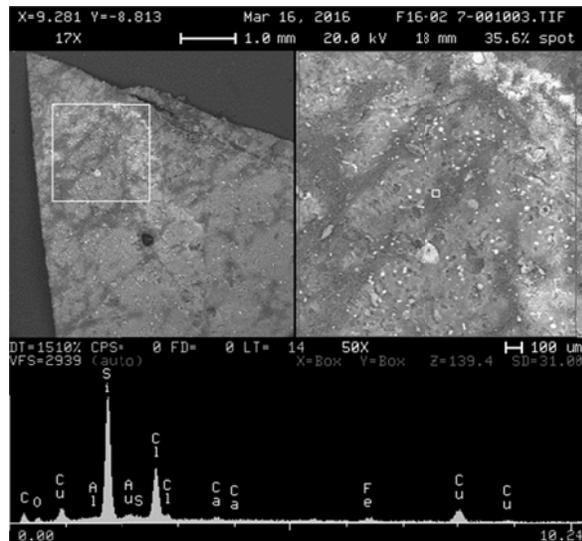
Investigation of center part:

(left) Base material contains Si, Cl, minor Cu & Fe.

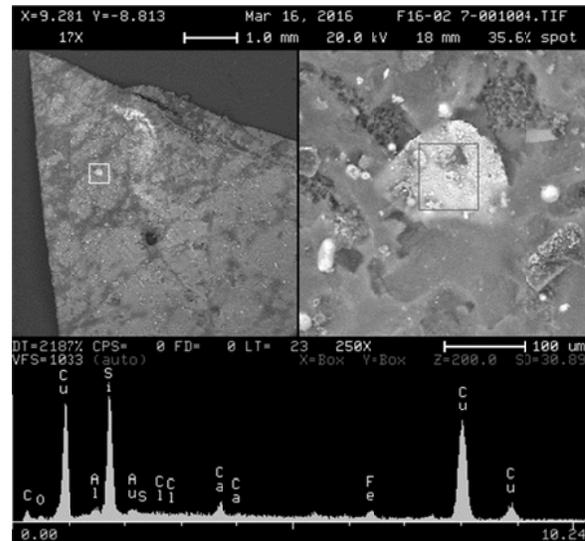
(right) Globule made of Si, Cu, minor Ca, Fe, Al.

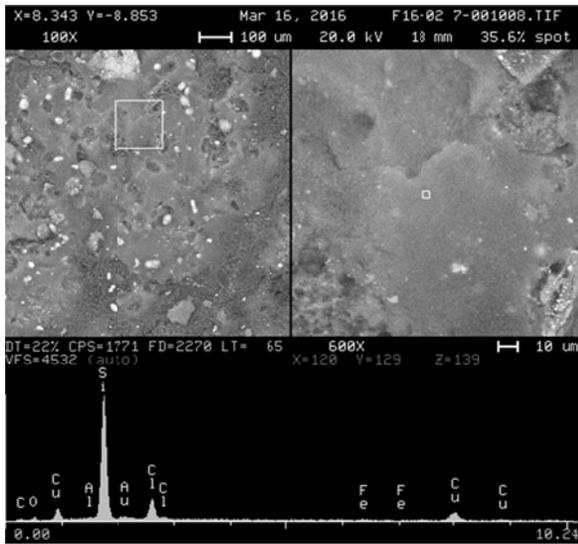
Investigation of middle part:

(left) Base material contains Si, Cl, minor Cu.

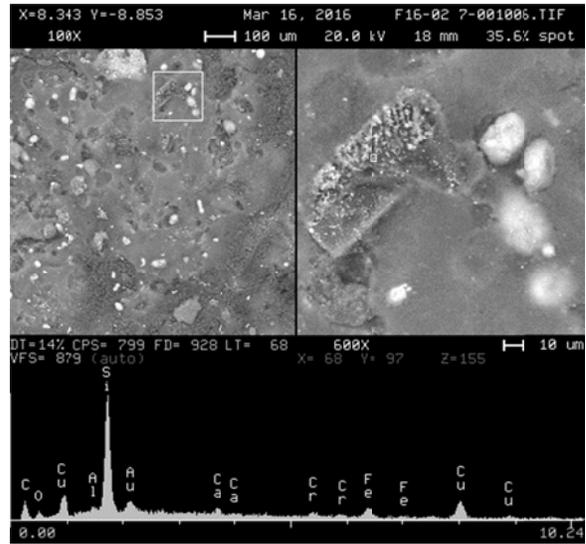
(right) Particle made of Si, Cu, minor Ca, Fe, Cr.

Note: spectrum above is aerial scanning over the whole region of the top right image.

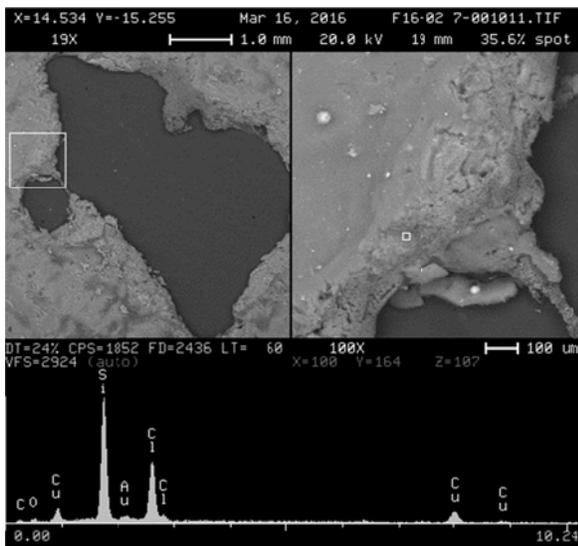
Investigation of hole:

(left) Base material contains Si, Cl, minor Cu.

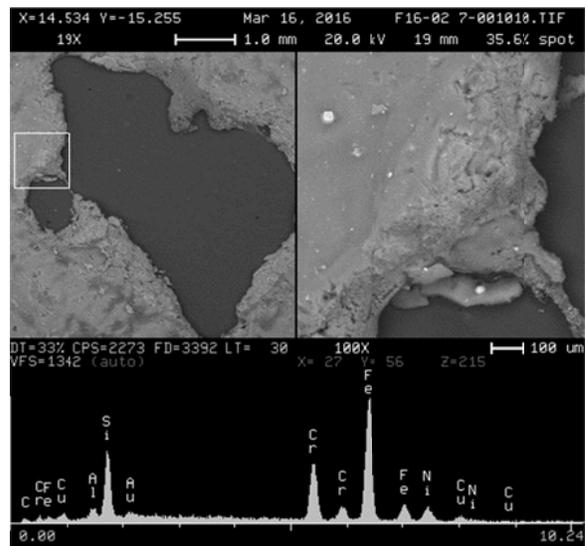
(right) Particle made of Fe, Si, Cr, minor Cu, Ni.

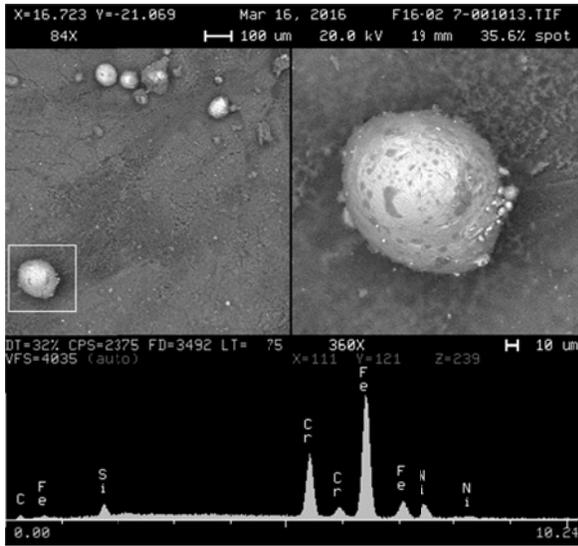
Investigation of globules/particles:

(left) Example of spherical particle.

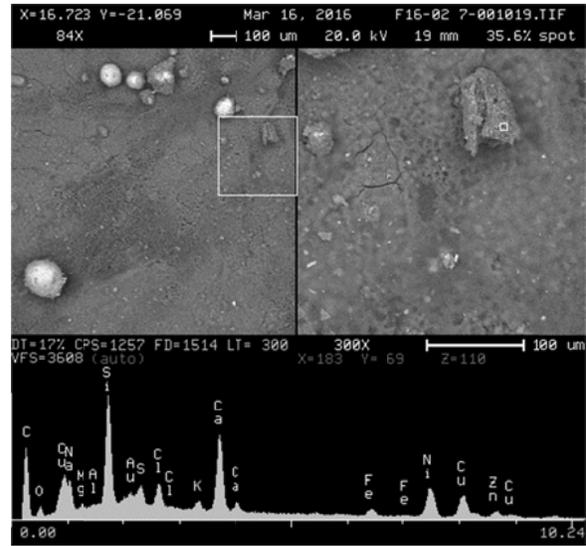
(right) Example of irregularly shaped particle.

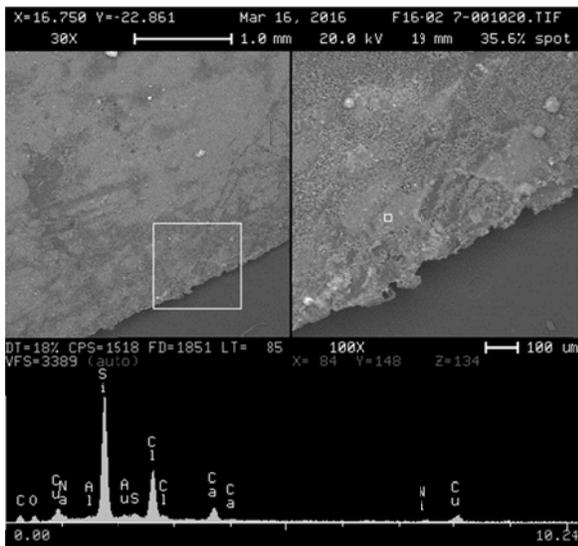
Investigation of rim area:

(left) Base material contains Si, Cl, minor Ca.

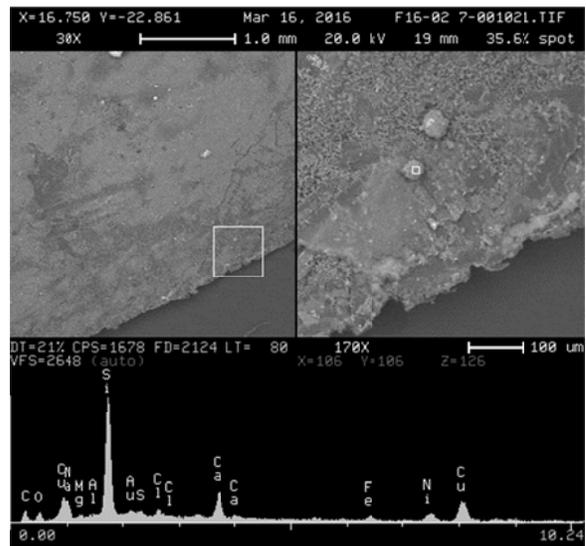
(right) Particle made of Si, Ca, minor Cu, Na.

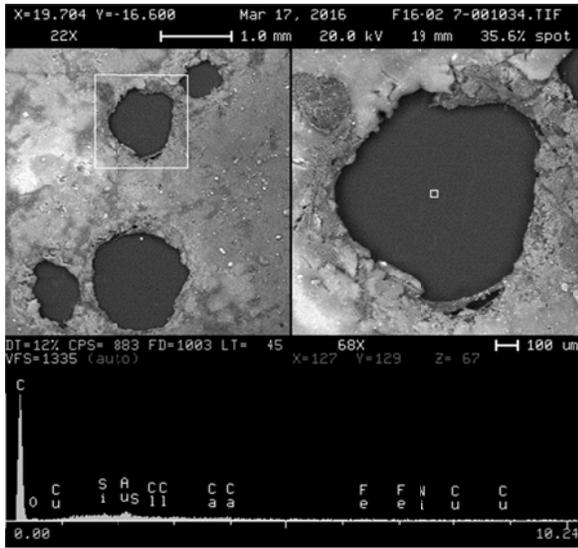
Investigation of carbon peak in “background”:

(left) Spectrum of carbon tape.

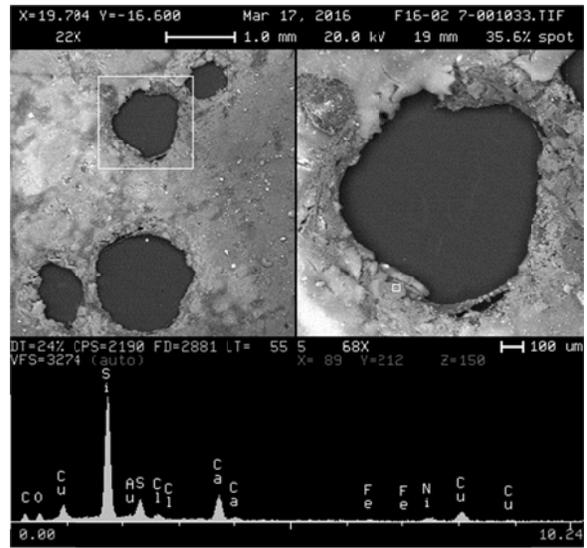
(right) Spectrum of background material.

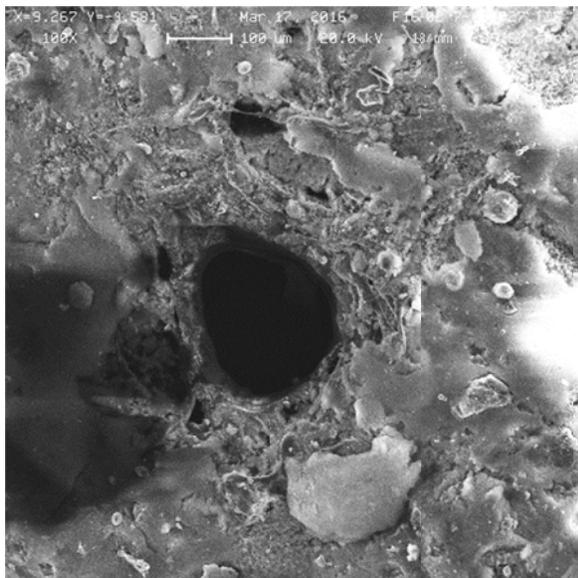
Investigation of different hole shapes:

(left) Overview of individual impact.

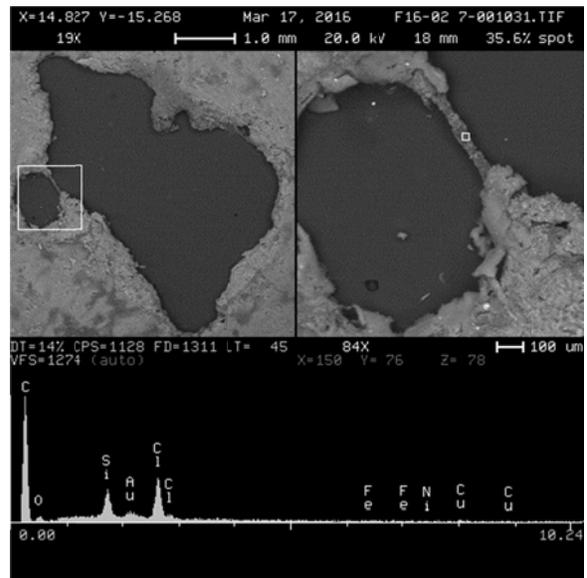
The sample was analyzed with both spot analyses and scanning analyses. The aim was to identify the nature of the black charring and to cover the center as well as the rim of the filter. One hole was in particular investigated for any differences in composition. From the optical appearance and from the chemical analyses it seems that individual impacts of 0.1 to 1 mm melted in some instances to larger holes.

(right) Images and spectrum of irregular hole.

The right image implies that several individual impacts melted together to form the currently visible form.

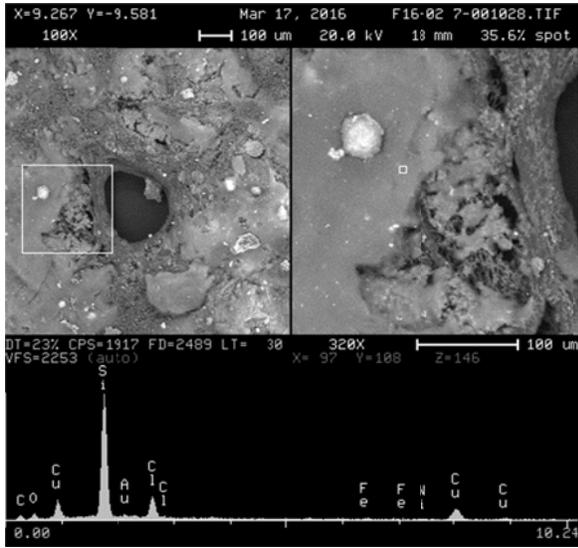
(left) Deposited material made of Si, minor Cu, Cl.

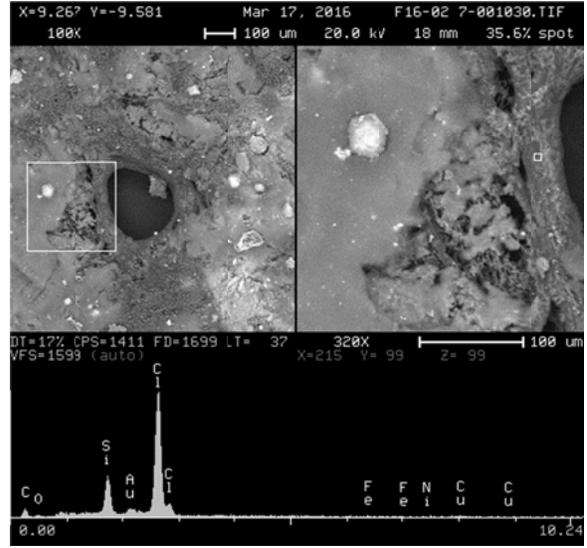
(right) Rim around holes is made of Si and Cl.
