Five-Year Surveillance Report for the 105-C, 105-D, 105-H, 105-F and 105-N/109-N Safe Storage Enclosures

Document Type: RPT

D. G. Ranade
Mission Support Alliance

Date Published
March 2016

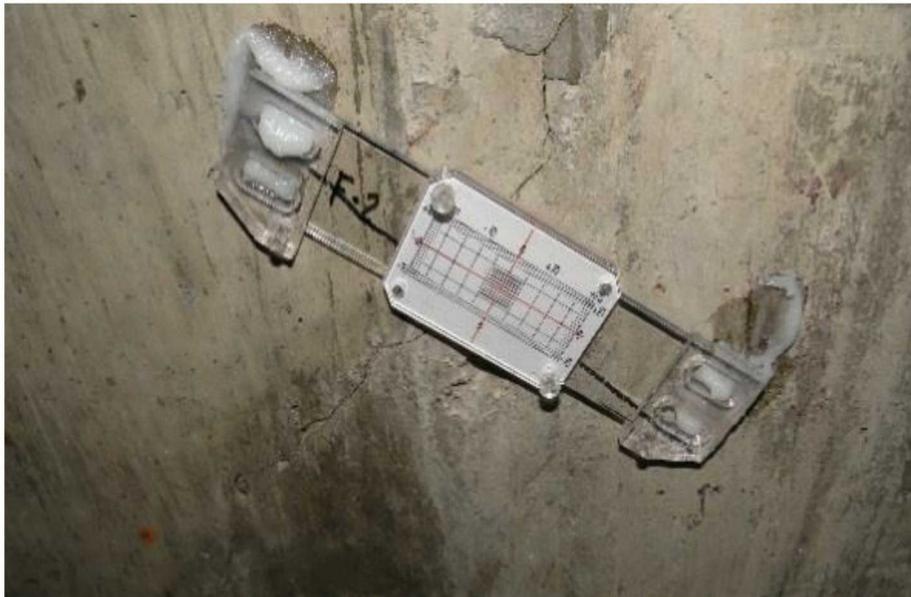
Figure 5. Crack Monitor Installed at 105-F.

Vertical cracks in the original concrete wall near and inside the vestibule were noted in the 105-F and 105-D SSEs. A crack monitor, shown in Figure 5, was installed in each of these SSEs to monitor any potential displacement along the cracks with time. It is interesting to note that similar cracks were observed in the 105-B Reactor building, which has construction very similar to the 105-F and 105-D SSEs. Bat guano and/or spider webs were present in all the SSEs. Live and dead bats were observed in some SSEs and evaluated by the IH for health and safety purposes. The inside conditions were dry in all of the SSEs and little or no evidence of water intrusion was noted. No evidence of groundwater intrusion was noted in any of the basement floors.

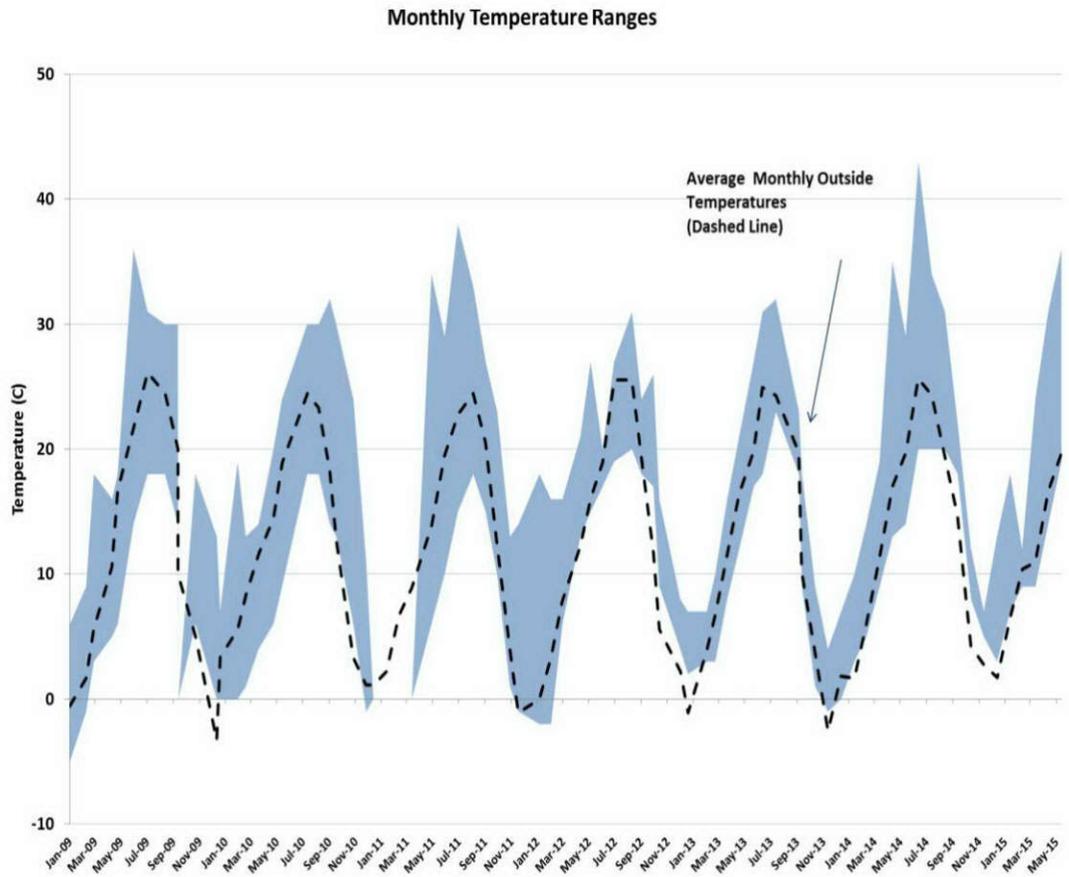
Figure 6. Monthly Temperature Readings and Average outside Temperature.

The temperature and flood-level sensors were operating within the acceptable ranges. A problem was observed with one backup temperature sensor reading in the 105-D SSE. It is not known whether the backup sensor is malfunctioning or the switch is malfunctioning. Data collected

since 2009 are presented in Figure 6. These data show that monthly maximum and minimum temperatures inside the SSE structures track with average outside temperatures. Additionally, none of the SSEs show evidence of surface water or groundwater flooding (alarm conditions) (Figure 7). Continued monthly monitoring of these systems may not provide any additional value.

4. Work with the Tri-Party agencies to discontinue the temperature and flood-level sensor monitoring. The data set to date clearly demonstrates that no upset conditions

(temperature or flooding) have been identified and the likelihood of future upset conditions is negligible.

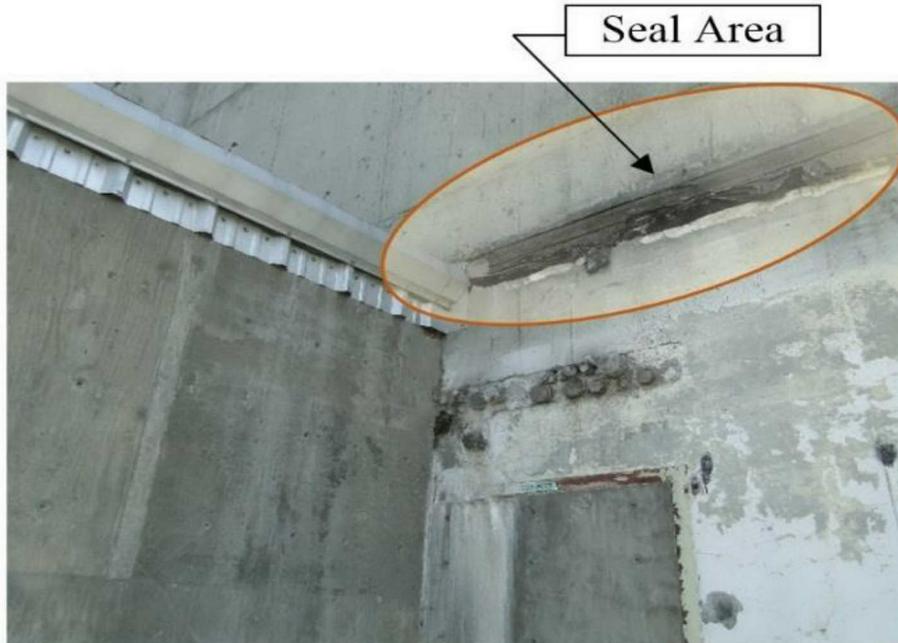
Figure 8. The Area to be Sealed at the 105-C SSE.

2. There is evidence of very slow water in-leakage at a pourback/roof structure junction at grade level; the leak is so slow as to only form white deposits, as shown in Figure 8.

The proposed action is to seal the outside area (Figure 8) where the in-leak may be occurring.

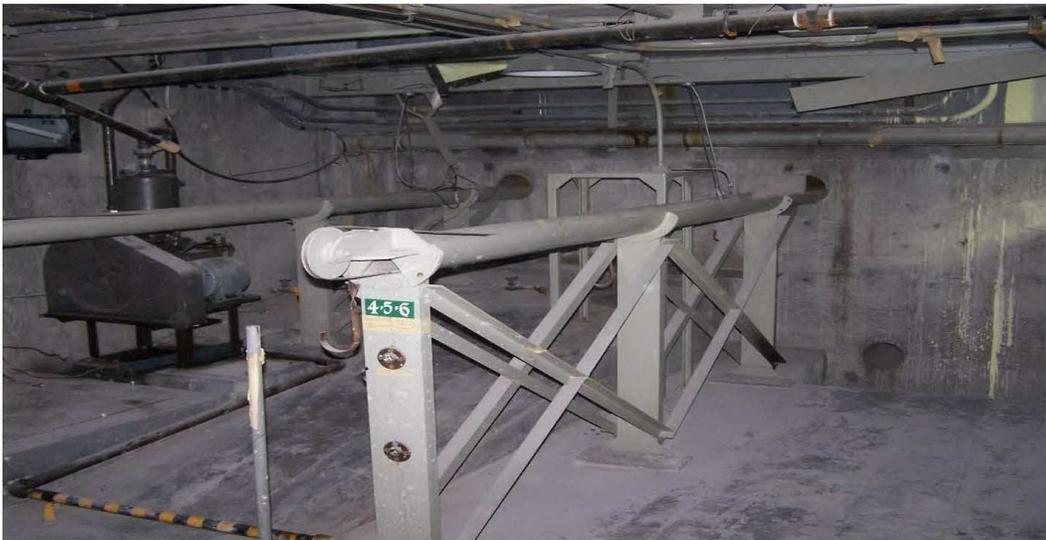
Photo 1- Showing how dusty/dirty floors are in 105 C

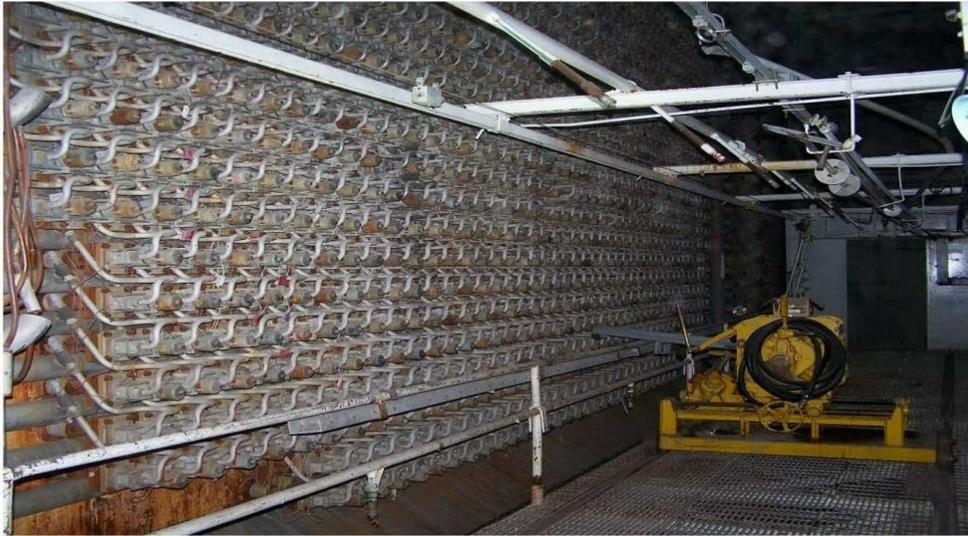
Photo 2- Rear face, only reactor that route leads to this, lots of left over items that are potentially hazardous.

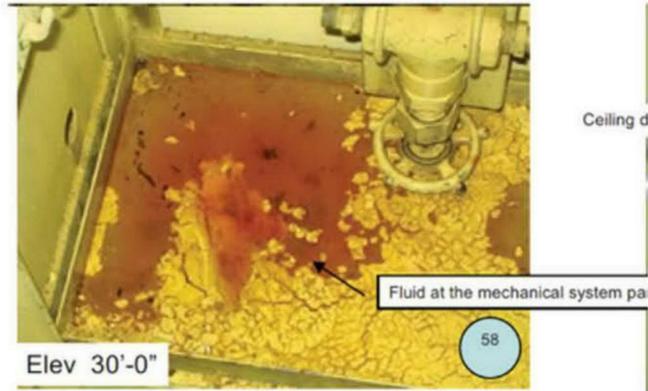
#	New Photo #	Description	Area / Location	Recommendation	Notes
Item # 58	3605	Unknown Liquid at a Mechanical System Component	Elev. 30'-0"	Recommend continuing observation and clean up / removal when possible	Hydraulic fluid is staying well within the equipment pan. Entire area 2' x 3x fluid is from op sys for shield door in pic 3607
	3601	Fluid on floor from overhead winch	Elev.. 30'-0"		
	3602	Overhead winch	Elev.. 30'-0"		
	3607	Shield door with hydraulic operating system	Elev.. 30'-0"		Slow drip releasing hydraulic fluid in pic 3605

Item 58 2008 – Unknown Liquid at a Mechanical System Component, Elev. 30'-0", recommend cleanup

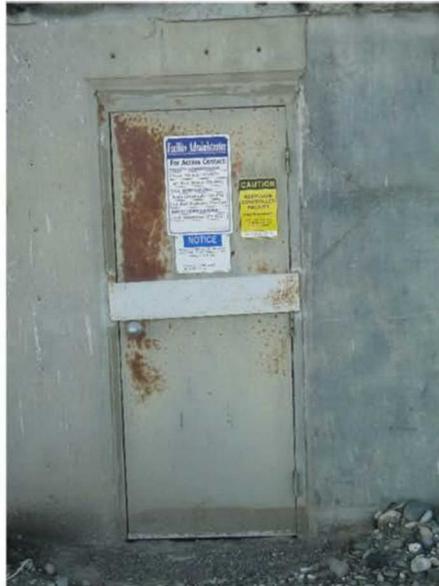
Item 33 – 2008 detail Metal Door at N Wall of Building Exterior, Elev. 0'-0", mild corrosion.

3640 Metal door @ N wall. Depression near door and mild corrosion

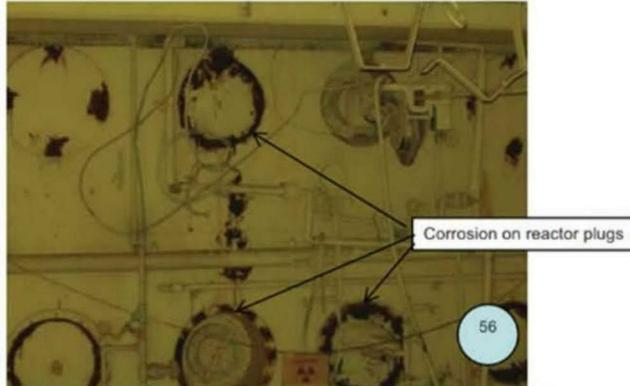
Item 56 2008 – Existing Reactor Block Wall, Elev. 30'-0", moderate corrosion

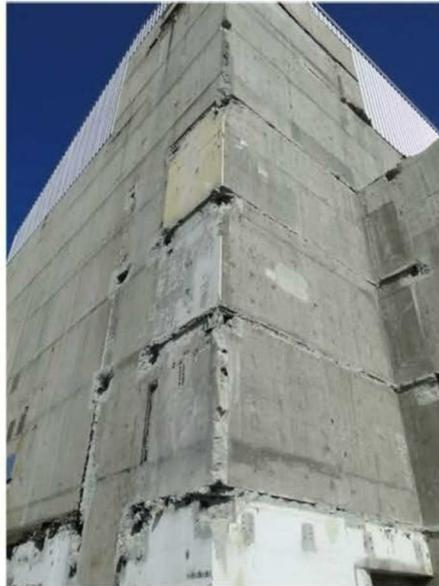
Item #4 2008 Detail Exposed aggregate and rebar at SW corner of building exterior- spalling

3648 demo damage no issue

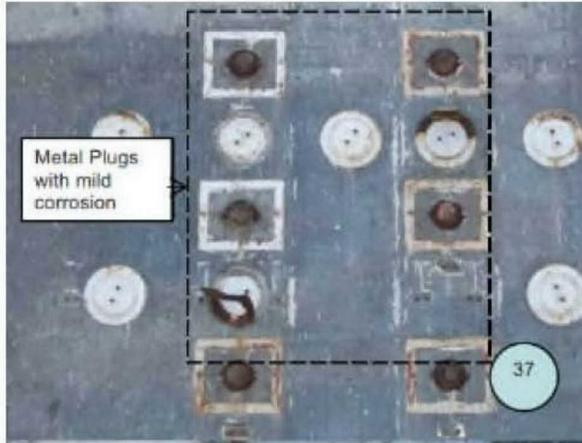
Item 37 – Exposed Metal Plugs at North Wall of Building Exterior, Elev. 0'-0", moderate corrosion

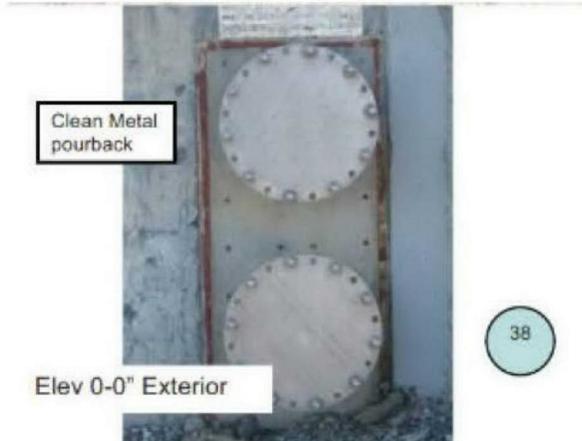
38 – Pourback ISS Detail at N Wall of Building Exterior, Elev. 0'-0", no visible defect

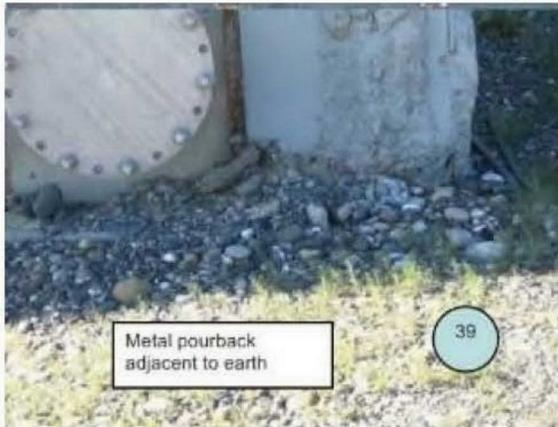
Item 39 – 2008 Detail Pourback ISS detail at N Wall of Building Exterior, Elev. 0'-0",
recommend soil removal

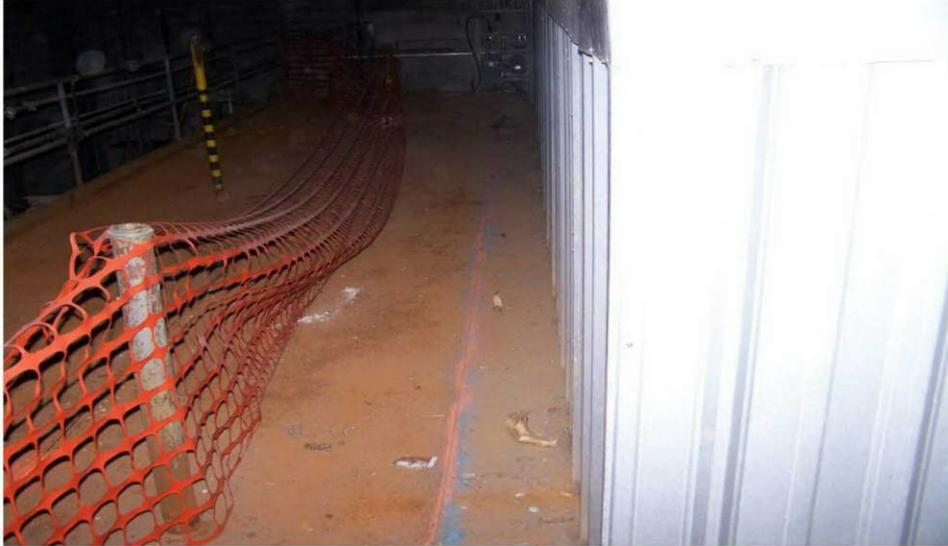
Photo 9 (Struck by hazard is actually on the back side of this tank, painted orange)

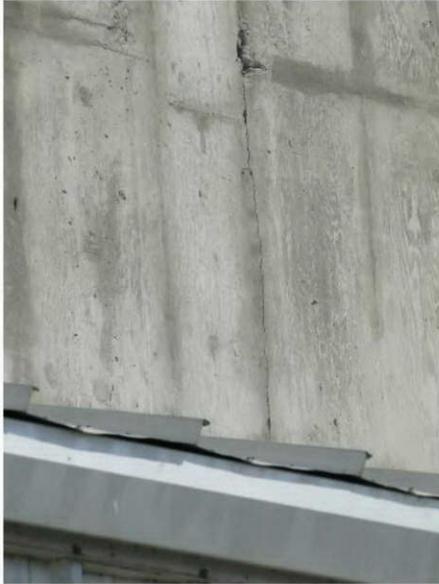
3676 Wall crack on exterior wall above vestibule

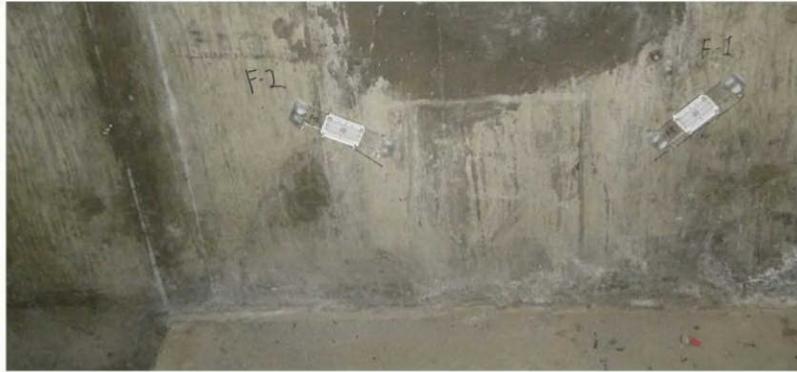
May 2015 update - Similar infills and cracks have been identified at both 105-D and 105-B (i.e., all of the original construction (1943) reactor buildings), along and below this infill. This confirms that this is not a demolition related or SSE construction issue.

Figure 1 – Crack Locations at top of stairs (after affixing Crack Monitors on 10/23/14)

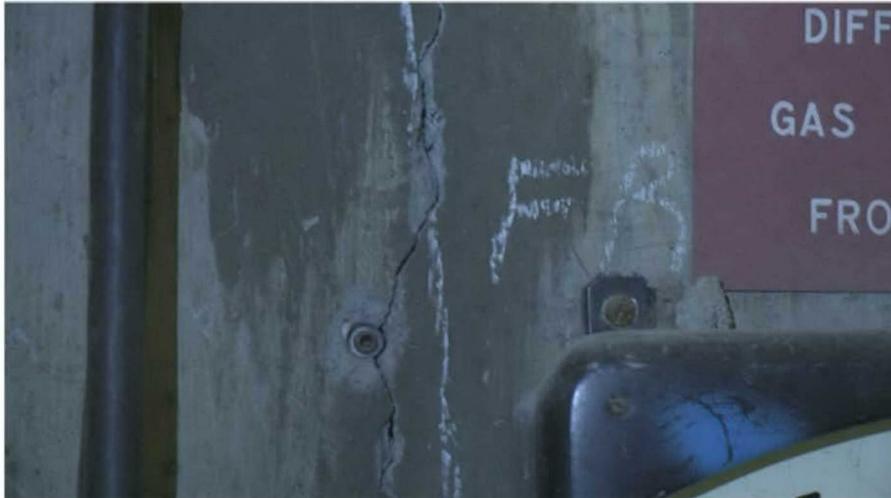
2981 Crack about 5 ft off floor

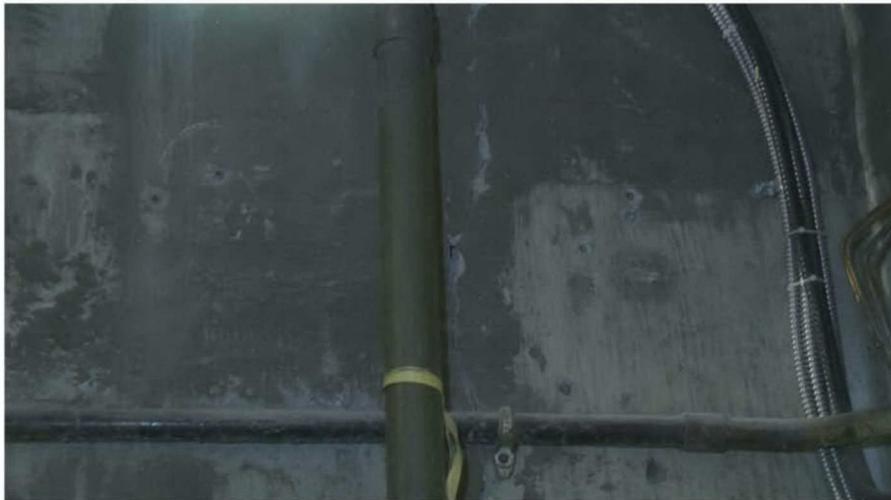
2982 Crack about 8 ft off floor

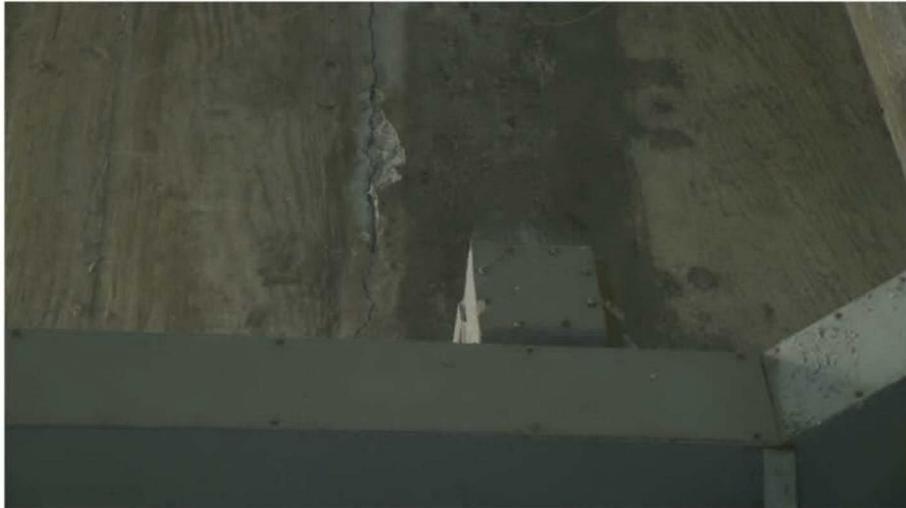
2014 Photo # 2984 Crack about 12 ft off floor

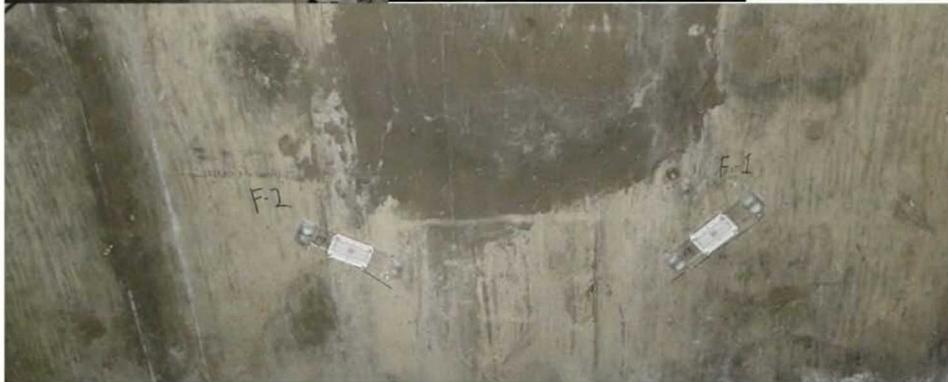
2014 Photos # 3124, 3125, 3119 As installed Crack Monitors at interior bottom corners of the infill

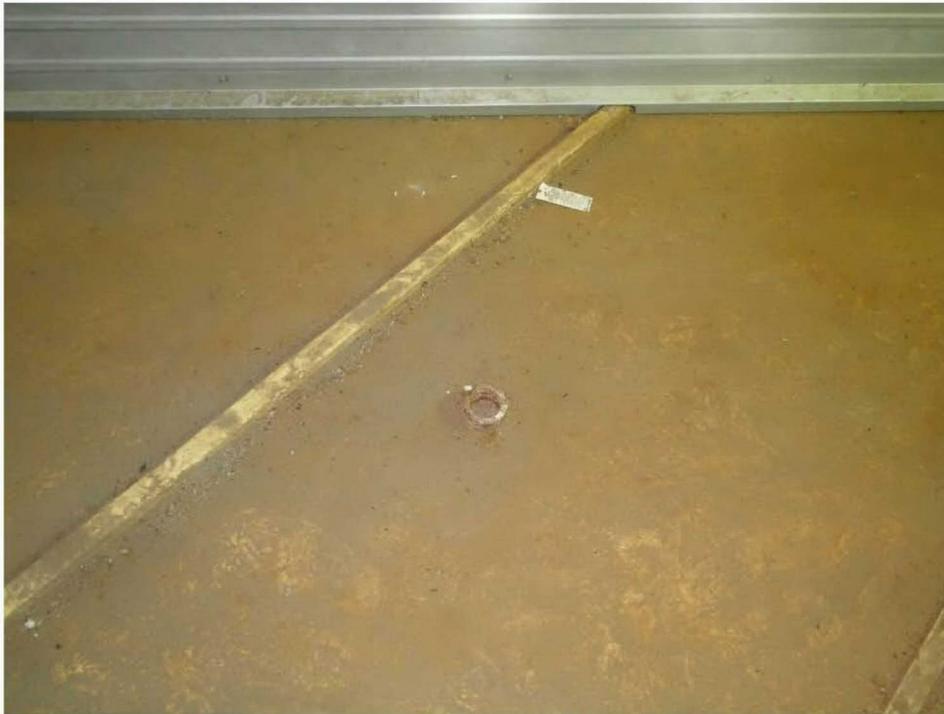
NEW ITEM 25A

3049 25A Contamination spot on SW corner next to top hat on floor

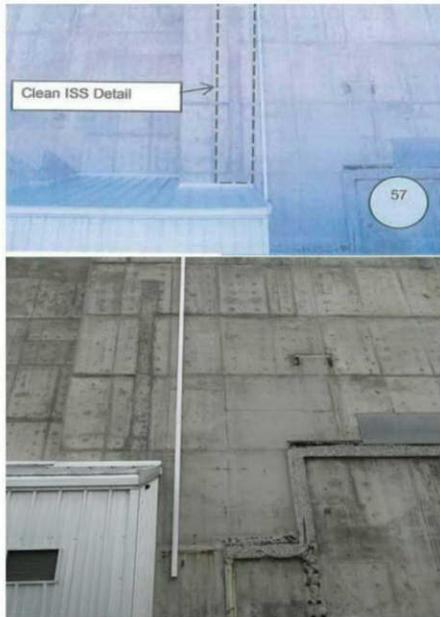
3015 Almost full length crack of south side of pourback. Next to downspout at vestibule. Concrete infill doesn't seem to be adhering to old wall. Crack goes all the way to interior. Refer back to 20A for further information.

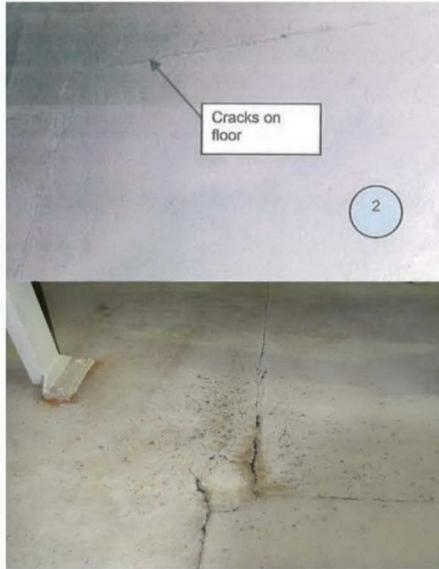
3023 Crack from 2008 was not obvious. No water stains on floor.

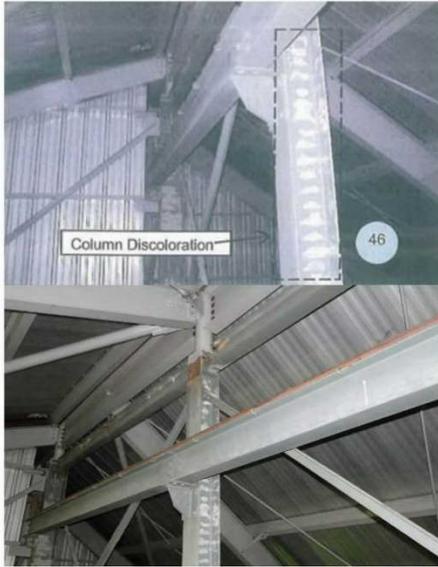
3066 no change since 2008. Discoloration confirmed to be grout stains from original CMU infill or Aged Red Lead coating. Remove from future surveillance.
