November 4, 2015

15-NWP-196

Re: Single-Shell Tank Dangerous Waste Compliance Inspection on March 30 and 31, 2015 at the Hanford Site, Resource Conservation and Recovery Act (RCRA) Site ID: WA7890008967, Nuclear Waste Program (NWP) Compliance Index No. 15.518

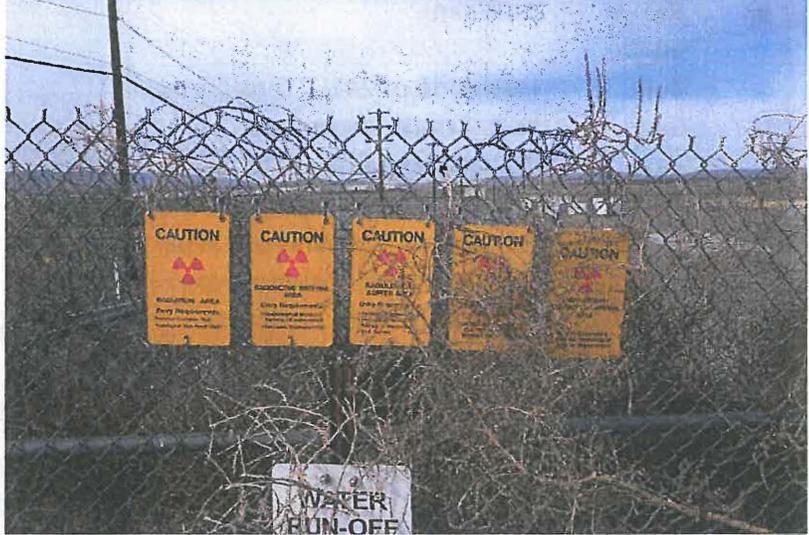
No.	Location	Activity Description/Comment	Photo
1.	200-W Single Shell Tank Farm 241-T	10:55 a.m. Posted signs on the Southeast corner of 241-T Tank Farm. Caution: -Radiation Area -Radioactive material Area -Radiological Buffer Area -Internally Contaminated Systems Located Within -Underground Radioactive Material Area White Sign states, "Water Run-Off Berm Do Not Disturb"

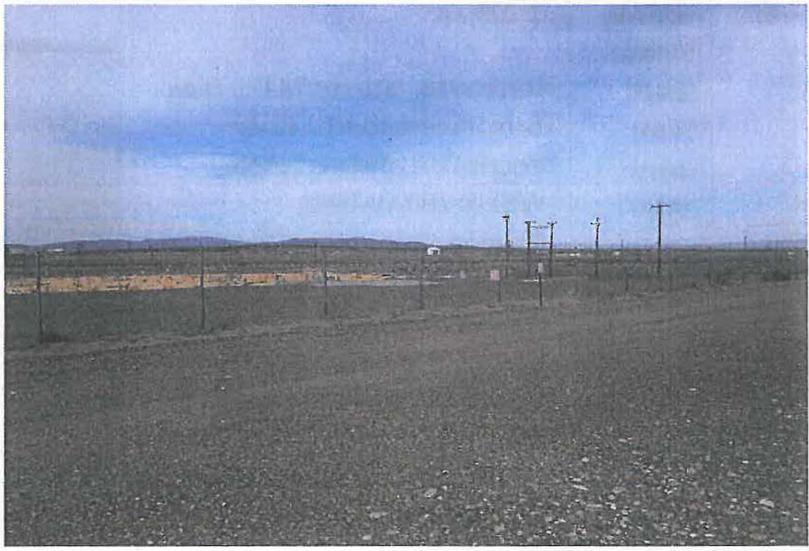
2.	200-W Single Shell Tank Farm 241-T	10:58 a.m. East side of 241-T Tank Farm, facing west. Sign on the berm states, "Water Run-Off Berm Do Not Disturb"

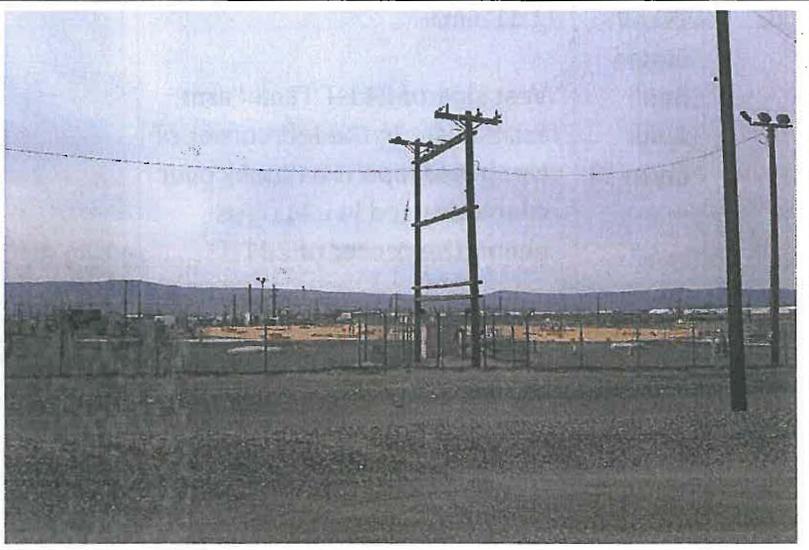
3.	200-W Single Shell Tank Farm 241-T	11:02 a.m. North side of 241-T Tank Farm, facing south.

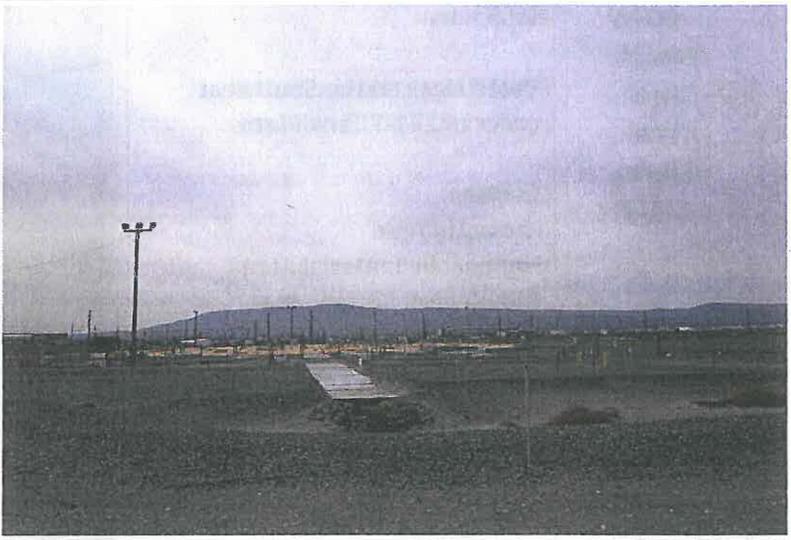
No.	Location	Activity Description/Comment	Photo
4.	200-W Single Shell Tank Farm 241-T	11:03 a.m. North side of 241-T Tank Farm, facing south. A covered drainage trench leads from inside the 241-T fence line into a drainage accumulation area. The trench and accumulation area is marked by radiation signs and a yellow/magenta chain.

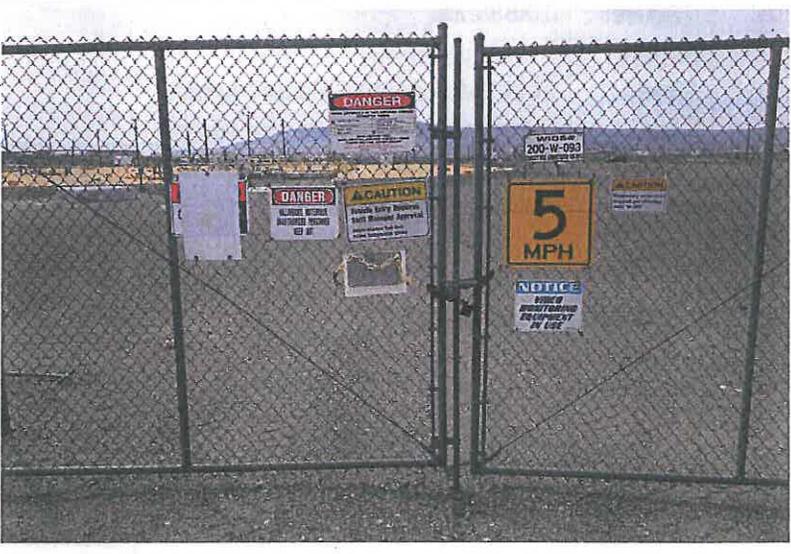
5.	200-W Single Shell Tank Farm 241-T	11:07 a.m. North side gate for 241-T Tank Farm, facing south. Brief description of signs below. -WIDS# 200-W-093 -Caution Respiratory Protection -Notice Video Monitoring -Danger Asbestos -Danger Hazardous Materials Unauthorized Personnel Keep Out -Caution Vehicle Entry Requires Shift Manger Approval

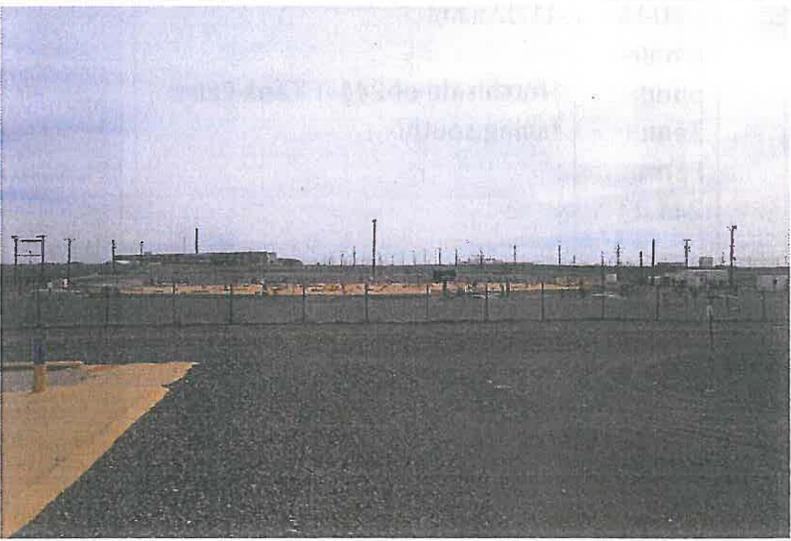
6.	200-W Single Shell Tank Farm - T	11:11 a.m. West side of 241-T Tank Farm, facing East. In the left corner of the photograph is a mock cover of what is used in 241-T, as seen in the center of 241-T.

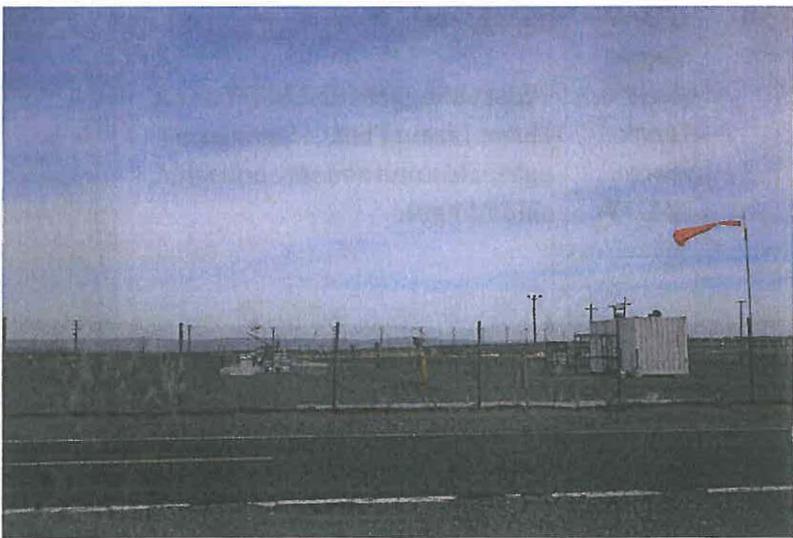
No.	Location	Activity Description/Comment	Photo
7.	200-W Single Shell Tank Farm - T	11:15 a.m. South side of 241-T Tank Farm, facing North.

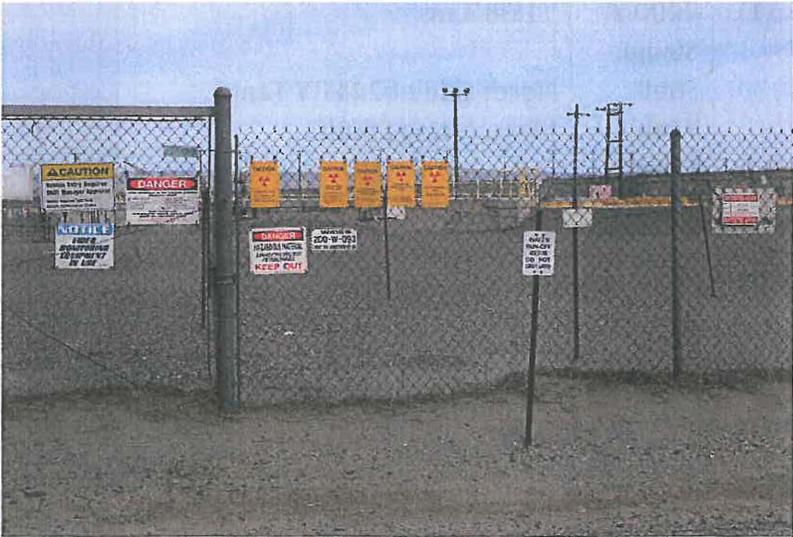
8.	200-W Single Shell Tank Farm - T	11:16 a.m. South side gate for 241-T Tank Farm, facing North. Signage on gate and right side of gate. The gate is located west of the change trailer MO-821.

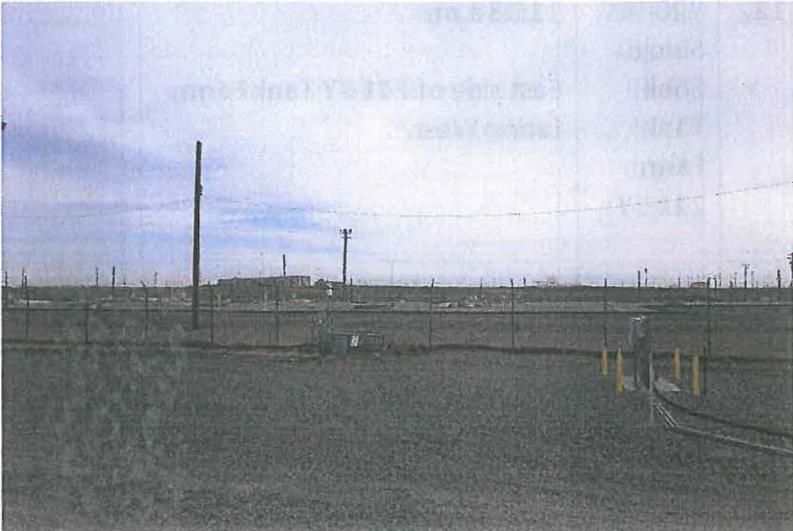
9.	200-W Single Shell Tank Farm 241-TY	11:30 a.m. West side of 241-TY Tank Farm, facing East. 241-TY has an asphalt cover.

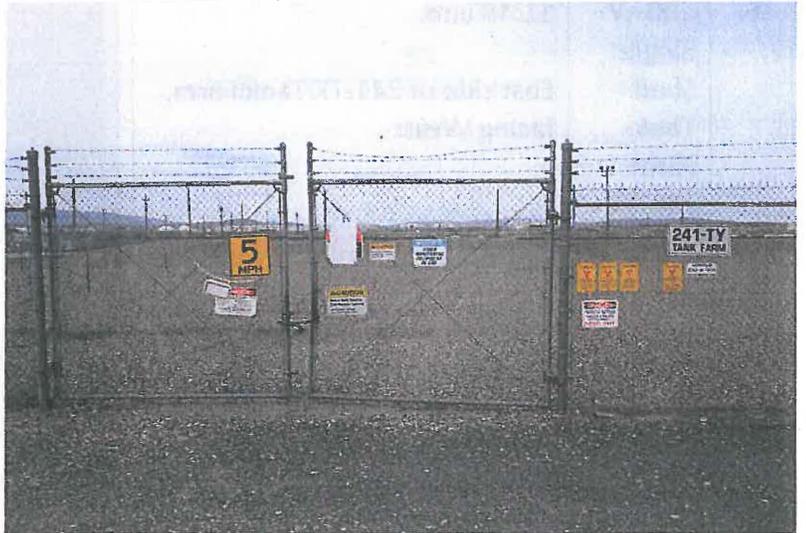
No.	Location	Activity Description/Comment	Photo
13.	200-W Single Shell Tank Farm 241-TY	11:41 a.m. East side gate for 241-TY Tank Farm, facing West. Signage on gate and right side of gate.

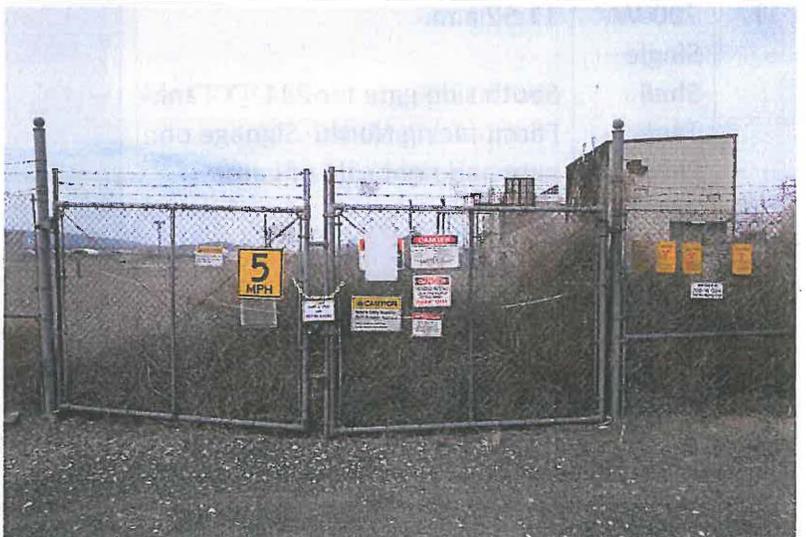
14.	200-W Single Shell Tank Farm 241-TX	11:46 a.m. East side gate for 241-TX Tank Farm, facing West. Signage on gate and right side of gate. The Building on the right side of the photograph is 241-T-601.

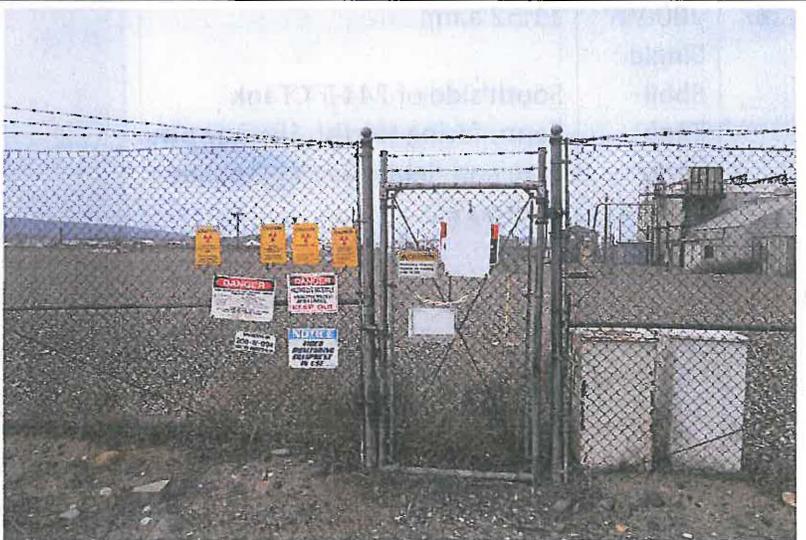
15.	200-W Single Shell Tank Farm 241-TX	11:47 a.m. East side gate for 241-TX Tank Farm, facing West. Signage on gate and left side of gate. The Building on the right side of the photograph is 241-T, which is adjacent to 241-T-601.

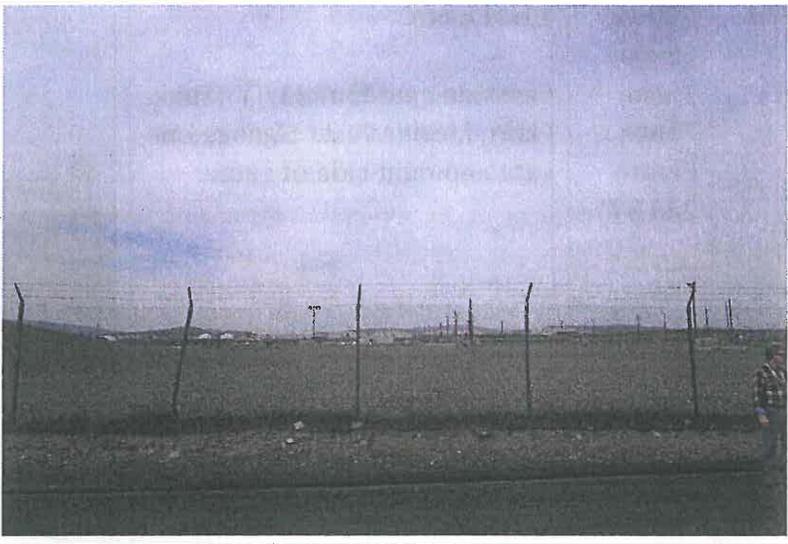
No.	Location	Activity Description/Comment	Photo
16.	200-W Single Shell Tank Farm 241-TX	11:48 a.m. East side of 241-TX Tank Farm, facing West.

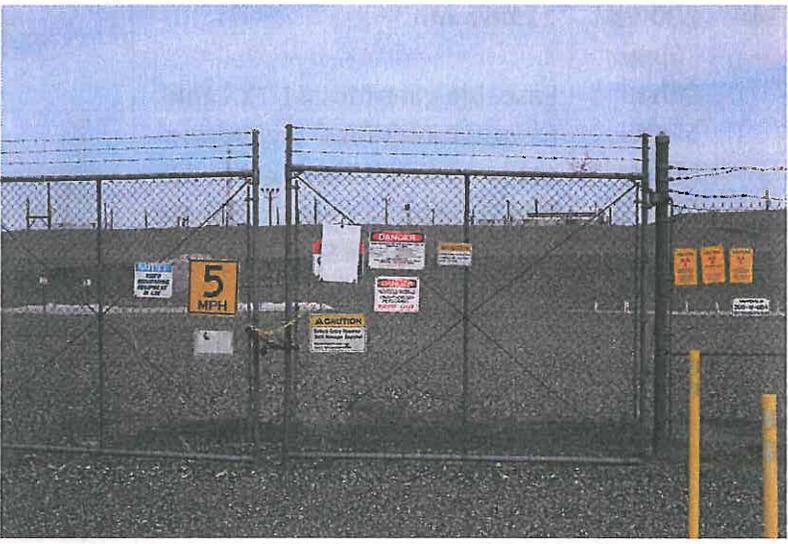
17.	200-W Single Shell Tank Farm 241-TX	11:52 a.m. South side gate for 241-TX Tank Farm, facing North. Signage on gate and right side of gate.

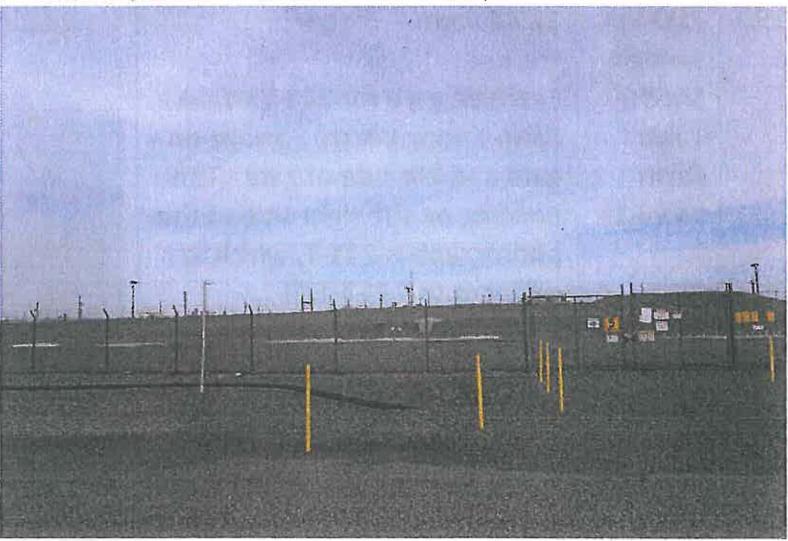
18.	200-W Single Shell Tank Farm 241-TX	11:52 a.m. South side of 241-TX Tank Farm, facing North. Signage on gate and right side of gate (See Photo 17).

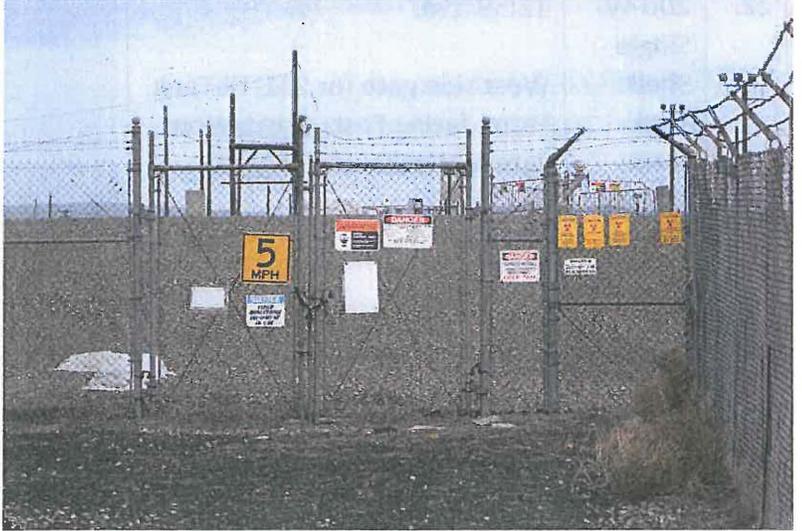
No.	Location	Activity Description/Comment	Photo
19.	200-W Single Shell Tank Farm 241-TX	11:54 a.m. Second South side gate for 241-TX Tank Farm, facing North. Signage on gate and right side of gate.

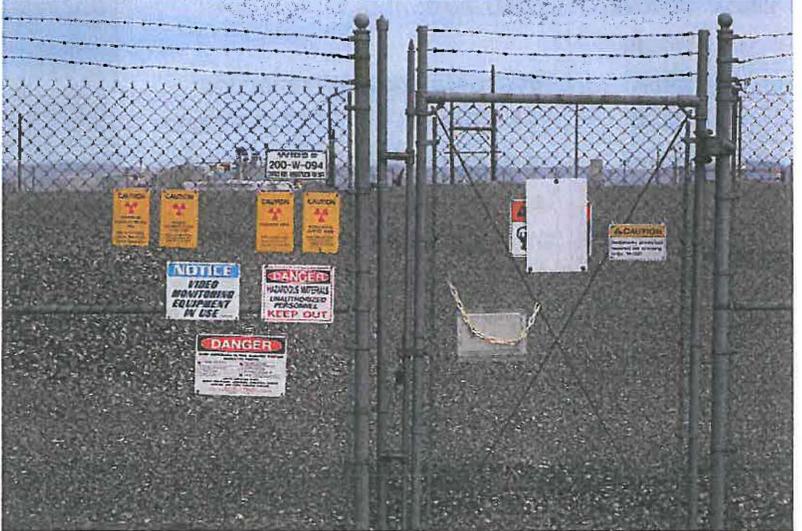
20.	200-W Single Shell Tank Farm 241-TX	11:54 a.m. Third South side gate for 241-TX Tank Farm, facing North. Signage on gate and left side of gate.

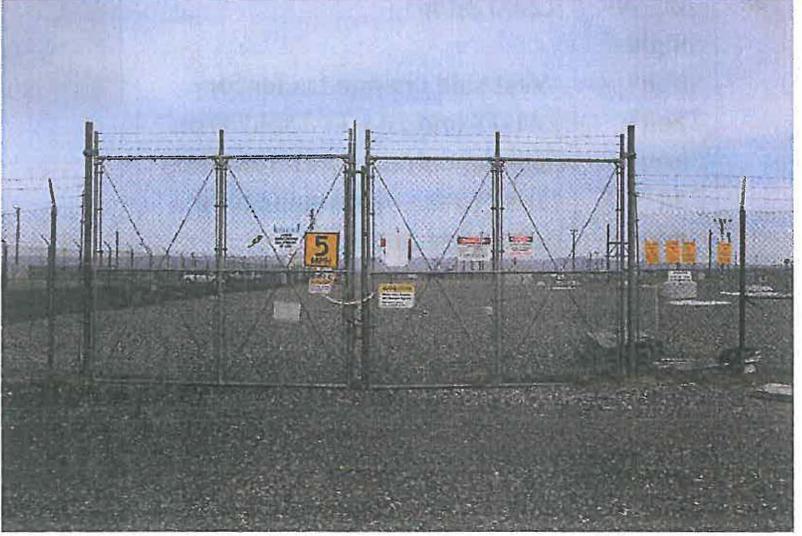
21.	200-W Single Shell Tank Farm 241-TX	11:57 a.m. Fourth South side gate for 241-TX Tank Farm, facing North. Signage on gate and right side of gate.

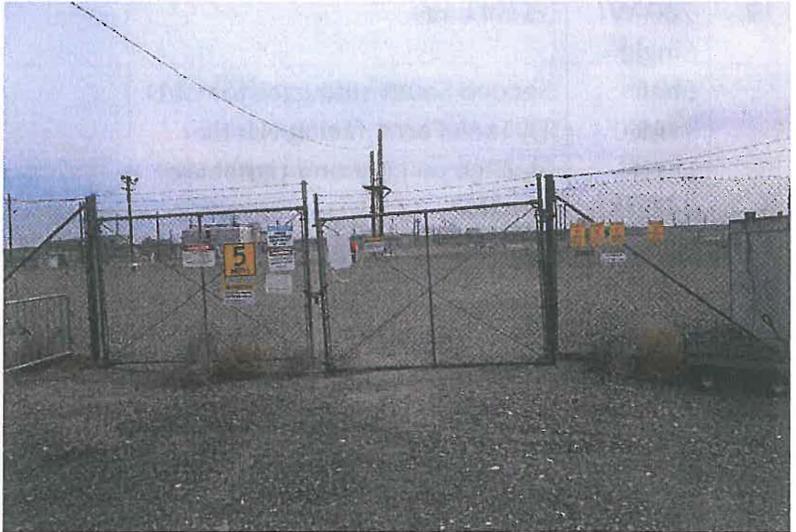
No.	Location	Activity Description/Comment	Photo
22.	200-W Single Shell Tank Farm 241-TX	11:59 a.m. West side gate for 241-TX Tank Farm, facing East. Signage on gate and right side of gate.

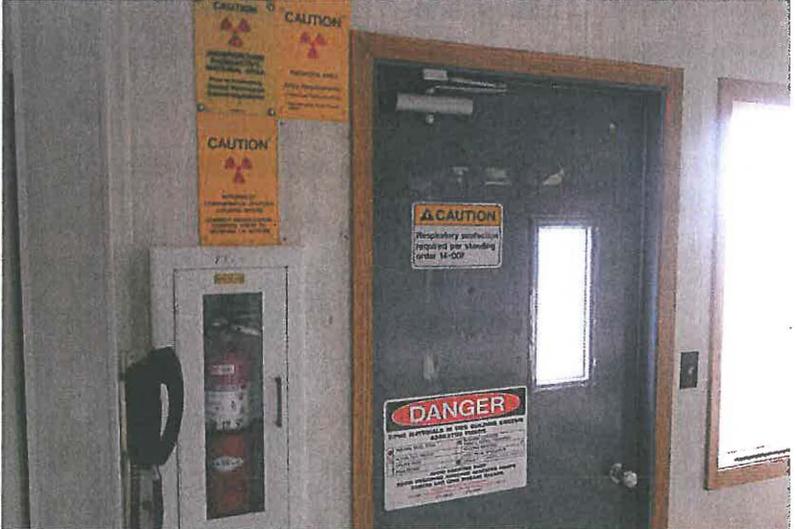
23.	200-W Single Shell Tank Farm 241-TX and 241-TY Change Trailer	12:01 p.m. West side change trailer for 241-TX and 241-TY Tank Farm. Signage on doors entering the tank farms. Signs, telephone, and portable fire extinguisher on the left side of door.

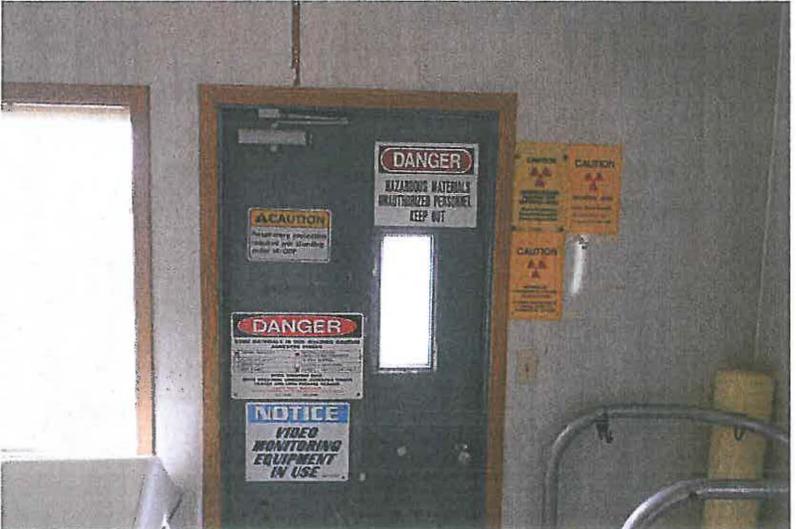
24.	200-W Single Shell Tank Farm 241-TX and 241-TY Change Trailer	12:01 p.m. West side change trailer for 241-TX and 241-TY Tank Farm. Signage on doors entering the tank farms. Also Signs on the right side of door.

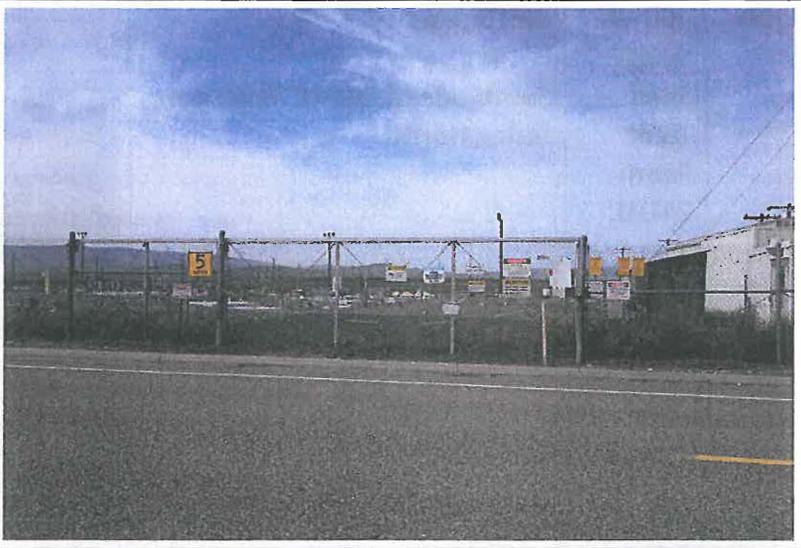
No.	Location	Activity Description/Comment	Photo
25.	200-W Single Shell Tank Farm 241-U	12:13 p.m. East side gate for 241-U Tank Farm, facing West. Signage on gate and both sides of gate.

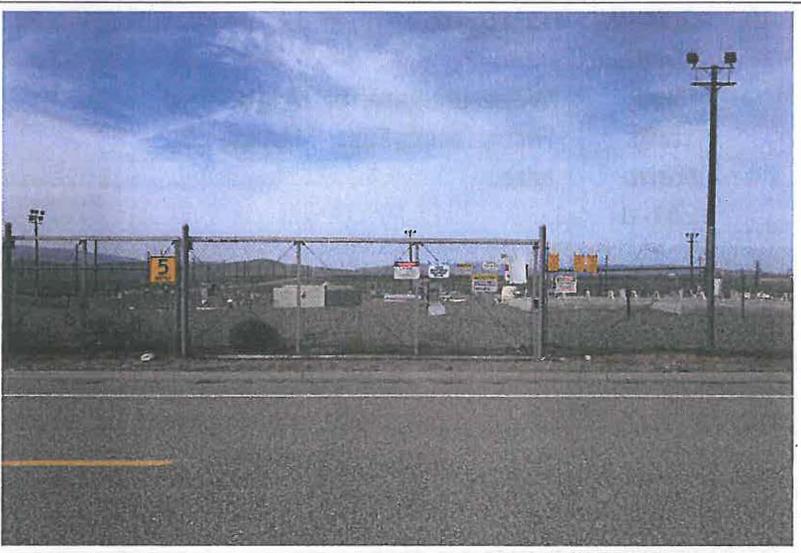
26.	200-W Single Shell Tank Farm 241-U	12:13 p.m. Second East side gate for 241-U Tank Farm, facing West. Signage on gate and both sides of gate.

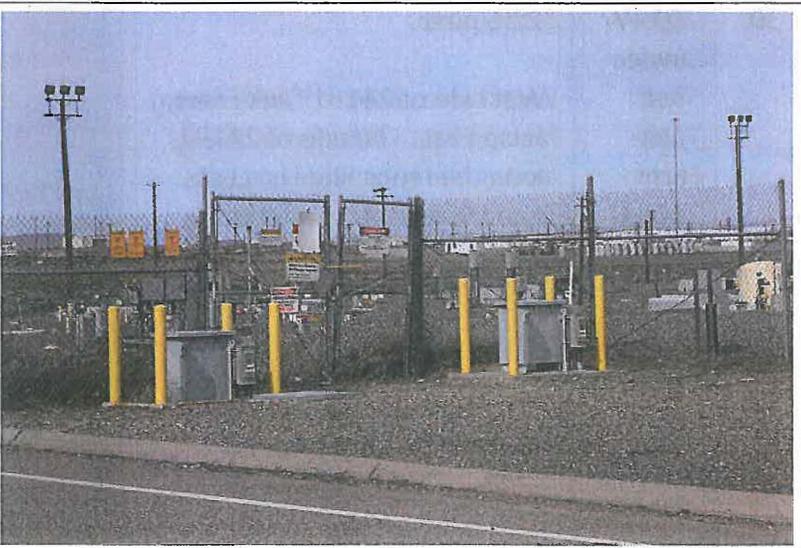
27.	200-W Single Shell Tank Farm 241-U	12:14 p.m. Southeast side gate for 241-U Tank Farm, facing Northwest. Signage on gate and left sides of gate.

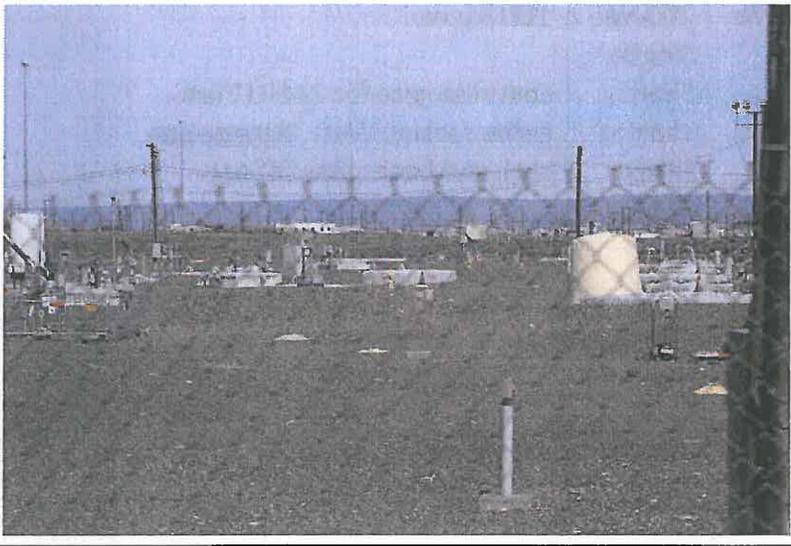
No.	Location	Activity Description/Comment	Photo
28.	200-W Single Shell Tank Farm 241-U	12:15 p.m. South side of 241-U Tank Farm, facing North.

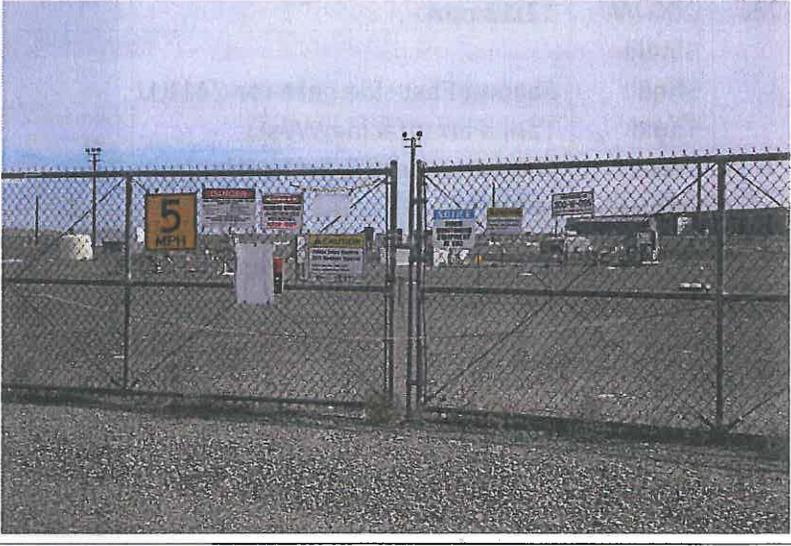
29.	200-W Single Shell Tank Farm 241-U	12:16 p.m. West side gate for 241-U Tank Farm, facing East. Signage on gate.

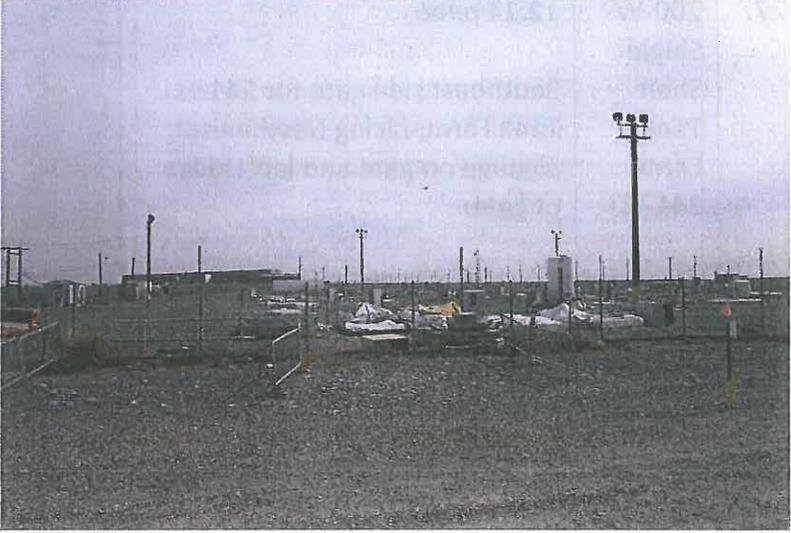
30.	200-W Single Shell Tank Farm 241-U	12:16 p.m. West side of 241-U Tank Farm, facing East. Outside of 241-U along the fence line is a Less Than 90-Day Accumulation Area.

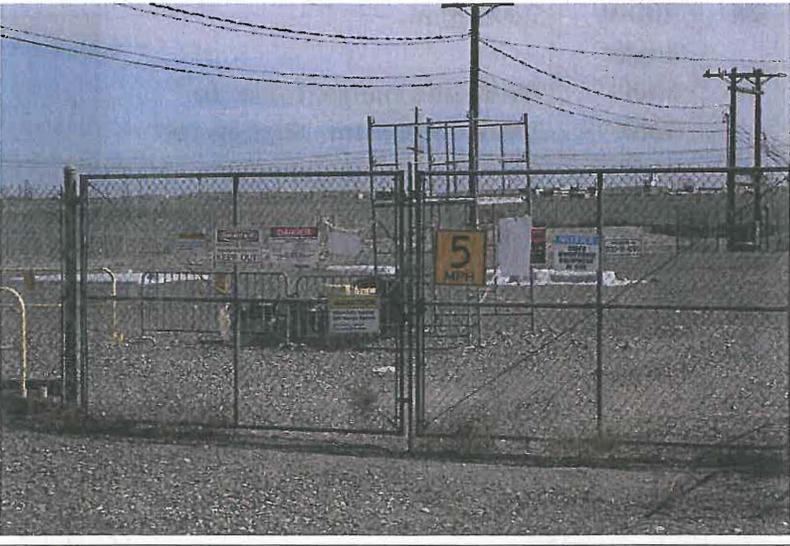
No.	Location	Activity Description/Comment	Photo
31.	200-W Single Shell Tank Farm 241-U	12:16 p.m. Second West side gate for 241-U Tank Farm, facing East. Signage on gate.

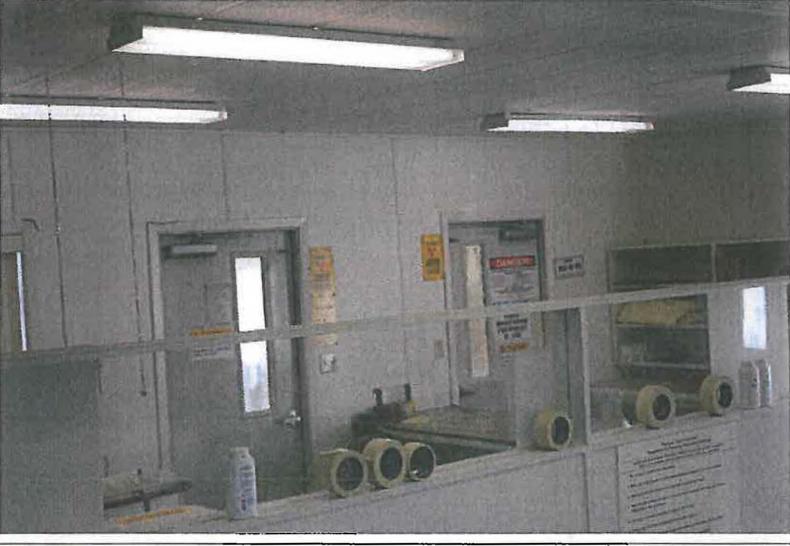
32.	200-W Single Shell Tank Farm Change Trailer for 241-U	12:19 p.m. West side change trailer for 241-U Tank Farm. Signage on doors entering the tank farms. Also Signs between the two doors entering 241-U.

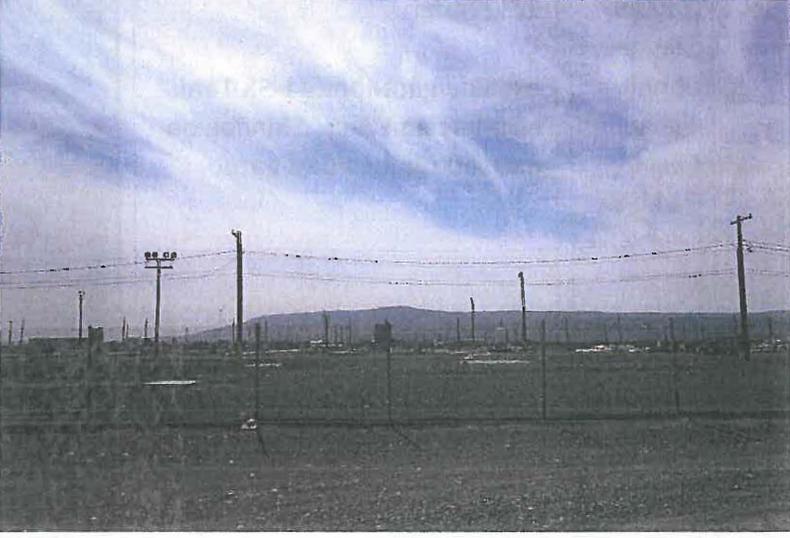
33.	200-W Single Shell Tank Farm 241-U	12:24 p.m. North side of 241-U Tank Farm, facing South.

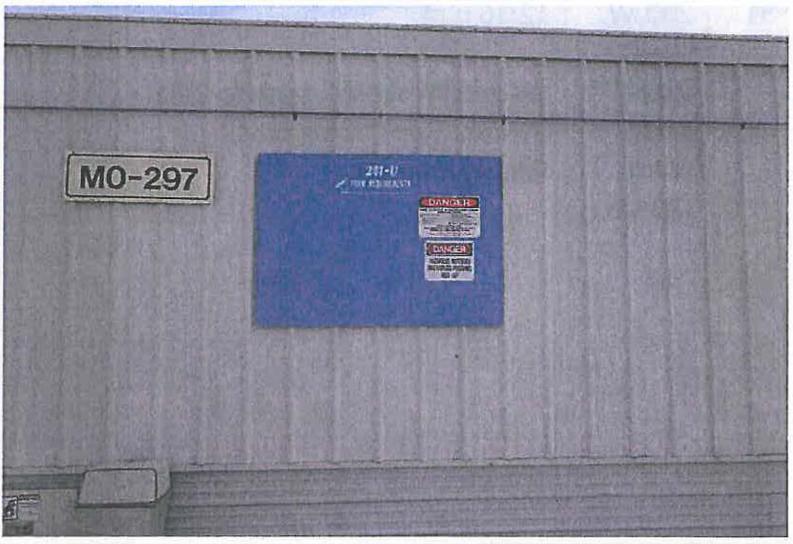
No.	Location	Activity Description/Comment	Photo
34.	200-W Single Shell Tank Farm Change Trailer for 241-U	12:25 p.m. West side change trailer for 241-U Tank Farm. Signage on the outside of the change trailer (MO-397).

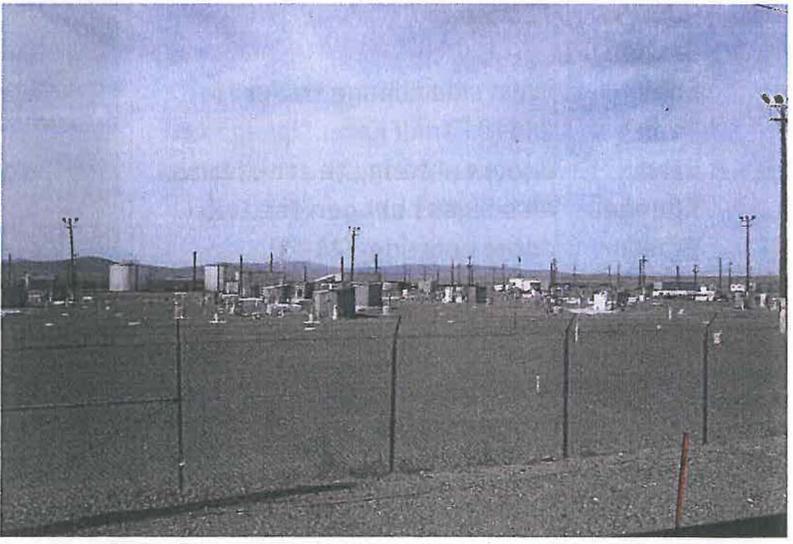
35.	200-W Single Shell Tank Farm 241-SX	12:32 p.m. East side of 241-SX Tank Farm, facing West.

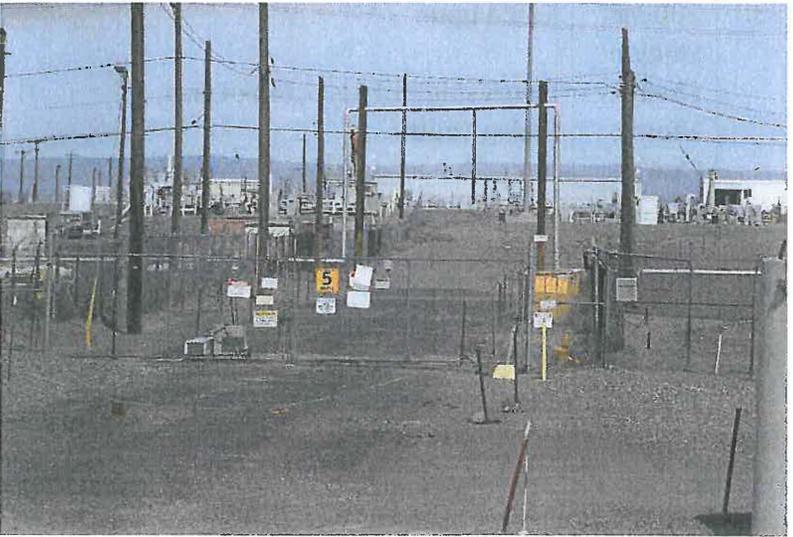
36.	200-W Single Shell Tank Farm 241-SX	12:32 p.m. East side gate for 241-SX Tank Farm, facing West. Signage on gate and right side of gate.

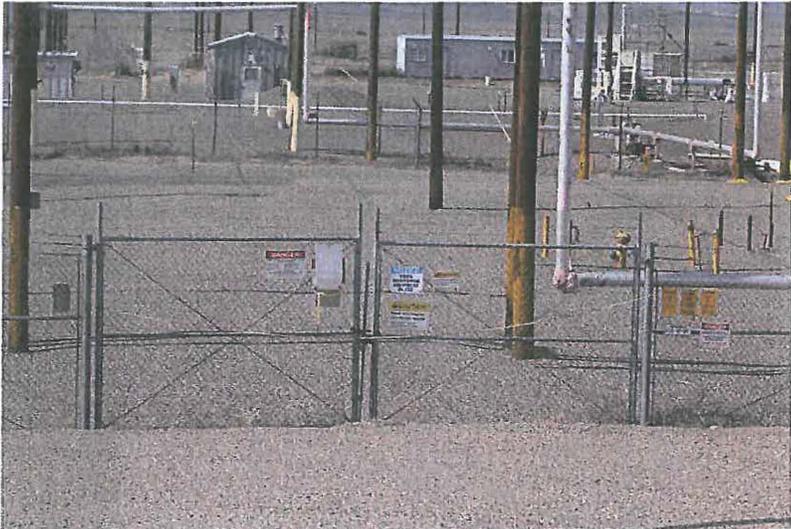
No.	Location	Activity Description/Comment	Photo
37.	200-W Single Shell Tank Farm 241-SX	12:35 p.m. East side gate for 241-SX Tank Farm, facing West. Signage on gate and right side of gate.

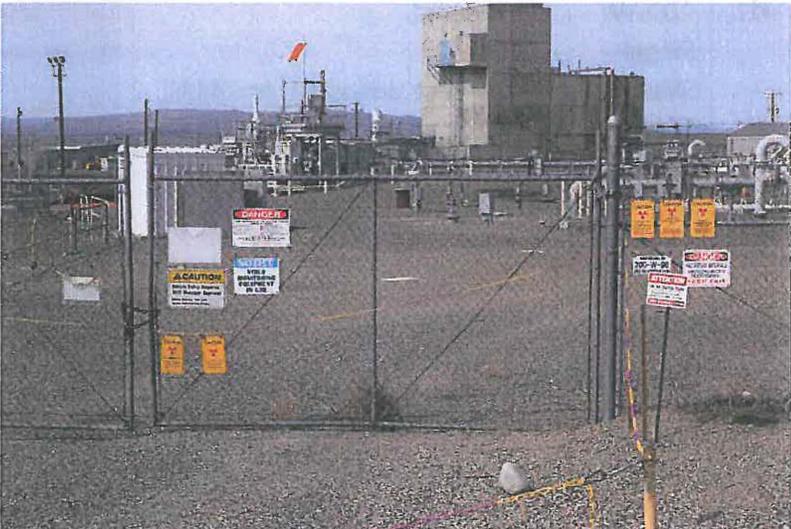
38.	200-W Single Shell Tank Farm 241-S	12:39 p.m. East side gate for 241-SY Double Shell Tank Farm and 241-S Single Shell Tank Farm, facing West. Signage on gate and right side of gate. The gate provides immediate access the 241-SY, but provides access to 241-S.

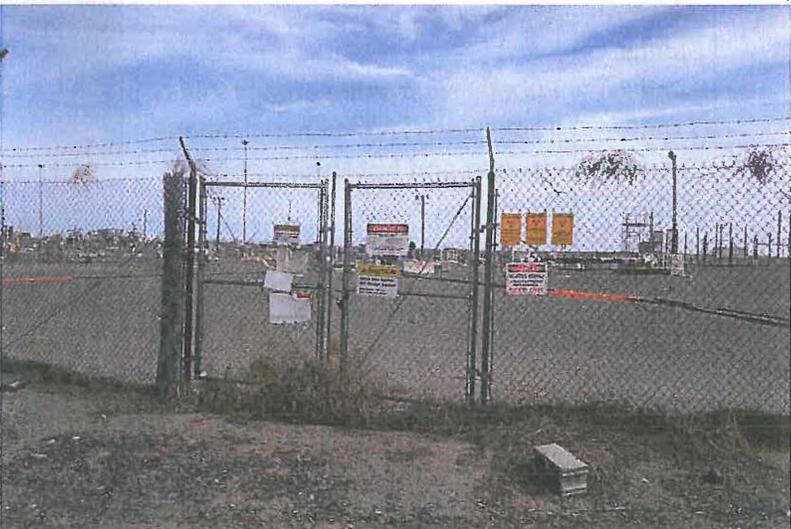
39.	200-W Single Shell Tank Farm 241-S	12:46 p.m. West side gate for 241-S Tank Farm, facing East. Signage on gate and right side of gate.

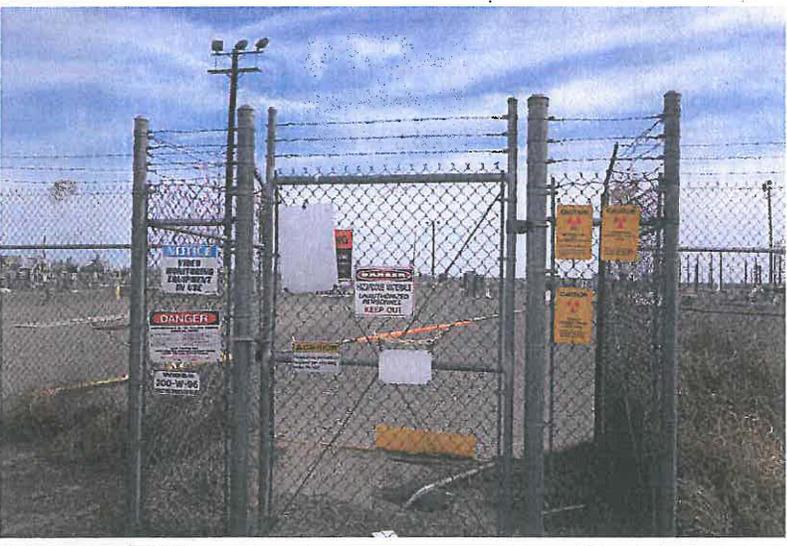
No.	Location	Activity Description/Comment	Photo
40.	200-W Single Shell Tank Farm 241-S	12:46 p.m. Second West side gate for 241-S Tank Farm, facing East. Signage on gate and both sides of gate.

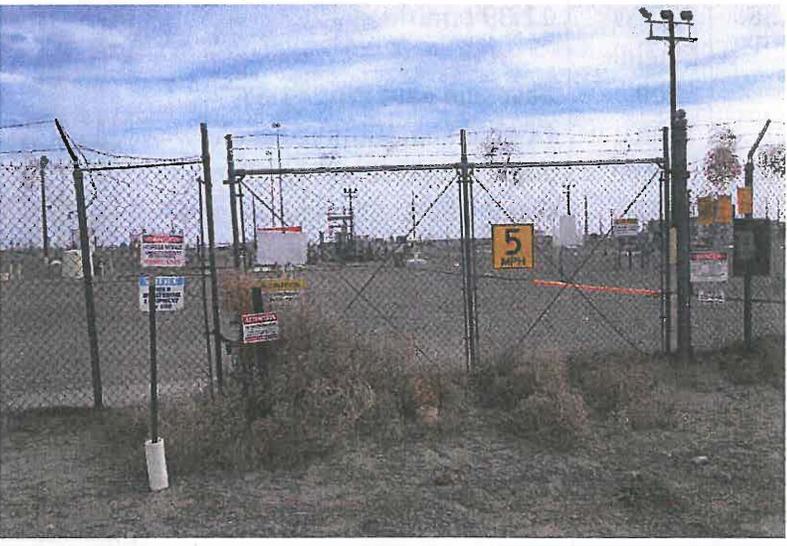
41.	200-W Single Shell Tank Farm 241-S	12:47 p.m. Third West side gate for 241-S Tank Farm, facing East. Signage on gate and both sides of gate.

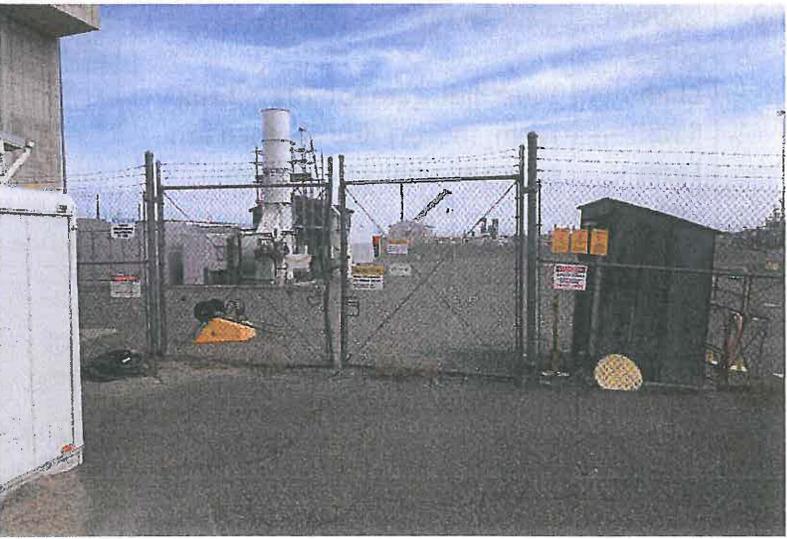
42.	200-W Single Shell Tank Farm 241-S	12:48 p.m. Fourth West side gate for 241-S Tank Farm, facing East. Signage on gate and both sides of gate.

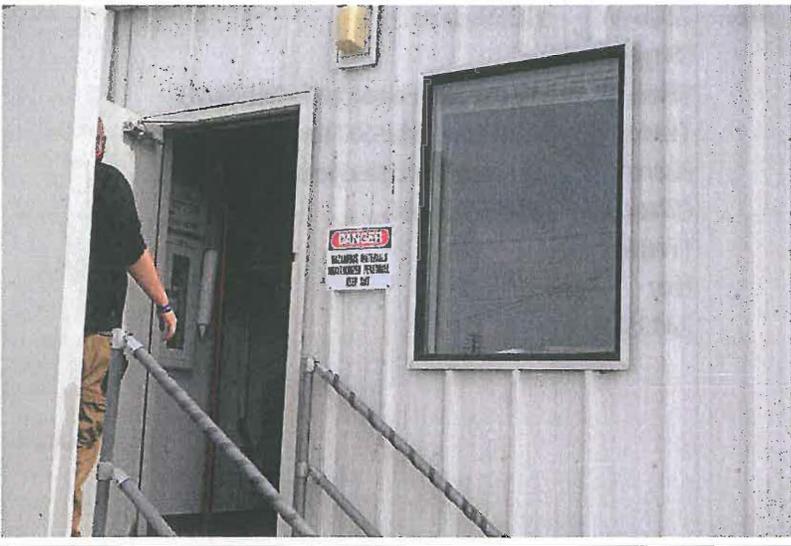
No.	Location	Activity Description/Comment	Photo
43.	200-W Single Shell Tank Farm Change Trailer for 241-S	12:50 p.m. West side change trailer (MO-295) for 241-SY Double Shell Tank Farm, with access to 241-S Single Shell Tank Farm. Signage on the right side of door.

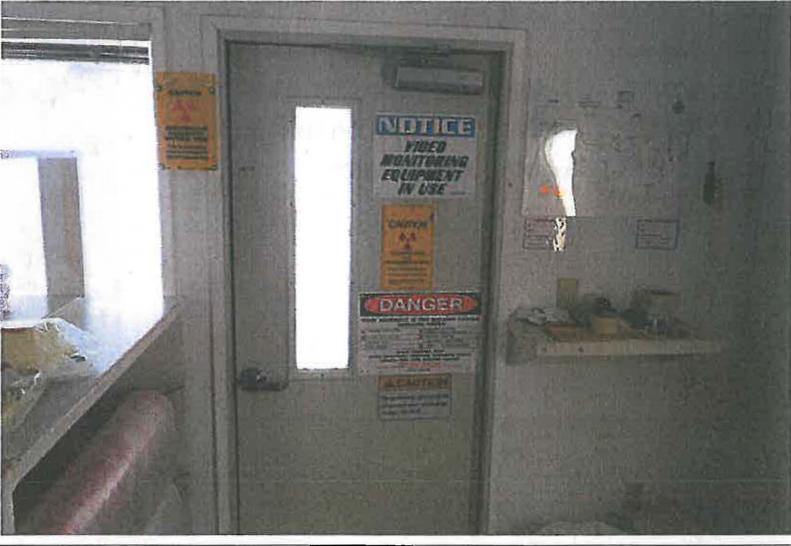
44.	200-W Single Shell Tank Farm Change Trailer for 241-S	12:55 p.m. West side change trailer (MO-295) for 241-SY Double Shell Tank Farm, with access to 241-S Single Shell Tank Farm. Signage on door and left side of door.

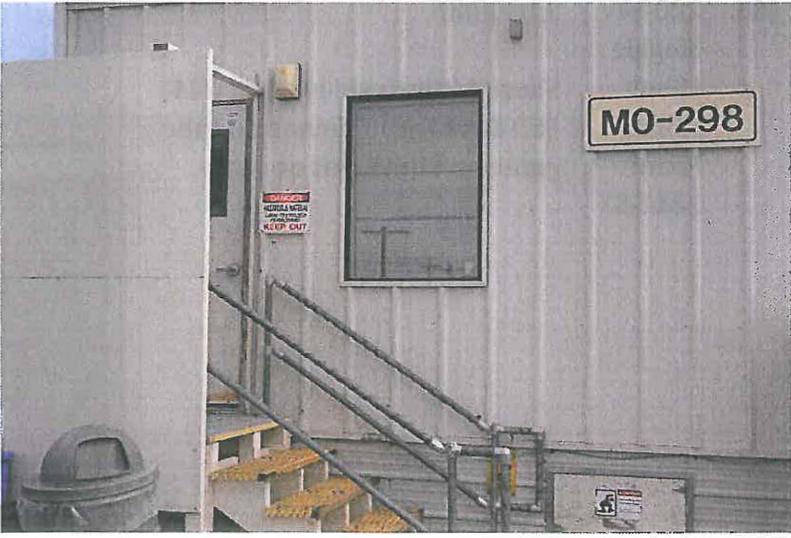
45.	200-W Single Shell Tank Farm Change Trailer for 241-SX	12:58 p.m. West side change trailer (MO-298) for 241-SX Tank Farm. Signage on the right side of door.

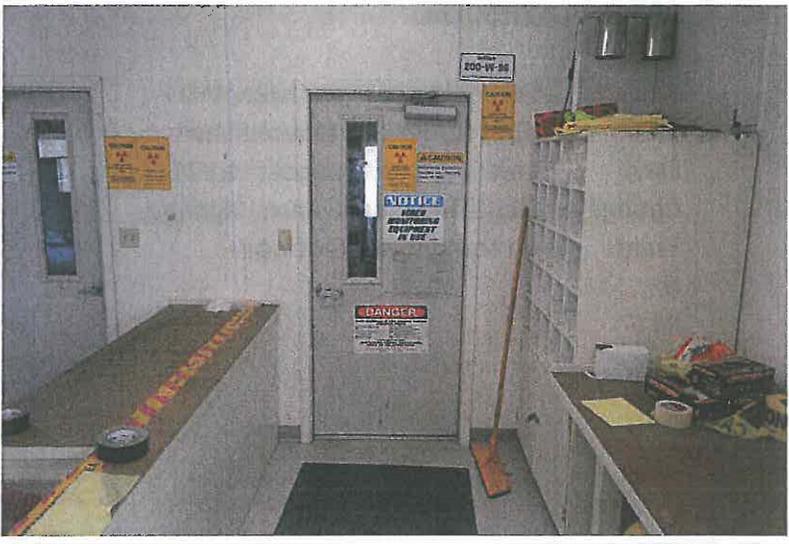
No.	Location	Activity Description/Comment	Photo
46.	200-W Single Shell Tank Farm Change Trailer for 241-SX	12:59 p.m. West side change trailer (MO-298) for 241-SX Tank Farm. Signage on the door and right side of door.

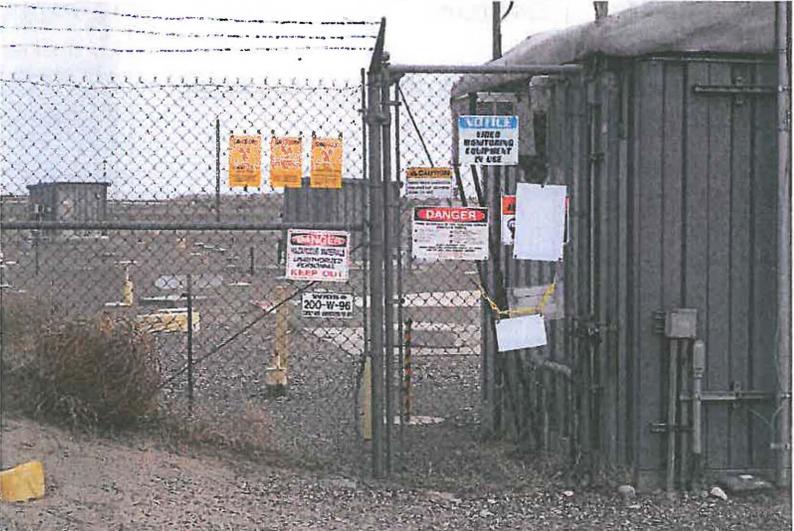
50.	200-W Single Shell Tank Farm 241-SX	1:03 p.m. Fourth West side gate for 241-SX Tank Farm. Signage on the gate and left side of gate.

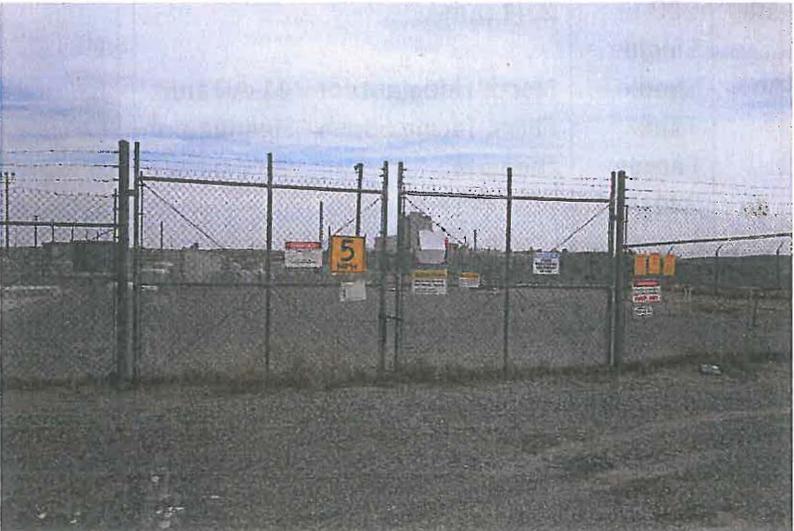
51.	200-W Single Shell Tank Farm 241-SX	1:04 p.m. Fifth West side gate for 241-SX Tank Farm. Signage on the gate and right side of gate.

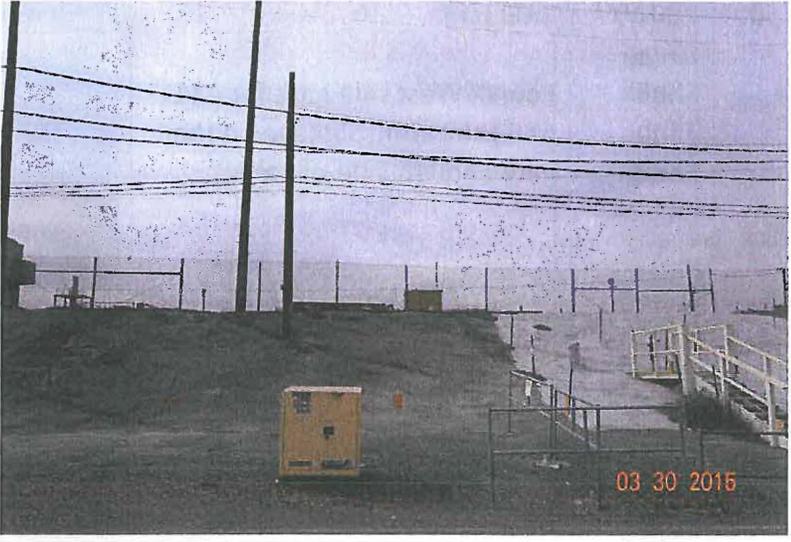
53.	200-E Single Shell Tank Farm 241-A	2:40 p.m. East side of 241-A Tank Farm, facing West.

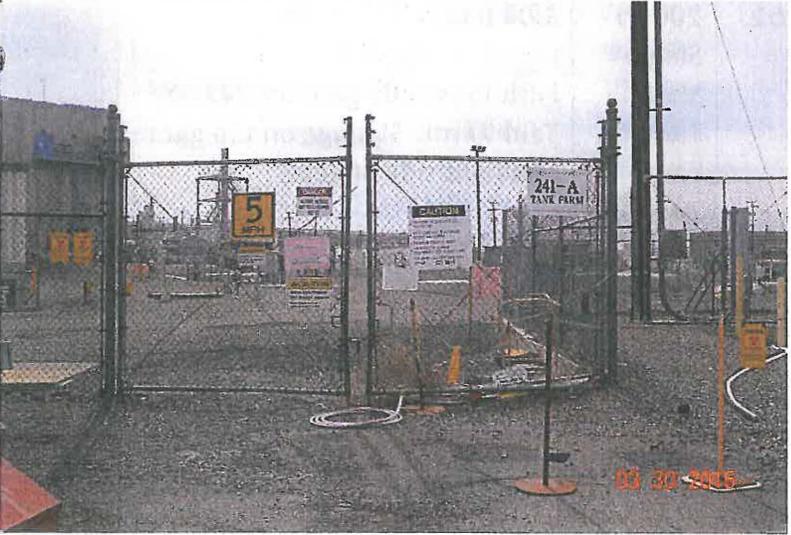
54.	200-E Single Shell Tank Farm 241-A	2:41 p.m. North side gate for 241-A Tank Farm, facing South. Signage on the gate.

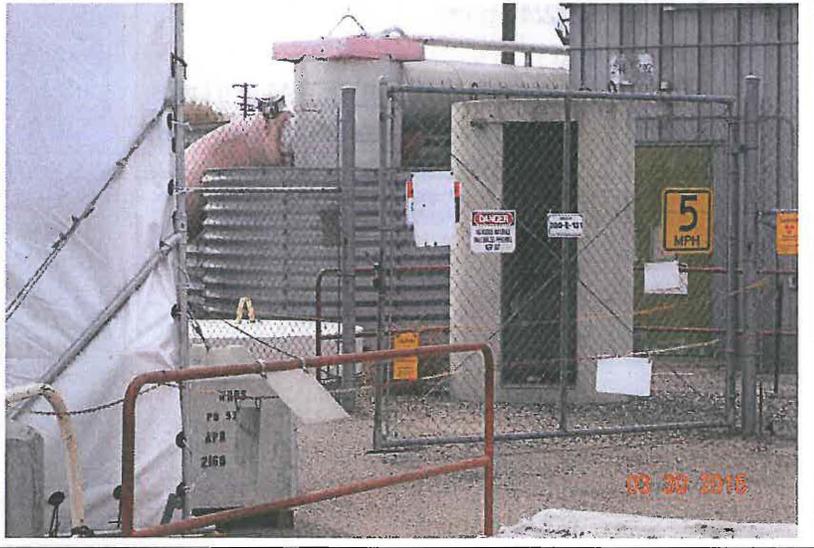
56.	200-E Single Shell Tank Farm 241-A	2:43 p.m. North side gate for and 241-A Tank Farm, facing Southwest. Signage on the gate and right side of gate.
