November 4, 2015

15-NWP-196

Re: Single-Shell Tank Dangerous Waste Compliance Inspection on March 30 and 31, 2015 at the Hanford Site, Resource Conservation and Recovery Act (RCRA) Site ID: WA7890008967, Nuclear Waste Program (NWP) Compliance Index No. 15.518

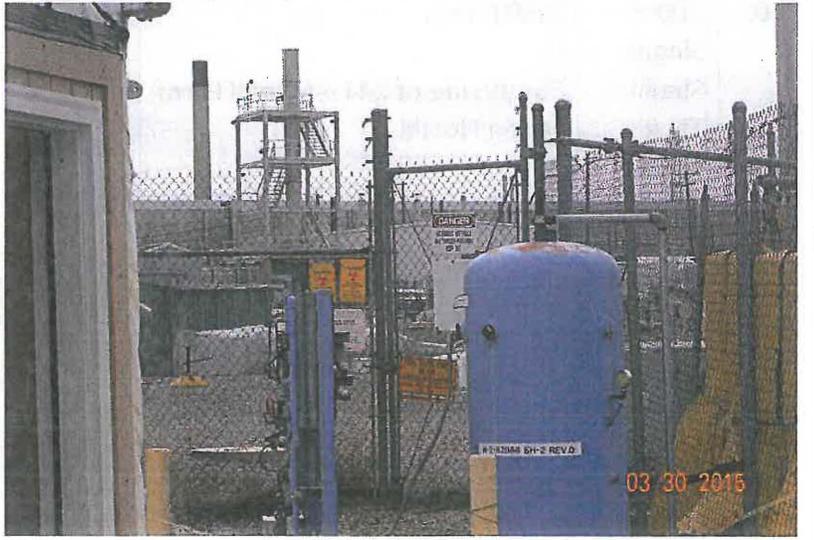
57.	200-E Single Shell Tank Farm 241-A	2:44 p.m. North side gate for 241-A Tank Farm, facing Southwest. Signage on the gate and left side of gate.

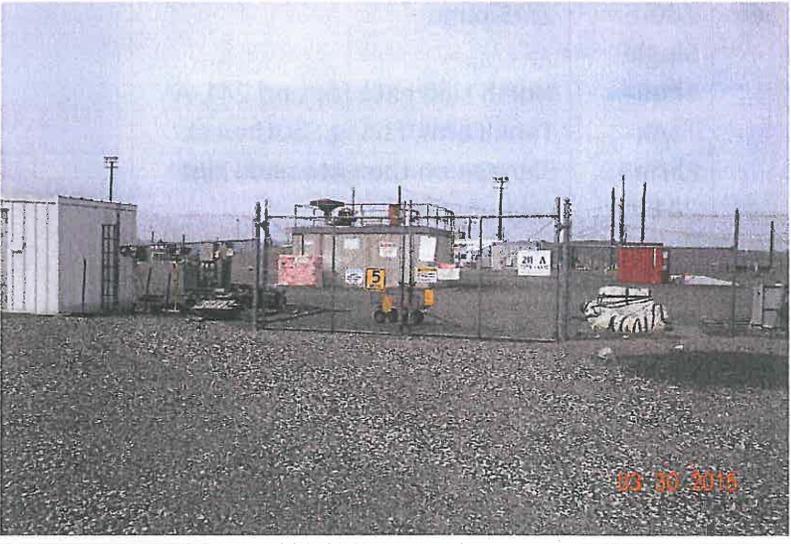
59.	200-E Single Shell Tank Farm 241-A	2:47 p.m. South side gate for 241-A Tank Farm, facing North. Signage on the gate.

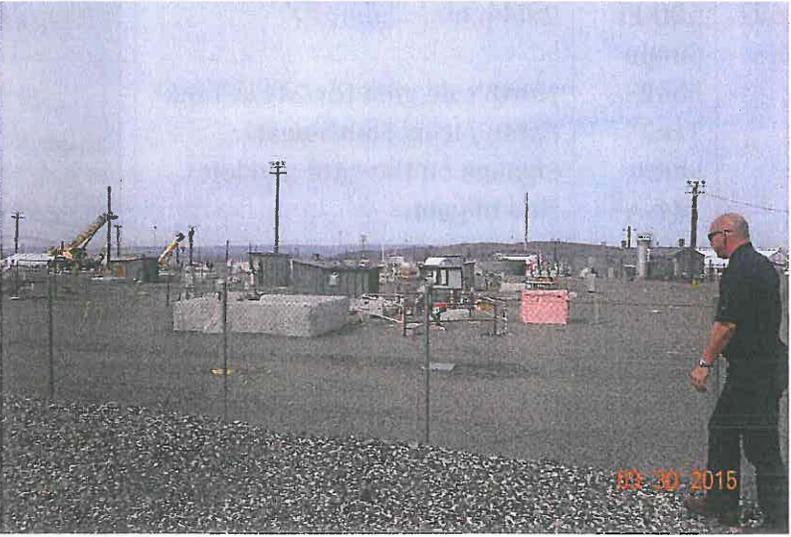
60.	200-E Single Shell Tank Farm 241-A	2:50 p.m. South side of 241-A Tank Farm, facing North.

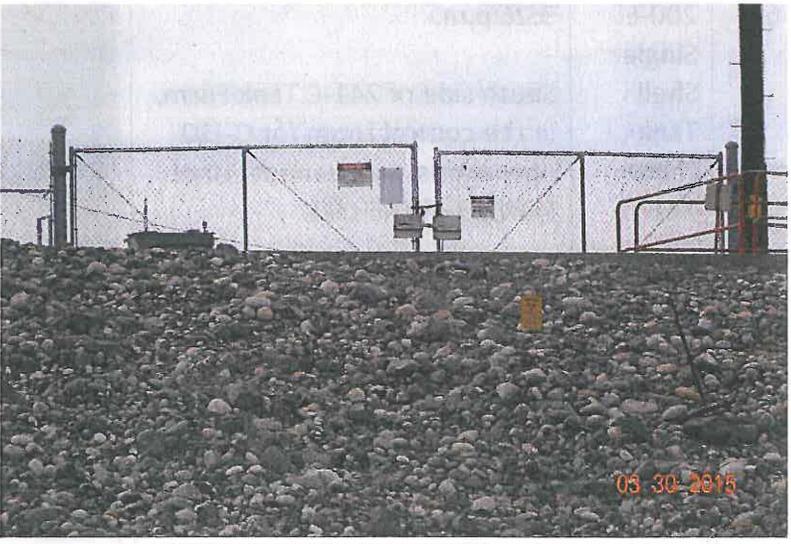
65.	200-E Single Shell Tank Farm 241-BY	3:56 p.m. East side gate for 241-BY Tank Farm, facing West. Signage on the gate.

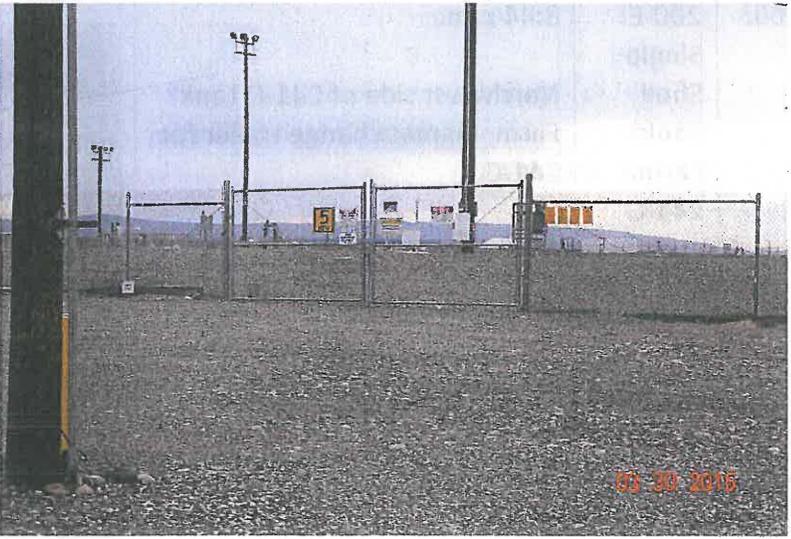
66.	200-E Single Shell Tank Farm 241-BX	3:56 p.m. East side gate for 241-BX Tank Farm, facing West. Signage on the gate and right side of gate.
