**SUBJECT: Post-Demolition Summary Report for the 183-B Water Treatment Plant
Clearwells and Pump House**

Post-Demolition Summary Report for the 183-B Water Treatment Plant Clearwells and Pumphouse

May 2014

This post-demolition summary report documents the characterization and final status of the 183-B Water Treatment Plant Clearwells and below-grade Pump House at the completion of deactivation, decontamination, decommissioning and demolition (D4) activities.

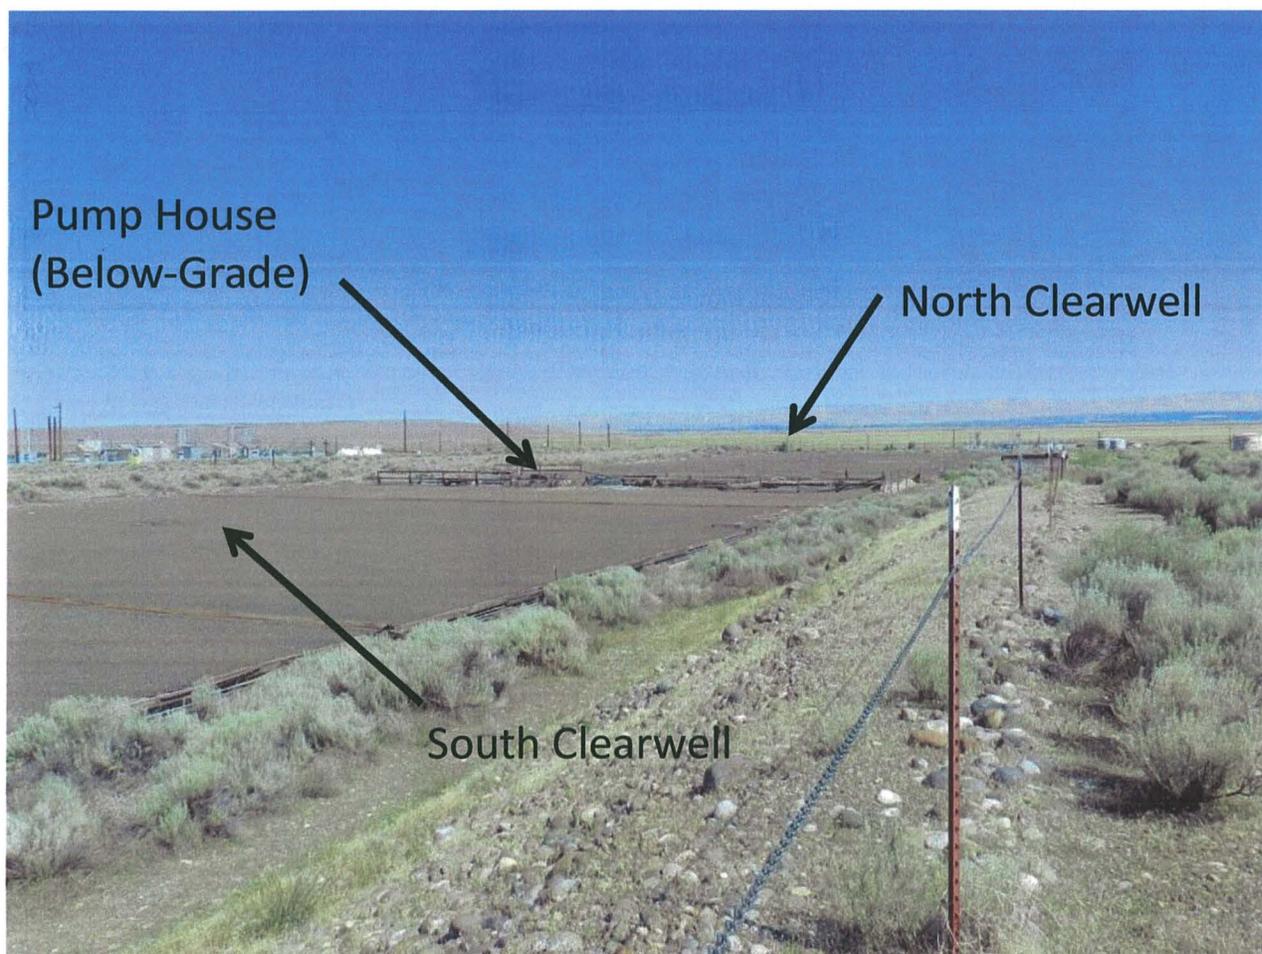
**Figure 1. 183-B Water Treatment Plant Clearwells and Pump House - Pre-Demolition
July 16, 2013 – Looking Northwest**

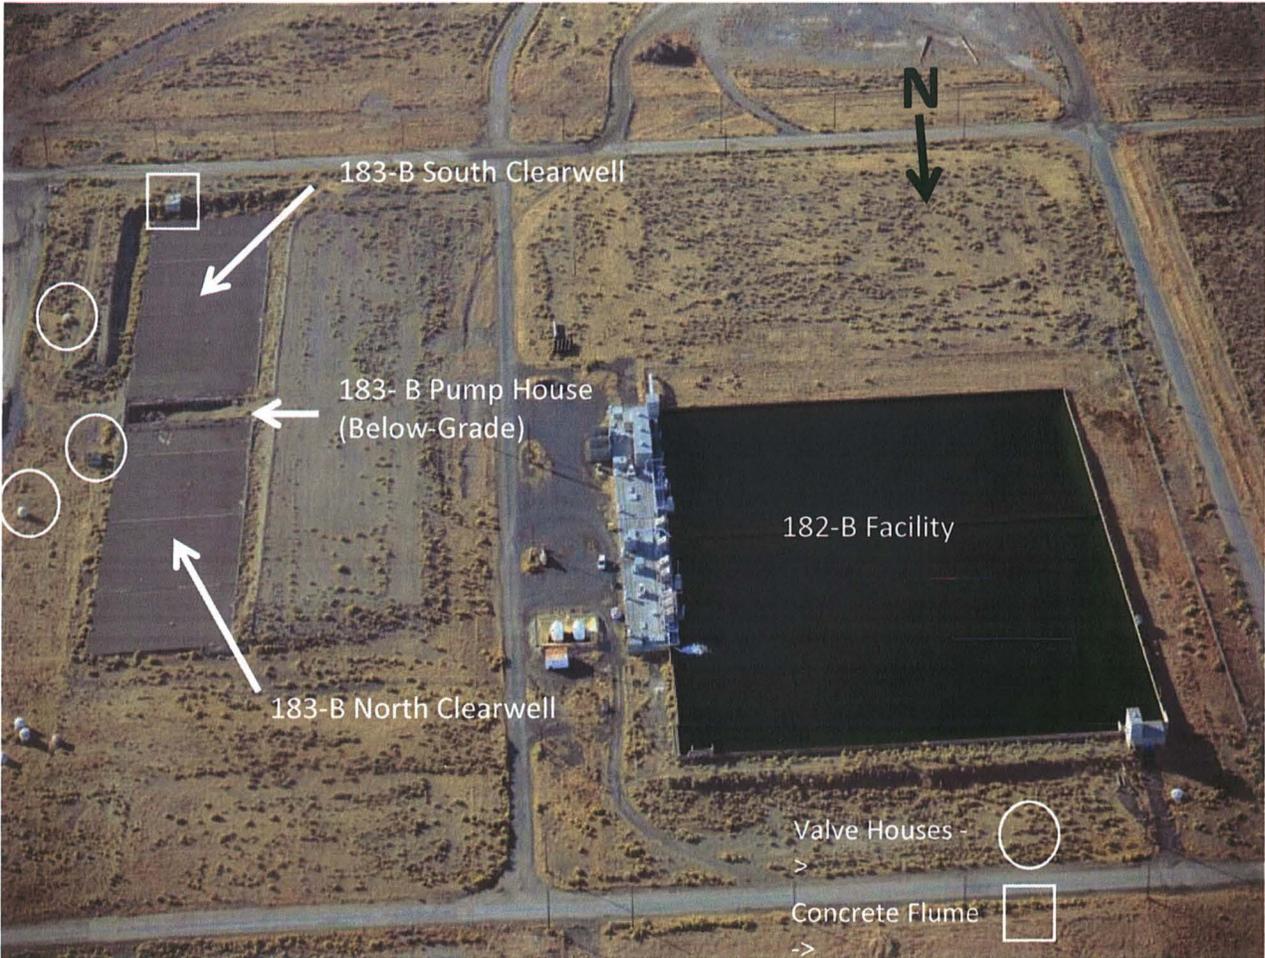
**Figure 2. Aerial View 183-B Water Treatment Plant Clearwells and Pump House – Pre-Demolition
October 17, 2012 – Looking South**

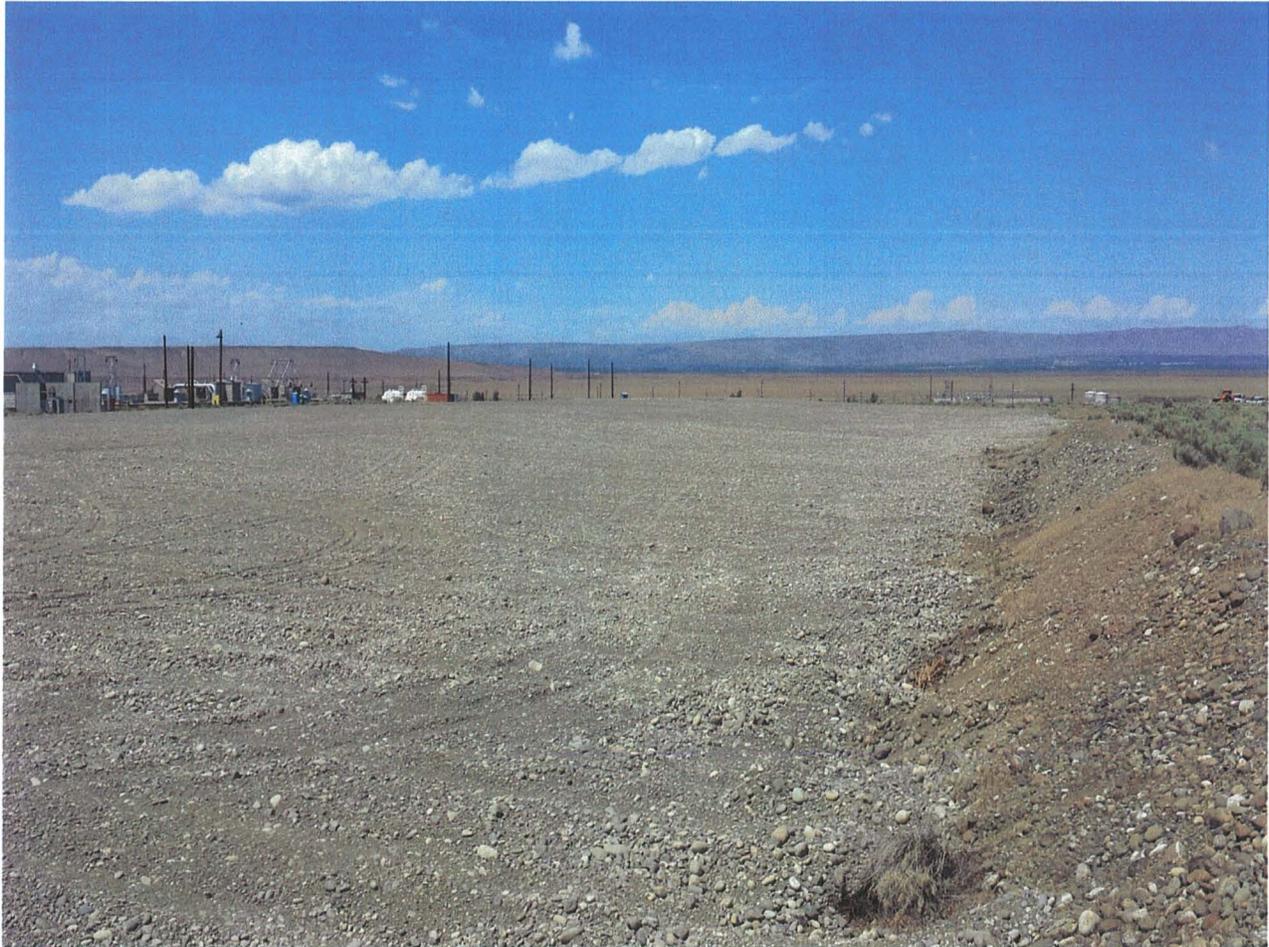
**Figure 3. 183-B Water Treatment Plant Clearwells and Pump House – Post-Demolition
June 2, 2014 – Looking Northwest**

Demolition of the Clearwell roofs and walls, Pump House walls, Valve Vaults, and Flume was completed by May 20, 2014. Five hundred and twenty eight (528) ERDF containers transported 8,283 tons of demolition debris to ERDF. No post-demolition Global Positioning Environmental Radiological Surveyor (GPERS) surveys were performed because the facility was radiologically clean. A post-demolition Global Positioning System (GPS) survey wasn't prepared because the below-grade walls and flooring remained in-place as reflected in the design drawings.

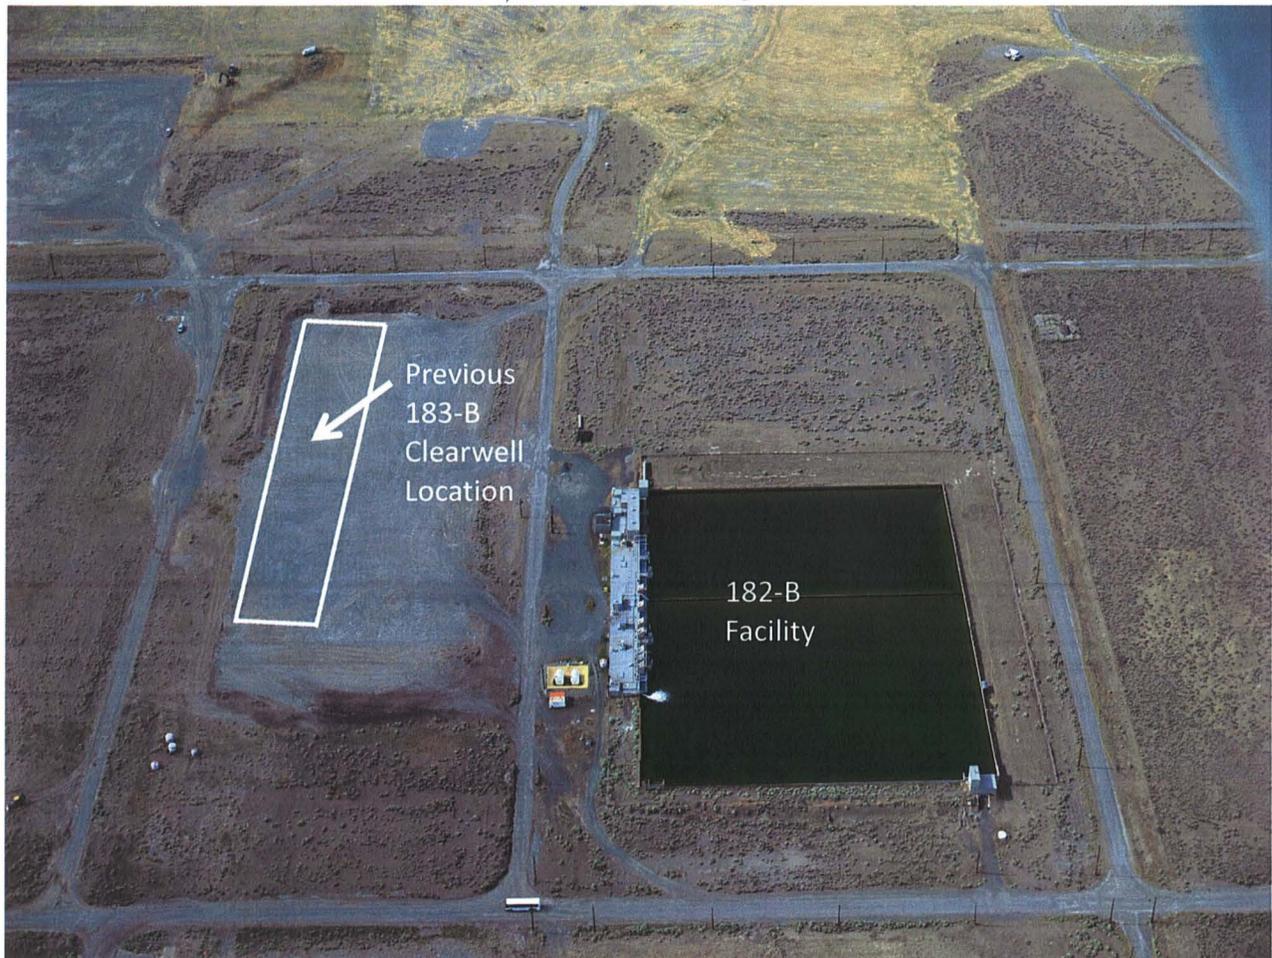
**Figure 4. Aerial View 183-B Water Treatment Plant Clearwells and Pump House – Post Demolition
June 12, 2014 – Looking South**
