## FACILITY STATUS CHANGE FORM

<b>Date Submitted:</b> Feb 9, 2011 <b>Originator:</b> David Warren <b>Phone:</b> 539-6040	<b>Area:</b> 100-N Area <b>Facility ID:</b> 153-N Electrical Substation <b>Action Memorandum:</b> 100-N Ancillary Facilities	<b>Control #:</b> D4-100-N-0008 rev.1
--	---	--

SUBJECT: **POST DEMOLITION SUMMARY REPORT FOR THE 153-N ELECTRICAL  
SUBSTATION**

# Post Demolition Summary Report for the 153-N Electrical Substation

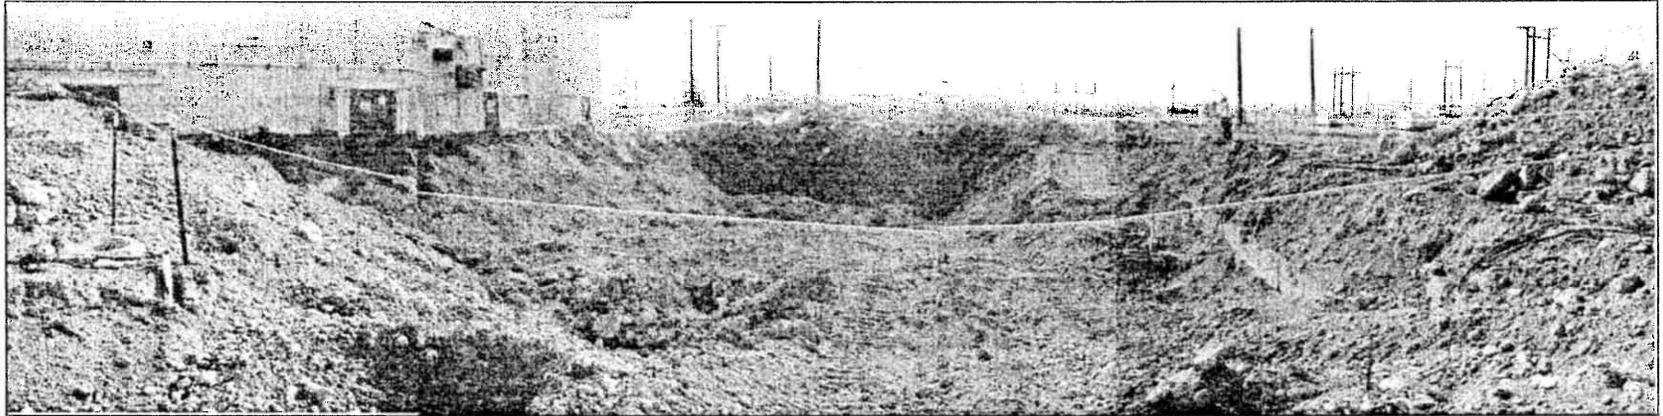
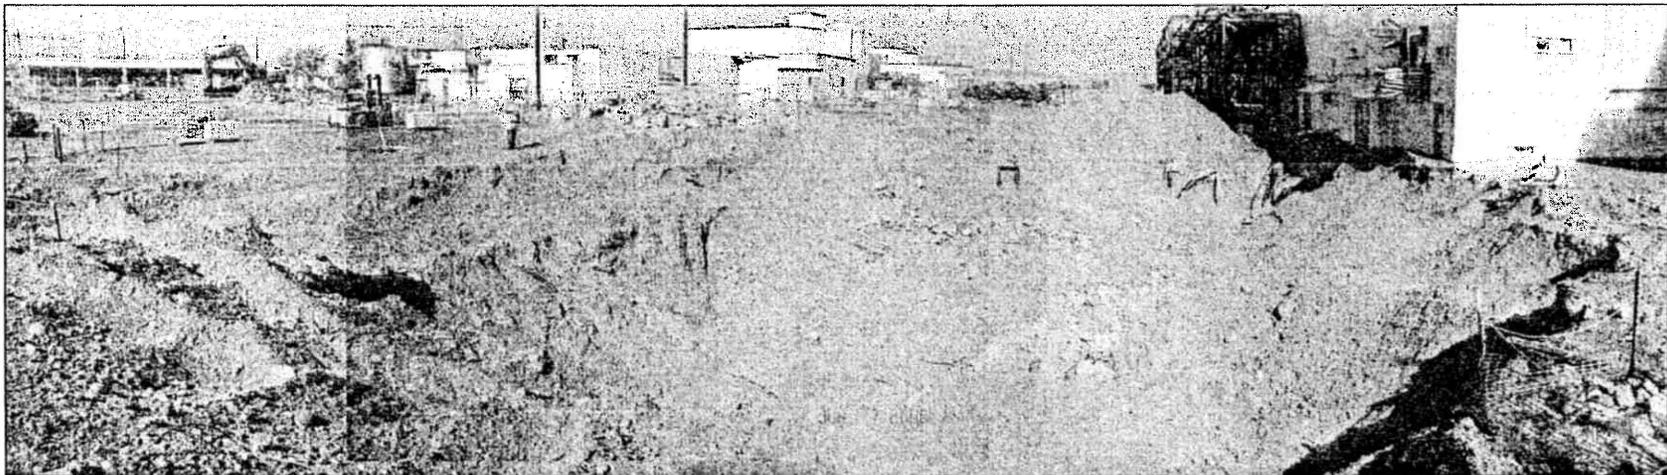
**Figure 2 - 153-N Electrical Substation Excavation**

- UPR-100-N-36, Diesel Generator Area – this inactive WIDS site is in an area used to work on compressor parts and had oil spills during this work. The WIDS description indicates that the most recent spills were cleaned up. The 153-N demolition excavation came up to the southern edge of this WIDS site, and may have intersected the WIDS site. During D4 demolition activities, the excavation was visually inspected for signs of staining. No staining was identified, and no indication of soil contamination could be found. Pictures of the facility excavation are provided as Figure 2.

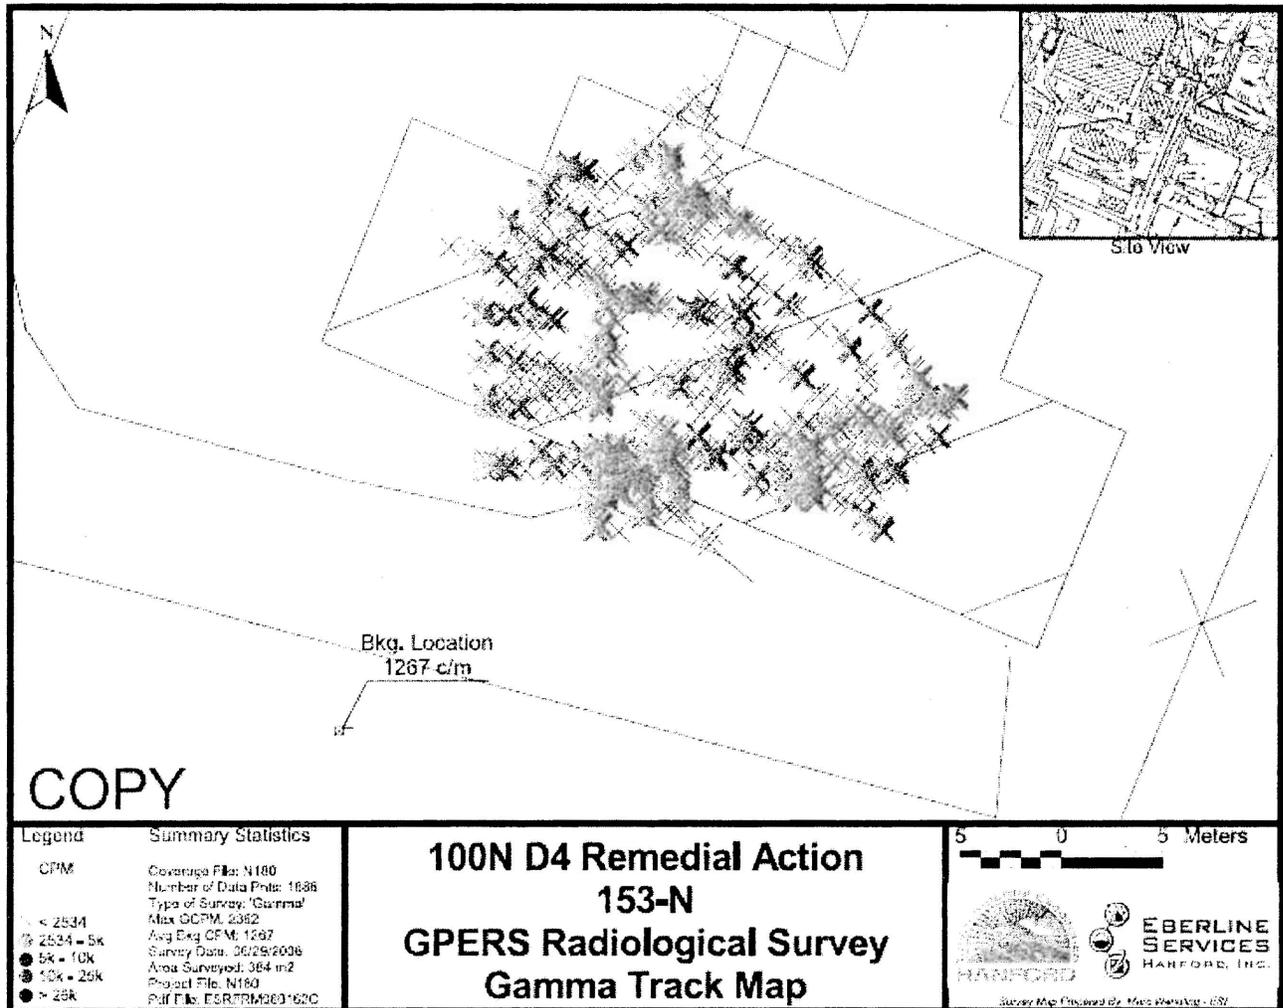
## Attachment 4 - GPERS Survey of 153-N Excavation, Gamma Track

This down posting survey included tech smears of the excavation equipment and the 153-N demo site, except for the excavation. A GPERS survey was performed in the excavation (see Attachments 4 and 5). No contamination was detected during the demolition of 153-N, and is documented in these surveys.
