FACILITY STATUS CHANGE FORM

D4 Project Soils and/or Below Grade Structures Completion Form 1723N Warehouse, 1723NX Laydown Yard, and MO-913 Change Trailer

**WASHINGTON CLOSURE HANFORD D4 FACILITY CHARACTERIZATION
HISTORICAL SITE ASSESSMENT FOR THE 1723-N WAREHOUSE AND 1723-NX
LAYDOWN YARD**

Post Demolition Summary Report for the 1723N Warehouse, 1723NX Laydown Yard and MO-913 Change Trailer

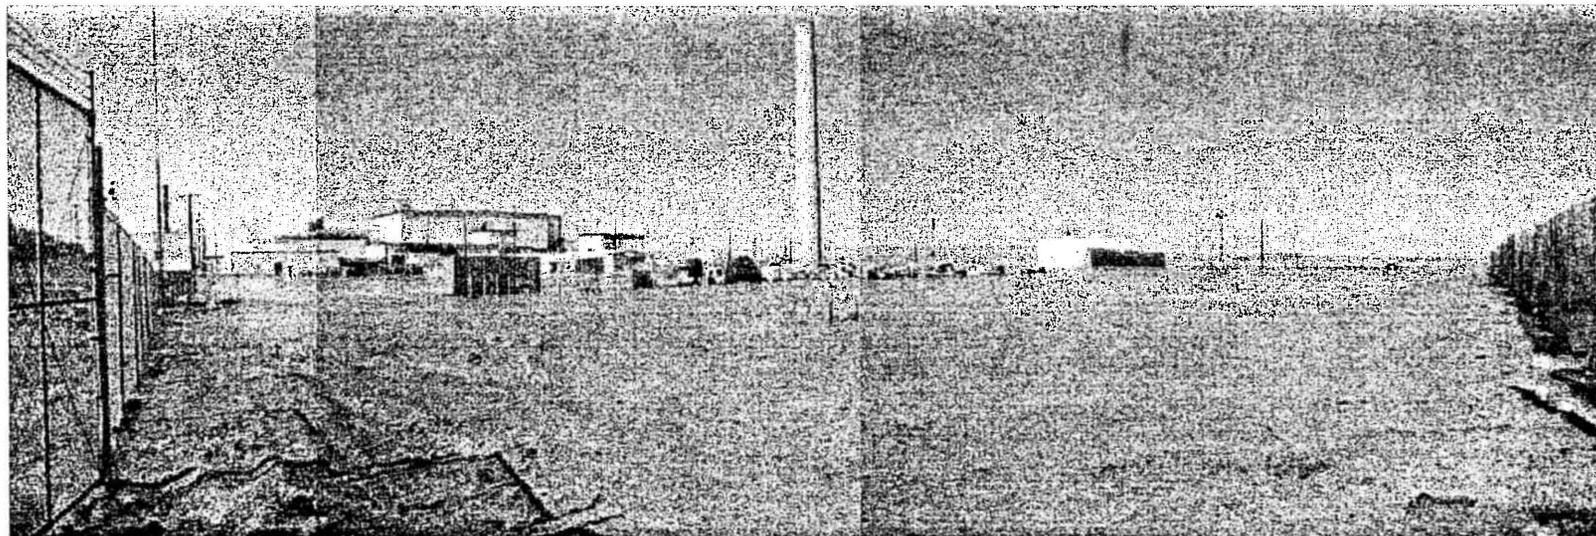
Figure 2 - 1723N Warehouse, 1723NX Laydown Yard, and MO-913 After Demo (Facing South-West)

The soil in the vicinity of these facilities was re-graded to fill in uneven ground to minimize tripping hazards.

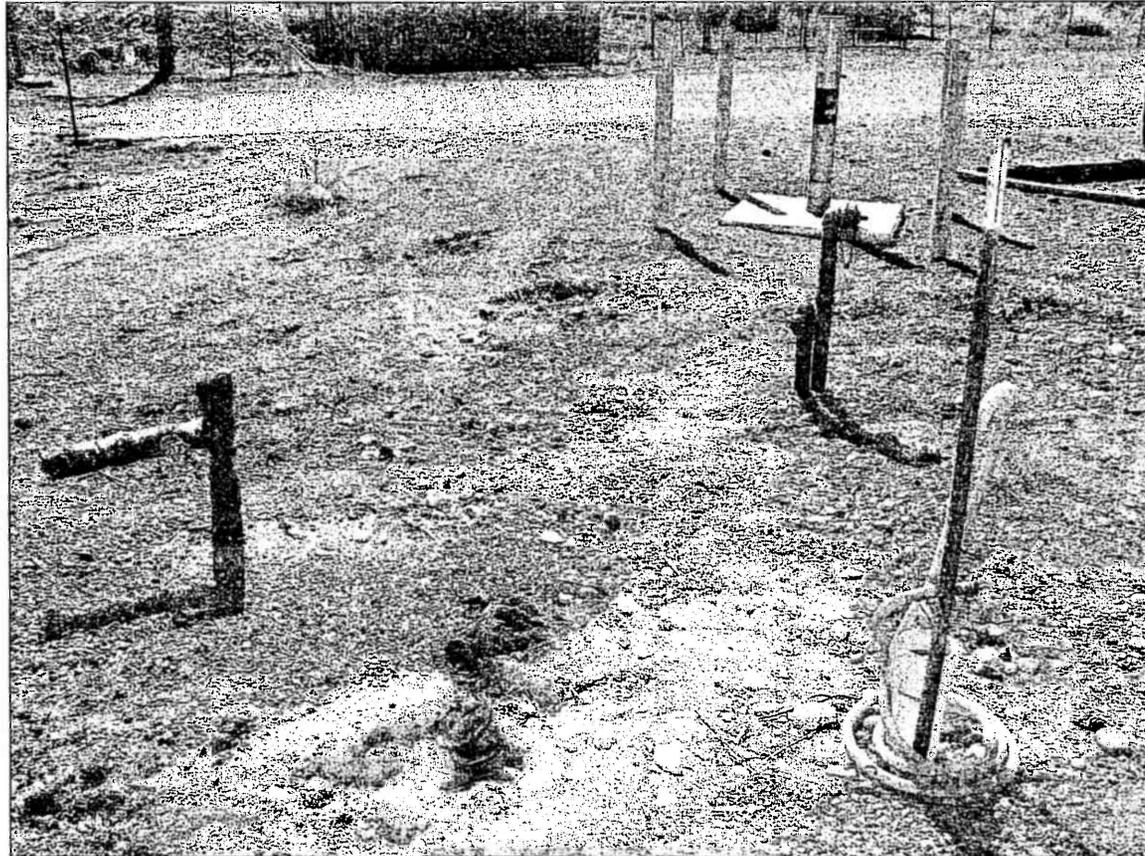
Figure 3 – Pipes Left In Place at MO-913

Pipes left in place include one domestic water line and one sewer line. These extend vertically from the ground and are located at the south-west corner of the previous location of MO-913 (see attached civil survey and picture).

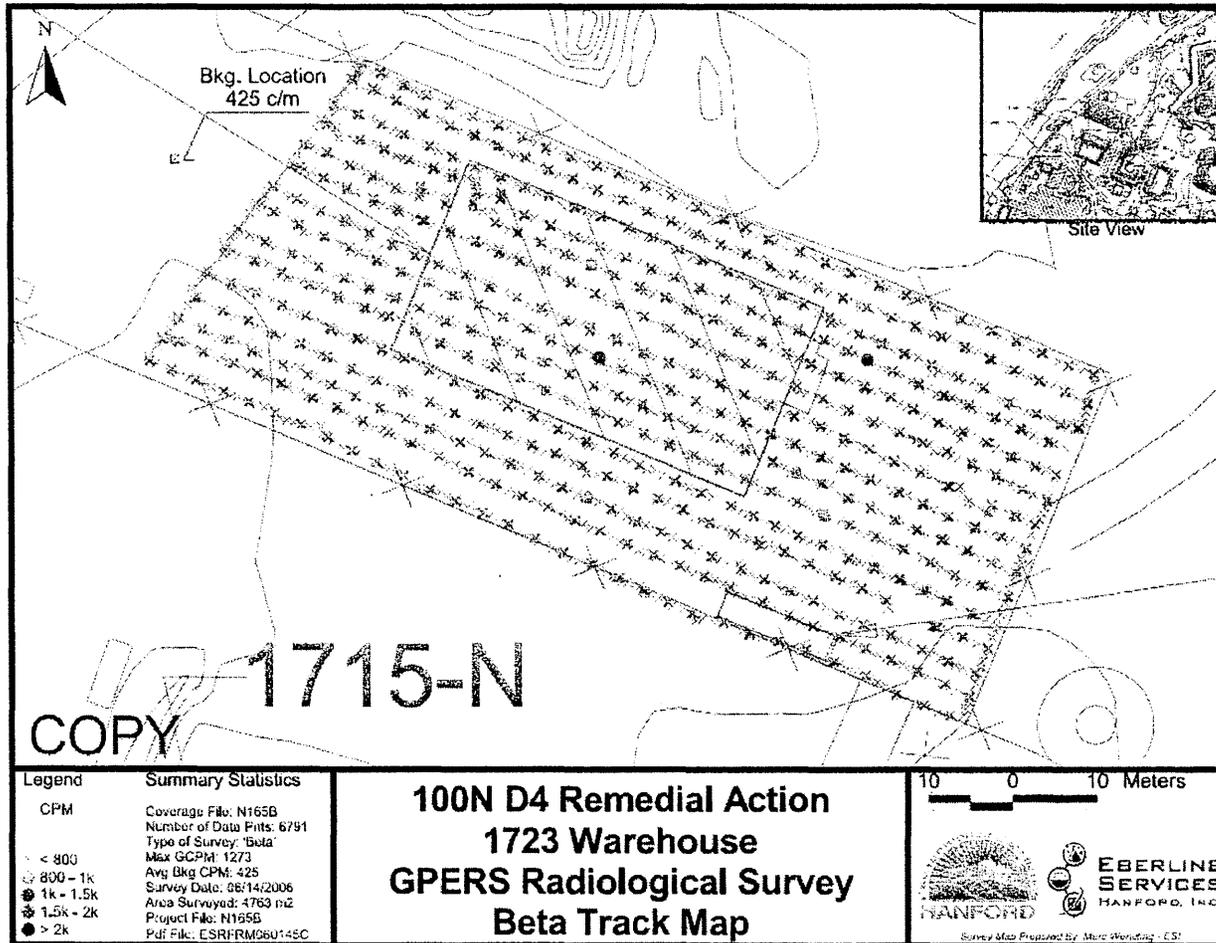
Figure 4 – Initial GPERS Beta Survey with Anomalous Points

GPERS surveys were completed at each of these facilities. Note that the original GPERS survey of the 1723N demolition site showed a number of readings above background for both beta and gamma tracks. The site was re-surveyed with the GPERS instruments, and the beta tracks were determined to be anomalous readings. However, the gamma track showed one valid spot of gamma contamination, which was subsequently cleaned up and re-surveyed (see RSR-IFSM-06-0089). See attached GPERS surveys at the end of this report as attachments. The final down posting performed at the site to down post from an SCA to a non-radiologically posted area was covered by radiological survey RSR-IFSM1-06-0109.
