FACILITY STATUS CHANGE FORM

Date Submitted: Apr 28, 2008 Originator: M. L. Proctor Phone: 521-9622	Area: 300 Facility ID: 3706/3706A Action Memorandum: #1 for the 300 Area	Control #: D4-300-006
--	--	---------------------------------

The 3706 and 3706A foundations and any potential soil excavation will be deferred to the 300-46 remedial action. The foundation is located directly above the 300-46 waste site. Removal of the foundation prior to waste site remediation could result in potential exposure of contaminants from the underlying soil.

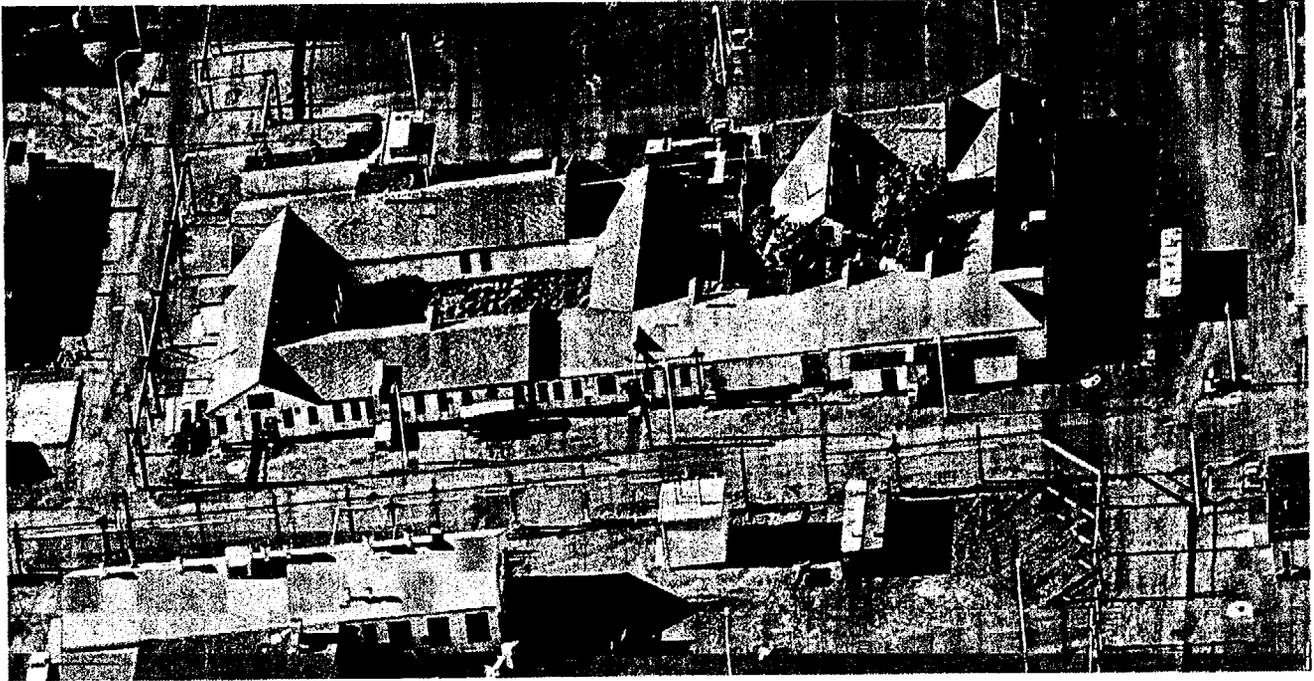
Aerial Photo taken August 2005 showing live trees within western most courtyard.

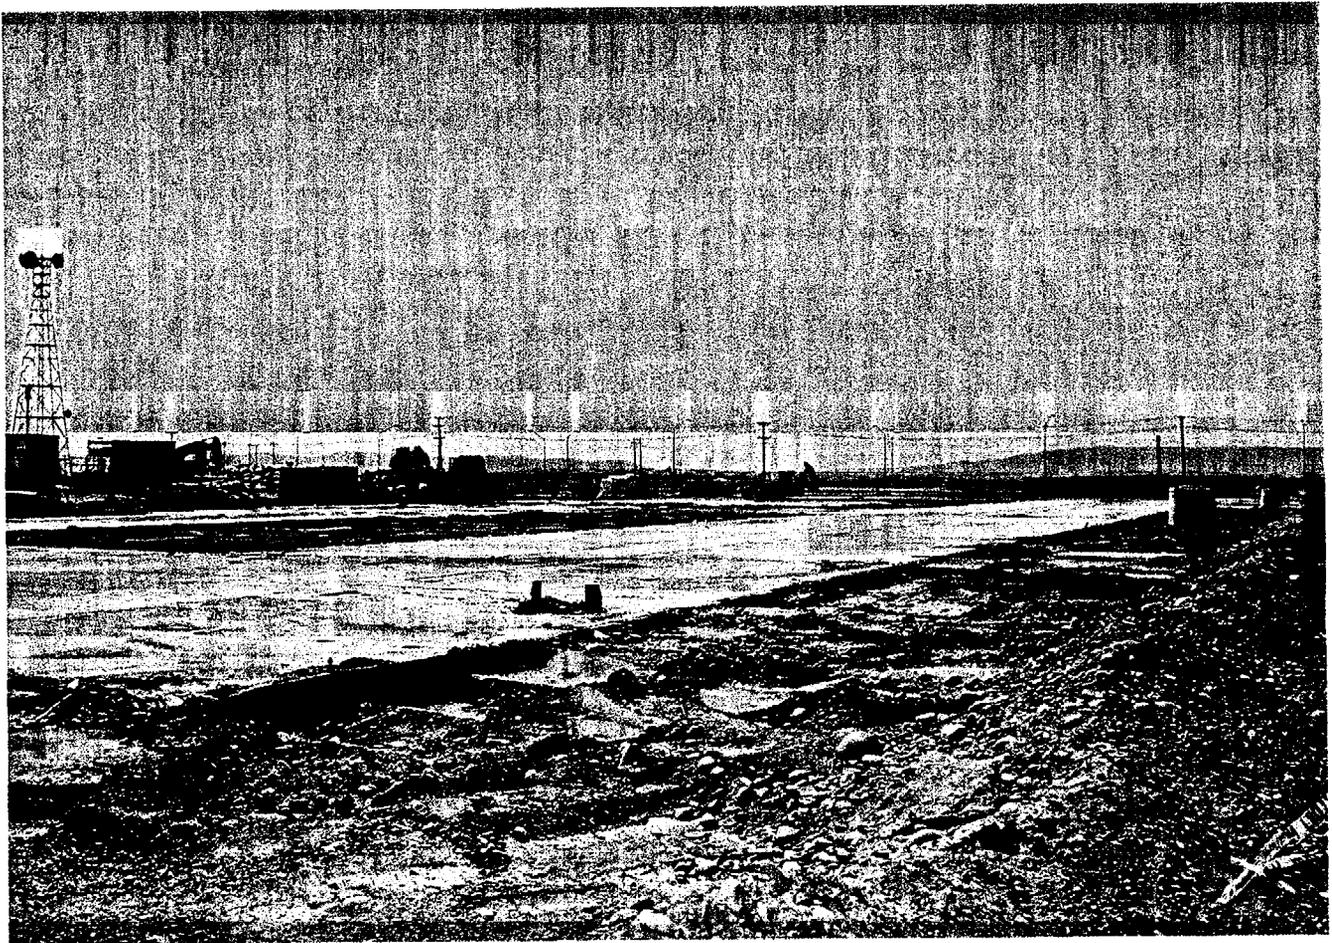
View of 3706 Concrete Slab from the Northeast (May 2006)
