FACILITY STATUS CHANGE FORM

Date Submitted: Mar 10, 2009 Originator: Bob Cathel Phone: (509) 845-6146	Area: 100-N Facility ID: 1714-N, 1714-NA, and 1714-NB Action Memorandum: 100-N Ancillary Facilities	Control #: D4-100N-0014
---	---	-----------------------------------

100-N D4 Project Facility Completion Form

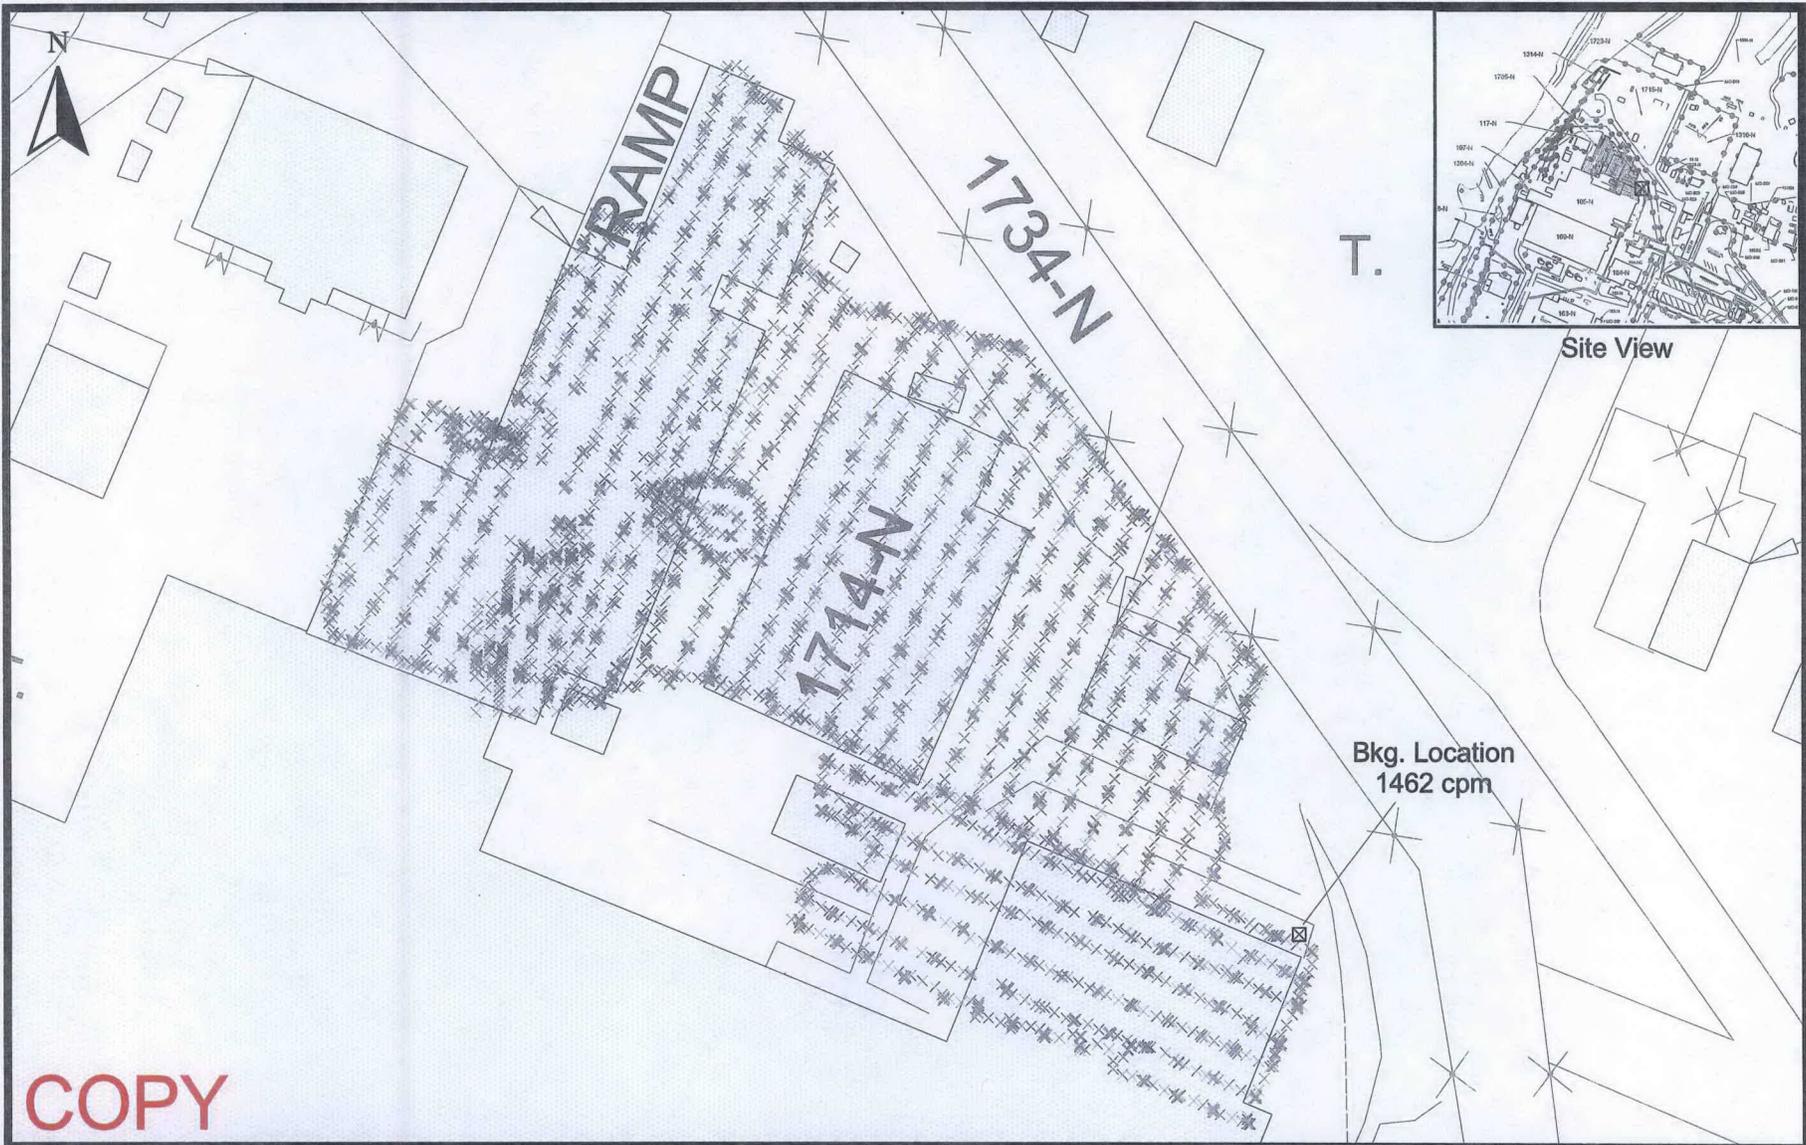
Attachment 2: GPERS Survey (1 page)

The clearance radiological surveys were performed on June 14, 2008 and documented in RSR-100N-08-1065 and RSR-100N-08-1130. All areas were direct surveyed. All surveyed areas were at less than detectable levels. A post-demolition Global Positioning Environmental Radiological Survey (GPERS) was conducted on the 1714-N complex as a final survey of this site on July 8, 2008. The 1714-N, -NA, and -NB buildings were surveyed along with the 1705-N complex, 1712-N, and 105-NB. During the survey, 10858 data points were measured and no data point was greater than 2 times the average background of 1462 counts per minute. A copy of the survey map is in Attachment 2.

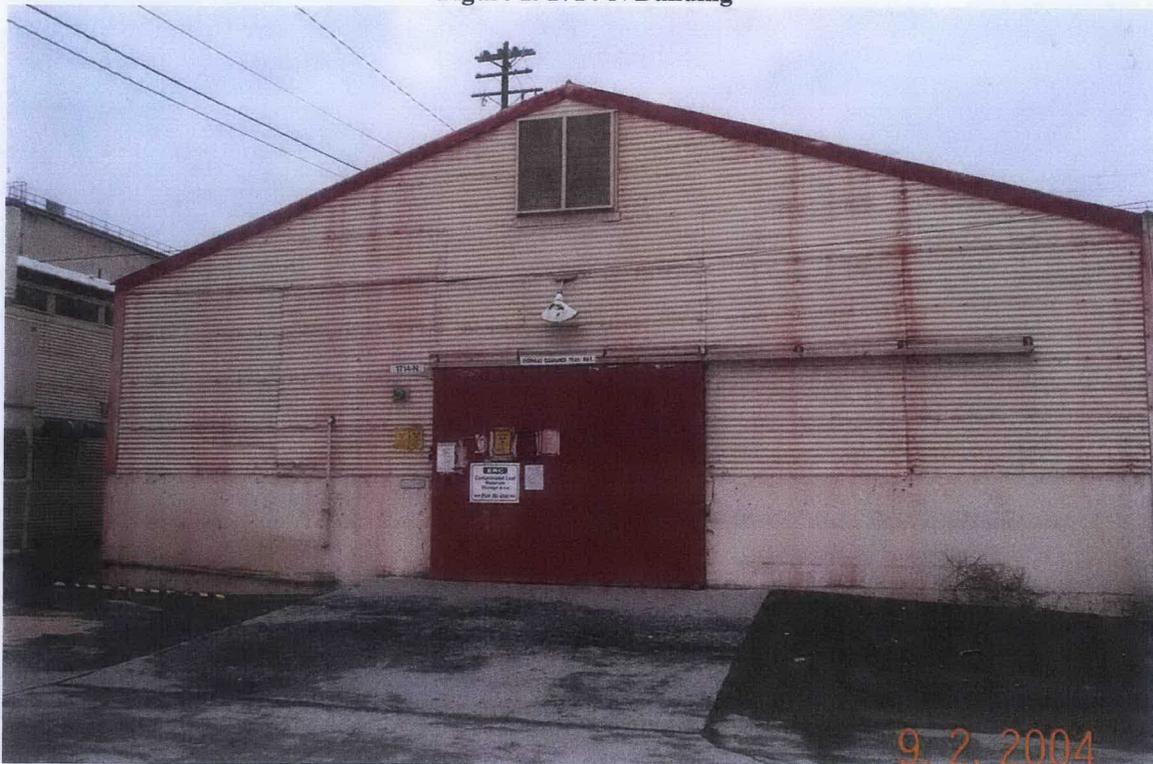
Figure 1. 1714-N Building

The 1714-N Warehouse was a rectangular, one-story, steel framed building with a poured concrete slab foundation, aluminum exterior wall surface with concrete on the lower 3 ft, and an aluminum metal roof. Interior walls were gypsum wallboard or aluminum siding. The building was 40 ft x 80 ft (3200 ft²) and was originally used as a tool and equipment storage facility. A long-term radioactive material storage area was established in this facility in 1994.

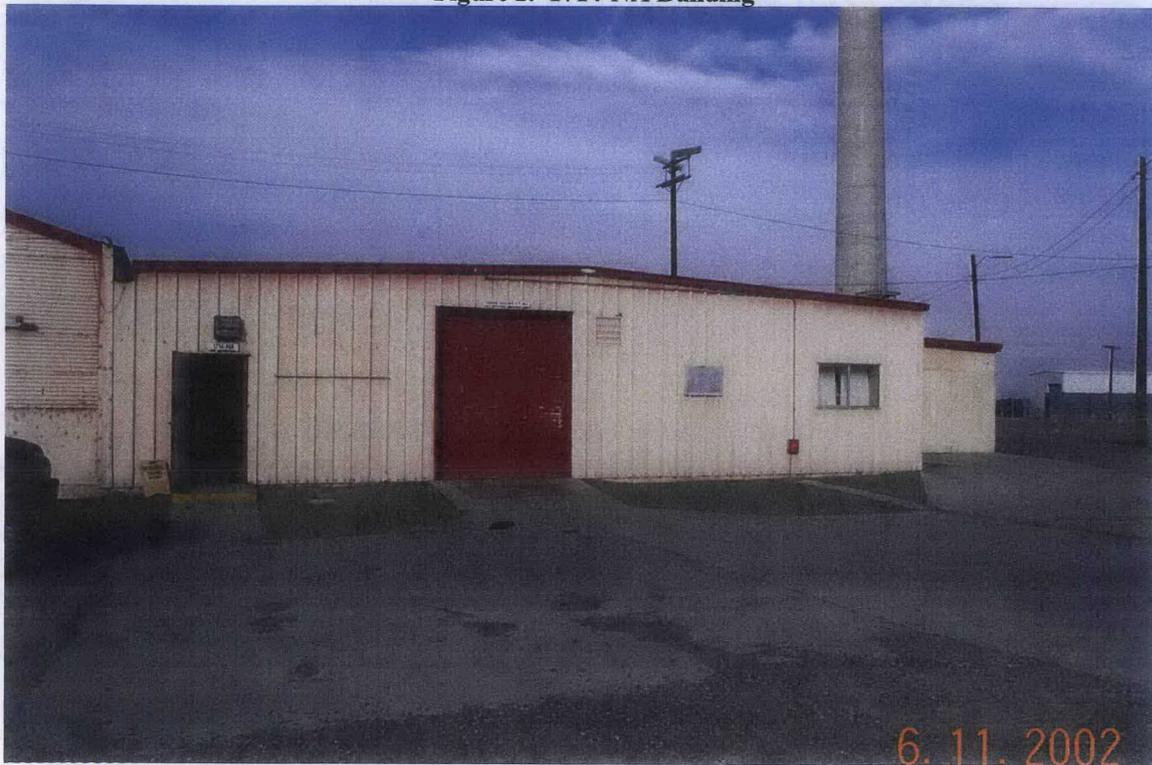
Figure 2. 1714-NA Building

The 1714-NA Warehouse was a rectangular, one story, steel framed building with a poured concrete slab foundation. The outer walls were aluminum except for concrete on the lower 3 ft on the south wall which it shared with 1714-N. The building roof was aluminum. Interior walls were unfinished and the foil back insulation was visible. The building was 50 ft x 80 ft (4000 ft²) and was originally used for inspecting and receiving functions. The last use for 1714-NA was for clean material storage.

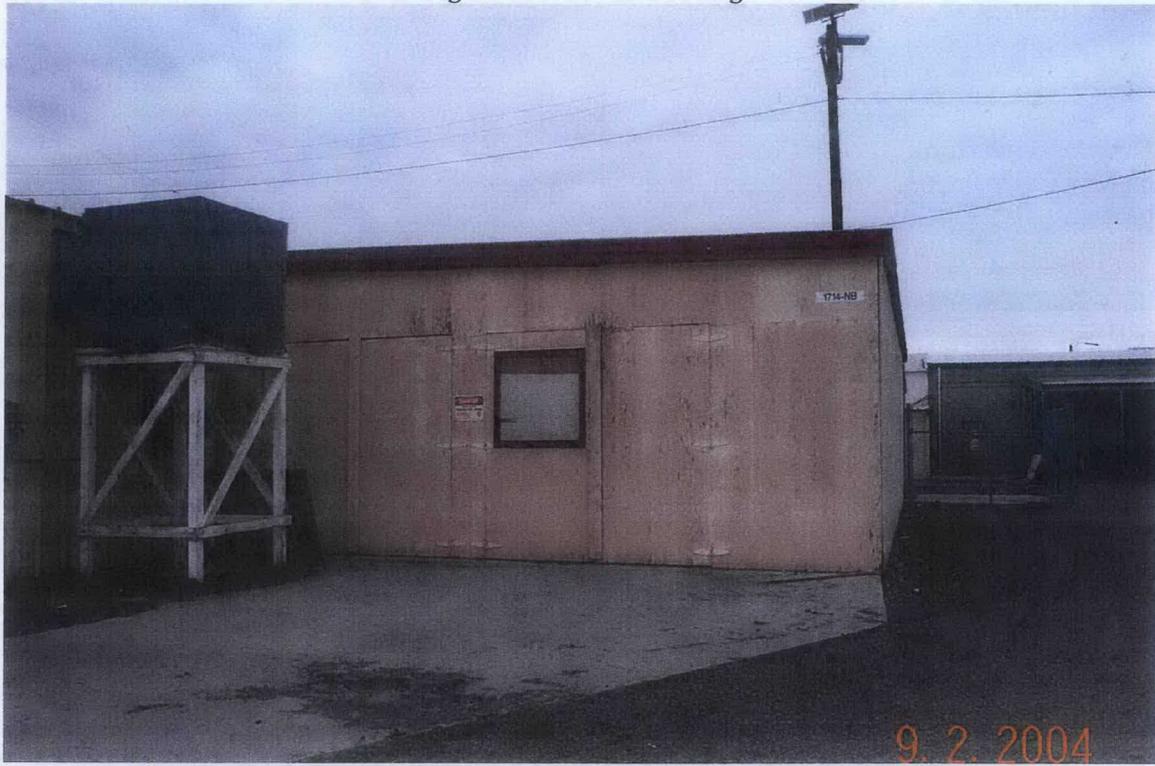
Figure 3. 1714-NB Building

The 1714-NB Warehouse was a rectangular, one story, wood framed building with wood siding on the East, West, and North sides. The south wall was a shared wall with 1714-NA and was steel framed with aluminum siding. The building was built on a concrete slab floor. The roof was steel framed covered with aluminum sheeting. The building was 24 ft x 40 ft (960 ft²) and was originally used for tool storage. It was last used for miscellaneous debris and equipment.

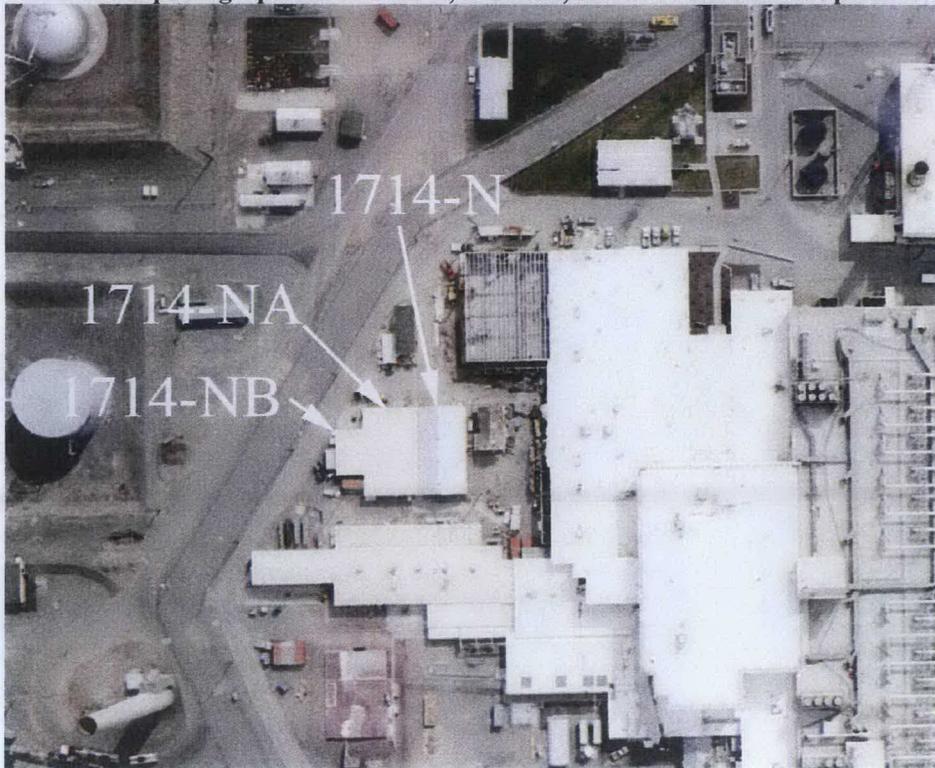
Figure 4. The aerial photograph shows 1714-N, 1714-NA, and 1714-NB facilities prior to removal.

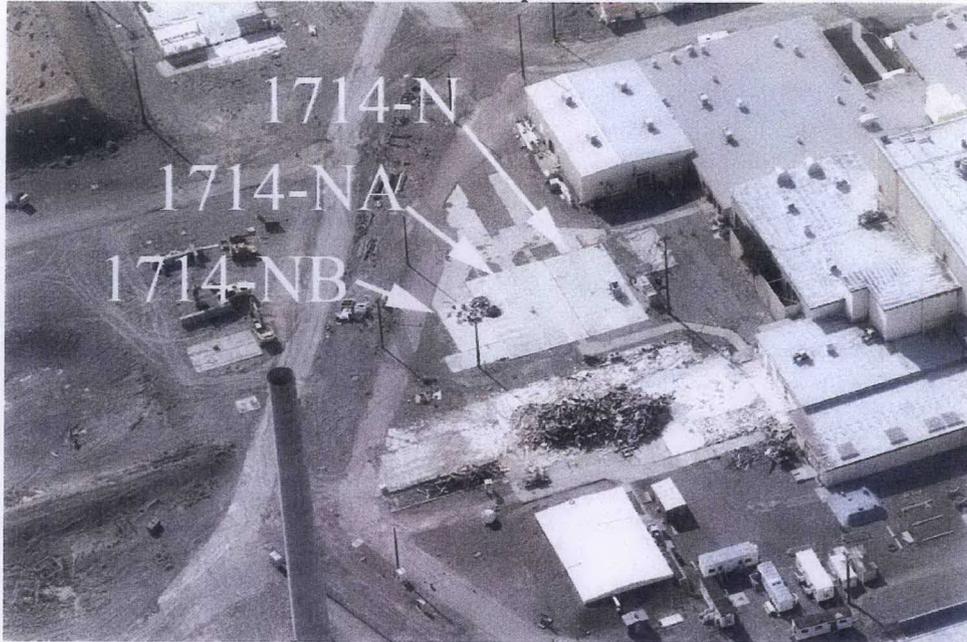
Figure 5. The aerial photograph shows the slabs from the 1714-N, 1714-NA, and 1714-NB facilities prior to removal.

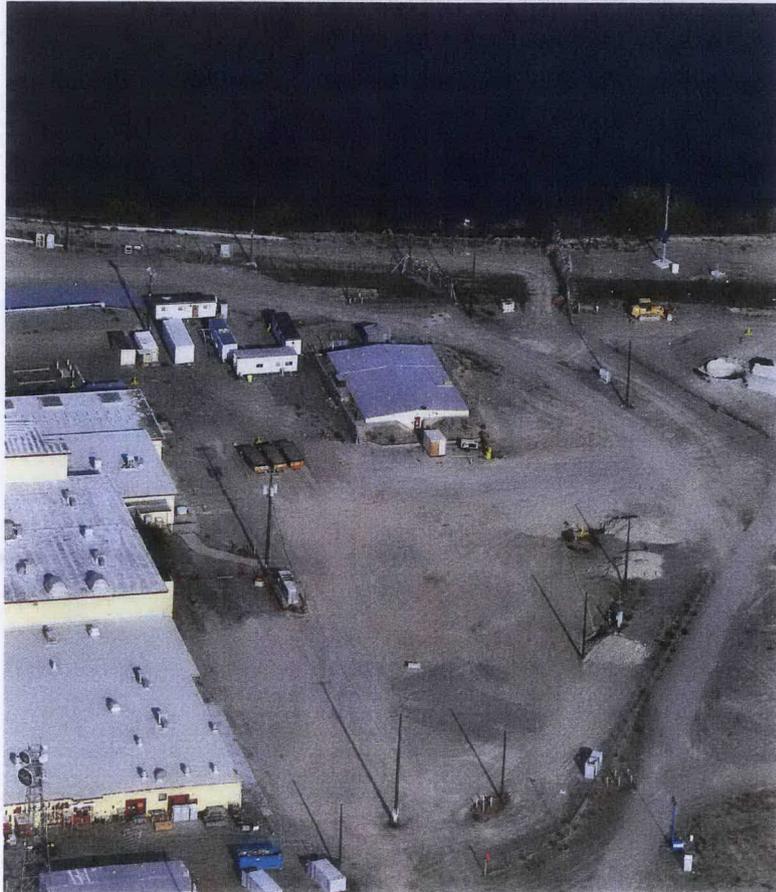
The 1714-N, -NA, and -NB facilities were initially demolished to the concrete pad. After demolition was completed, the building debris was stockpiled on the concrete pad, loaded out and disposed at ERDF. All traces of the 1714-N, -NA, & -NB concrete pads were removed in 2008. A minimal amount of soil was removed along with the concrete pads. Backfill material from 100-N Borrow Pit was brought in to regrade the site.

Figure 6 The aerial photograph shows the site of the 1714-N, 1714-NA, and 1714-NB after demolition and slab removal.
