FACILITY STATUS CHANGE FORM

Date Submitted: Mar 10, 2009 Originator: Bob Cathel Phone: (509) 845-6146	Area: 100-N Facility ID: 1712-N Action Memorandum: 100-N Ancillary Facilities	Control #: D4-100N-0015
---	---	-----------------------------------

100-N D4 Project Facility Completion Form

The 1712-N Insulation Shop was used as an insulation fabrication shop at 100-N. The 1712-N facility was constructed in 1962 as part of the original N-Reactor complex. It was a rectangular, two-story, steel framed building with a reinforced poured concrete foundation, corrugated metal exterior wall surface, and a corrugated metal gable roof. The second story was enclosed on one-half, and open from the first floor to the roof on the second story in the second half. Interior walls were 5.1 cm by 10.2 cm (2 in by 4 in) studs with cement asbestos or gypsum wallboard. A small wood and corrugated sheet metal lean-to type storage shed was attached to the northwest corner of 1712-N. An asbestos dust collector was located on a concrete pad at the northeast corner of 1712-N. The building was 20 ft x 40 ft (800 ft²).

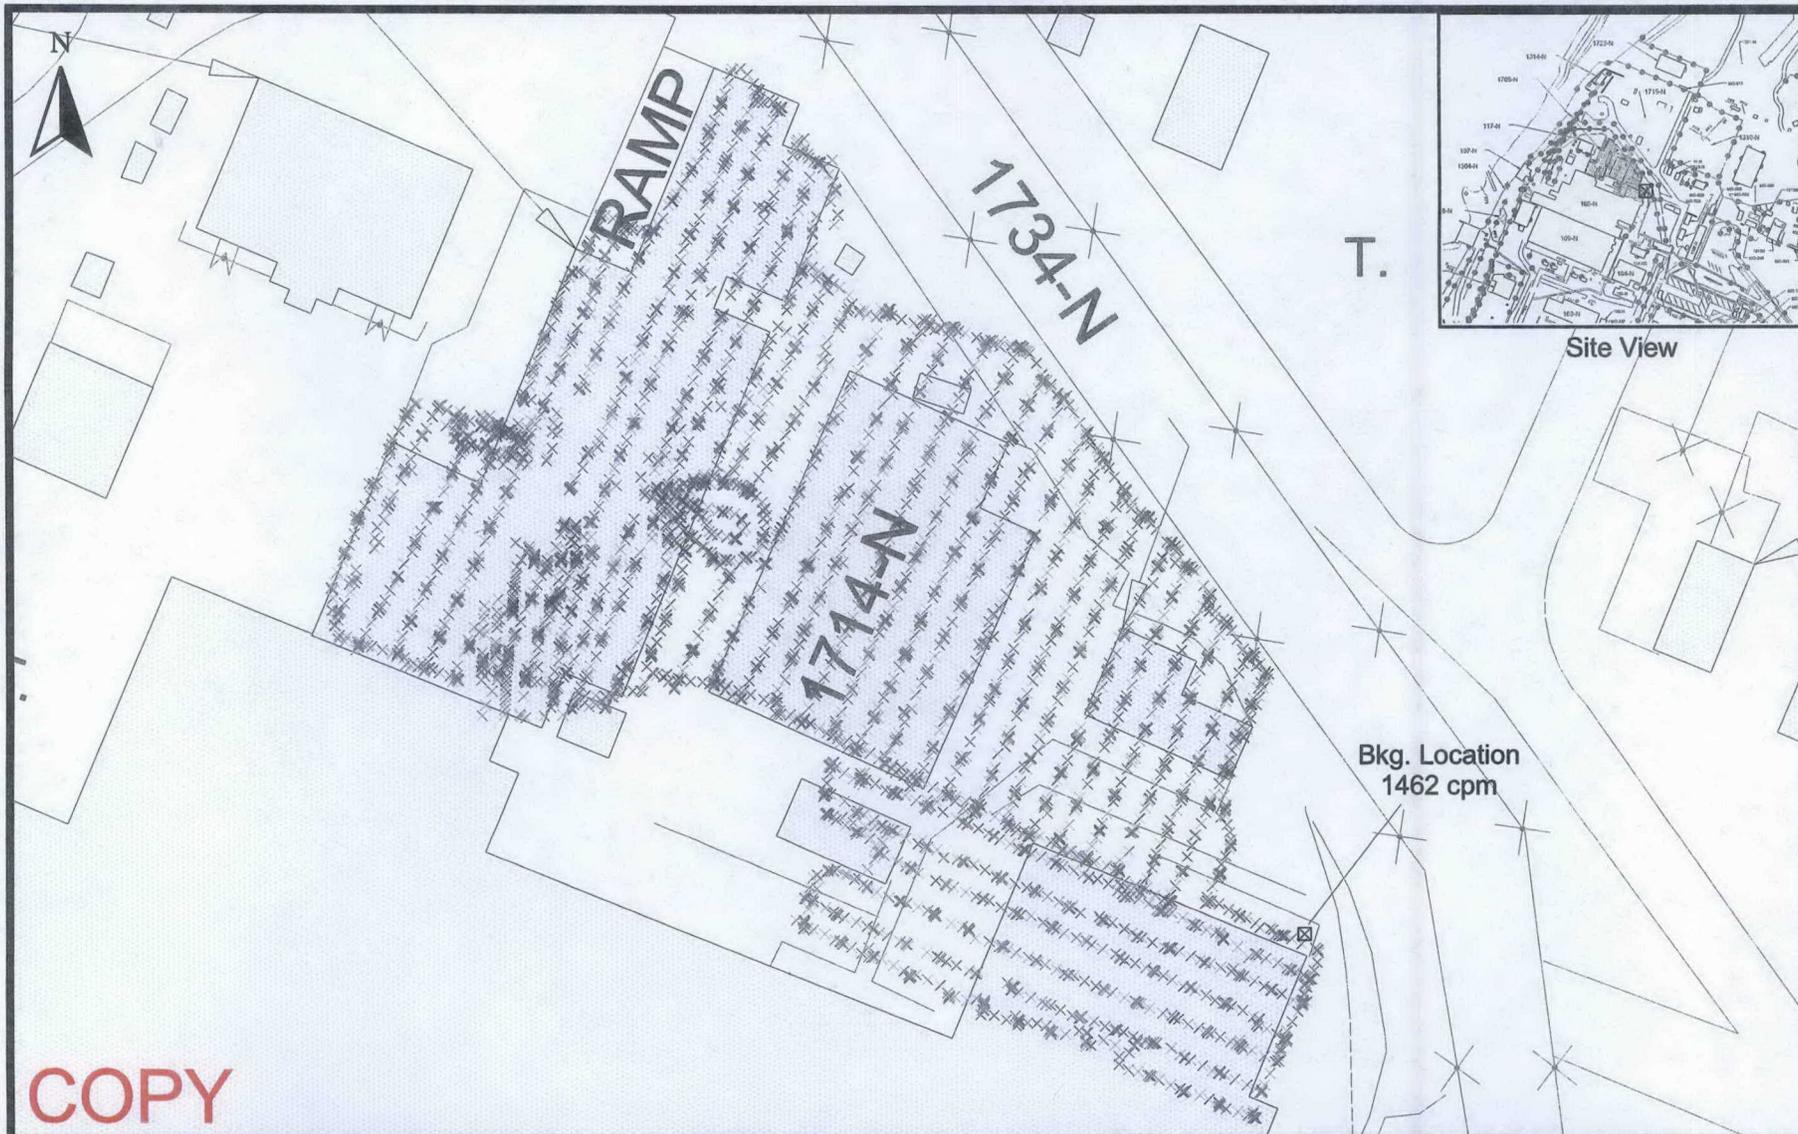
**100N D4 Project
 1705N Slab Village
 GPERS Radiological Survey
 Gamma Track Map**

The clearance radiological surveys were performed on June 14, 2008 and documented in RSR-100N-08-1065. All areas were direct surveyed. All surveyed areas were at less than detectable levels. A post-demolition Global Positioning Environmental Radiological Survey (GPERS) was conducted on the 1712-N facility as a final survey of this site on July 8, 2008. The 1712-N facility was surveyed along with the 1705-N complex, 1714-N complex, and 105-NB. During the survey, 10858 data points were measured and no data point was greater than 2 times the average background of 1462 counts per minute. A copy of the survey map is in Attachment 2.

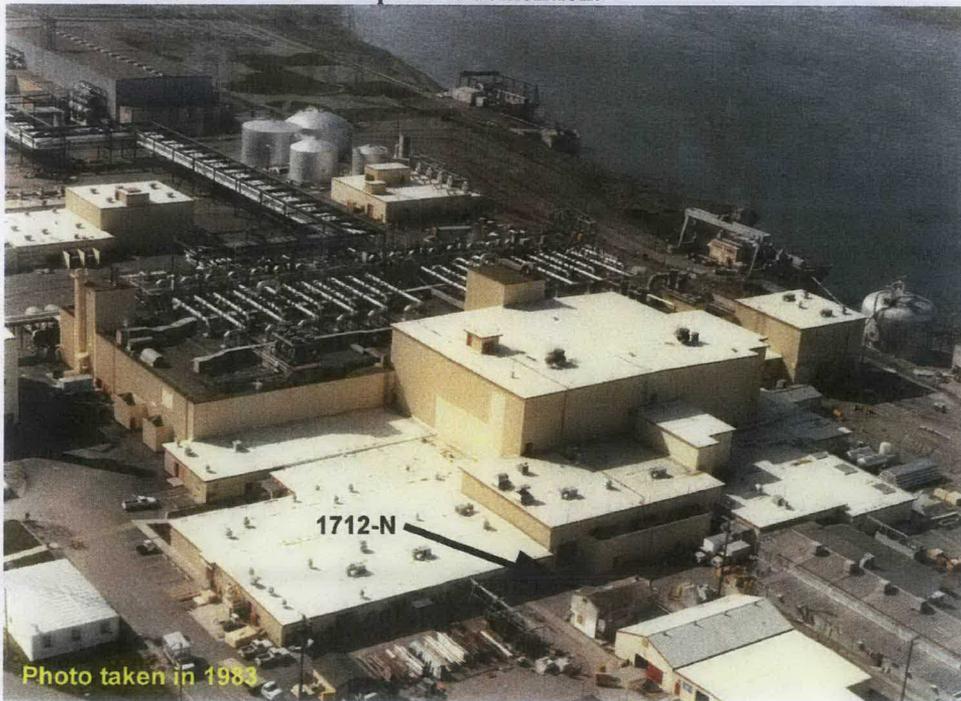
Figure 2. The aerial photograph shows the location of the 1712-N facility prior to demolition.

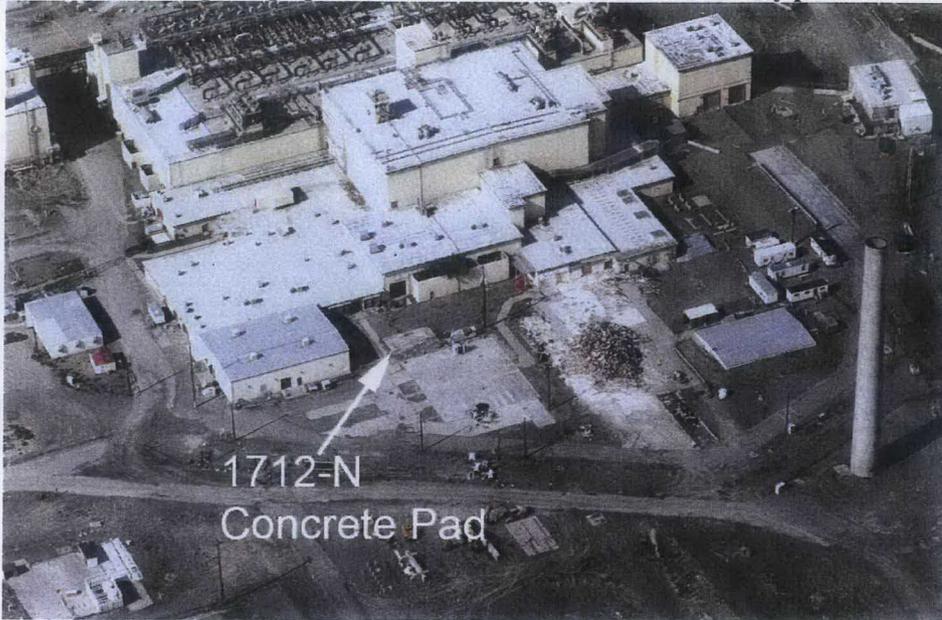
Figure 3. The aerial photograph shows the slab from the 1712-N facility prior to removal.

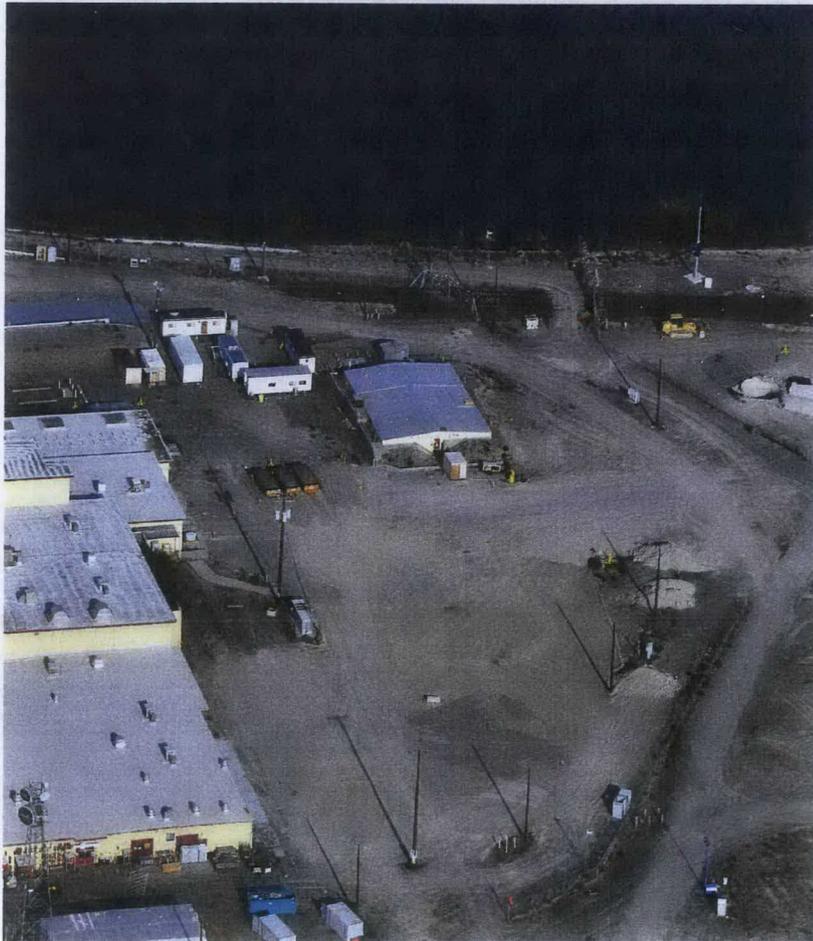
The 1712-N building and concrete pad were demolished and removed. A minimal amount of soil was removed along with the concrete pad. The site has been regraded with material from the 100-N borrow pit.

Figure 4 The aerial photograph shows the site of the 1712-N facility after demolition and slab removal.
