## FACILITY STATUS CHANGE FORM

<b>Date Submitted:</b> Mar 10, 2009 <b>Originator:</b> Bob Cathel <b>Phone:</b> (509) 845-6146	<b>Area:</b> 100-N <b>Facility ID:</b> 105-NB <b>Action Memorandum:</b> 100-N Ancillary Facilities	<b>Control #:</b> D4-100N-0016
---	---	-----------------------------------

## 100-N D4 Project Facility Completion Form

This document provides information regarding the 105-NB facility history, characterization and final status at the completion of deactivation, decontamination, decommissioning and demolition (D4) activities.

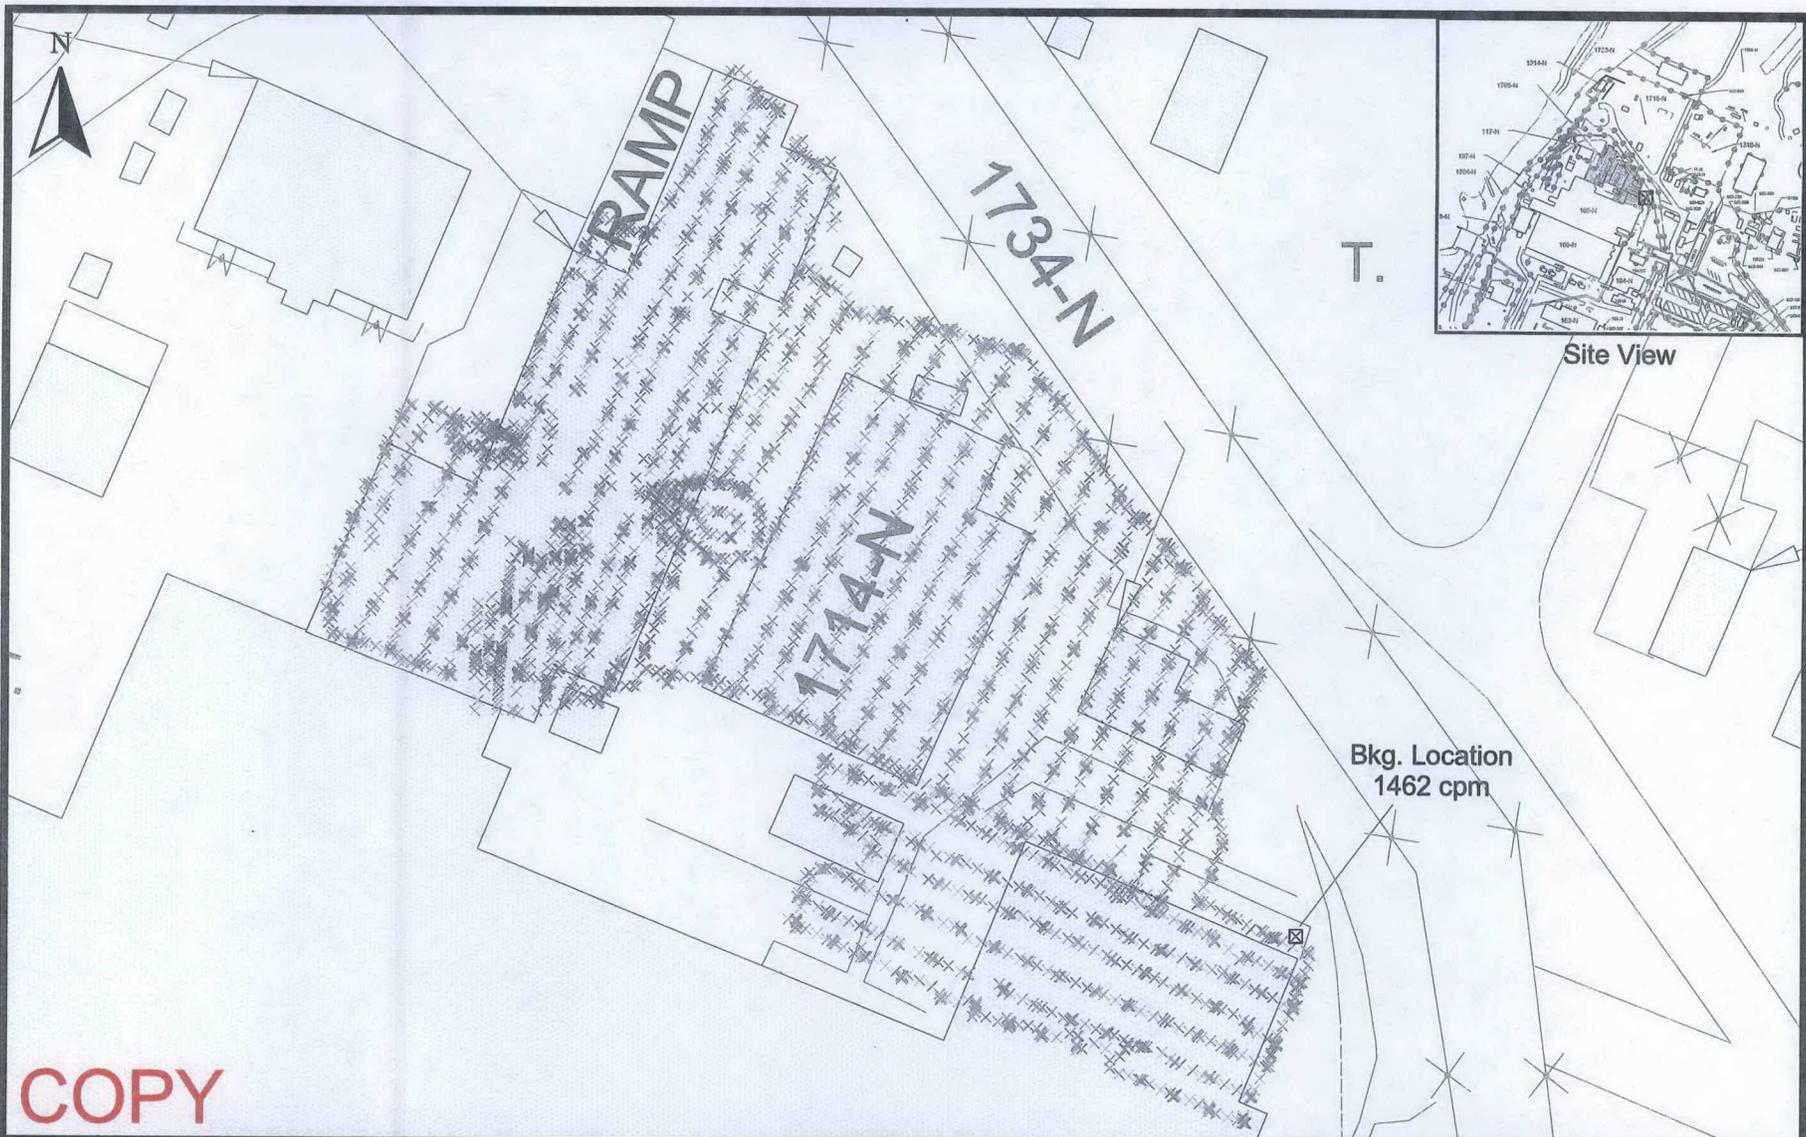
**100N D4 Project**  
**1705N Slab Village**  
**GPERS Radiological Survey**  
**Gamma Track Map**

An initial radiological down-posting survey was performed on August 22, 2007 and documented in RSR-100N-07-0194. All areas were direct surveyed. All surveyed areas were at less than detectable levels. The clearance radiological survey was performed on June 25, 2008. This survey was part of a larger survey of several buildings in the area. The survey is documented in RSR-100N-08-1130. All areas were direct surveyed and were less than detectable levels. A post-demolition Global Positioning Environmental Radiological Survey (GPERS) was conducted on the 105-NB facility area as a final survey of this site on July 8, 2008. The 105-NB facility was surveyed along with the 1714-N complex, 1705-N complex, and 1712-N. During the survey, 10858 data points were measured and no data point was greater than 2 times the average background of 1462 counts per minute. A copy of the survey map is in Attachment 2.

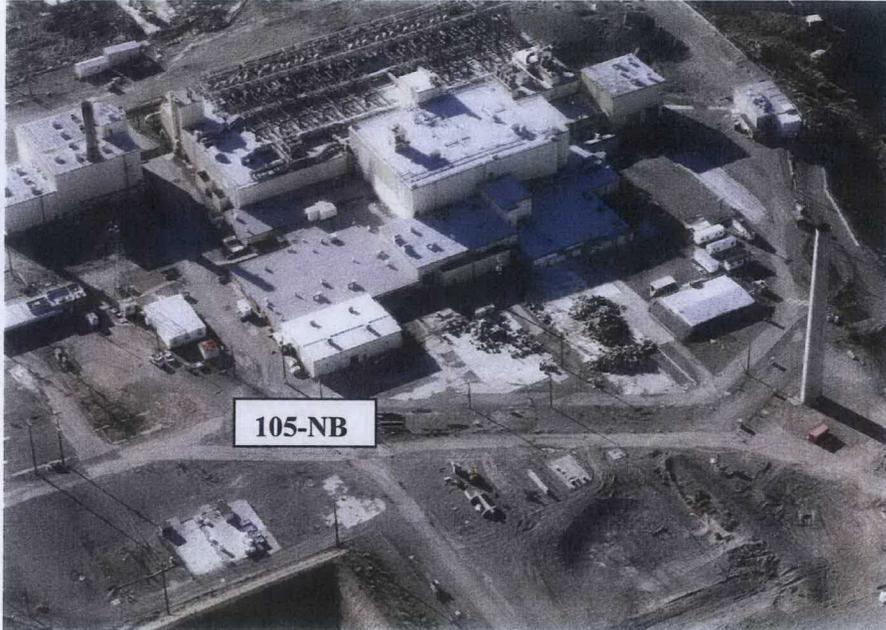
**Figure 1. A aerial photograph of the 105-NB Building before demolition**

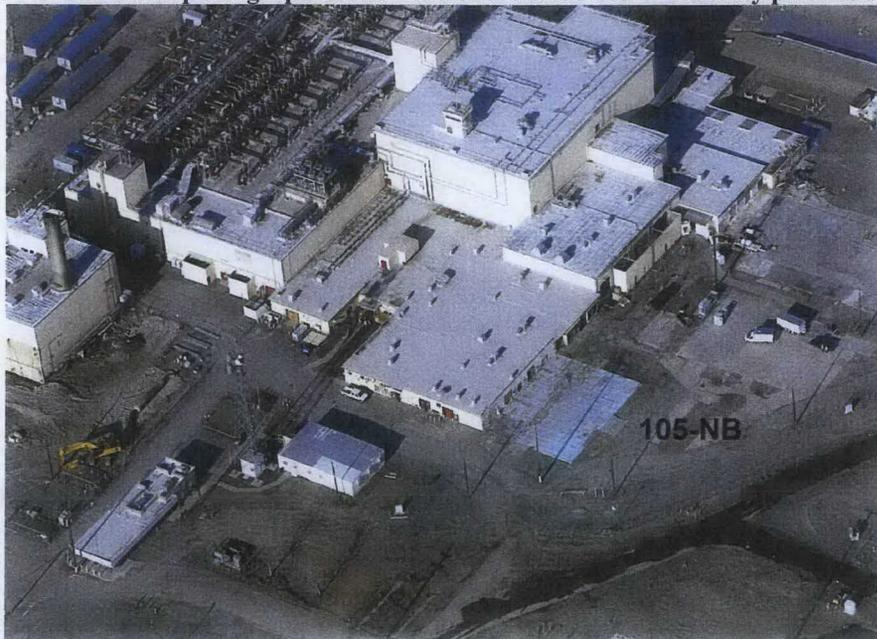
**Figure 2. The aerial photograph shows the slab from the 105-NB facility prior to removal.**

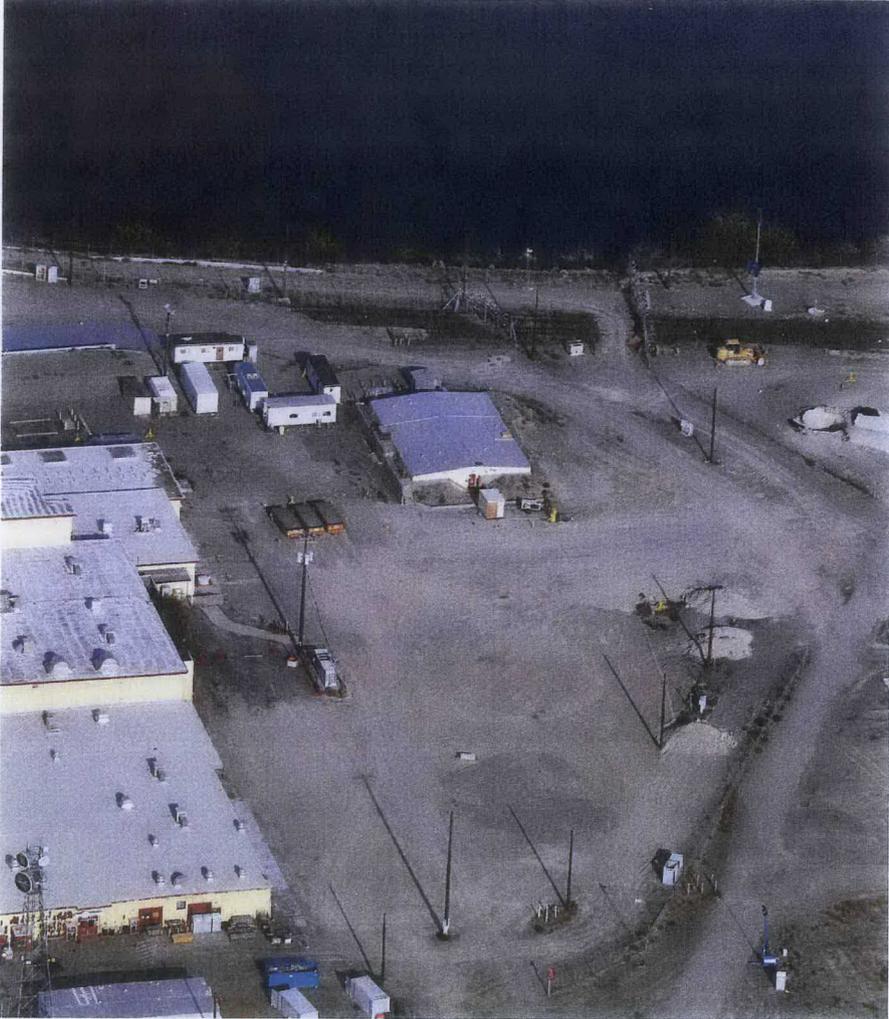
Figure 3. The aerial photograph shows the site of the 105-NB after demolition and slab removal.
