## FACILITY STATUS CHANGE FORM

## D4 Project Facility Completion Form 153-N Electrical Substation

SUBJECT: **POST DEMOLITION SUMMARY REPORT FOR THE 153-N ELECTRICAL  
SUBSTATION**

# Post Demolition Summary Report for the 153-N Electrical Substation

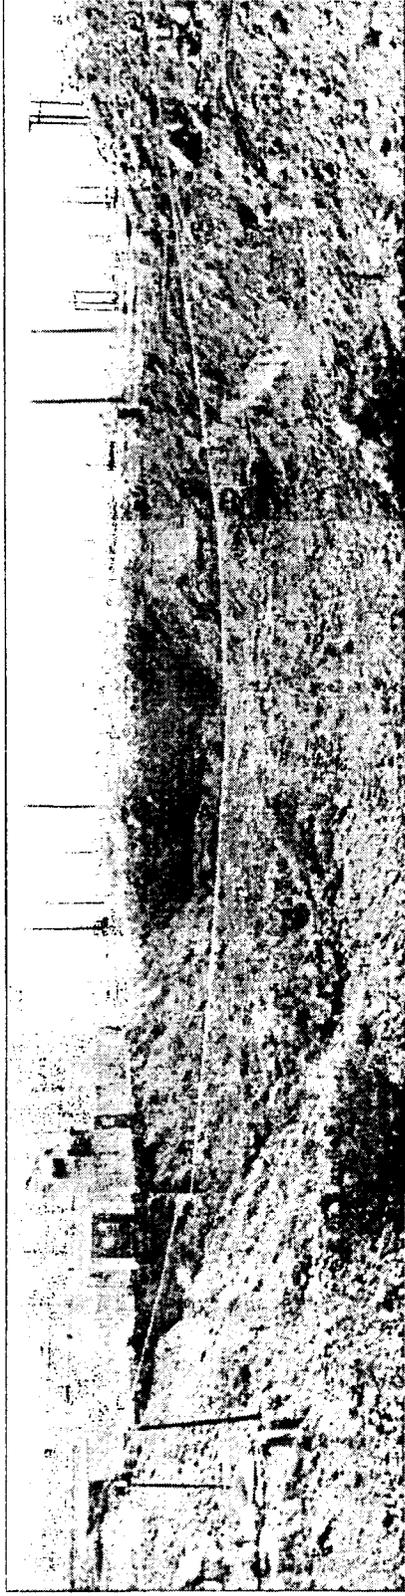
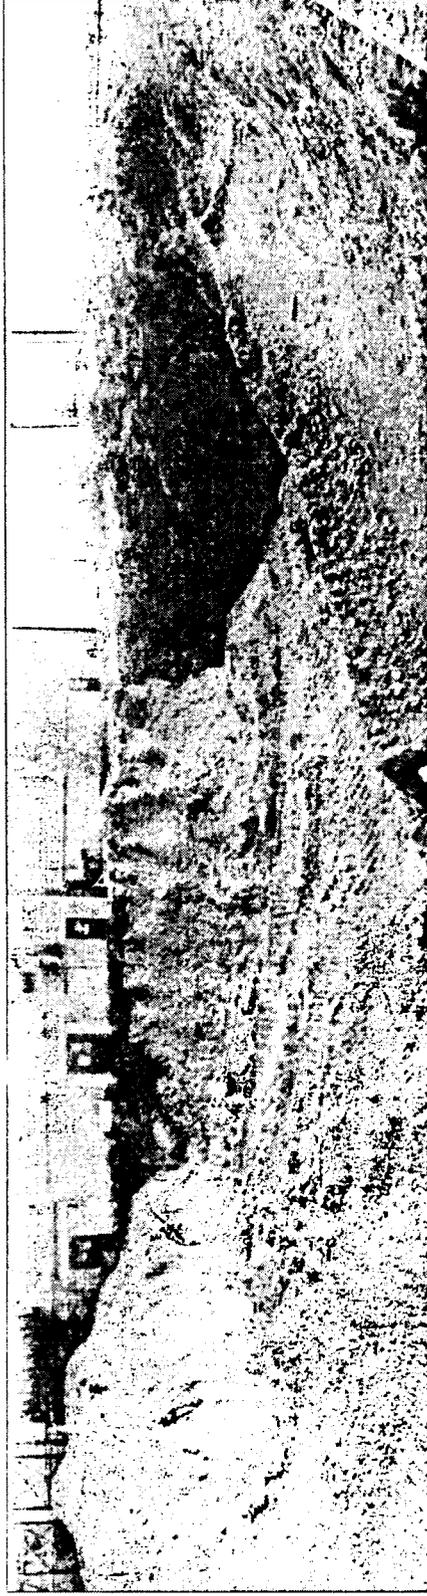
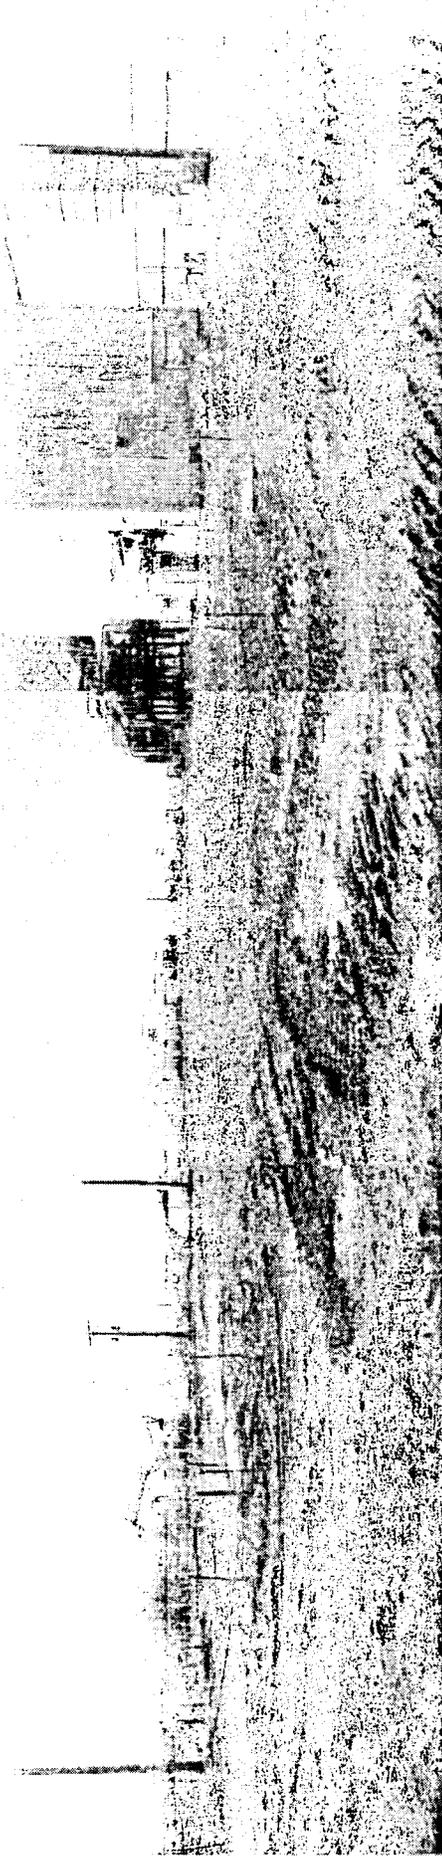
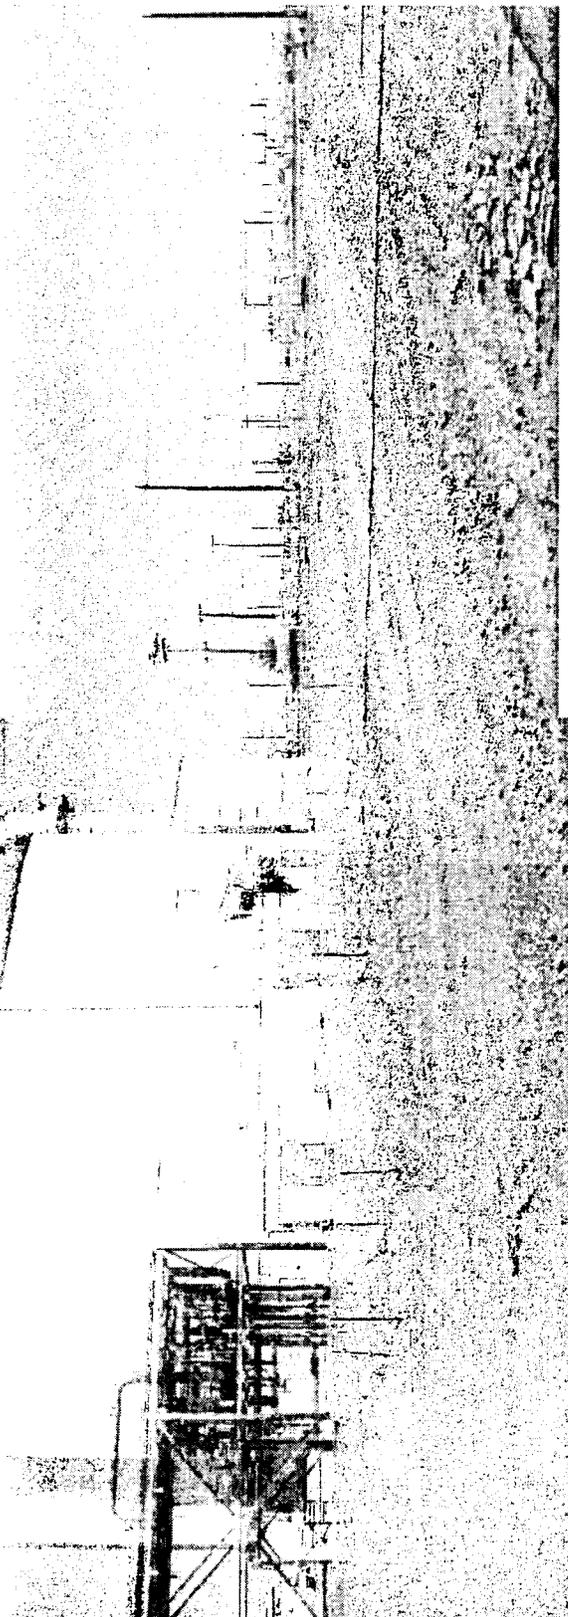
**Figure 2 - 153-N Electrical Substation Excavation**

UPR-100-N-36, Diesel Generator Area – this inactive WIDS site is in an area used to work on compressor parts and had oil spills during this work. The WIDS description indicates that the most recent spills were cleaned up. The 153-N demolition excavation came up to the southern edge of this WIDS site, and may have intersected the WIDS site. During D4 demolition activities, the excavation was visually inspected for signs of staining. No staining was identified, and no indication of soil contamination could be found. Pictures of the facility excavation are provided as Figure 2.

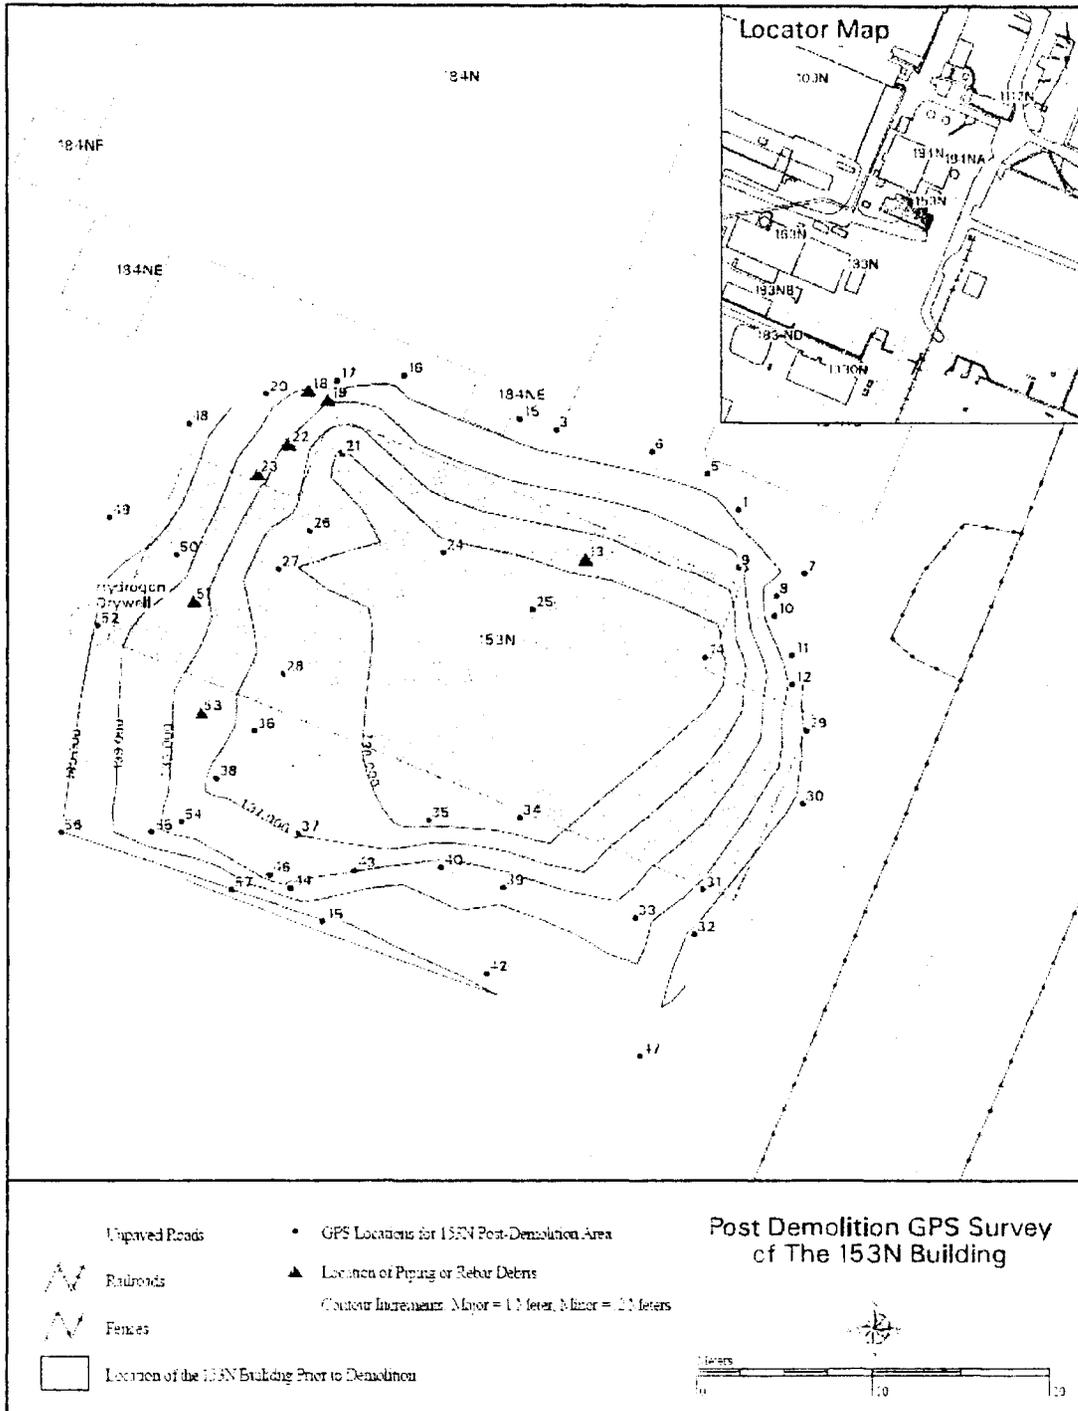
## Attachment 4 – Post-Demo Civil Survey

A GPS civil survey was performed on the 153-N prior to demolition. This survey located the corners of the building and the corners and extents of near-by structures. A post demolition civil survey was performed. This survey documented the extent of the excavation (footprint and depth) as well as remaining structures (electrical conduits and concrete structures) extending into the excavation. It should be noted, that these remaining concrete structures are not from the 153-N facility but rather footings from adjacent structures.

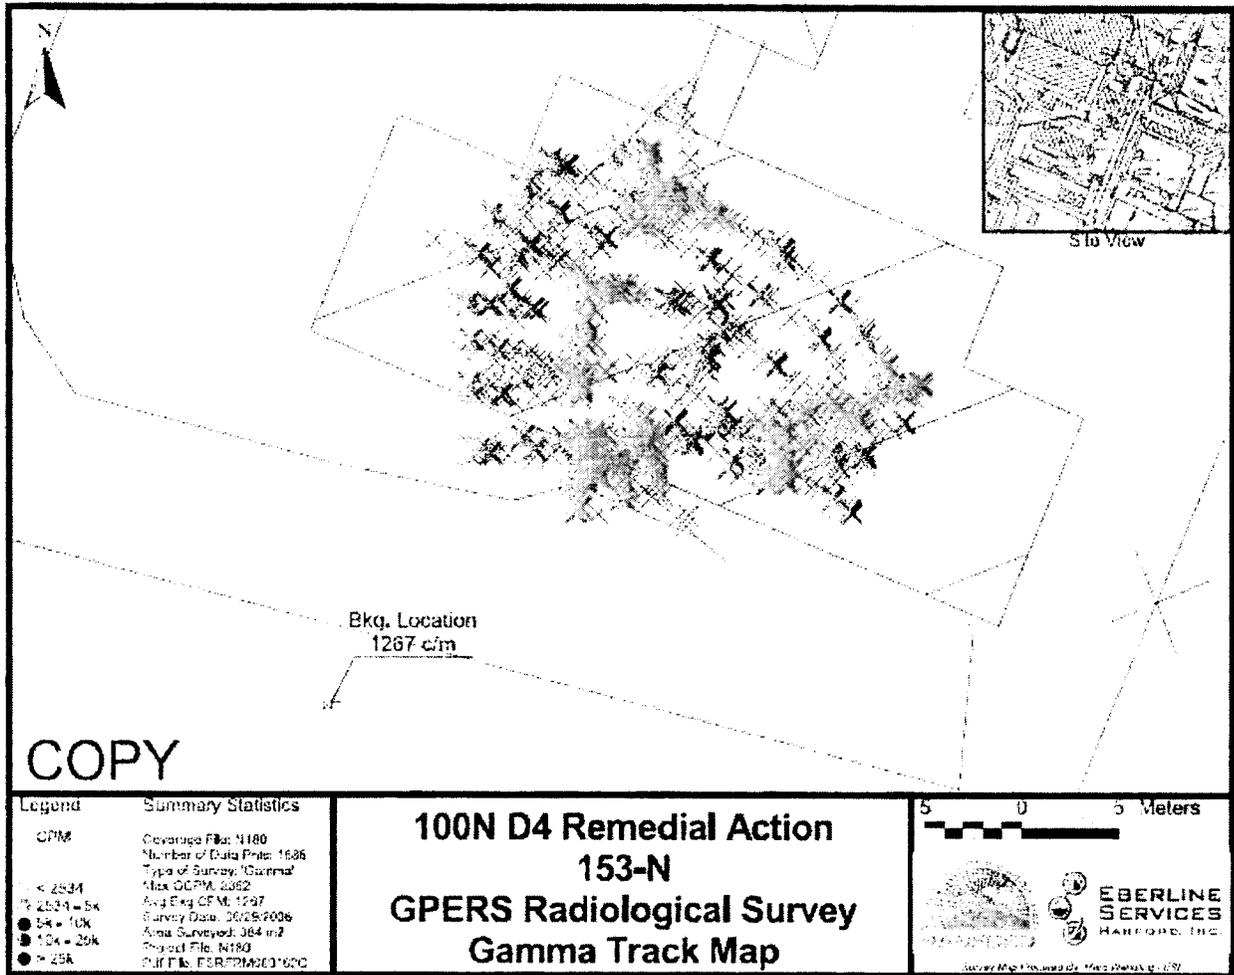
## Attachment 4 - GPERs Survey of 153-N Excavation, Gamma Track

This down posting survey included tech smears of the excavation equipment and the 153-N demo site, except for the excavation. A GPERS survey was performed in the excavation (see Attachments 4 and 5). No contamination was detected during the demolition of 153-N, and is documented in these surveys.
