FACILITY STATUS CHANGE FORM

Date Submitted: May 13, 2012 Originator: David Warren Phone: (509) 539-6040	Area: 100-N Facility ID: 184-N, -NA, -NB, -NC, -ND, -NE, & -NF Action Memorandum: 100-N Ancillary Facilities	Control #: D4-100N-0021
---	--	-----------------------------------

100-N D4 Project Facility Completion Form

184-N, 184 -NB, 184-NC, 184-ND, 184-NE, and 184-NF Facility Completion

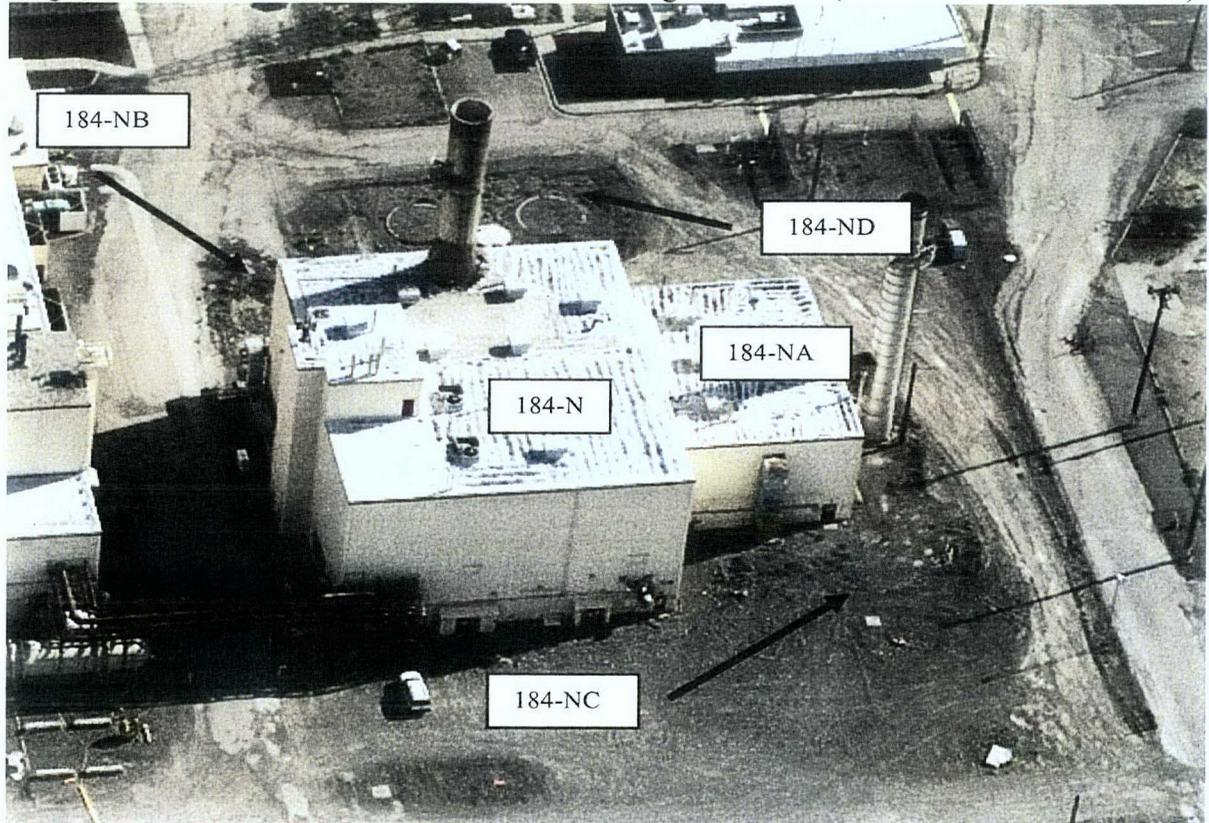
Figure 4. 184-NB, 184-NC, and 184-ND following demolition (184-N and 184-NA remain)

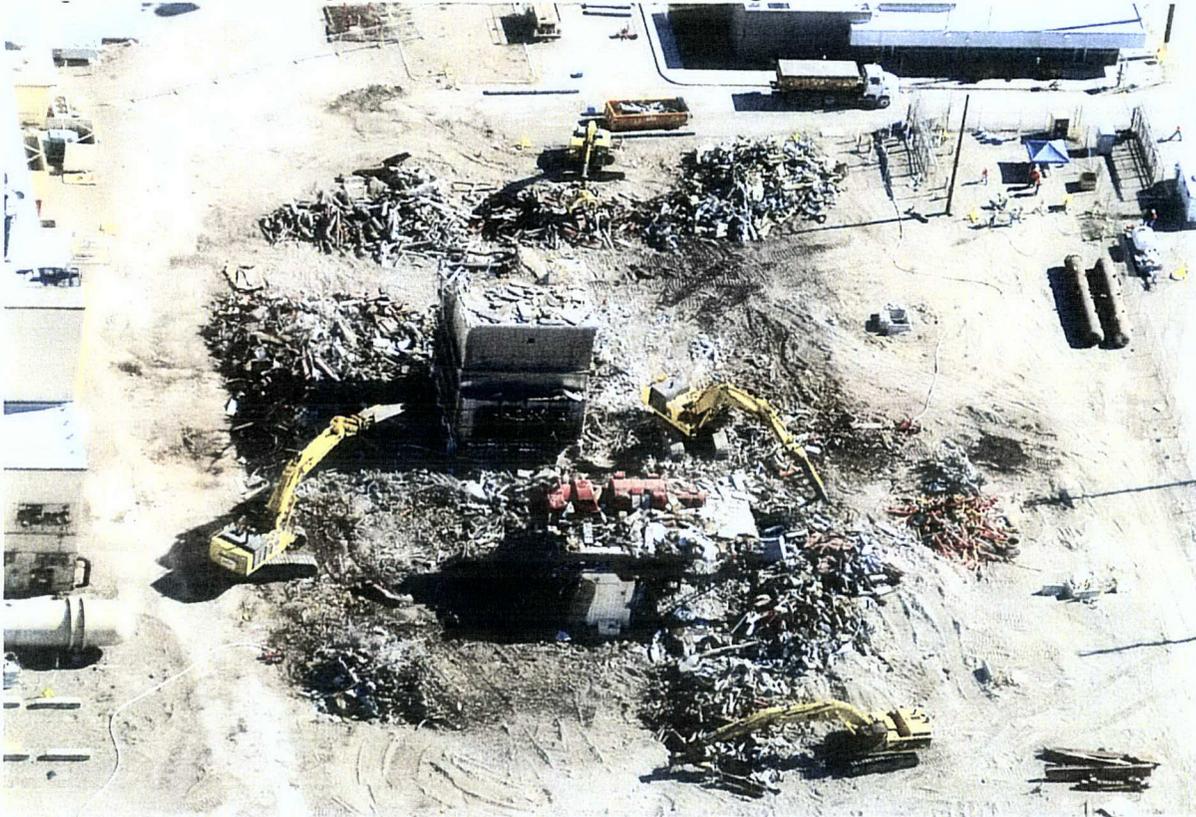
Figure 5. 184-N Powerhouse during demolition

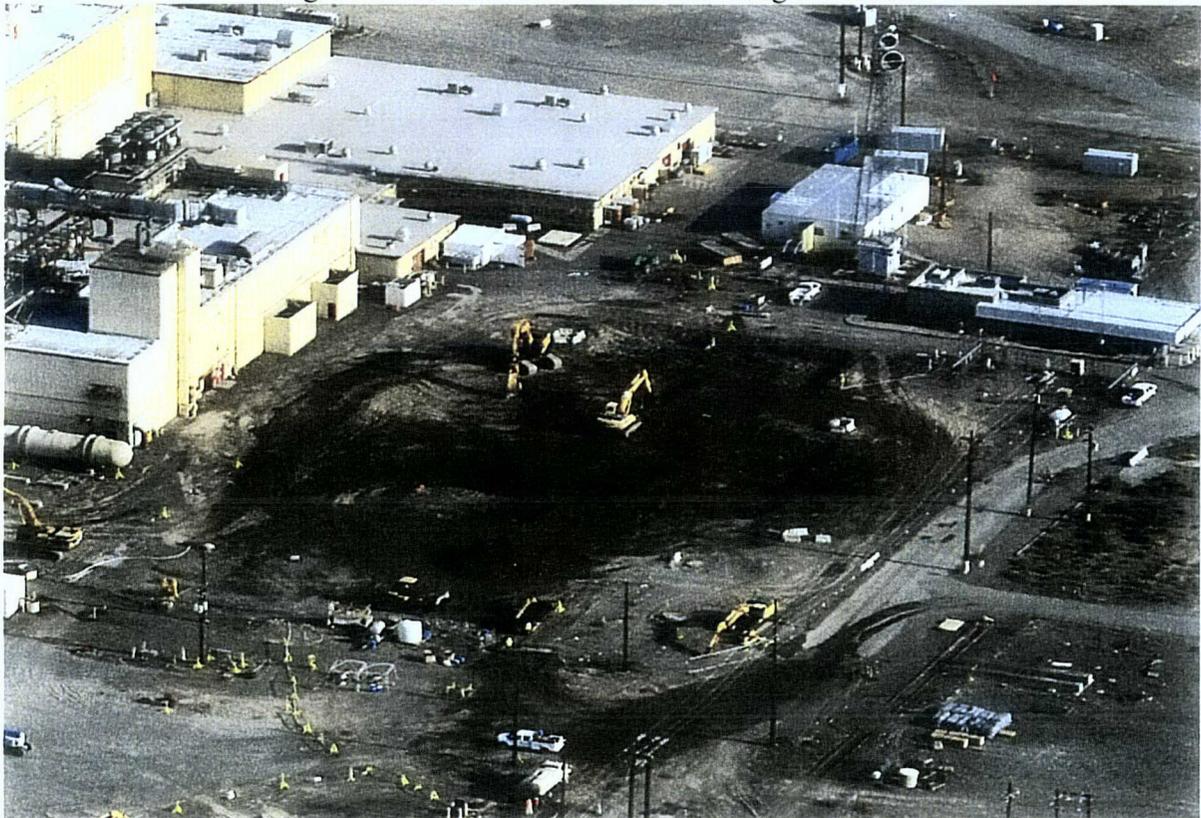
Figure 5. 184-N Powerhouse following demolition

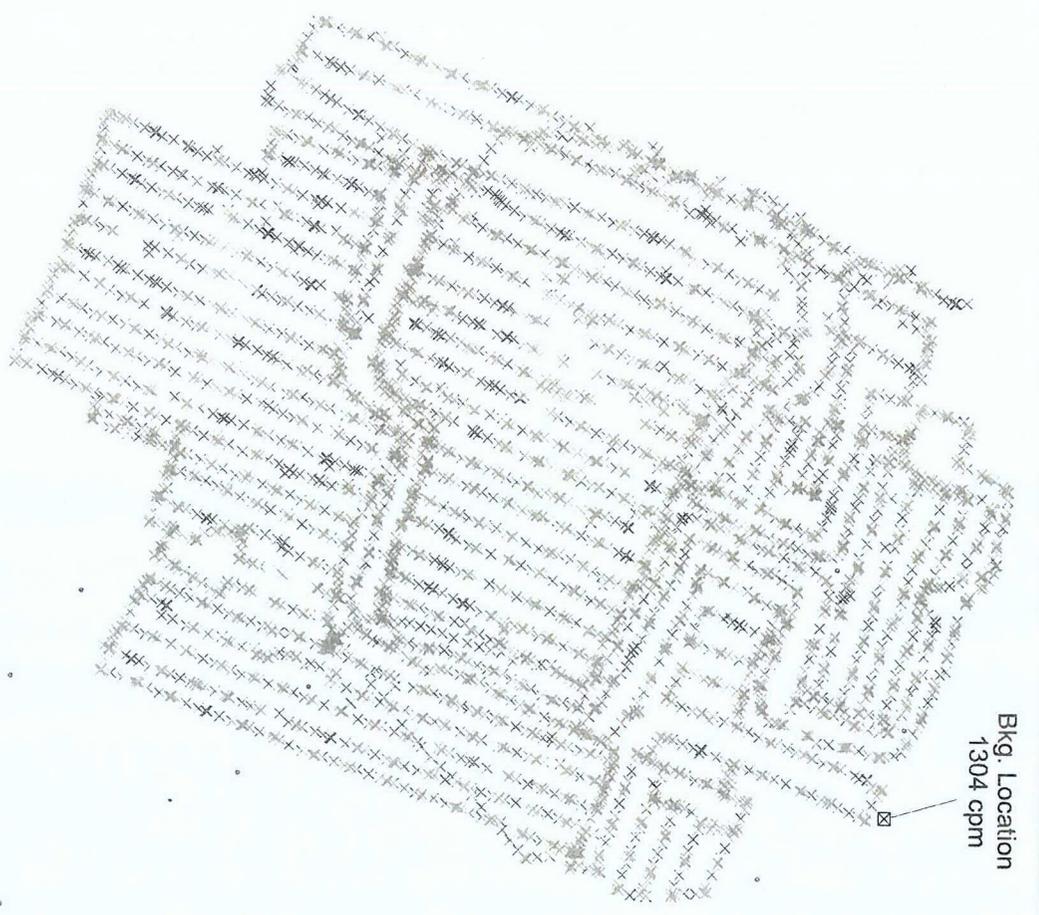
100N D4 Project
184-N Area
GPERS Radiological Survey
Gamma Track Map

conducted in September 2008. 8,594 data points were measured and no data point was greater than 2 times the average background of 1,304 counts per minute. A copy of the survey map is in Attachment 4.

Coverage File: N269
Number of Data Pnts: 8594
Type of Survey: Gamma
Max GCPM: 2543
Avg Bkg CPM: 1304
Survey Date: 09/25/2008
Area Surveyed: 5848 m2
Project File: N269
Pdf File: ESRFRM080145C
