Re: Department of Ecology's Dangerous Waste Compliance Inspection at Hanfords 242-A  
Evaporator RCRA ID# WA7890008967 on November 13, 2012

**Washington Department of Ecology  
Hazardous Waste & Toxics Reduction Program  
Compliance Report**

**Site: 200 Area Hanford Permit, 242-A Evaporator Dangerous Waste  
Management Unit  
RCRA ID#: WA 7890008967**

Inspection Date: November 13, 2012 - 9:00 am to 4:30 pm

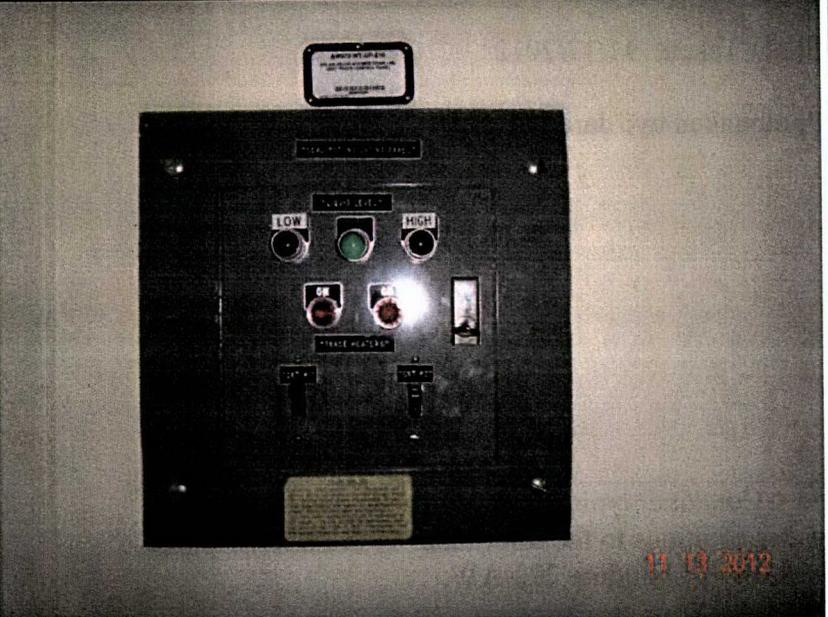
Area & Description	Photographs
<p>#1 – Building 272-AW: Seal pot indication panel for the safety shower seal loop liquid level.</p> <p>Date photo taken: 11/13/2012</p> <p>Photo taken by: Jared Mathey</p>

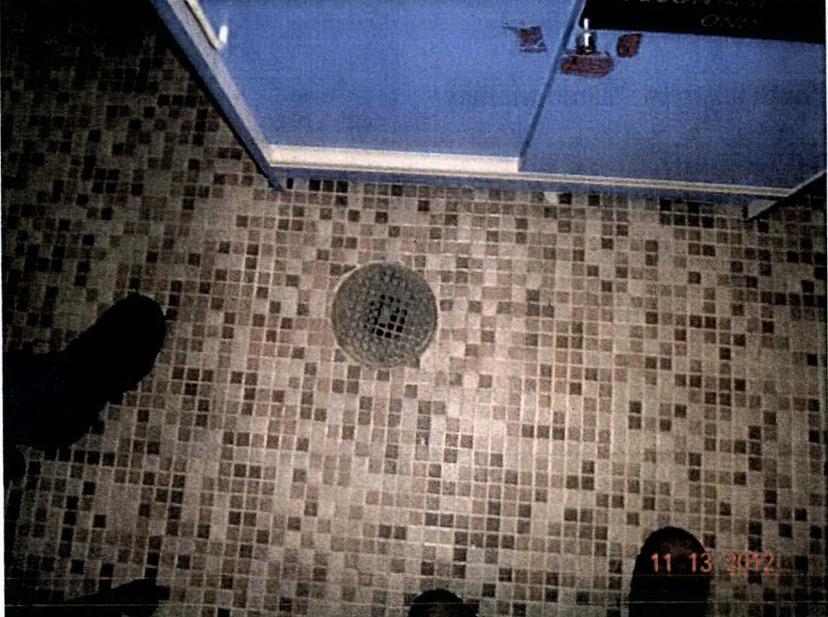
<p>#2 – Building 272-AW: Location where water is added weekly to the safety shower drain to seal loop.</p> <p>Photo Taken: 11/13/2012</p> <p>Photo taken by: Jared Mathey</p>

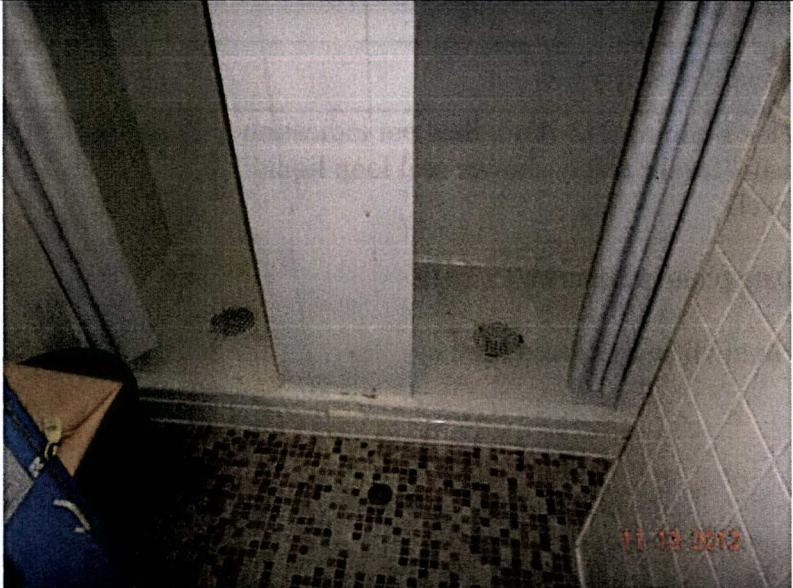
Area & Description	Photographs
<p>#3 – Safety showers in building 272-AW. Drains connect to floor drain where water is added.</p> <p>Photo Taken: 11/13/2012</p> <p>Photo taken by: Jared Mathey</p>

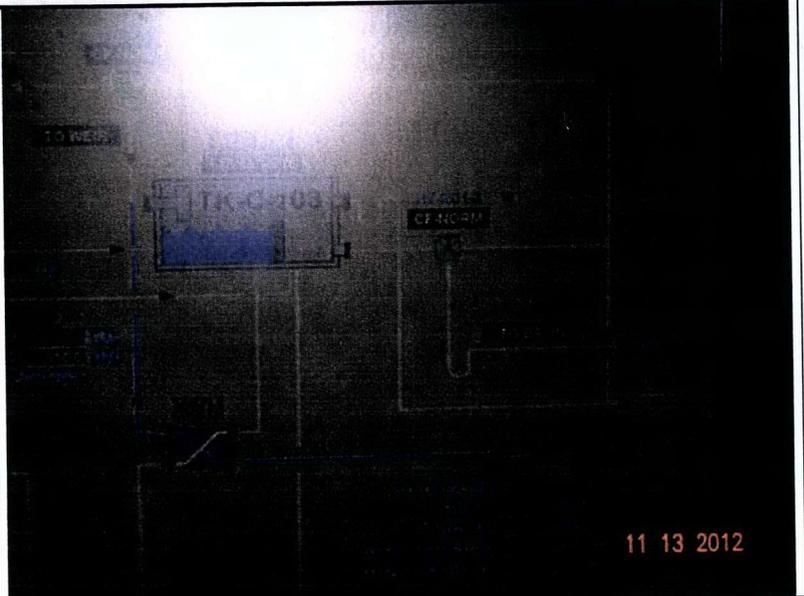
Area & Description	Photographs
<p>#5 – Picture of the 242-A Evaporator MCS control panel.</p> <p>Photo Taken: 11/13/2012</p> <p>Photo taken by: Jared Mathey</p>

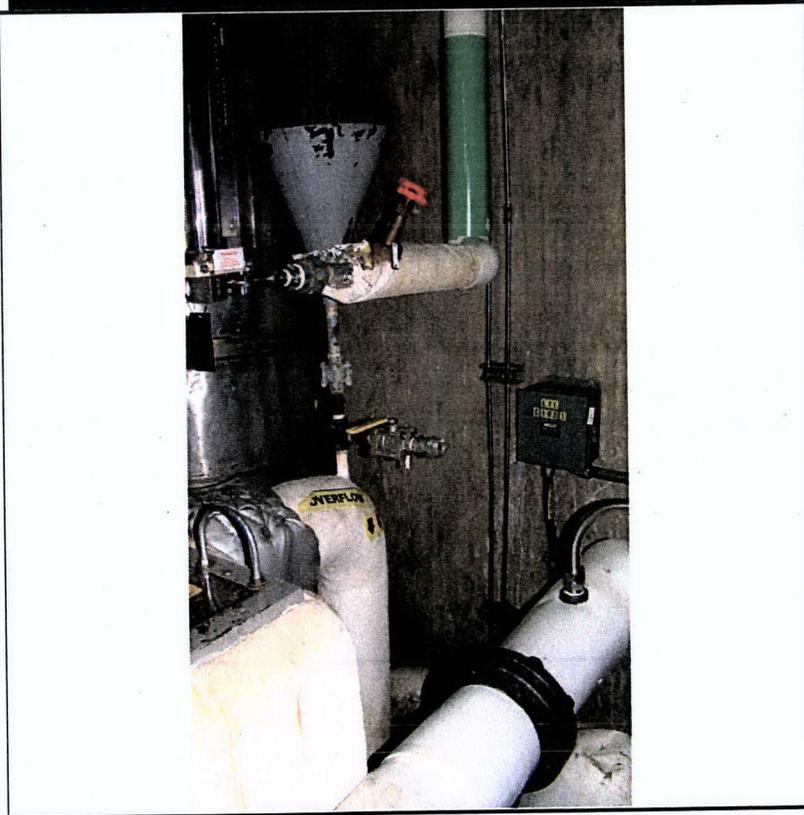
<p>#6 – Water funnel to fill seal loop C-103-1</p> <p>Date photo taken: 11/13/2012</p> <p>Photo taken by: James Hamilton –WRPS</p>

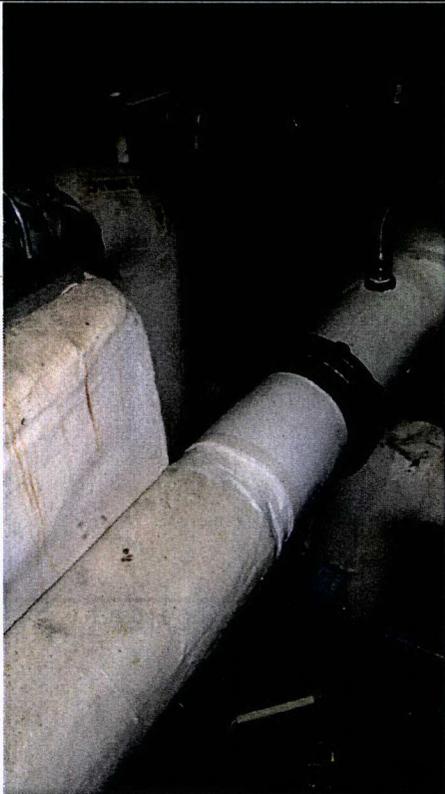
Area & Description	Photographs
<p>#7 – 242-A condenser room seal loop C-103-1 and conductivity alarm LEL C-103-1</p> <p>Date photo taken: 11/13/2012</p> <p>Photo taken by: James Hamilton –WRPS</p>

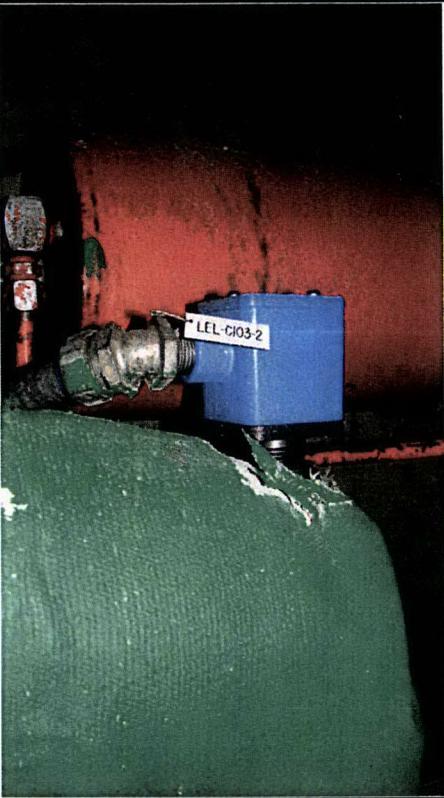
Area & Description	Photographs
<p>#11 – 242-A condenser room conductivity alarm LEL C103-2 for seal loop C-103-2</p> <p>Date photo taken: 11/13/2012</p> <p>Photo taken by: James Hamilton –WRPS</p>

- 2) The 242-A Inhibited Alarm Logbook Data Sheets, provided by the facility, indicated that the conductivity alarm LEL C-103-2 had a "bad sensor" on April 14, 2007. These records showed that the alarm was not replaced and continued to be in a cycle "of being inhibited and/or returned to service" from April 14, 2007 to April 7, 2010.

- 1) **Immediately, upon receipt of this inspection report**, O&M records associated with adding water to seal loops and floor drains in the 242-A condenser room, will be properly documented and maintained.
- 2) **Within 30-days of receipt of this inspection report**, develop an O&M preventative maintenance datasheet procedure for all 242-A's seal loop conductivity alarms and provide a copy of the procedure to Ecology for review and approval. At a minimum, the procedure will include a schedule for maintaining these alarms and replacement when not functioning properly.

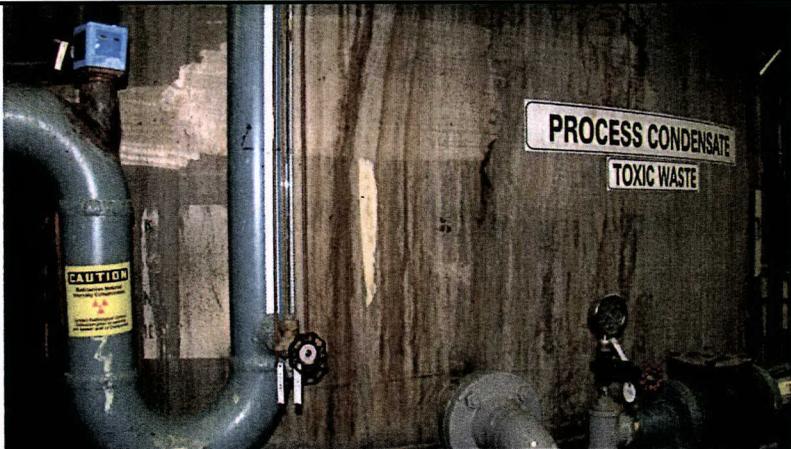
<p>#12 – 242-A condenser room conductivity alarm LEL C100-1 and seal loop C-100-1</p> <p>Date photo taken: 11/13/2012</p> <p>Photo taken by: James Hamilton –WRPS</p>

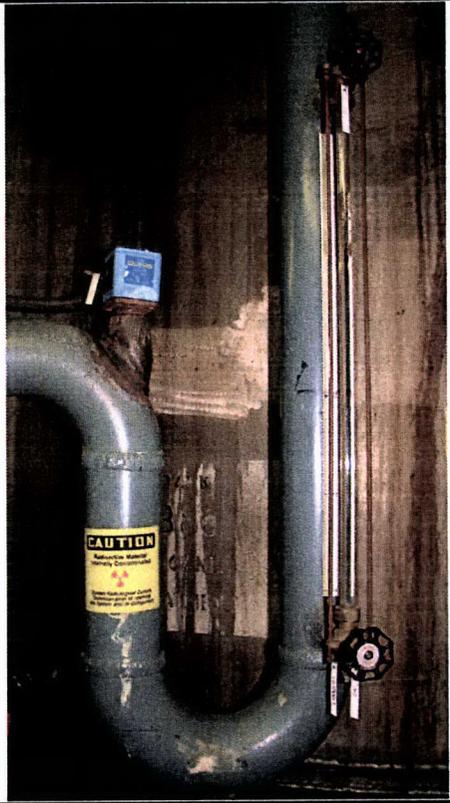
Area & Description	Photographs
<p>#13 – 242-A condenser room conductivity alarm LEL C100-1 and seal loop C-100-1</p> <p>Date photo taken: 11/13/2012</p> <p>Photo taken by: James Hamilton –WRPS</p>

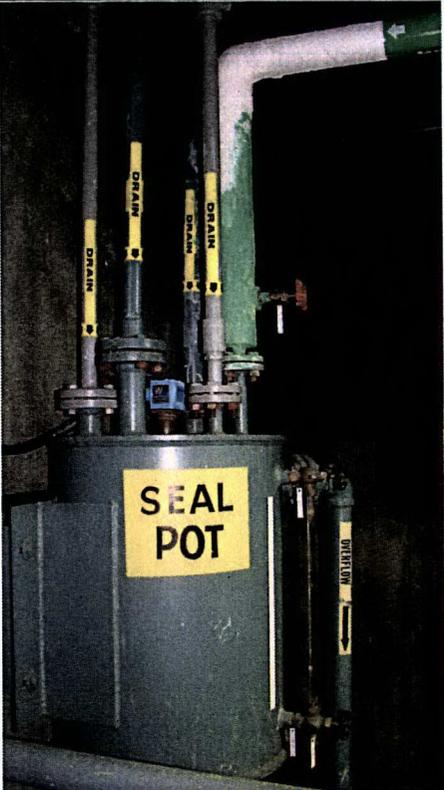
Area & Description	Photographs
<p>#15 – 242-A condenser room Seal Pot – SP-1</p> <p>Date photo taken: 11/13/2012</p> <p>Photo taken by: James Hamilton –WRPS</p>

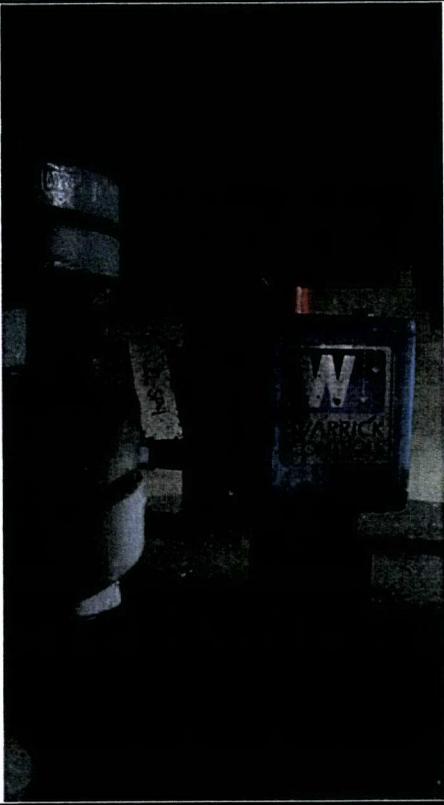
Area & Description	Photographs
<p>#17 – 242-A condenser room conductivity alarm LEL SP-1</p> <p>Date photo taken: 11/13/2012</p> <p>Photo taken by: James Hamilton –WRPS</p>

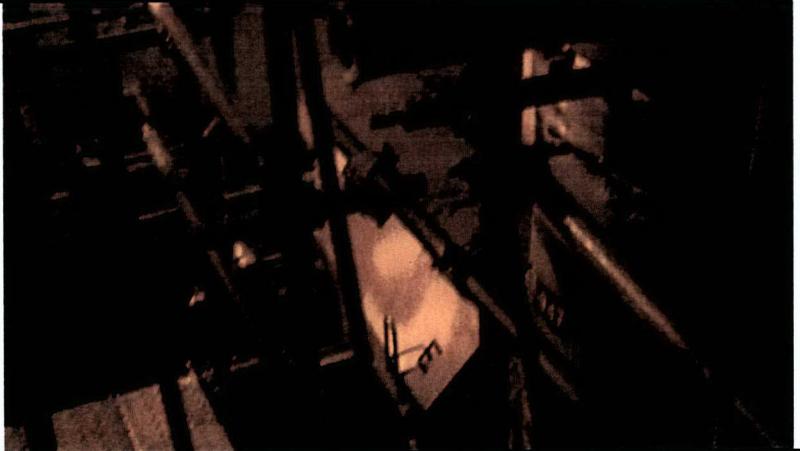
<p>#18 – 242-A Evaporator pump room</p> <p>Date photo taken: 11/13/2012</p> <p>Photo taken by: James Hamilton –WRPS</p>
