W-105, RESPONSE TO LOI 73

KAISER ENGINEERS HANFORD CONCURRENCE PERTAINING TO THE WESTINGHOUSE
HANFORD COMPANY INVESTIGATION OF THE STRUCTURAL FAILURE IN THE 8" CARRIER
AT 200E LERF BASINS (PROJECT W-105)

From: Materials and Welding Engineering
Phone: 3-4156 S2-03
Date: September 4, 1991
Subject: INVESTIGATION OF STRUCTURAL FAILURES IN 8 INCH CARRIER PIPES AT
200E LERF BASINS (PROJECT W-105)

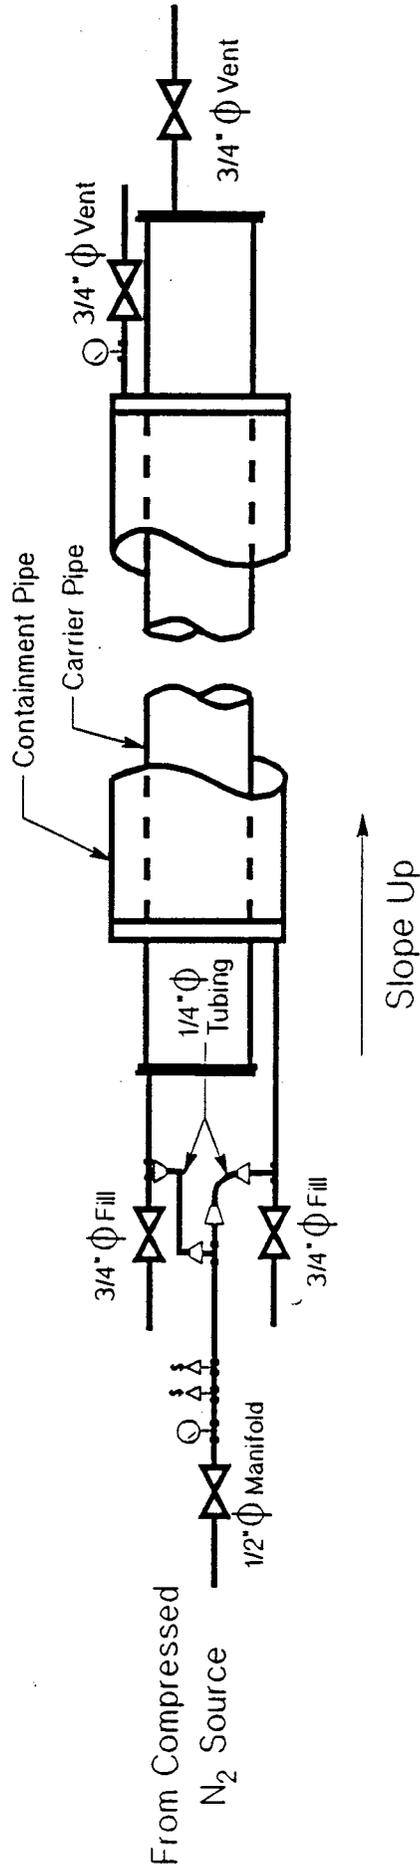
Figure 2
Liquid Effluent Retention Facility
KEH Containment Hydrostatic Test Rig
 (Not to Scale)

The carrier pipe and the containment pipe are required to pass separate hydrostatic tests. The carrier pipe is tested at 150 lbf/in² (gauge) and the containment pipe at 90 lbf/in² (gauge) (see Figure 2). The subject failures occurred in the 8-inch carrier pipes at some point during the hydrostatic testing operations (filling, venting, pressurizing and depressurizing) for the 12-inch containment pipe, following successful hydrostatic testing of the 8-inch carrier pipe (see Figures 3 through 6).

The pipefitter crews devised and set up the hydrostatic test rig (see Figure 2) to meet the general requirements of the applicable construction specification, W-105-C3, and Book 2 of the KEH Construction Force Manual, Procedure CFM 6.1 for hydrostatic tests. The crews also developed their own methods for filling, pressurizing, venting, and depressurizing the piping for the hydrostatic test operations. No engineering sketch or drawing of the specific test arrangement was available. Valve opening and closing sequences were carried out according to past experience and best judgement. This is apparently consistent with construction force practices at Hanford for hydrostatic testing of piping systems. However, most piping applications are of single wall design and prior to the use of fiberglass reinforced pipe, applications of double contained piping at Hanford involved carbon steel and stainless steel piping which are significantly less susceptible to failure from external pressure.

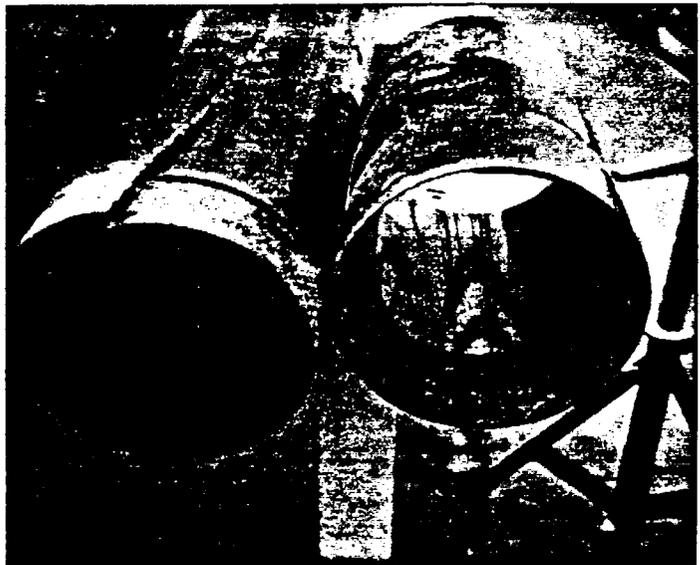
Figure 6. Failed Section of
8-Inch Carrier Pipe
from LERF Basin 43-44,
Bell Type Coupling
