## FACILITY STATUS CHANGE FORM (for DOE/RL-2010-34 Facilities)

<b>Date Submitted:</b> March 26, 2014 <b>Originator:</b> Clay McCurley <b>Phone:</b> 942-8928	<b>Area:</b> 100-B <b>Facility ID:</b> 151B Primary Electrical Substation <b>Action Memorandum:</b> General Hanford Site Decommissioning Activities	<b>Control #:</b> D4-100B-004
--	--	----------------------------------

**Photographs of the 151B Primary Electrical Substation (2 pages)**

## Visual Inspection of 151-B Switch Yard March 6, 2014

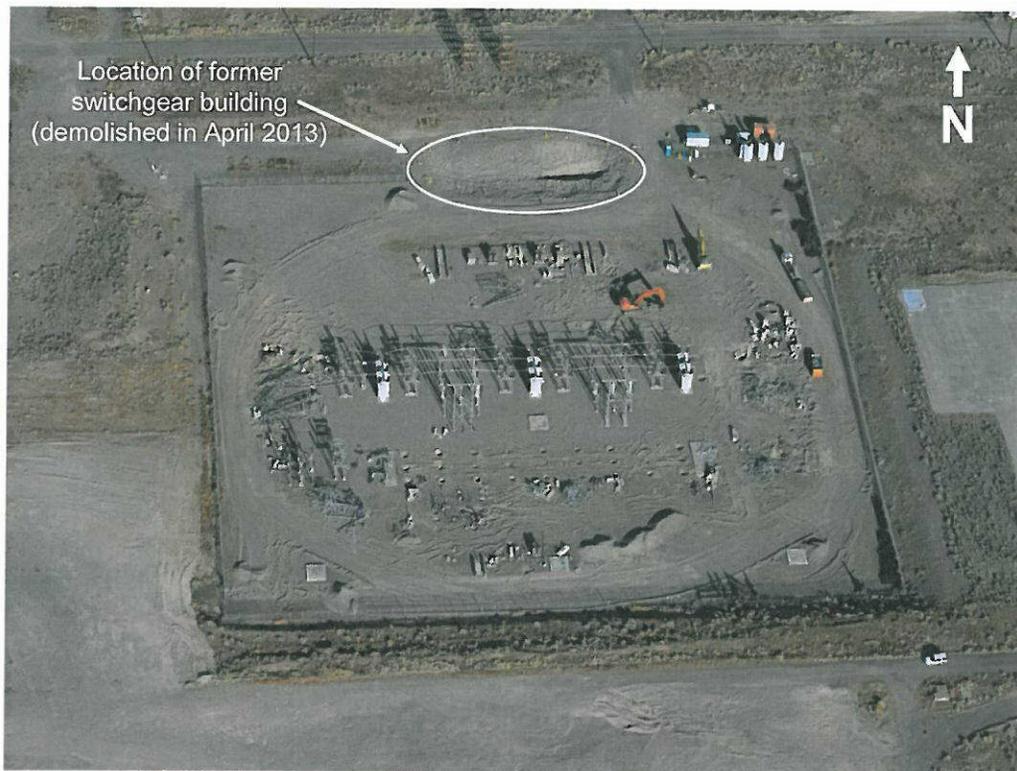
Demolition of the switch yard began in October, 2013. Figure 3 (Attachment 2) provides an aerial view of D4 activities in progress. Figure 4 (Attachment 2) provides an overview of the

**Figure 3. 151B Switch Yard During Demolition in November 2013 (facing north)**

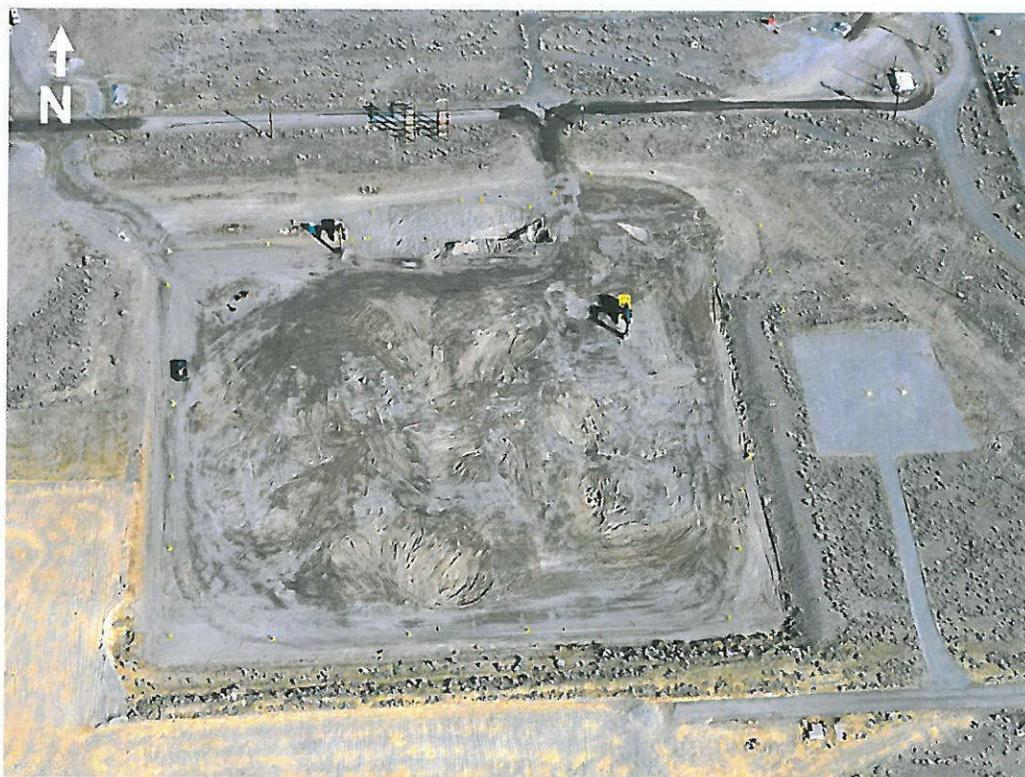
switchyard after the completion of demolition. Most of the metal (e.g., metal towers, stands, transformers) was recycled.

**Figure 4. 151B Switch Yard After Demolition Completion in March 2014**

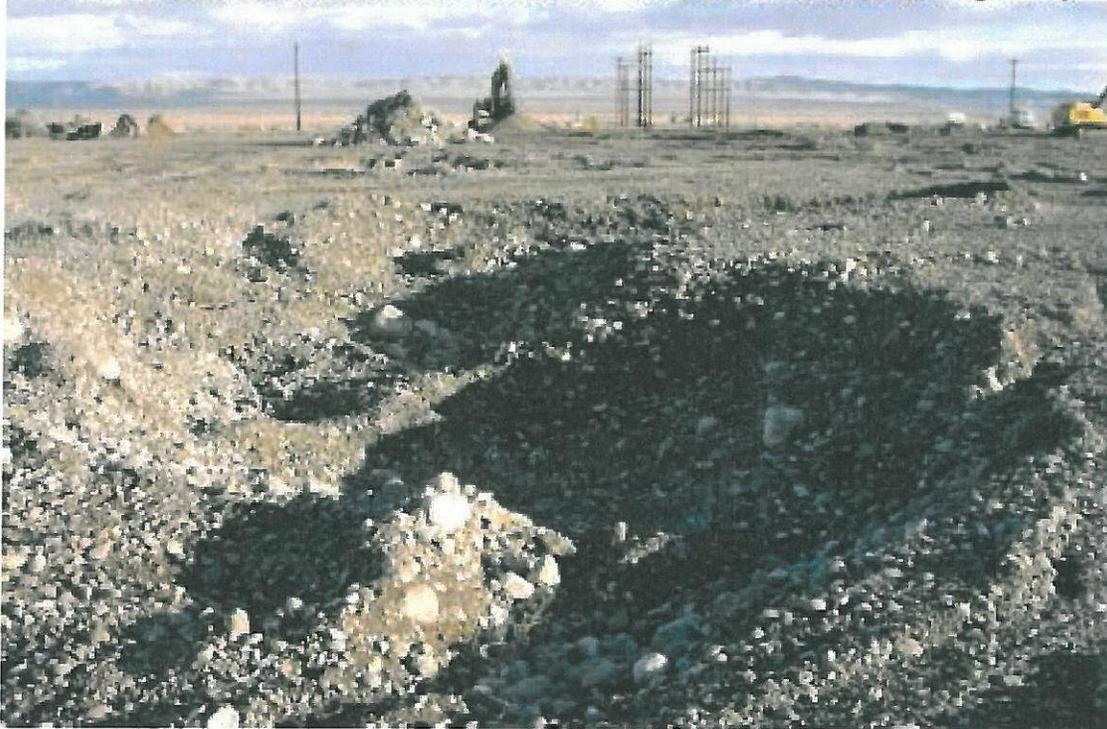
Mike/Mark. I conducted a visual inspection of the 151-B Switch Yard on Thursday, March 6, 2014. The D4 crew still had load out activities to complete (e.g., rubble piles still on site) but the area was sufficiently complete to evaluate for soil stains and anomalies. None were observed. Attached are photos documenting the inspection. In accordance with the *Removal Action Work Plan for River Corridor General Decommissioning Activities* (DOE/RL-2010-34, Rev. 2), the top of the duct bank near the northeast corner, shown in Photo 6, is greater than 1 foot in depth and can be left in place. Contact me if you have any questions. Clay

Photo 1. Excavation from demolition of OCBs near southwest corner (facing north).

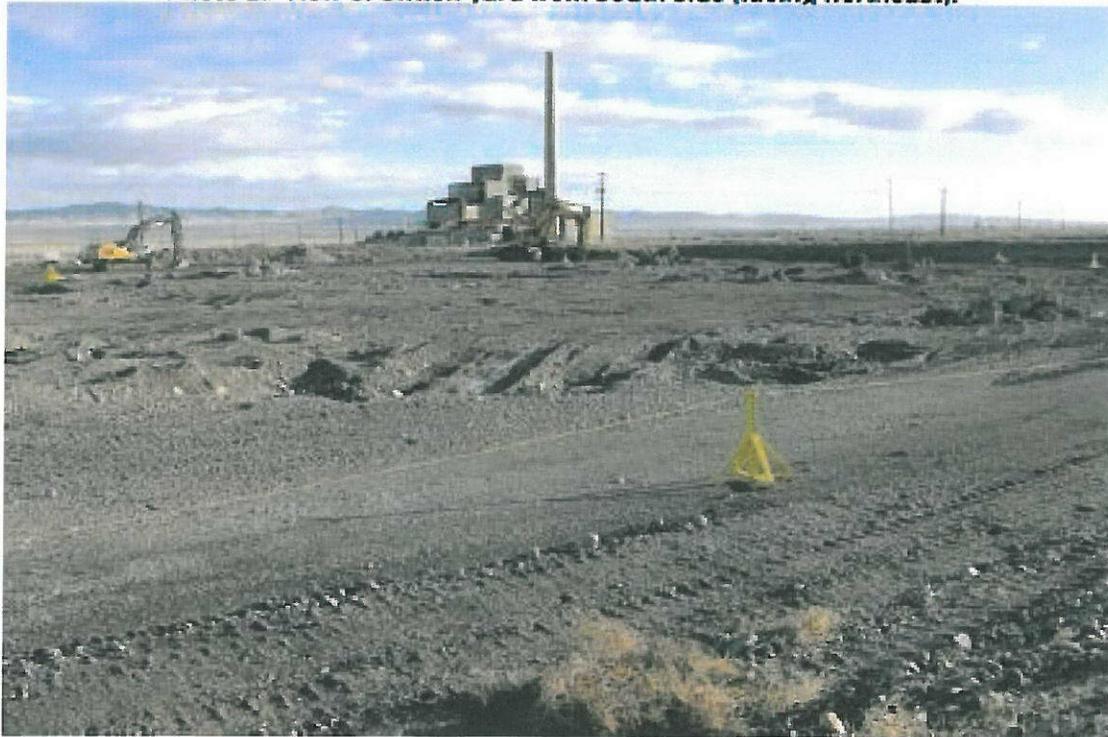
Photo 2. View of switch yard from south side (facing northeast).

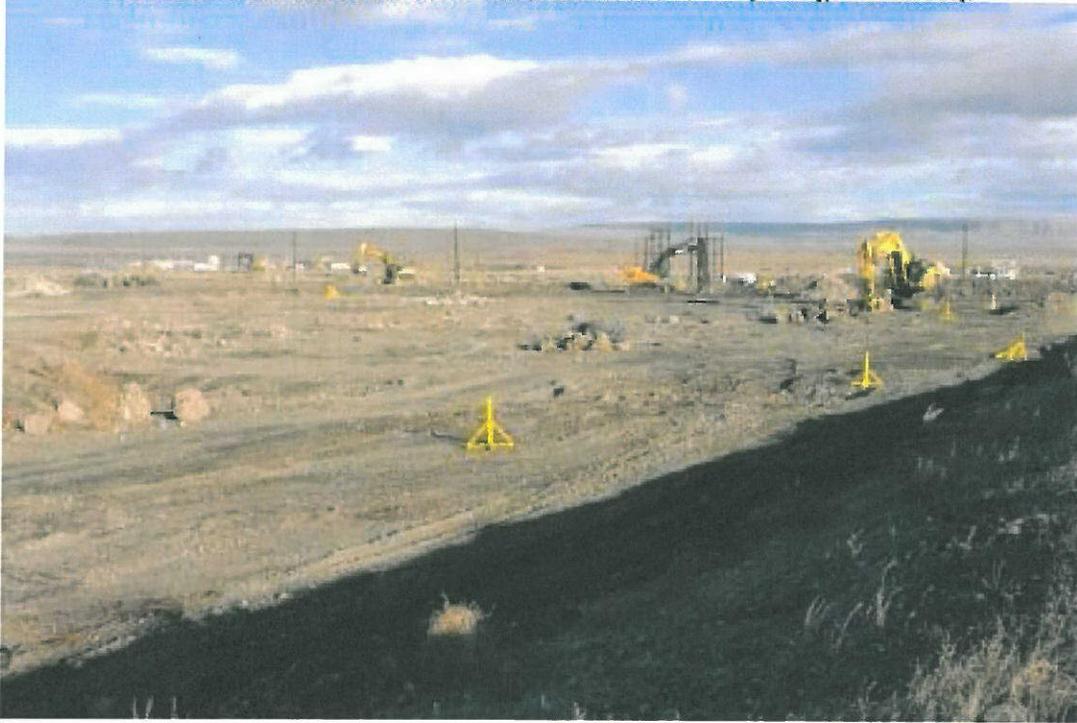
**Photo 3. View of switch yard from southeast corner (facing northwest).**

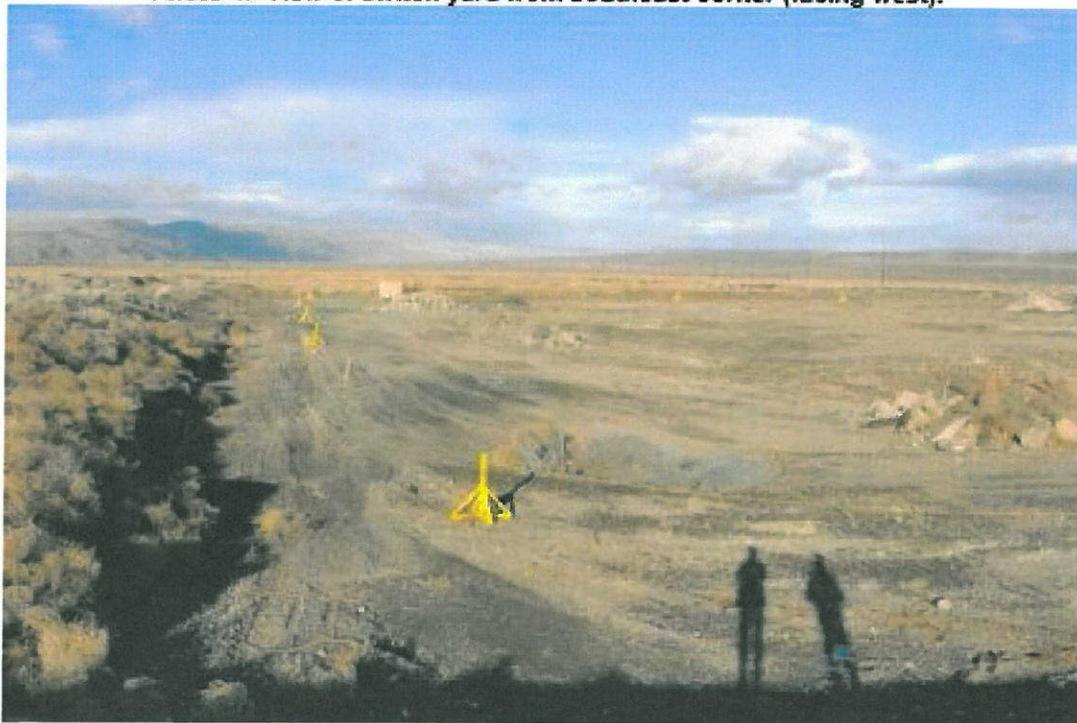
**Photo 4. View of switch yard from southeast corner (facing west).**

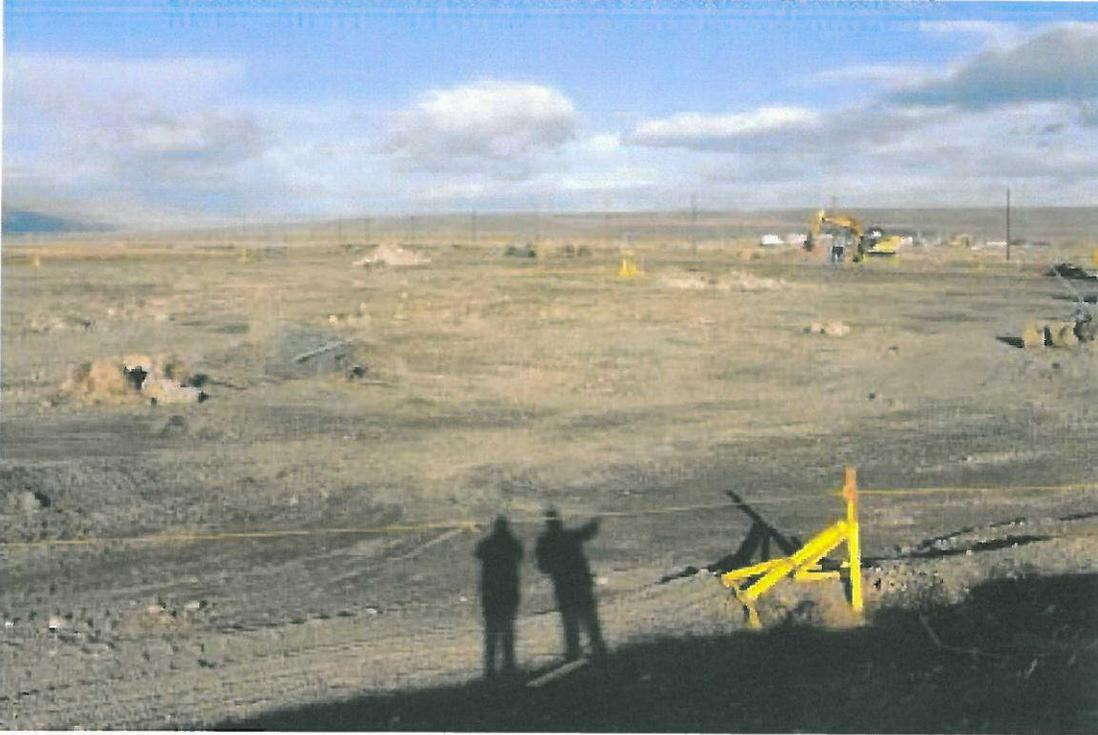
**Photo 5. View of switch yard from east side (facing northwest).**

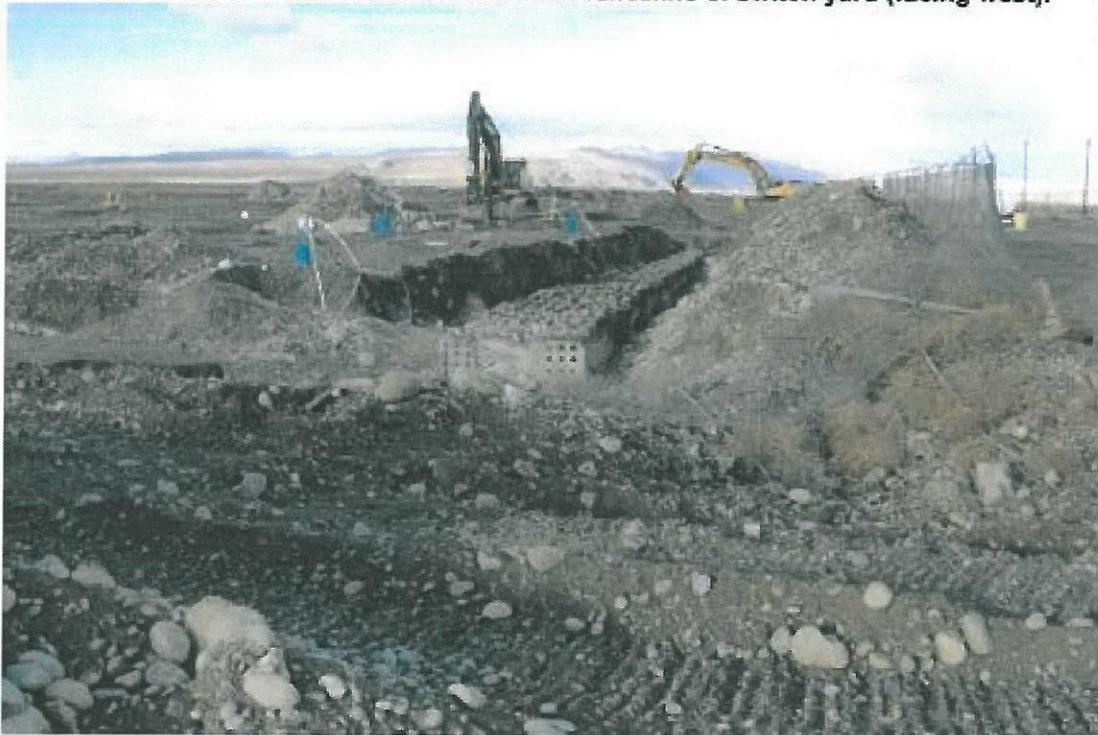
All switch yard equipment, perimeter fence, and support pads were removed to -3 feet below grade and recycled or disposed at the ERDF. Two below-grade concrete vaults (near the northeast corner of the switch yard) were demolished to -3 feet below grade and backfilled with borrow pit material to eliminate safety concerns associated with steepened edges. A below-grade duct bank running east/west near the facility's north fenceline was uncovered, confirmed to be

greater than 1 foot in depth, and left in place. Most of the cement asbestos piping (embedded in concrete) that provided conduit between yard support structures (concrete pads) was removed and disposed under asbestos controls. In areas where the conduit was greater than 3 feet in depth, it was left undisturbed and buried in place.

**Photo 6. View of duct bank near northern fenceline of switch yard (facing west).**
