## FACILITY STATUS CHANGE FORM (for DOE/RL-2010-34 Facilities)

<b>Date Submitted:</b> June 9, 2014 <b>Originator:</b> Clay McCurley <b>Phone:</b> 942-8928	<b>Area:</b> 100-B <b>Facility ID:</b> 183B Clear Wells <b>Action Memorandum:</b> General Hanford Site Decommissioning Activities	<b>Control #:</b> D4-100B-003
--	--	----------------------------------

SUBJECT: **183-B Clear Well Structural Evaluation**

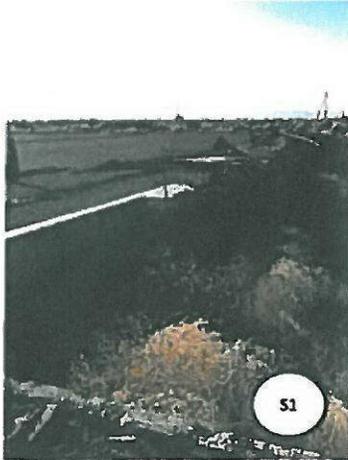
**S1** – South Wall of Demolished Pump Room - Exposed reinforcing steel bars, mild corrosion.

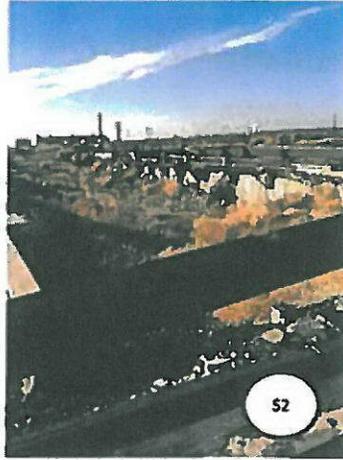
**S2** – North Wall of Demolished Pump Room - Exposed reinforcing steel bar, mild corrosion.

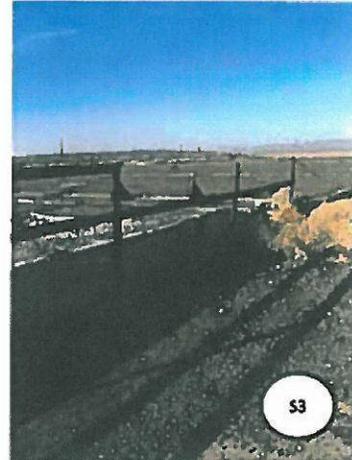
**S3** – East Wall of Northern Clear Well - Damaged wooden handrails; Exposed concrete roof.

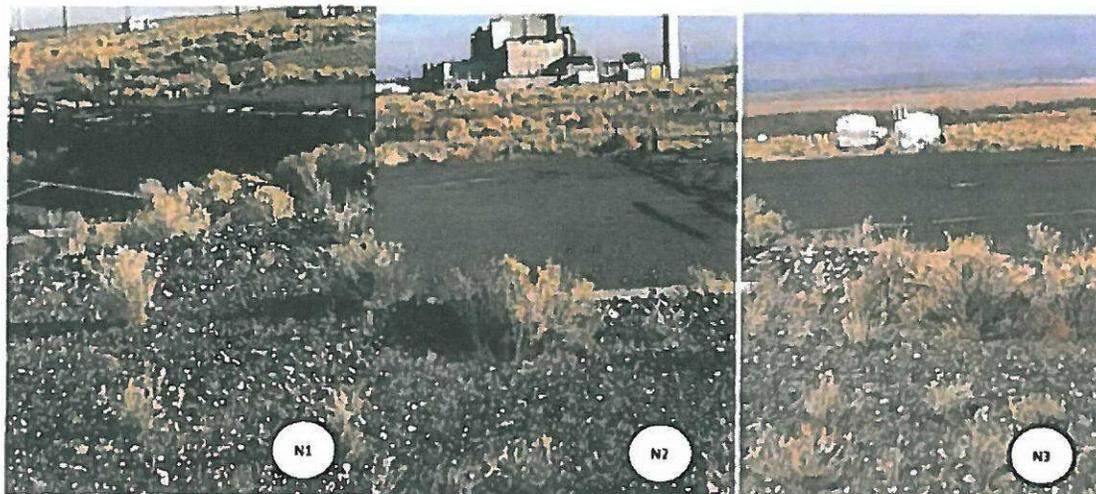
- N1** – South wall of the demolished Pump Room, View from West side - Broken handrails; Exposed reinforcing steel bar, mild corrosion.
- N2** – North Clear Well Roof, View from West side – exposed concrete roof common to E wall.
- N3** – North Clear Well Roof, View from West side – Exposed concrete roof, N wall.

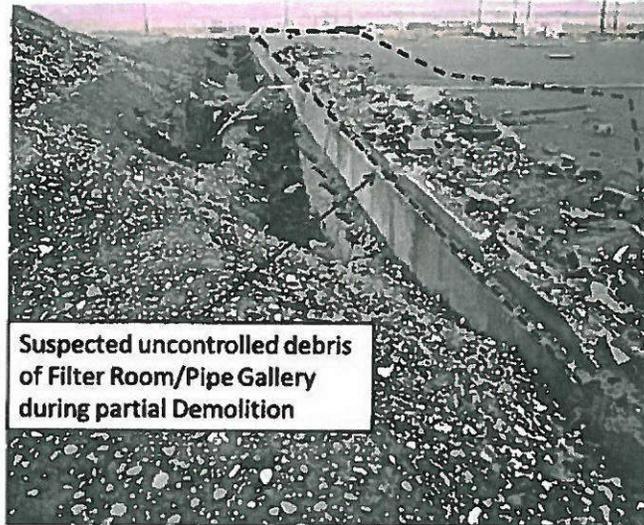
Suspected uncontrolled debris  
of Filter Room/Pipe Gallery  
during partial Demolition

In-process condition of Clear Well Room after Filter Room and Pipe Gallery demolition  
(circa 1987)

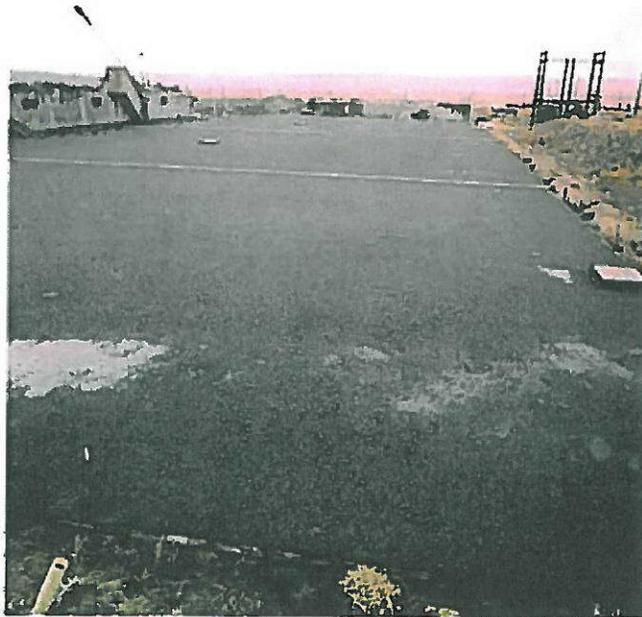
Clear Well Roof showing displaced gravel with concrete roof exposed,  
(circa 1987)

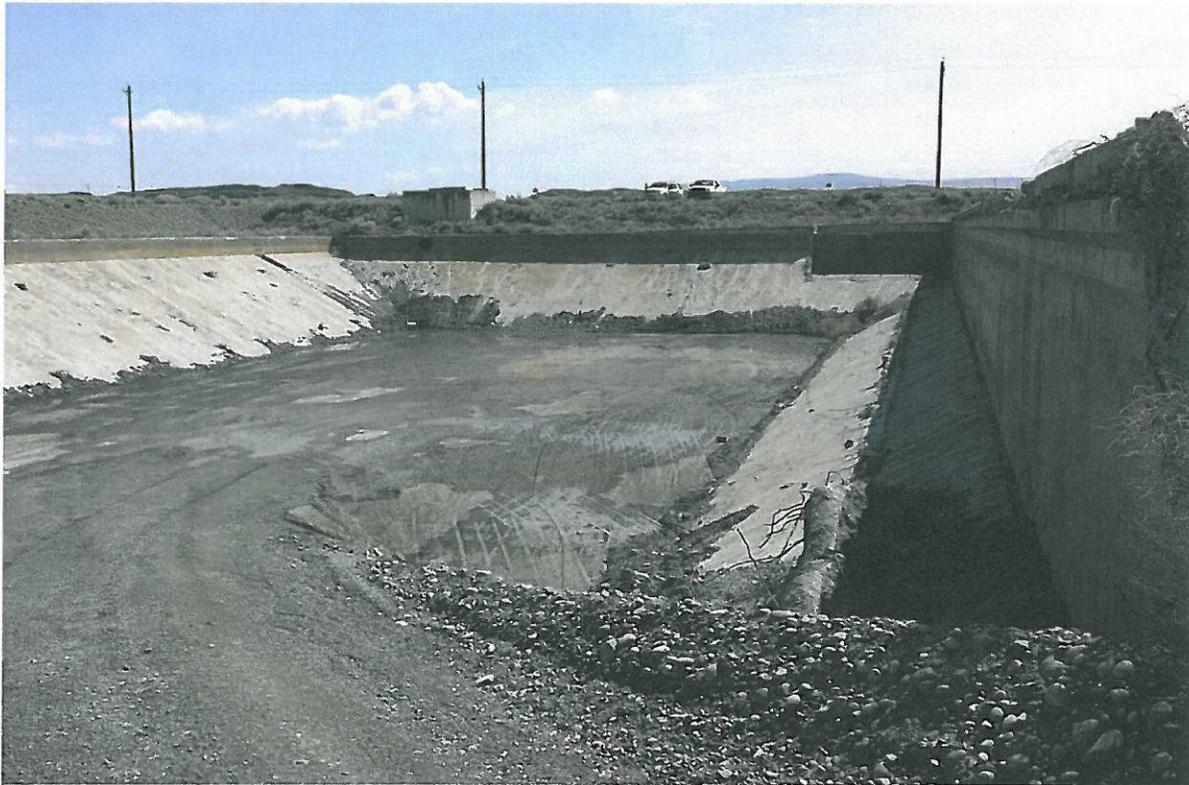
South Clearwell facing south on 04/17/2014

Mark/Mike. Dan Saueressig inspected the 183B clear wells prior to backfill and supplied me with his notes and photos. With those, I prepared this report (photos attached). He indicated that he inspected the south clear well in April and the north clear well recently (May 7), both prior to backfill. Neither had any unusual staining. For the north clear well, he indicated that holes had been punched in the floor.
