DOE/RL-94-30
Rev. 0

Riverland Expedited Response Action Assessment

Date Published
June 1995

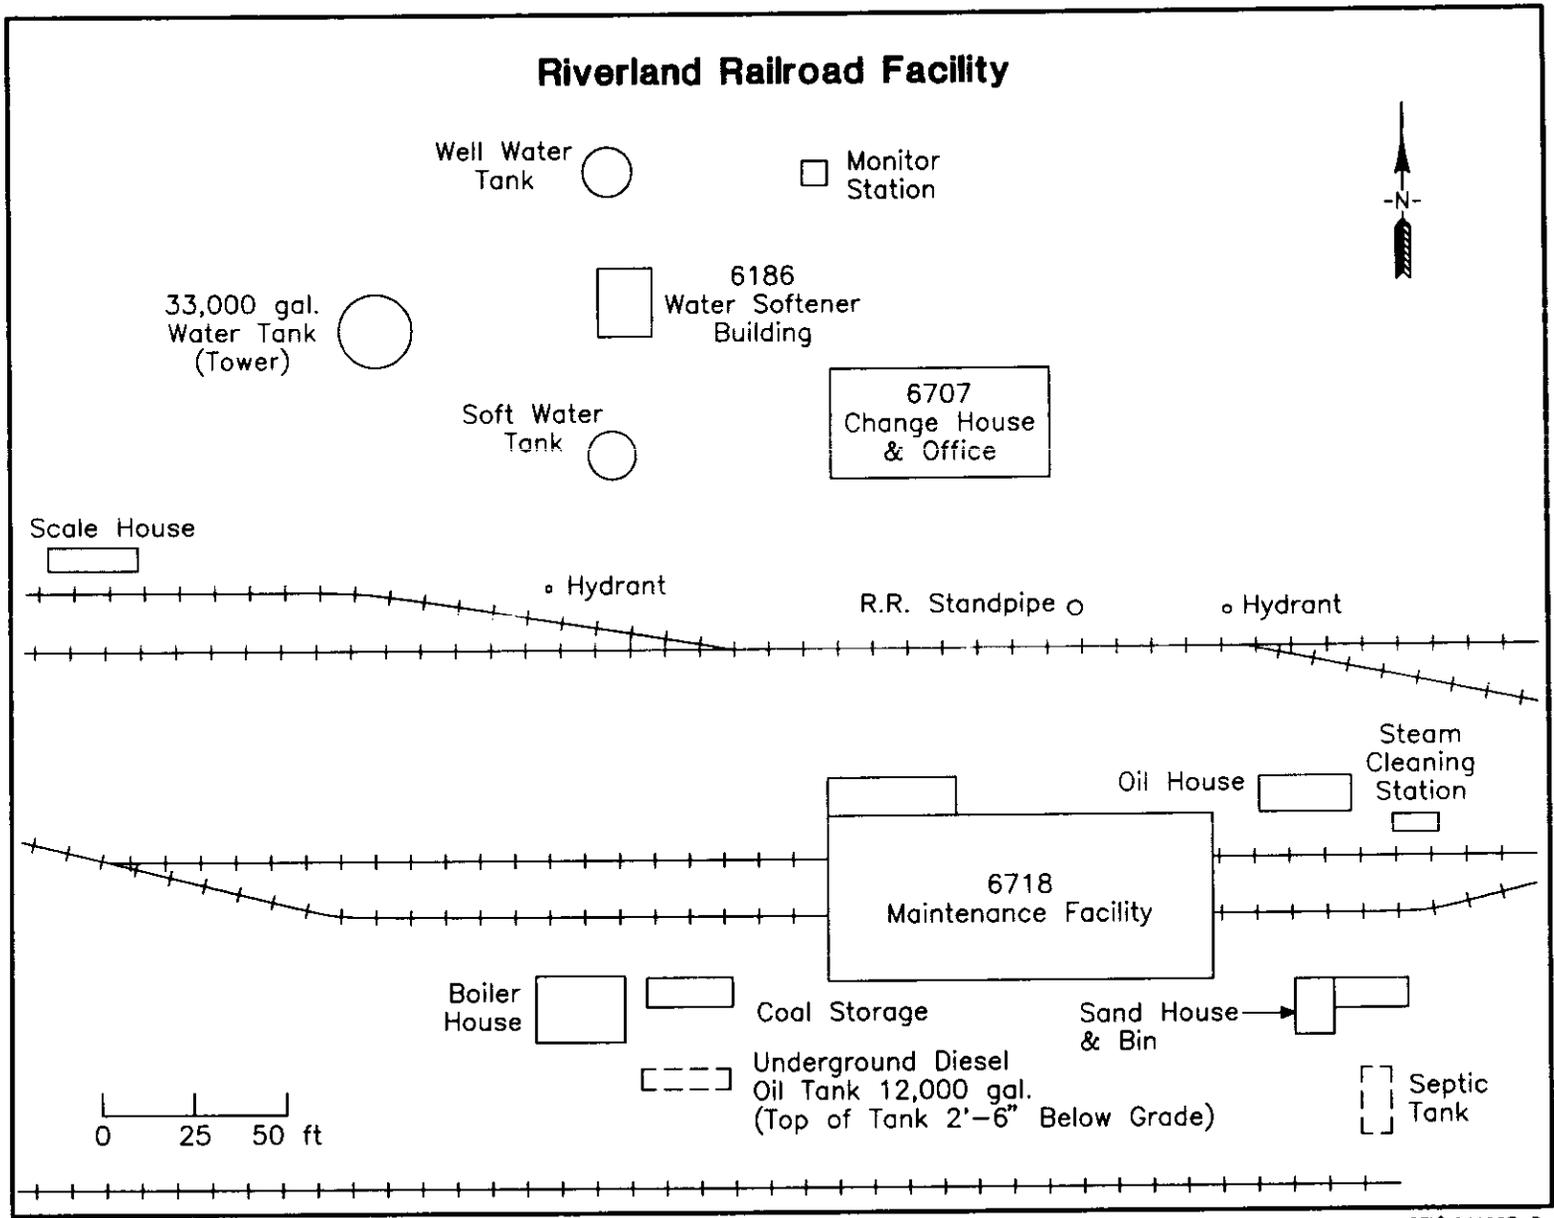
Figure 3. Riverland Rail Yard.

The Riverland Rail Yard Maintenance Facility (Building 6718, Figure 3) operated from 1943 until October 1954 when operations began in the 1100 Area 1171 Building railroad maintenance facility. Railcar decontamination continued in the two maintenance pits until 1956.

The Riverland Railroad Maintenance Shop cleanup activities started on July 12, 1993 when the soil covering the shop concrete pad was removed. The entire cleanup action was monitored with immunoassay field screening kits that detected diesel (tph) concentrations at or above 200 ppm.

Demolition of the concrete pad began on September 21, 1993. Thirty-four dump truck loads of concrete (10 yd³) were taken to the 100-B concrete stock pile. The concrete was recycled through a concrete crusher system.

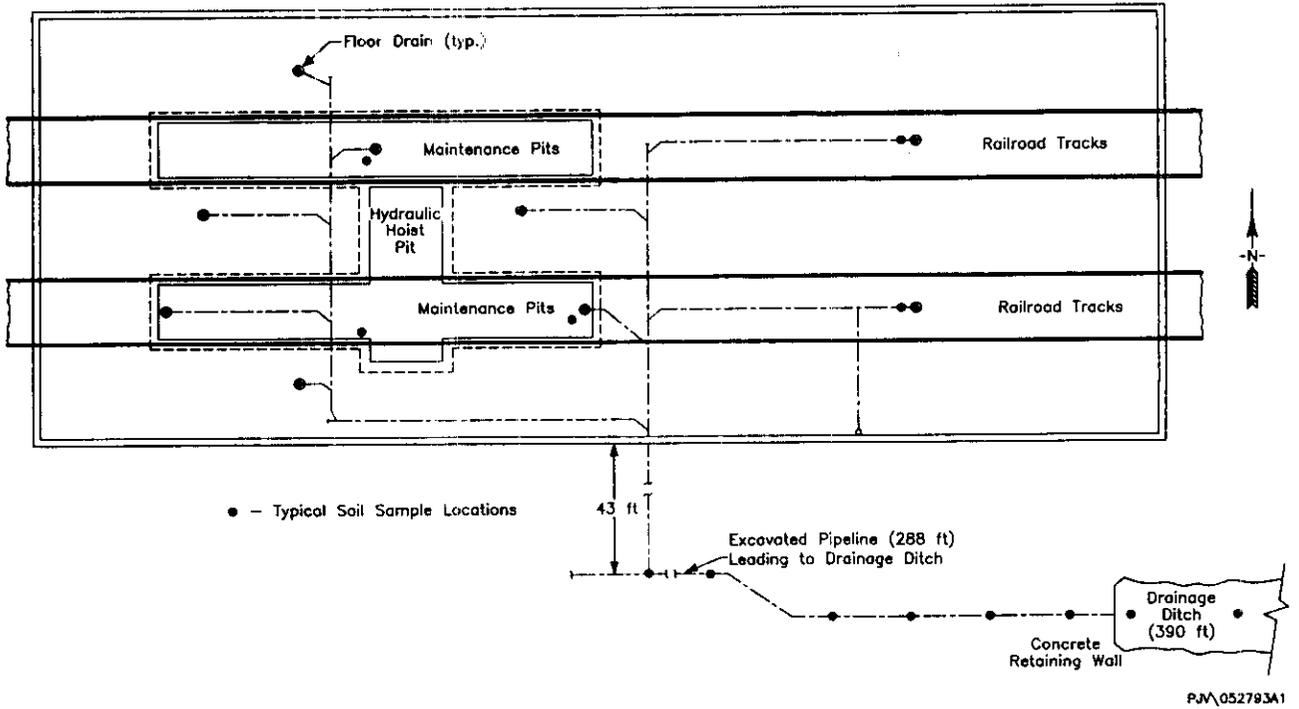
Figure 4. Riverland Rail Yard Maintenance Facility (Bldg. 6718) Floor Drain Plan.

Periodic maintenance floor pit cleaning consisted of brushing the walls with a broom and diesel fuel then rinsing with water. The rinse drained through the pit floor drains (Figure 4).

Diesel contaminated soil removal started on September 27, 1993. The contaminated soil consisted of soils beneath the concrete pad, clay drain pipes and associated soils, and drainage ditch soils. A total of 43 dump truck loads of soil (10 yd³ each) were removed and hauled to a 100-C Area concrete pad for bioremediation.

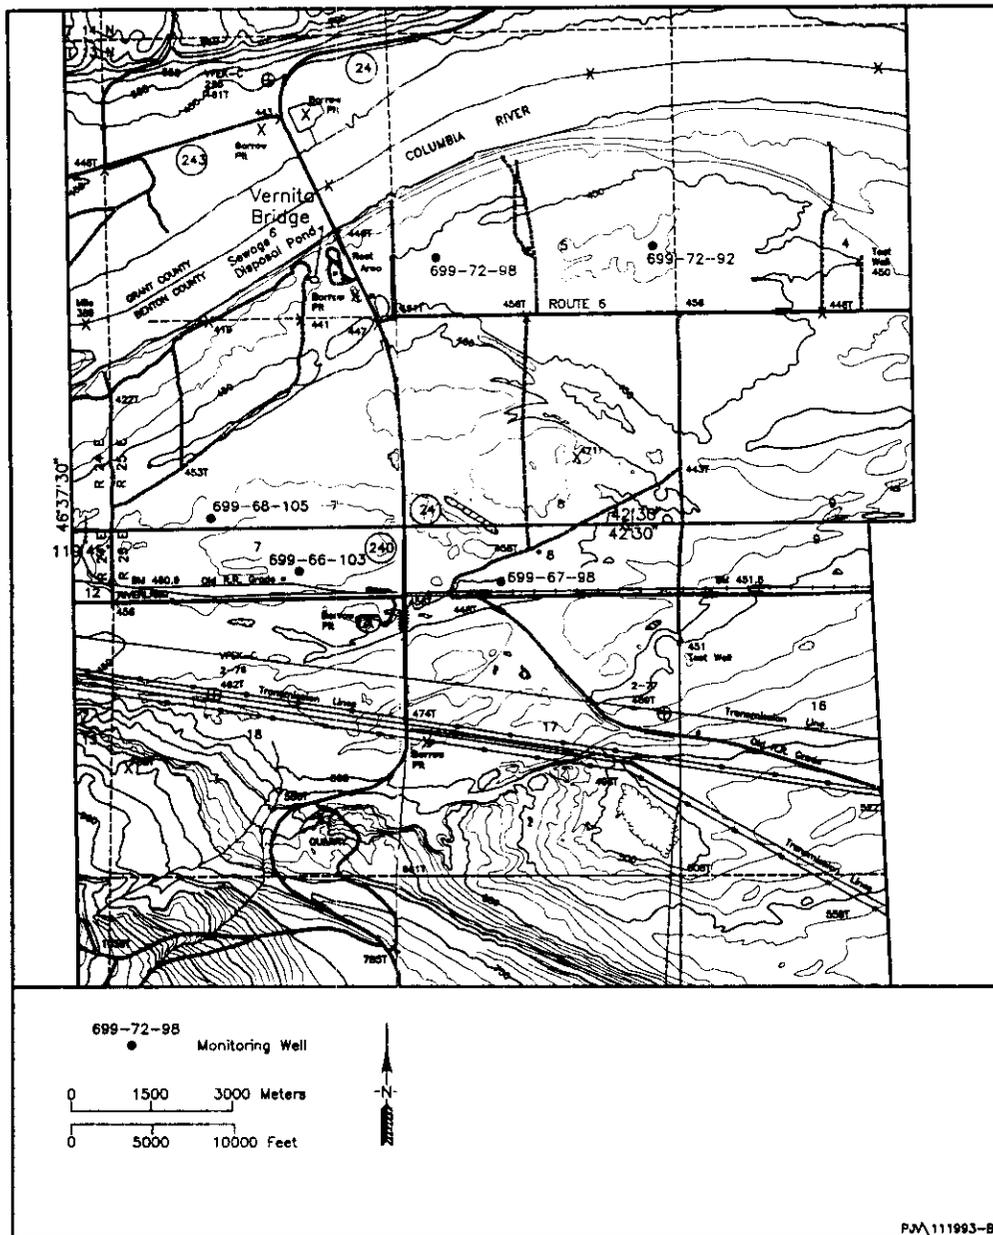
Figure 5. Groundwater Well Locations.

There is no known groundwater contamination associated with the 100-IU-1 Operable Unit. There are only two shallow depth groundwater monitoring wells (Figures 3 and 5) within the operable unit. The first, 699-66-103, is located down gradient of the Riverland Maintenance Shop site, and the second, 699-68-105, is located down gradient and to the northwest of

699-66-103. Sample analysis data from as far back as 1971 do not show groundwater contamination problems. Also, two additional groundwater monitoring wells, 699-67-98 and 699-72-92, (down gradient of the operable unit) do not indicate contamination.
