Meeting Minutes  
Interim Status Dangerous Waste Tank Systems  
Hanford Federal Facility Agreement and Consent Order  
Milestone M-32-00

PROJECT MANAGERS MEETING  
January 23, 1997

Interim Status Dangerous Waste Tank System  
Hanford Federal Facility Agreement and Consent Order  
Milestone M-32-00 Project Managers Meeting minutes  
January 23, 1997

**Ultrasonic Nondestructive Examination of Double-Shell Tanks**

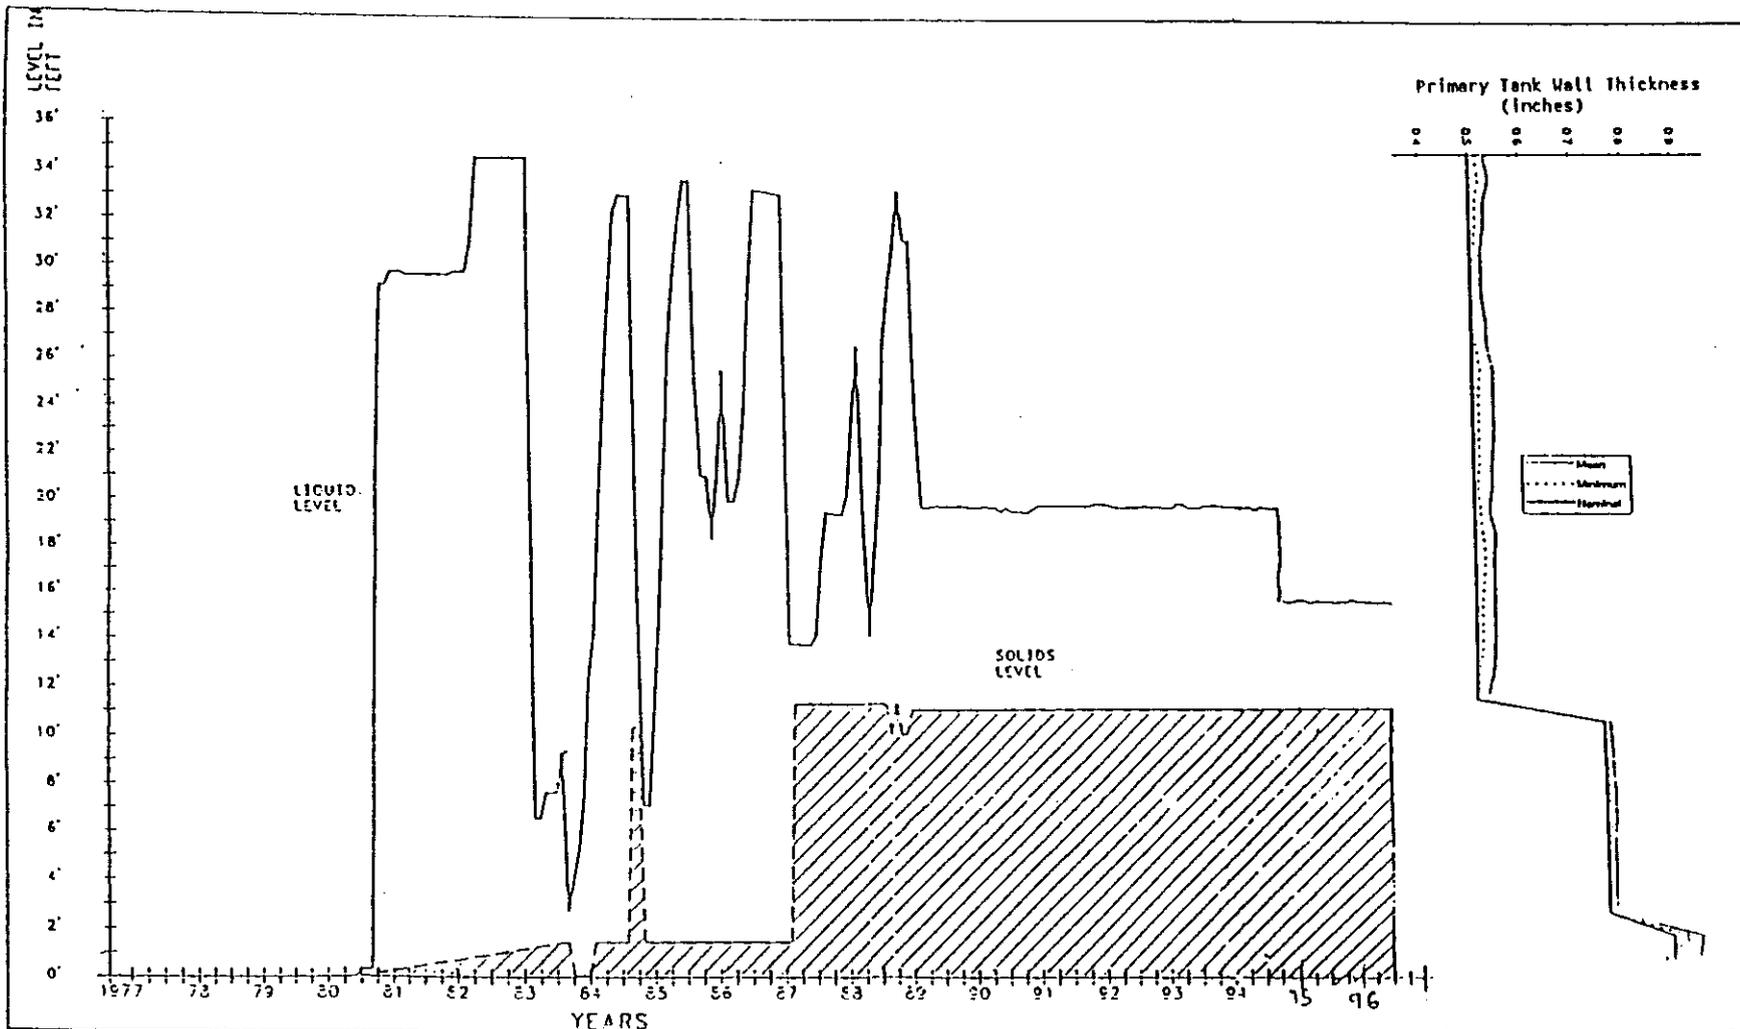
TANK AW-103 DATA REVIEW - Mr. Posakony showed a video of the AW tank UT test. Each 10" x 35' strip took 6-8 hours to complete once equipment was deployed. The primary wall was found to be within design tolerance. The secondary tank had more indications than the primary wall; there was no pitting, but inclusions were found. The secondary tank also had some stud indications due to construction activities (weld patch, scaffolding, rebar).

Comparison of As-Measured and ASTM-Specified Plate Thickness with Waste Level, DST 241-AW-103

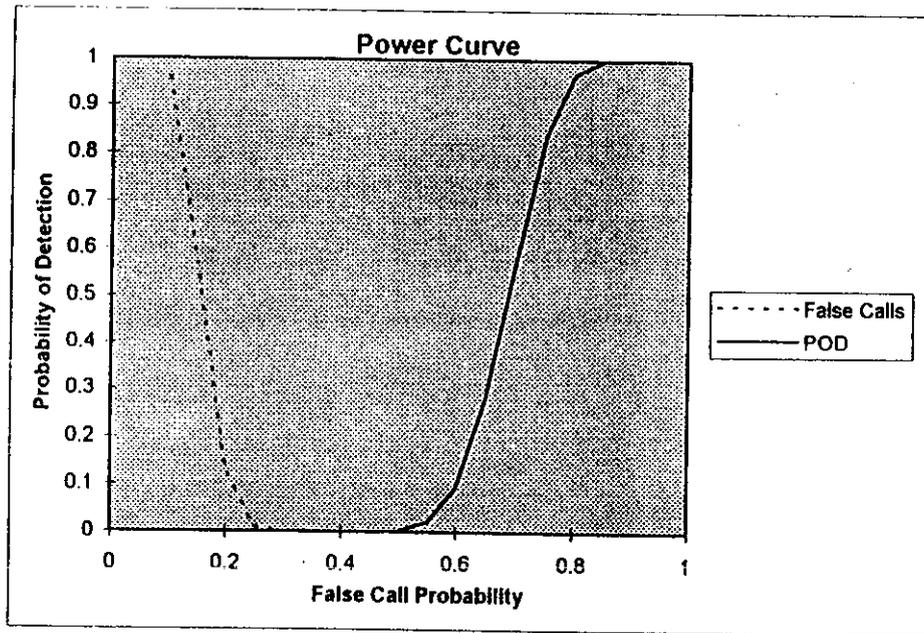
Figure No. 1 Example of ASME Power Curve, Calculation and Plot for a Test Involving 50 Defects (Flaw Grading Units) and 100 Blank Grading Units

An example of the analysis process for the POD/FCP relationship is described in Figure No. 1, Page 3A. The calculations are based on a 70% minimum screening guideline. To obtain the data in this figure, a grid matrix is set-up which contains 50 flaws and 100 blank grading units.

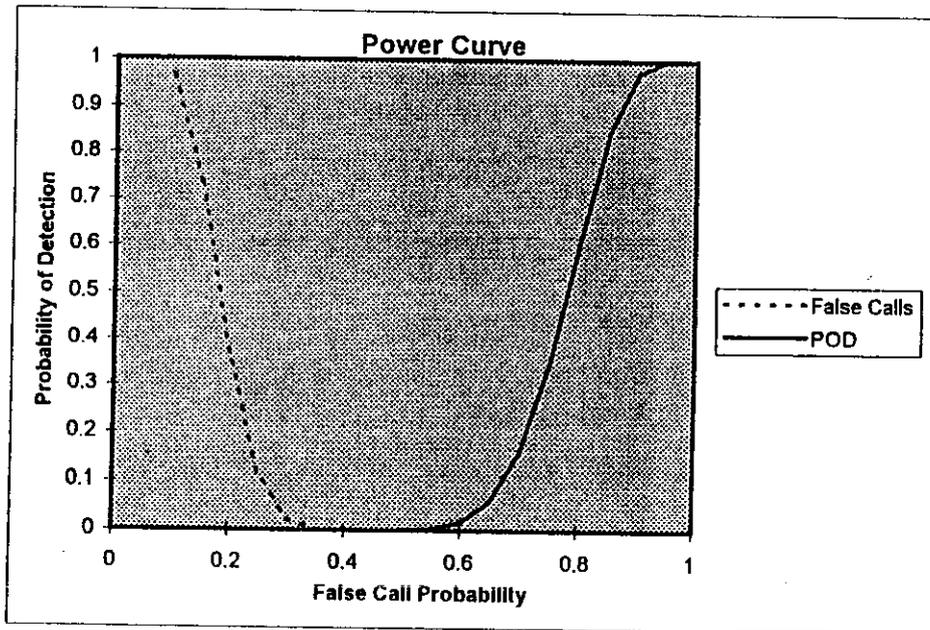
Figure No. 2 ASME Power Curve Developed for Performance Demonstration Tests

The system used by SAIC (P-Scan equipment, procedure and personnel ) performed very well. The system POD was 90% with a 95.8% confidence bound. The error in pit/wastage sizing was 0.0028 RMS. The error in crack depth measurement was 0.0933 RMS. The crack depth measurement error, which is close to the limit defined in the specification, is the result of under sizing one of the six cracks in the test plates.

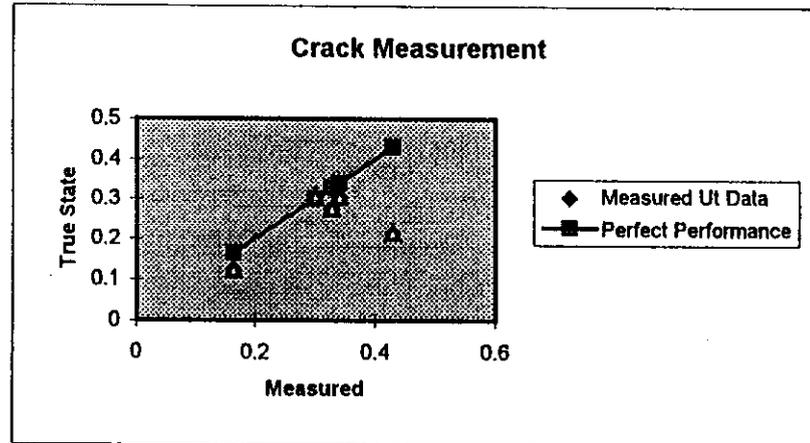
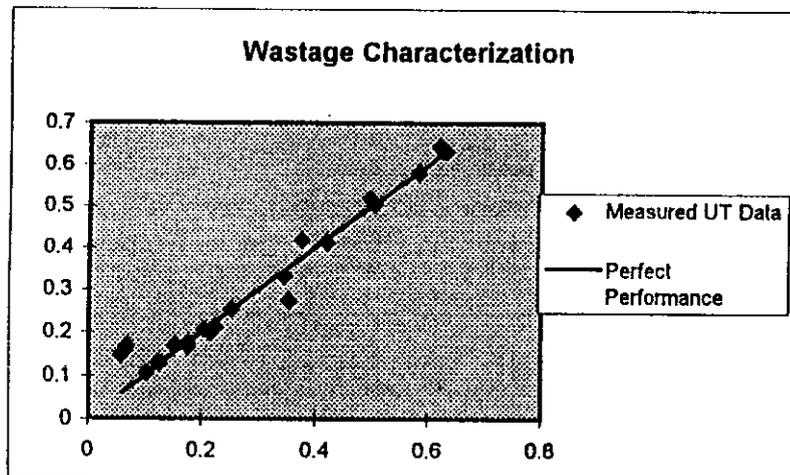
Figure No. 3 Comparison Between PNNL and SAIC Measurements and Graphs of Pit/Wastage and Crack Measurements

The individual data sheets provided by SAIC show that the system has a capability of measuring wastage within +/- 0.015 inches provided the remaining wall is more than 0.1 inches. The system did not accurately size simulated wastage in the test plate where the remaining wall was only 0.06 inches. Pits larger than 0.25-inch diameter and deeper than 0.1 inches were sized within +/- 0.04 inches which exceeded the specification of +/- 0.05 inches. Some smaller pits were detected, but 0.25-inch diameter was considered a minimum requirement. The system detected all cracks deeper than 20% of wall thickness and sized all but one quite accurately. This particular crack was undersized in depth but length was plotted accurately.
