DOE/RL-98-46
Rev. 0

Information on Hazardous Substance Releases Within the 1100 Area

Prepared for: Hanford Natural Resource Trustee Council
as a support document for the 1100 Area Preassessment
Screen

July 1998

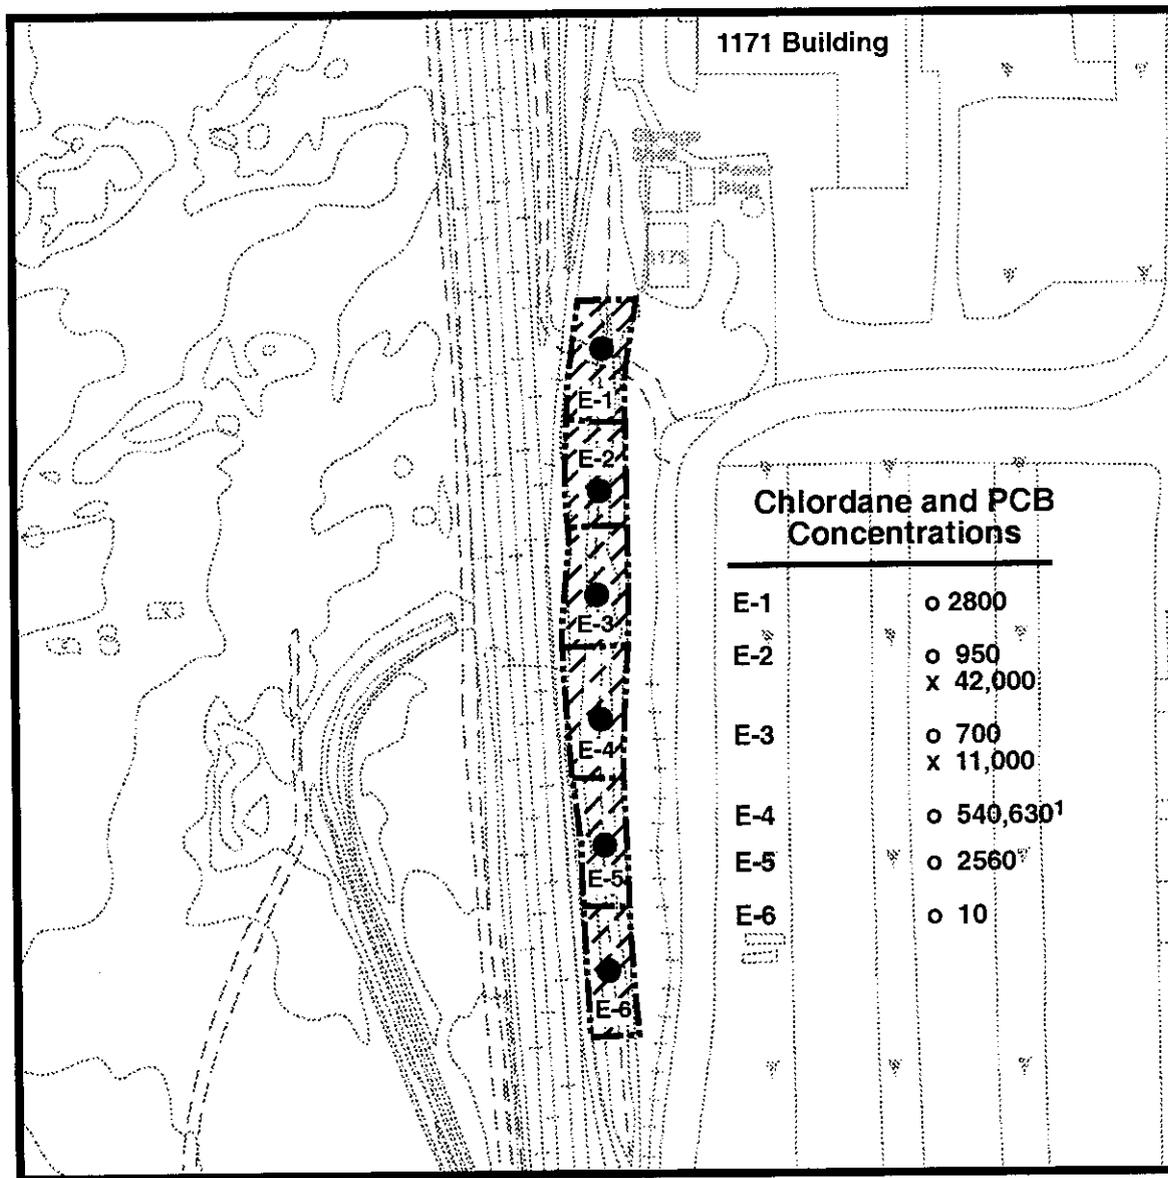
Figure 3. Ephemeral Pool - Chlordane and PCB Distribution in Surface Soils.

Two surface soil samples were taken within the Ephemeral Pool during the Phase I remedial investigation. The results indicated the presence of PCBs in low to moderate concentrations (300 to 4,700 $\mu\text{g/kg}$). Surface soil samples identified the presence of inorganic and organic contaminants (DOE-RL 1992a). "Chlordane, heptachlor, and PCBs were the identified COPCs. Heptachlor was detected in one of two soil samples collected during the Phase I remedial investigation" (DOE-RL 1992a). Maximum concentrations of hazardous substances are listed in Table 3.

Ephemeral Pool remediation was based on PCB contamination, with the MTCA A cleanup level of 1 ppm. This cleanup level was designated as a RAO in the ROD to prevent soil ingestion and dermal contact with soils containing PCBs above 1 ppm. Remediation of the site began in February 1995. Excavation and stockpiling of waste (principally, the PCB Aroclor-1260) began

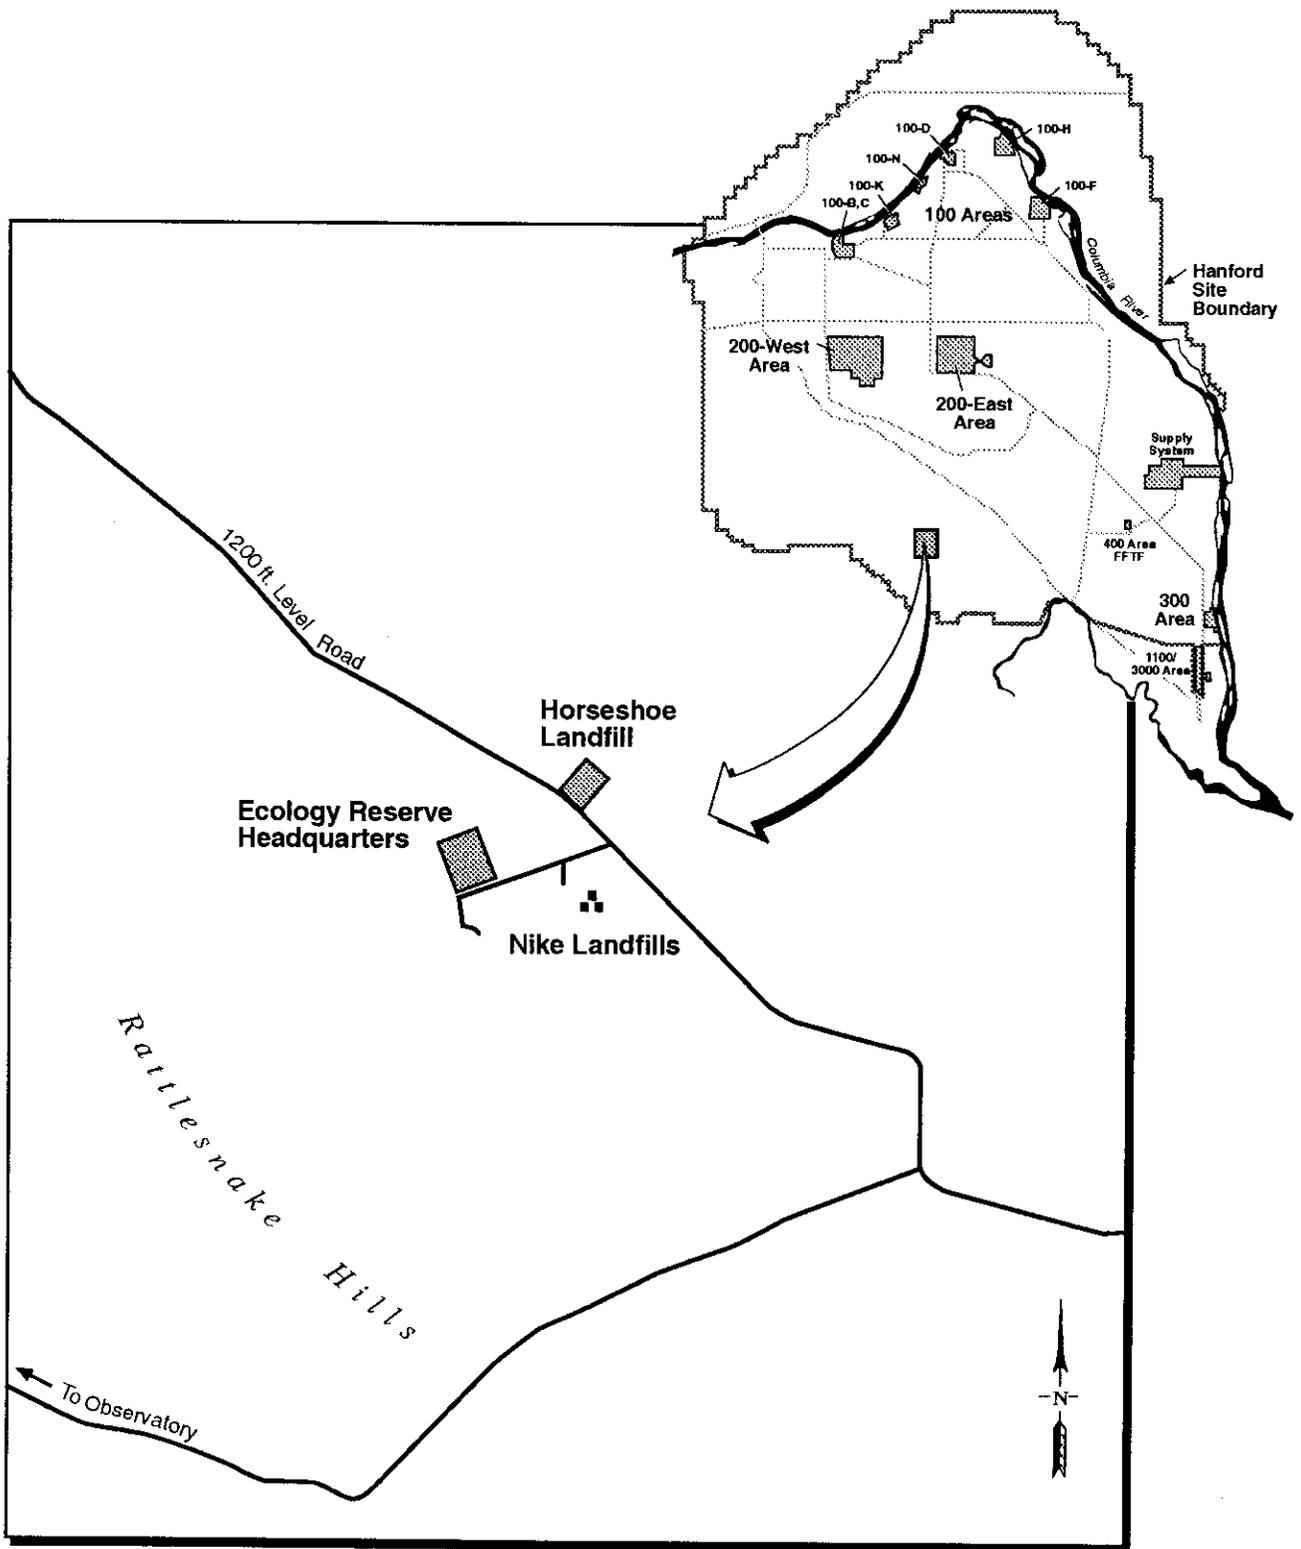
Figure 10. Horseshoe and Nike Landfills.

Five trenches were excavated from anomaly 6. The first three trenches showed no evidence of buried wastes or disturbed soil on the west side of the anomaly, except for copper grounding wire. Sheet metal scrap, fence posts, wood debris, and a washtub were excavated from the fourth trench. Cable, cement blocks, scrap metal, three ripped and partially collapsed 209-L drums, plastic and metal parts, and four 25.4-cm battery-type containers with screens were excavated from the fifth trench.

While excavating anomaly 6, the crew noted an insecticide-like odor from one of the excavated soil piles. Four soil samples from the pile all indicated DDT concentrations greater than 10 ppm from field test kits. A grab soil sample was collected from the area of the highest DDT reading from the field screen. An offsite laboratory analyzed the grab sample; DDT, DDD, and DDE concentrations were 945, 360, and 27 ppm, respectively. Five more soil samples were taken from the other excavated soil piles. These samples were screened using test kits, with all five samples indicating DDT greater than 10 ppm. These levels exceeded Ecology's established action levels of 1 ppm to remove DDT-contaminated soil.
