STATE OF WASHINGTON  
DEPARTMENT OF ECOLOGY

Re: Dangerous Waste Compliance Inspection on March 11, 2020, at the Non-Radioactive Dangerous Waste Landfill, RCRA Site ID: WA7890008967, Nuclear Waste Program (NWP) Compliance Index No.: 20.696.

20-NWP-109  
Nonradioactive Dangerous Waste Landfill  
RCRA Site ID: WA7890008967  
NWP Compliance Index No.: 20.696  
Inspection Date: March 11, 2020

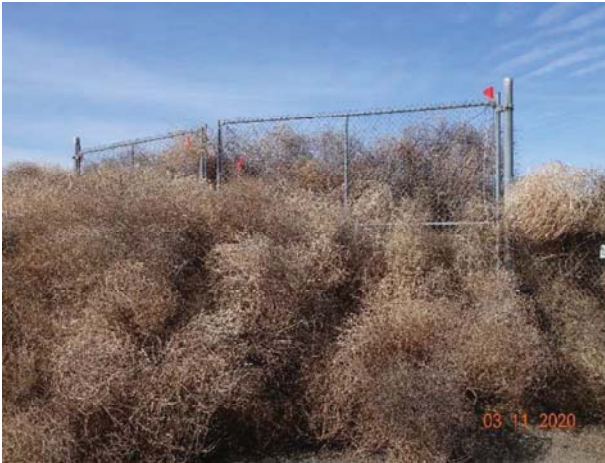
I began my site inspection with the gate. I observed the gate had a large amount of tumbleweeds in front of it and took the following picture. I attempted to get around enough tumbleweeds for a visual of the gate lock and signs. However, I was not able to see the lock and I was not able to read the signs on the gate.

DSC# 02691 - Tumbleweeds in front of the access gate at NRDWL.

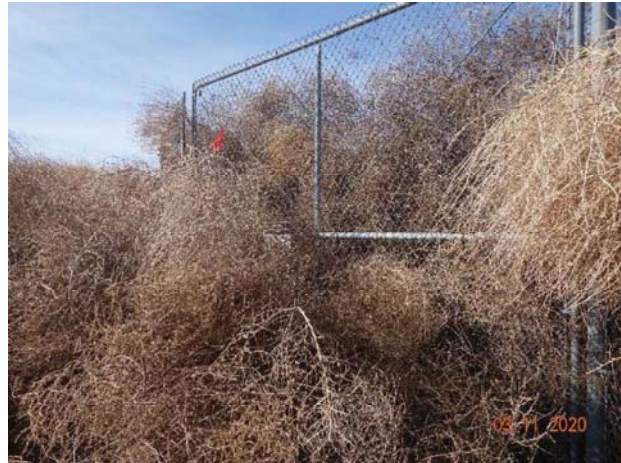
DSC# 02690 - Tumbleweeds blocking view of security signs and the gate lock at NRDWL.

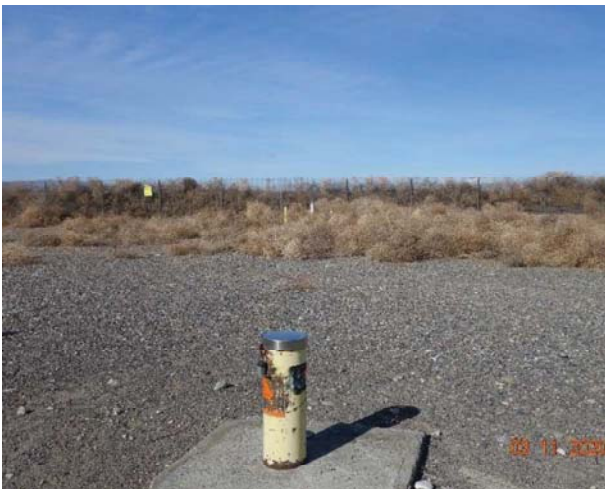
From the gate I could see some of the wells and that the tumbleweeds had been cleared away from them. I walked over and identified wells 699-25-34B, 699-25-34F and 699-25-33A. I also observed that each well was capped, locked and tagged. I took a picture of the wells. I also took a picture of the signs hung on the fence. The signs I observed said "Caution, Asbestos Waste Disposal Site, Do not create dust". I did not observe any sign stating "Danger, Unauthorized Personnel Keep Out" (or equivalent).

DSC# 02692 - Well Number 699-25-33A with tumbleweeds surrounding 699-25-34F and 699-25-34A.

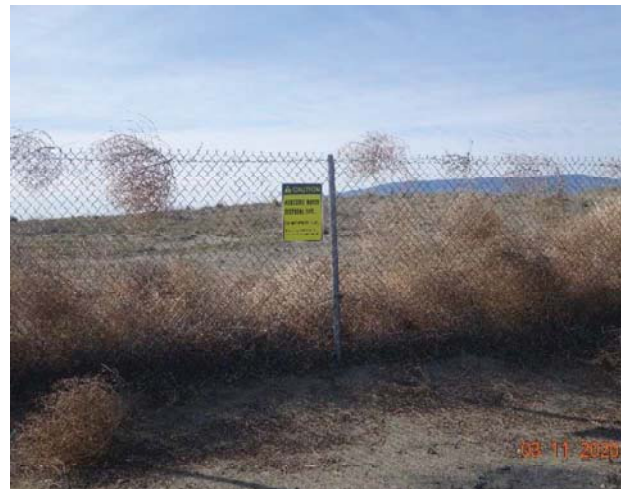
DSC# 02693 - Observed signage hung on the fence at NRDWL.

**Observations:** During the inspection, I walked along the east and north fence lines of the Non-Radioactive Dangerous Waste Landfill. The east fence line is over four hundred feet long, and the north fence line is over nine hundred feet long. I took a picture of the signs I observed hung on the fence between the corners of the landfill. The signs I observed said "Caution, Asbestos Waste Disposal Site, Do not create dust". I did not observe any sign stating "Danger,

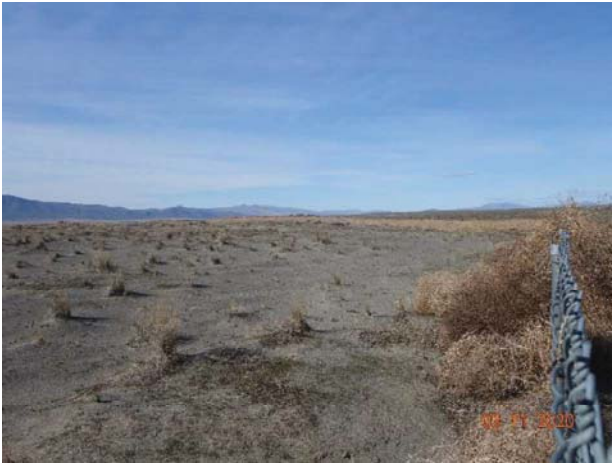
DSC# 02694 - The general location of the subsidence at NRDWL.

During my site inspection on March 11, 2020, I observed subsidence within the facility. I observed in Occurrence Report EM-RL-CPRC-CENTPLAT-2020-0003 that “the lead worker was conducting surveillance by slowly driving a pickup truck crisscrossing the surface of the site planting warning flags on unmarked impediments. The front tires of the pickup truck got stuck in a subsidence deep enough that the lead worker could not back out.”

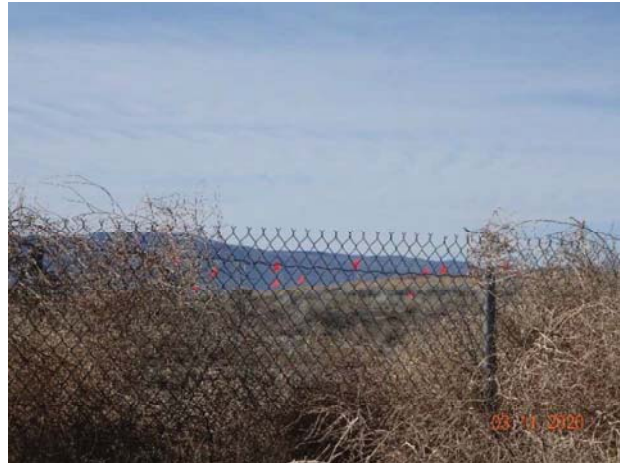
DSC# 02695 - Flags marking the exact location of the subsidence at NRDWL.

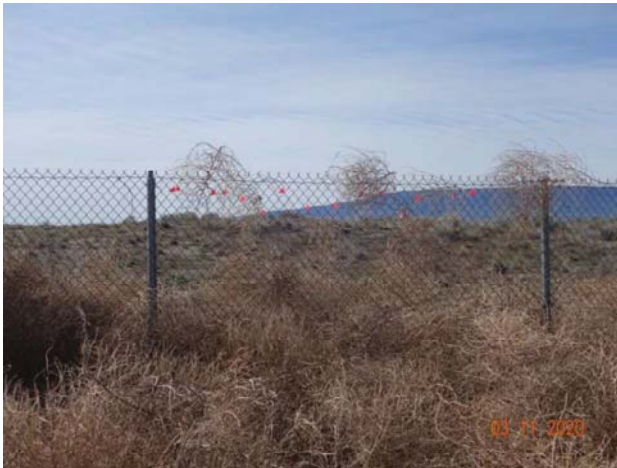
DSC# 02696 - Flags marking the location of the subsidence at NRDWL, and tumbleweeds along the fence line.

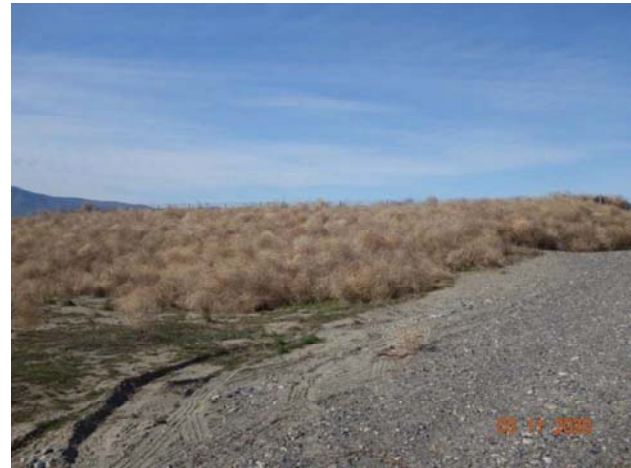
DSC# 02697 - A large pile of tumbleweeds collected near the northeast corner of NRDWL.
