Evaluation of Cracking in the 241-AZ Tank Farm Ventilation Line

WHC-SD-WM-TI-478 Rev. 0

**EVALUATION OF CRACKING IN THE
241-AZ TANK FARM VENTILATION LINE**

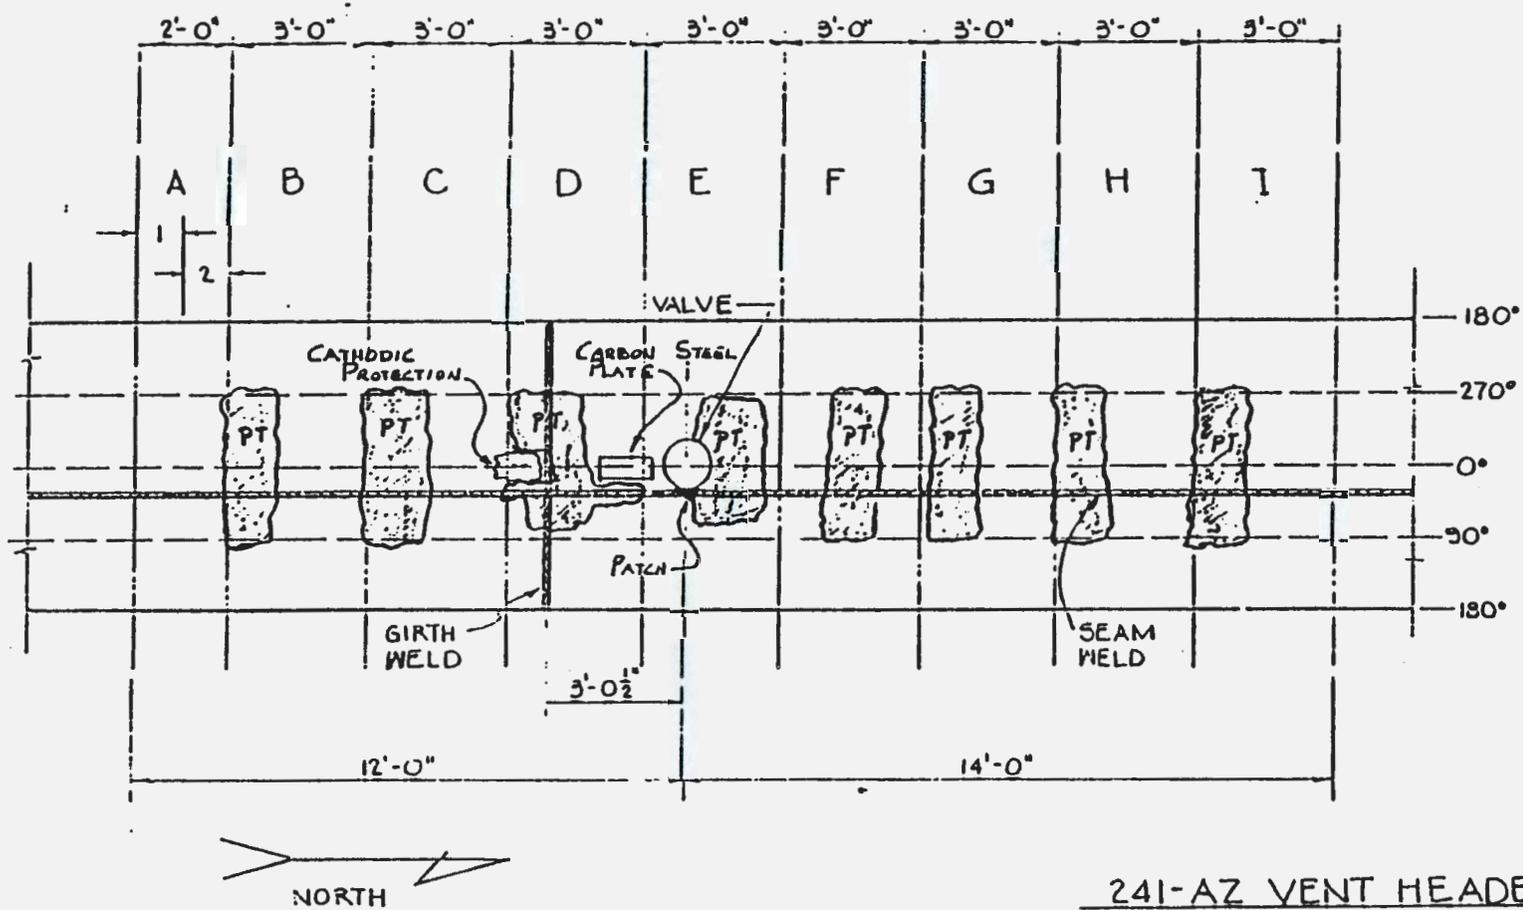
Figure 1: Regions of AZ Tank Farm Ventline Examined by Visual and Liquid Penetrant Methods.

Examination of the excavated ventilation line progressed in several stages. Figure 1 is a map showing all the areas examined by visual and liquid penetrant methods. In the eight areas examined (identified as Regions B through I, in Figure 1) only Regions D and E exhibited a consistent pattern of cracking. Figure 2 presents a schematic illustration of the observations in these two areas.

Liquid penetrant examination around the fillet weld attaching the branch connection to the ventilation line revealed the first evidence of cracking. A single crack about 2-1/4 inches long appeared in the base metal about 1/2 inch away from the weld. Cracking caused by a very high temperature failure process should occur very close to the weld, where the temperatures are highest and thermally-induced plastic strains are greatest. The observed

The final visual examination of Region E revealed a third crack across the seam weld about 2 inches from the north corner of the second patch. Liquid penetrant examination failed to detect this crack also, so it was classified as a through-wall crack.

A small area of intense cracking occurred in the base metal several inches north of the second patch just below the seam weld. The crack orientation was generally axial, but with some circumferential character evident.

The circumferential girth weld is a convenient location to start the cracking in Region D of the ventilation line. Four axial (i.e., transverse to weld direction) cracks occurred in base metal adjacent to the weld; no other cracking occurred within about one inch on either side of this weld. Residual stresses surely exist in and around this field weld, since post-weld heat treatment would not have been applied. The residual stress distribution given by Masubuchi (1980, Page 207) should represent the qualitative features of the girth weld stresses. Transverse cracks near the weld are consistent with tensile circumferential stresses at that location. Compressive axial stress on the outside surface is consistent with an absence of circumferential cracks. Liquid penetrant examination conducted after completing the girth weld should have revealed base metal cracking associated with pipe installation, so transverse cracks near the girth weld must have formed during service. This finding suggests that the other cracking in this region also developed during ventilation line service.

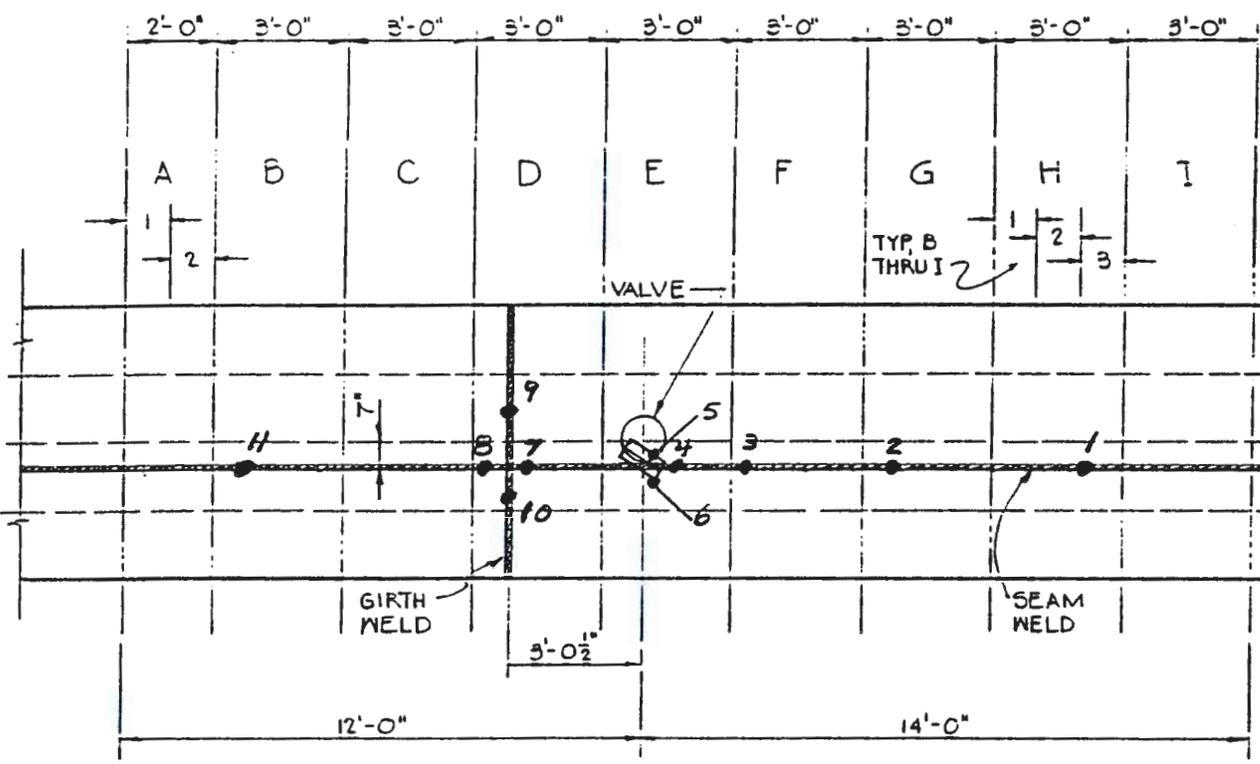
FERRITE CONTENT
241-AZ VENT HEADER
INSPECTION RECORD

- NOTE: 1) 10' NORTH OF VALVE : < 2.5
 2) 6' NORTH OF VALVE : < 2.5
 3) 3' NORTH OF VALVE : < 2.5
 4) SEAM WELD AT PATCH : < 2.5
 5) UPPER PATCH WELD : > 5.0, < 7.5
 6) LOWER PATCH WELD : > 7.5, < 10.0
 7) NORTH SEAM AT GIRTH WELD : < 2.5
 8) SOUTH SEAM AT GIRTH WELD : < 2.5
 9) GIRTH WELD AT 315° : > 7.5, < 10.0
 10) GIRTH WELD AT 45° : > 7.5, < 10.0
 11) 8' SOUTH OF VALVE : < 2.5
 12) RANDOM BASE METAL : < 2.5
