FACILITY STATUS CHANGE FORM

Date Submitted: 1/14/2013	Area: 100-N	Control #: D4-100N-0024
Originator: David Warren	Facility ID: 108-N Chemical Unloading Facility	
Phone: 539-6040	Action Memorandum: 100-N Ancillary Facilities

D4 Project Facility Completion Form

Attachment 1: Facility Information (10 pages)

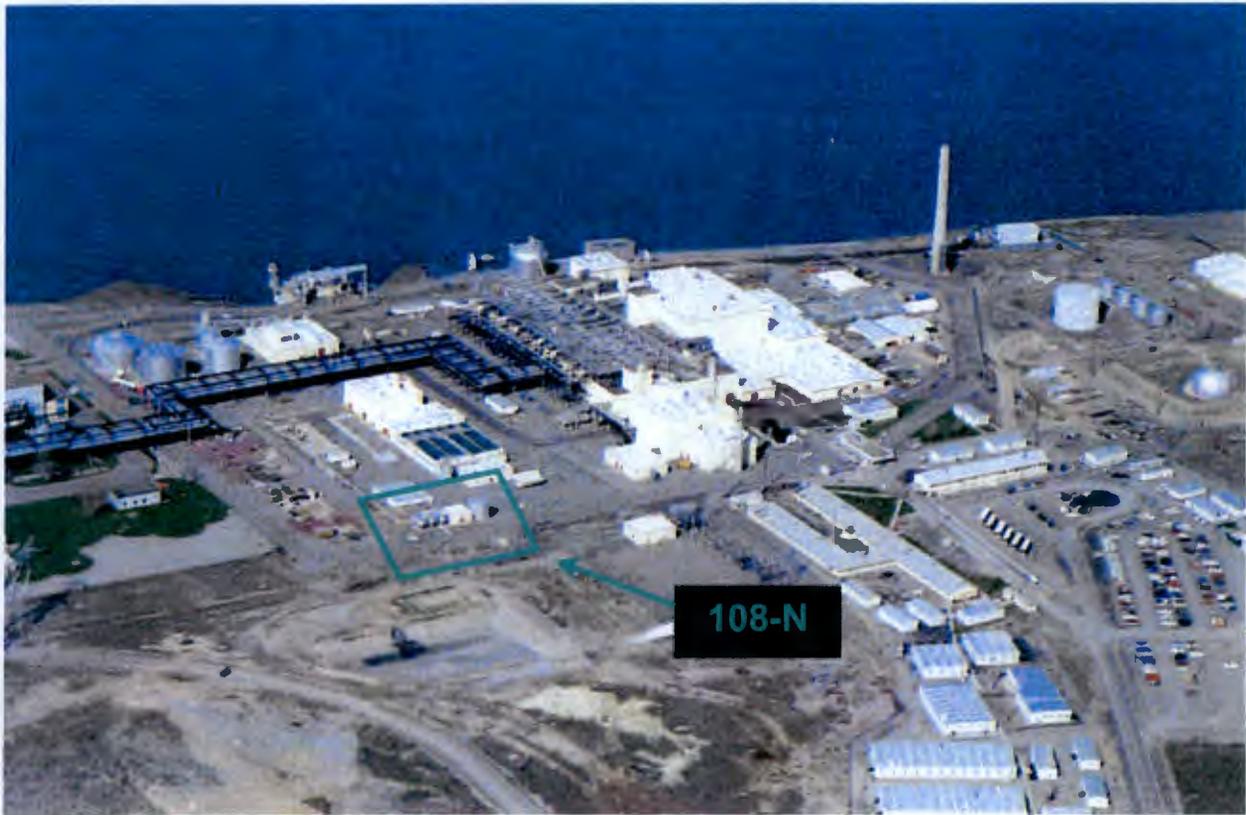
108-N Pre-Demolition

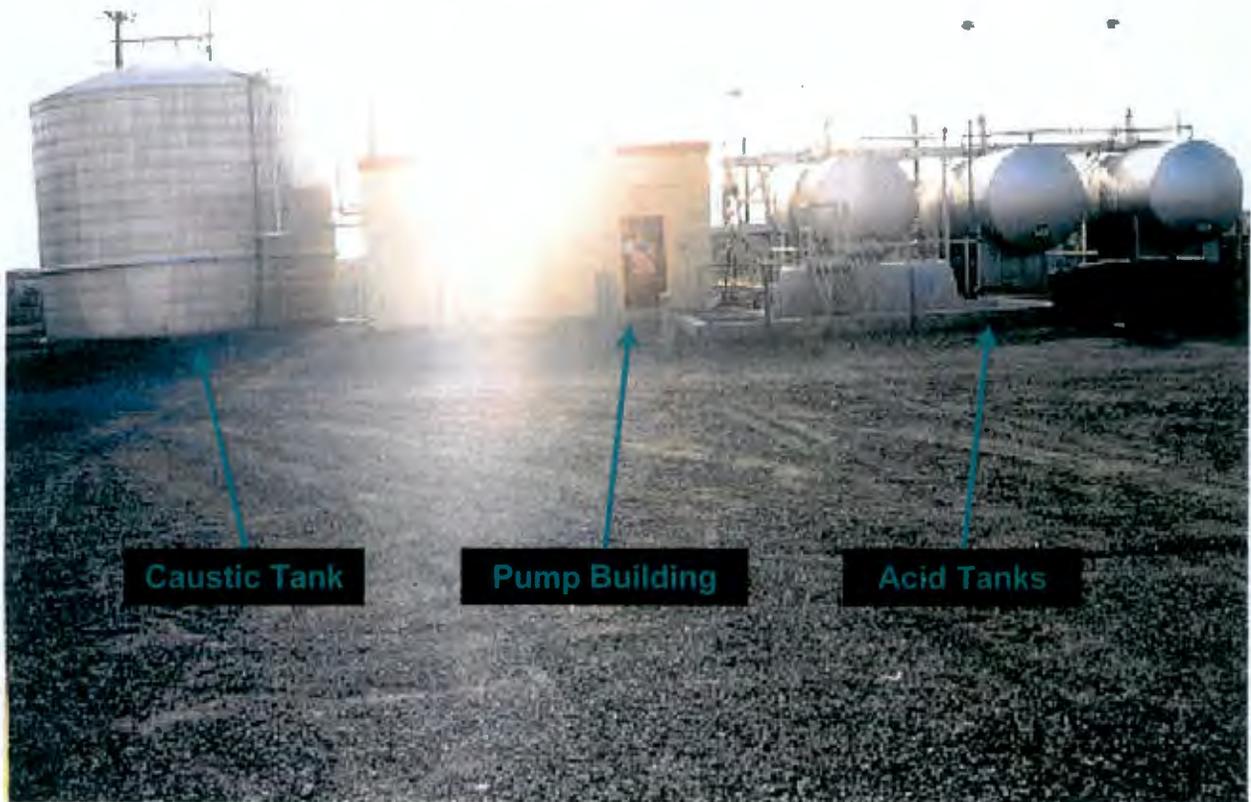
108-N Chemical Storage Tanks & Pump Building Pre-Demolition (Looking Southeast)

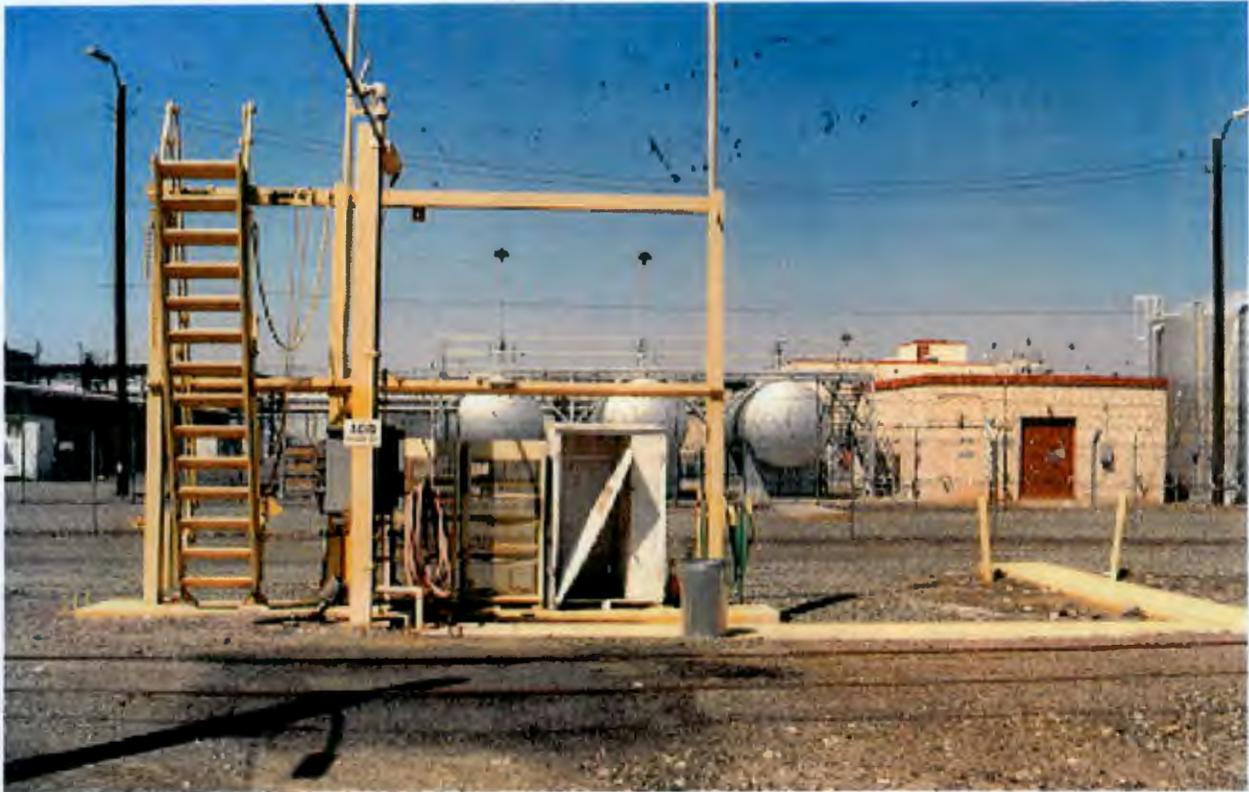
108-N Railcar Unloading Station (Looking Northwest)

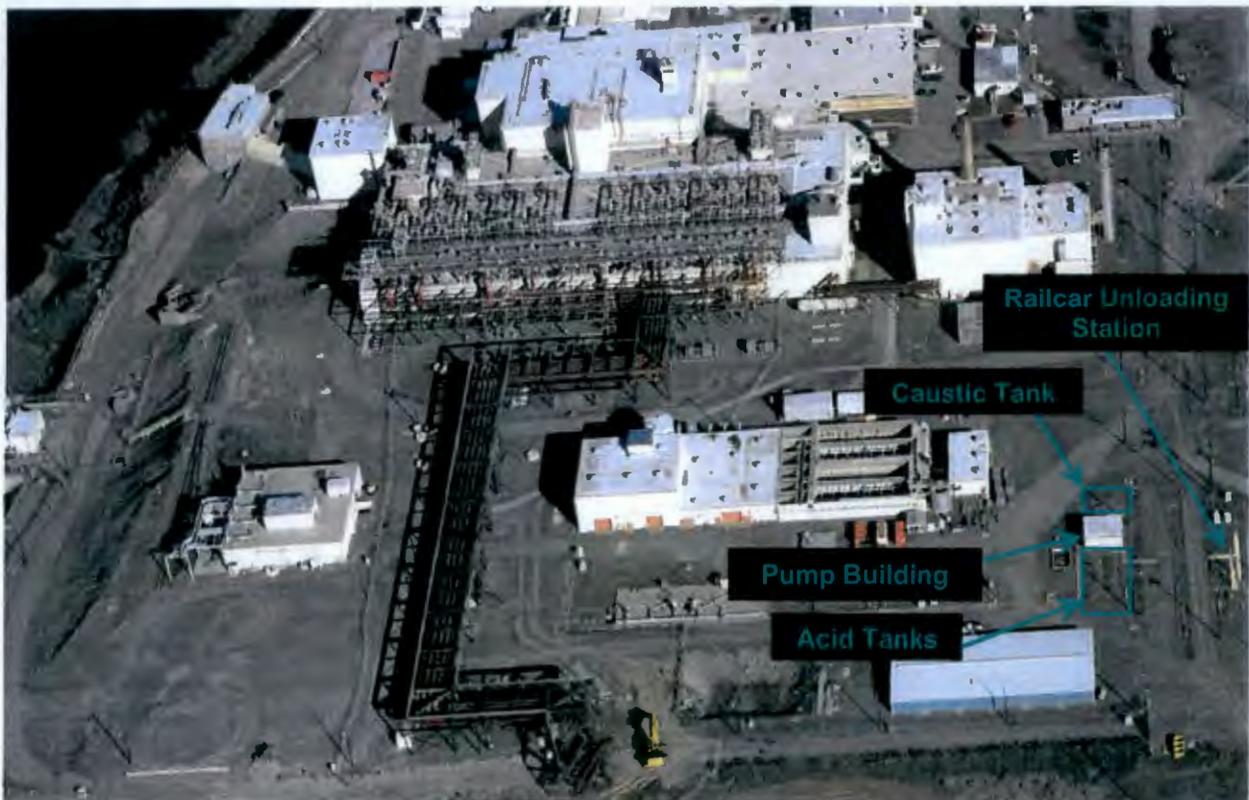
108-N After Removal of Chemical Storage Tanks

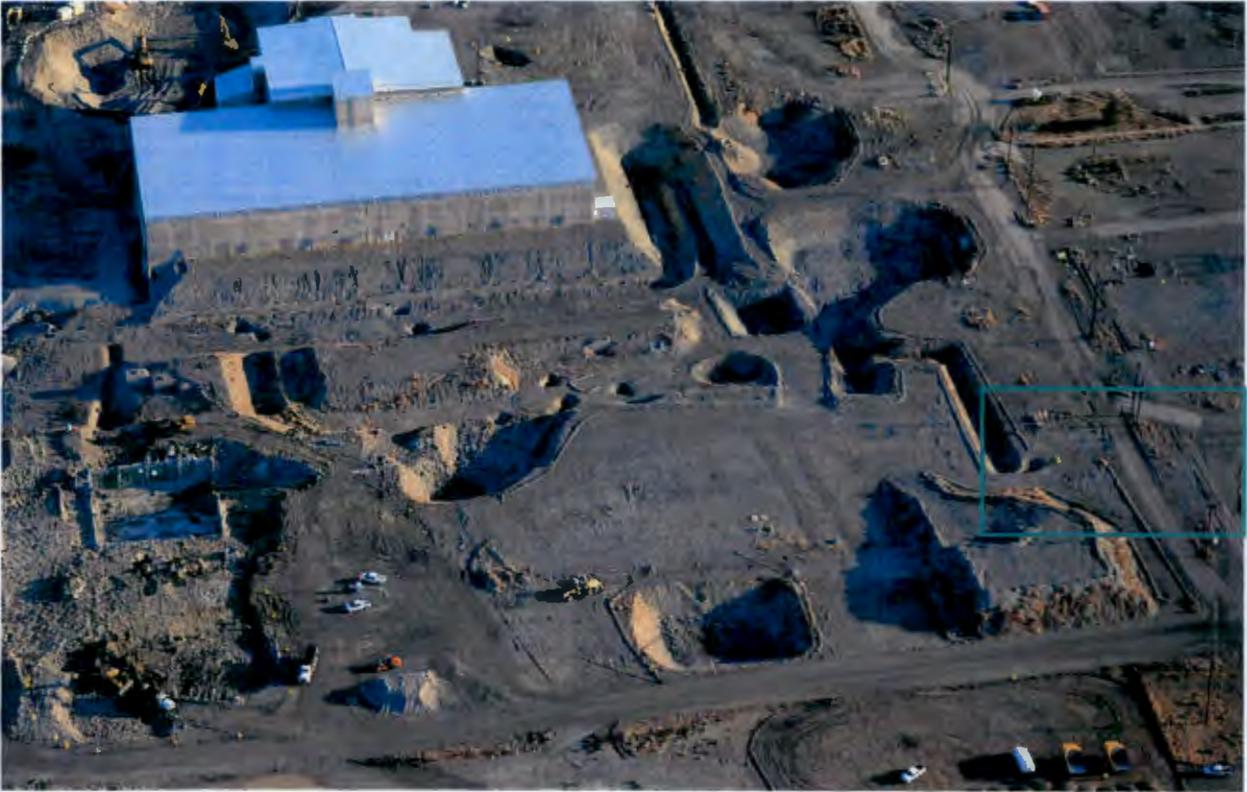
108-N After Demolition & Backfill

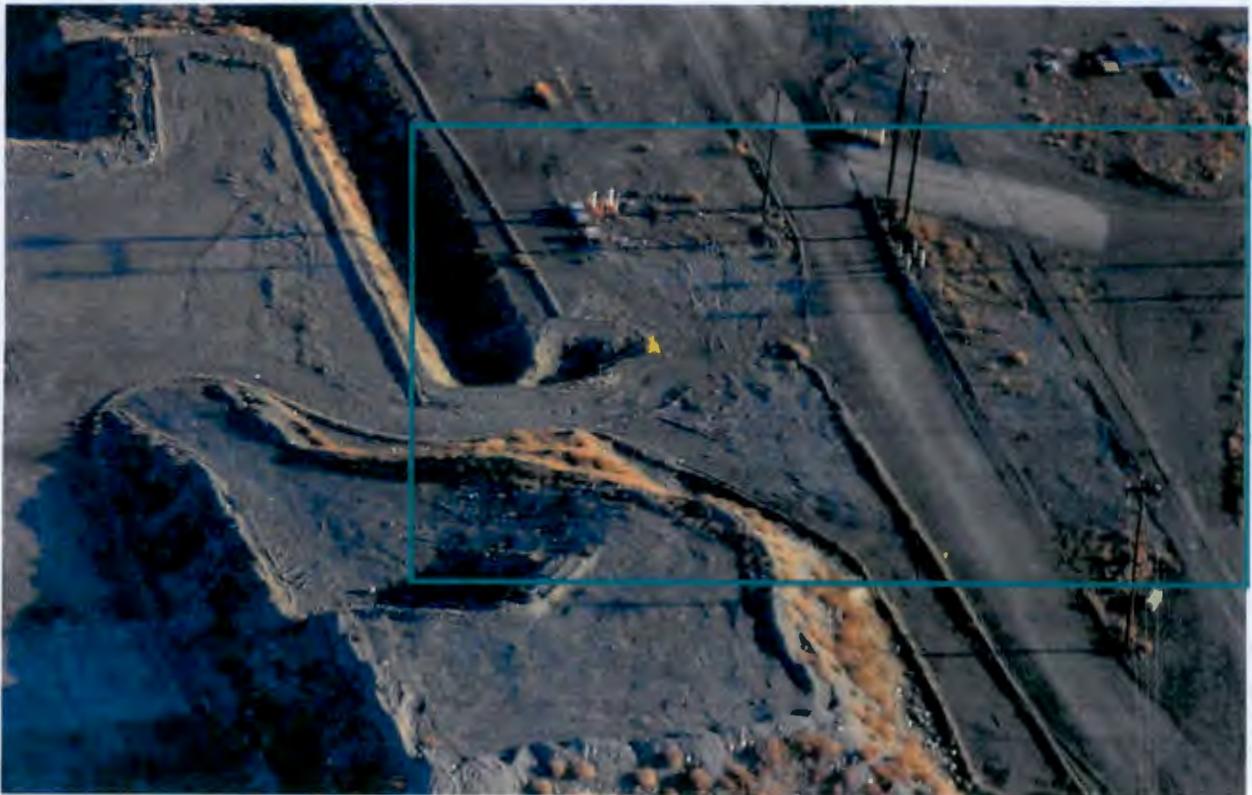
108-N After Demolition & Backfill

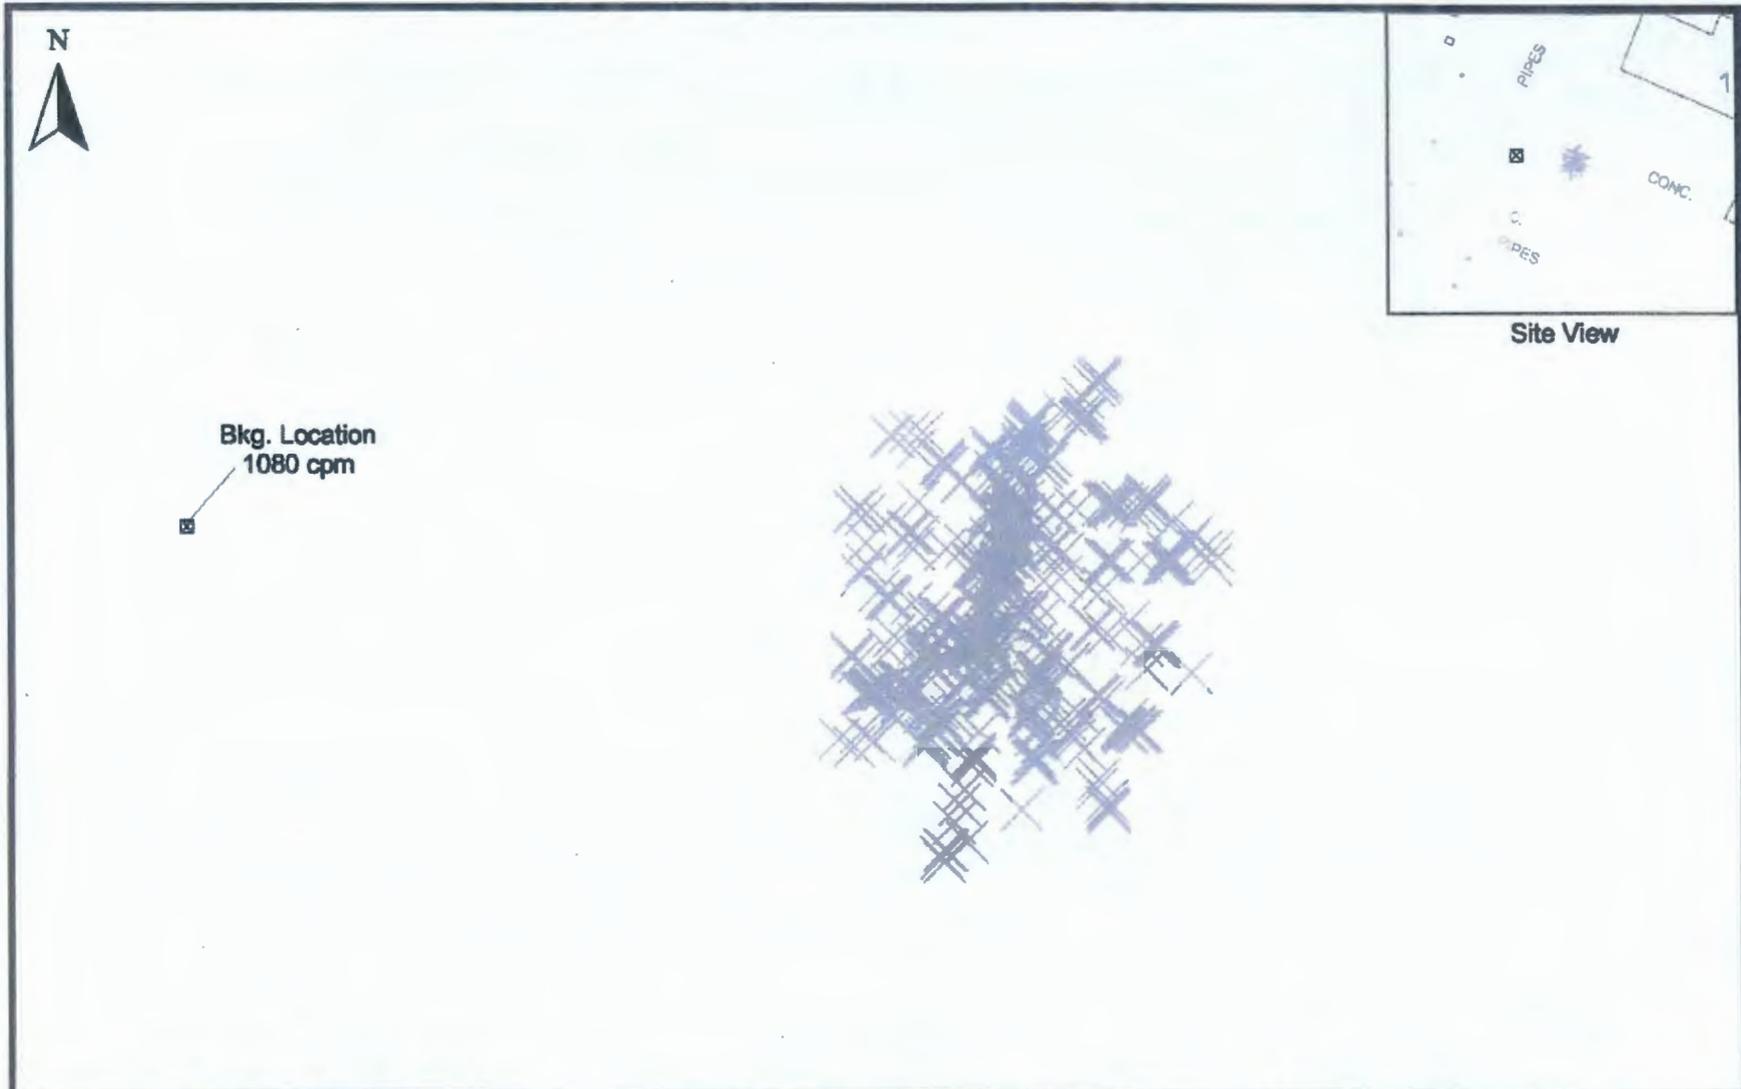
**100N Field Remediation
108-N Excavation
GPERS Radiological Survey
Gamma Track Map**

Coverage File: N325
Number of Data Pnts: 748
Type of Survey: 'Gamma'
Max GCPM: 1639
Avg Bkg CPM: 1080
Survey Date: 11/20/2008
Area Surveyed: 87 m2
Project File: N325
Pdf File: ESRFRM080170

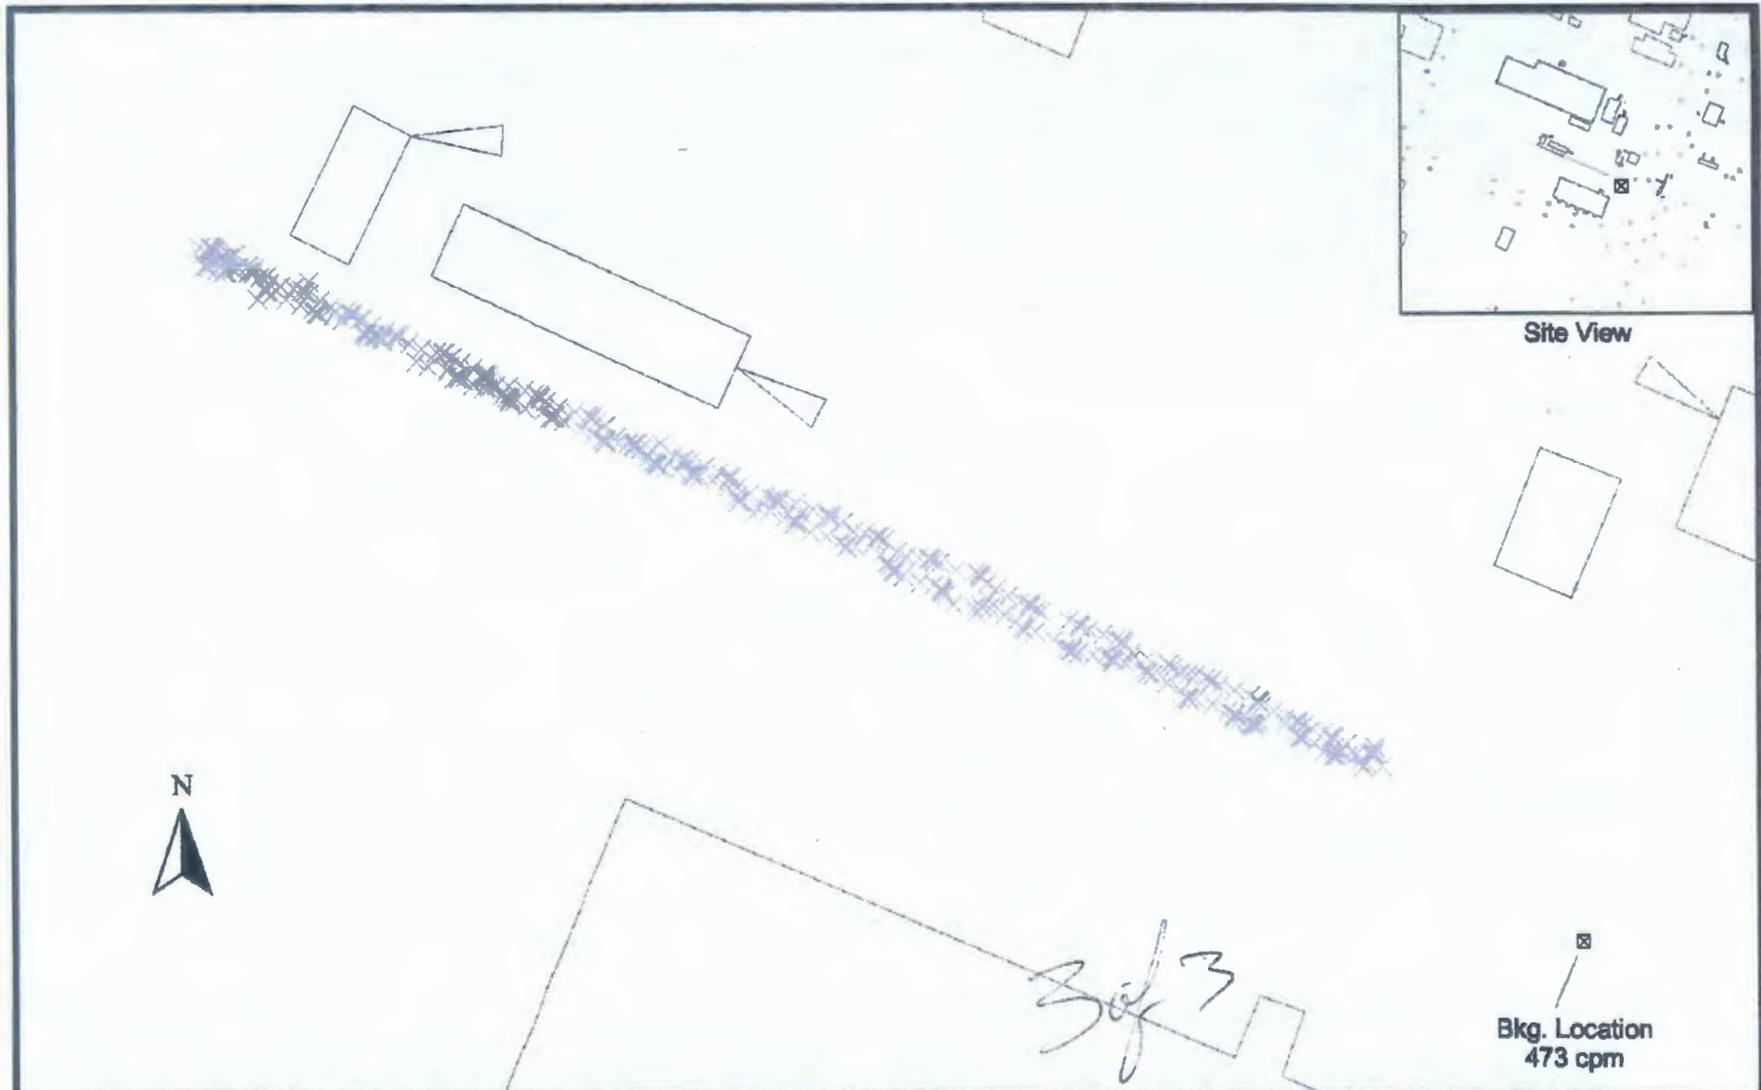
**100N D4 Project
108-N Chemical Trench
GPERS Radiological Survey
Beta Track Map**

Legend	Summary Statistics
NETCPM	Coverage File: N051A
× < 800	Number of Data Pnts: 650
● 800 - 1000	Type of Survey: 'Beta'
● 1000 - 1200	Max GCPM: 754
● 1200 - 1400	Avg Bkg CPM: 473
● > 1400	Survey Date: 02/20/2008
	Area Surveyed: 144 m2
	Project File: N051A
	Pdf File: ESRFRM080012

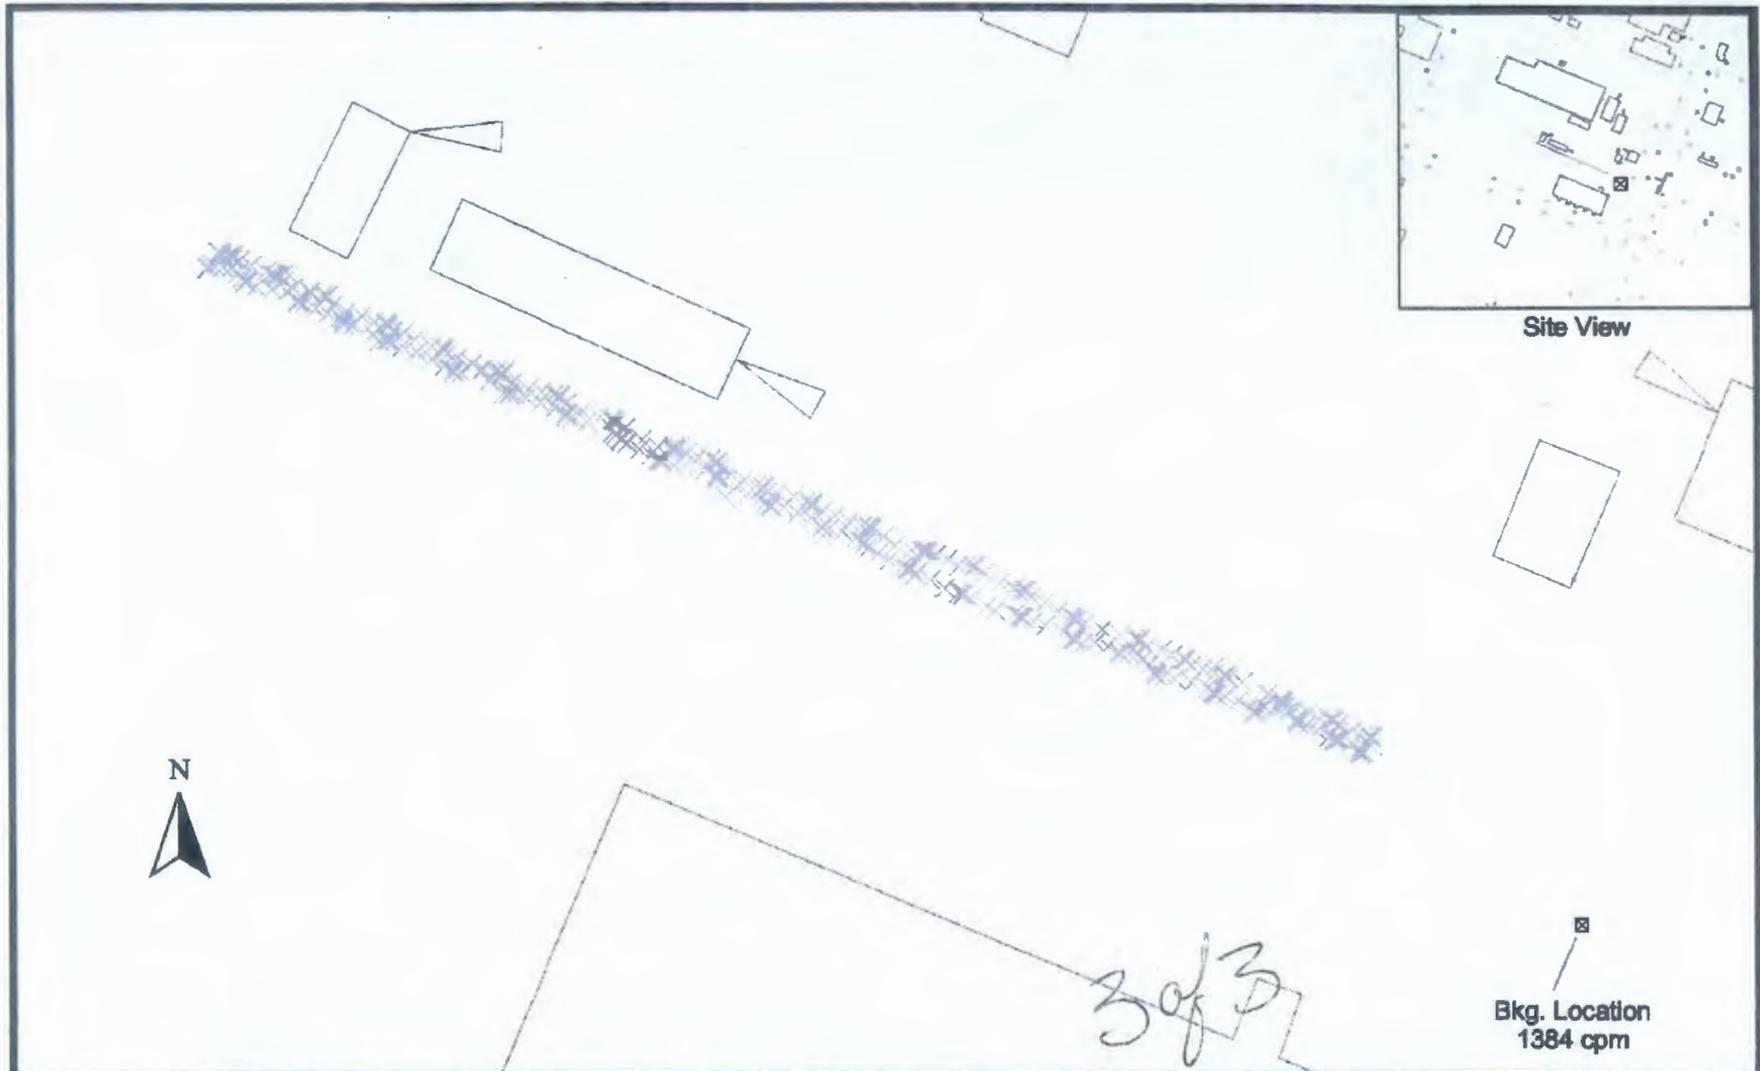
100N D4 Project
108-N Chemical Trench
GPERS Radiological Survey
Gamma Track Map

Coverage File: N051
 Number of Data Pnts: 547
 Type of Survey: 'Gamma'
 Max GCPM: 1708
 Avg Bkg CPM: 1384
 Survey Date: 02/20/2008
 Area Surveyed: 144 m2
 Project File: N051
 Pdf File: ESRFRM080011
