## FACILITY STATUS CHANGE FORM

<b>Date Submitted:</b> Jul 25, 2012 <b>Originator:</b> John Harrie <b>Phone:</b> 509.308.9935	<b>Area:</b> 300 Area <b>Facility ID:</b> 335 and 336 <b>Action Memorandum:</b> Action Memorandum #3	<b>Control #:</b> D4-300-065
--	---	---------------------------------

## Attachment 1: Facility Information

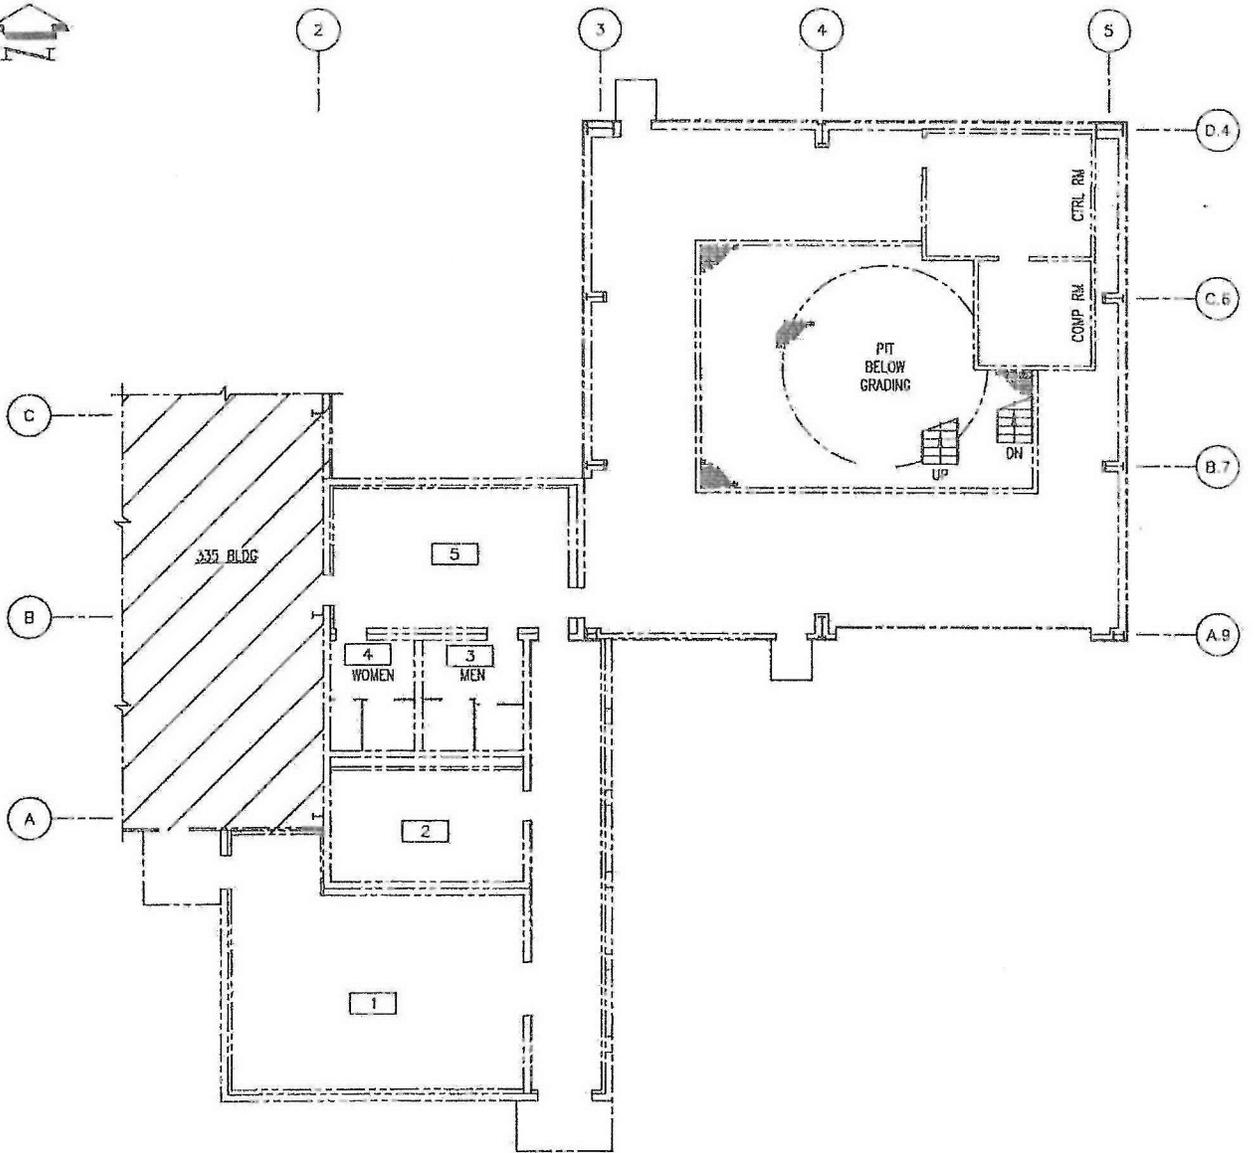
## **Attachment 3: 336 Floor Plan**

The 335 and 336 building debris and slab foundations were removed and disposed of at EDRF. Prior to demolition, a 50 feet (17 m) deep caisson was filled with controlled density fill (Reference Attachment 3, 336 Floor Plan, showing location). The caisson was left in place following demolition, which was supported by characterization data that demonstrated leaving the structure did not fail remedial/removal action goals. EPA concurred with this approach, which is documented in Attachment 2. 335-336 were outside the 300 Area Underground Radioactive Material Area (URMA), a non-radiological building and demolished using clean equipment, therefore, no GPERS survey was performed. Excavation was backfilled to grade with clean fill.

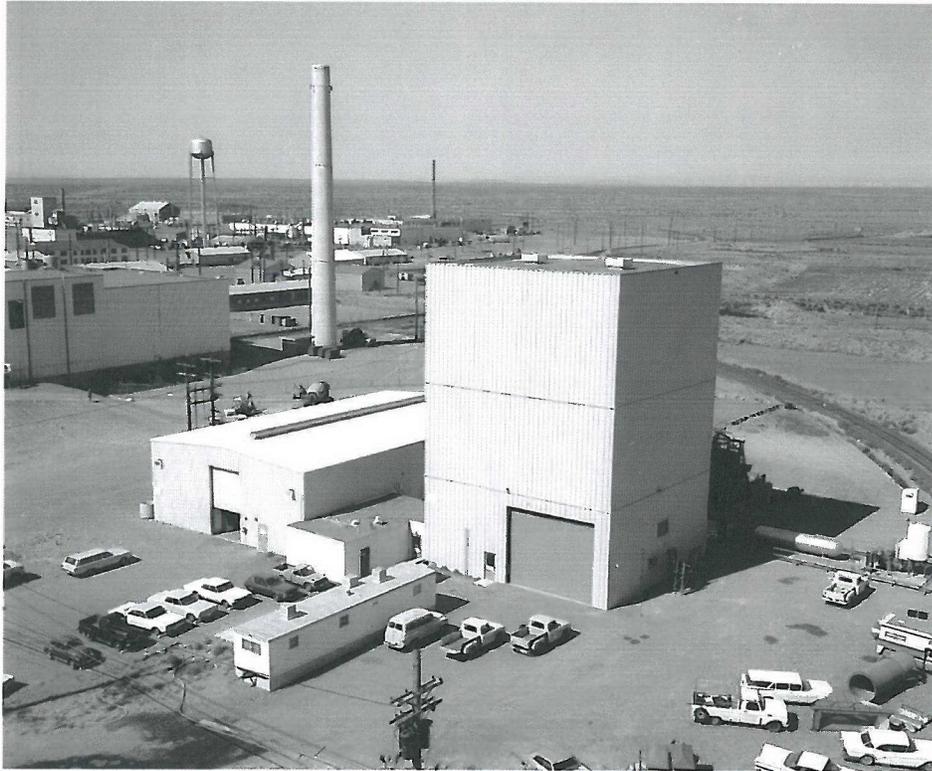
**Figure 1: Looking northwest at the 335 – 336 Buildings on September 21, 1971.**

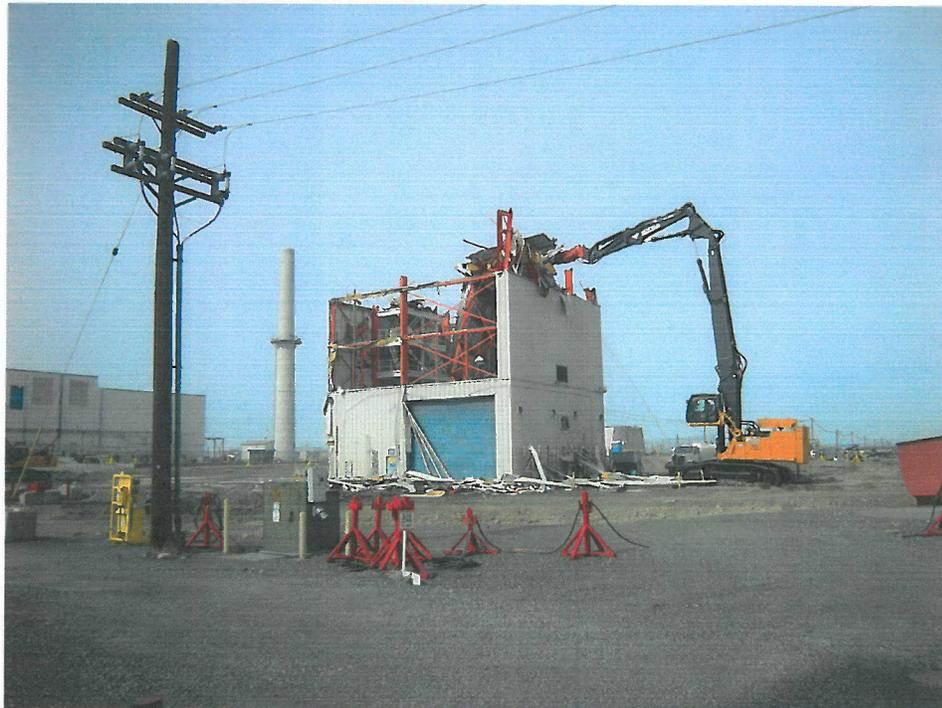
**Figure 2. Looking northwest at the 336 Highbay during demolition on March 15, 2010.**

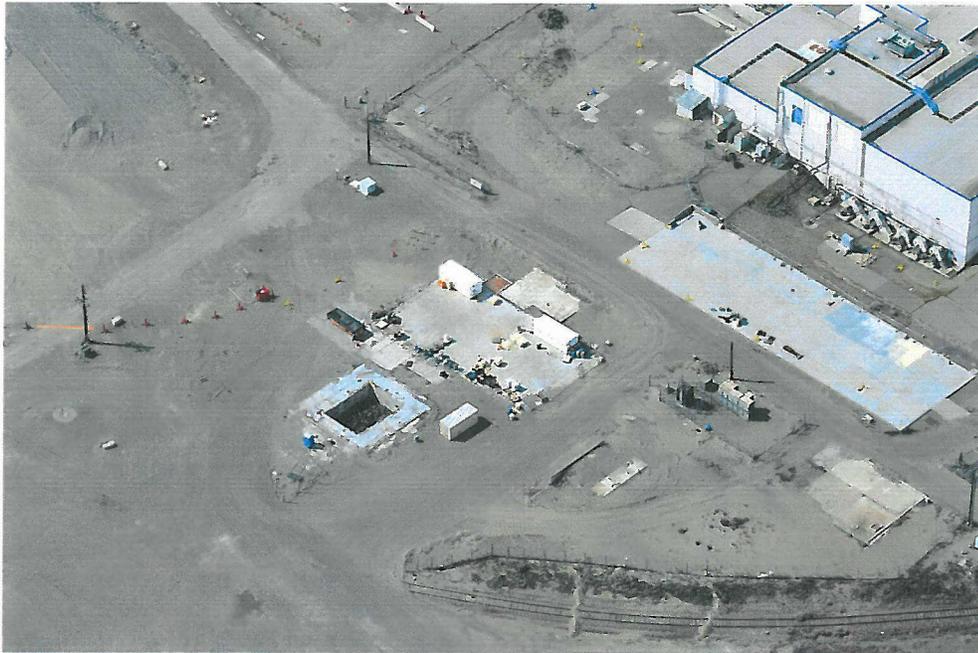
**Figure 3. Looking southwest at 335 and 336 Building slabs on April 13, 2012.**

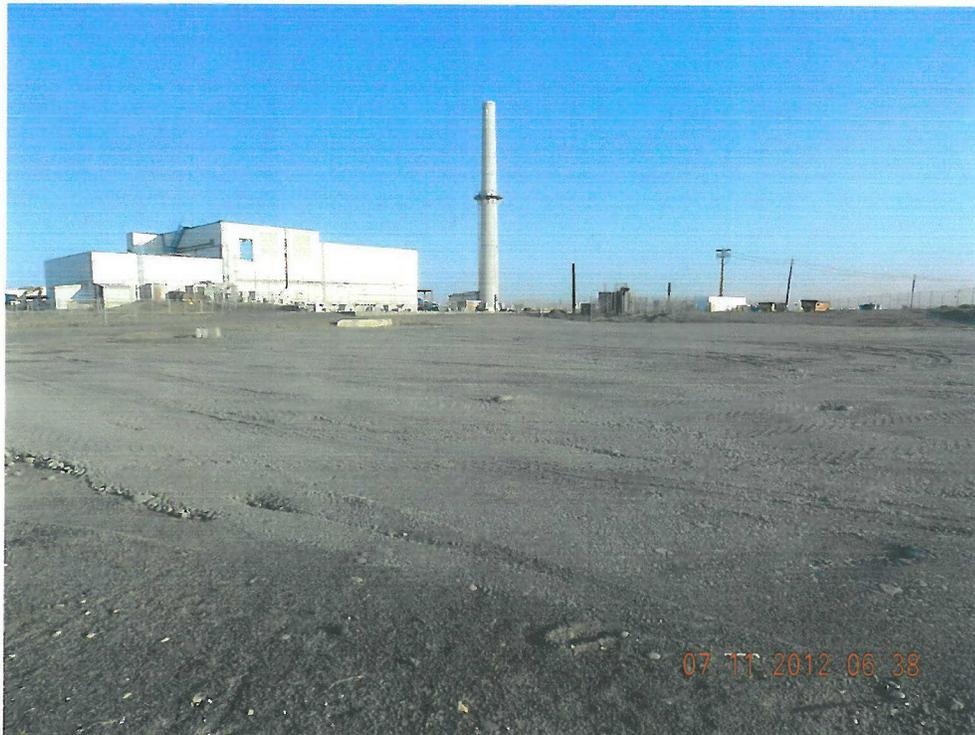
**Figure 4. Looking northwest at 335 and 336 following backfill in July of 2012.**
