Visual Examination of Tank Annuli at the 241-AW Tank Farm

WHC-SD-WM-RPT-034

SEPTEMBER 1992

WESTINGHOUSE HANFORD COMPANY  
For The  
U.S. Department of Energy  
Richland Field Office (RL)

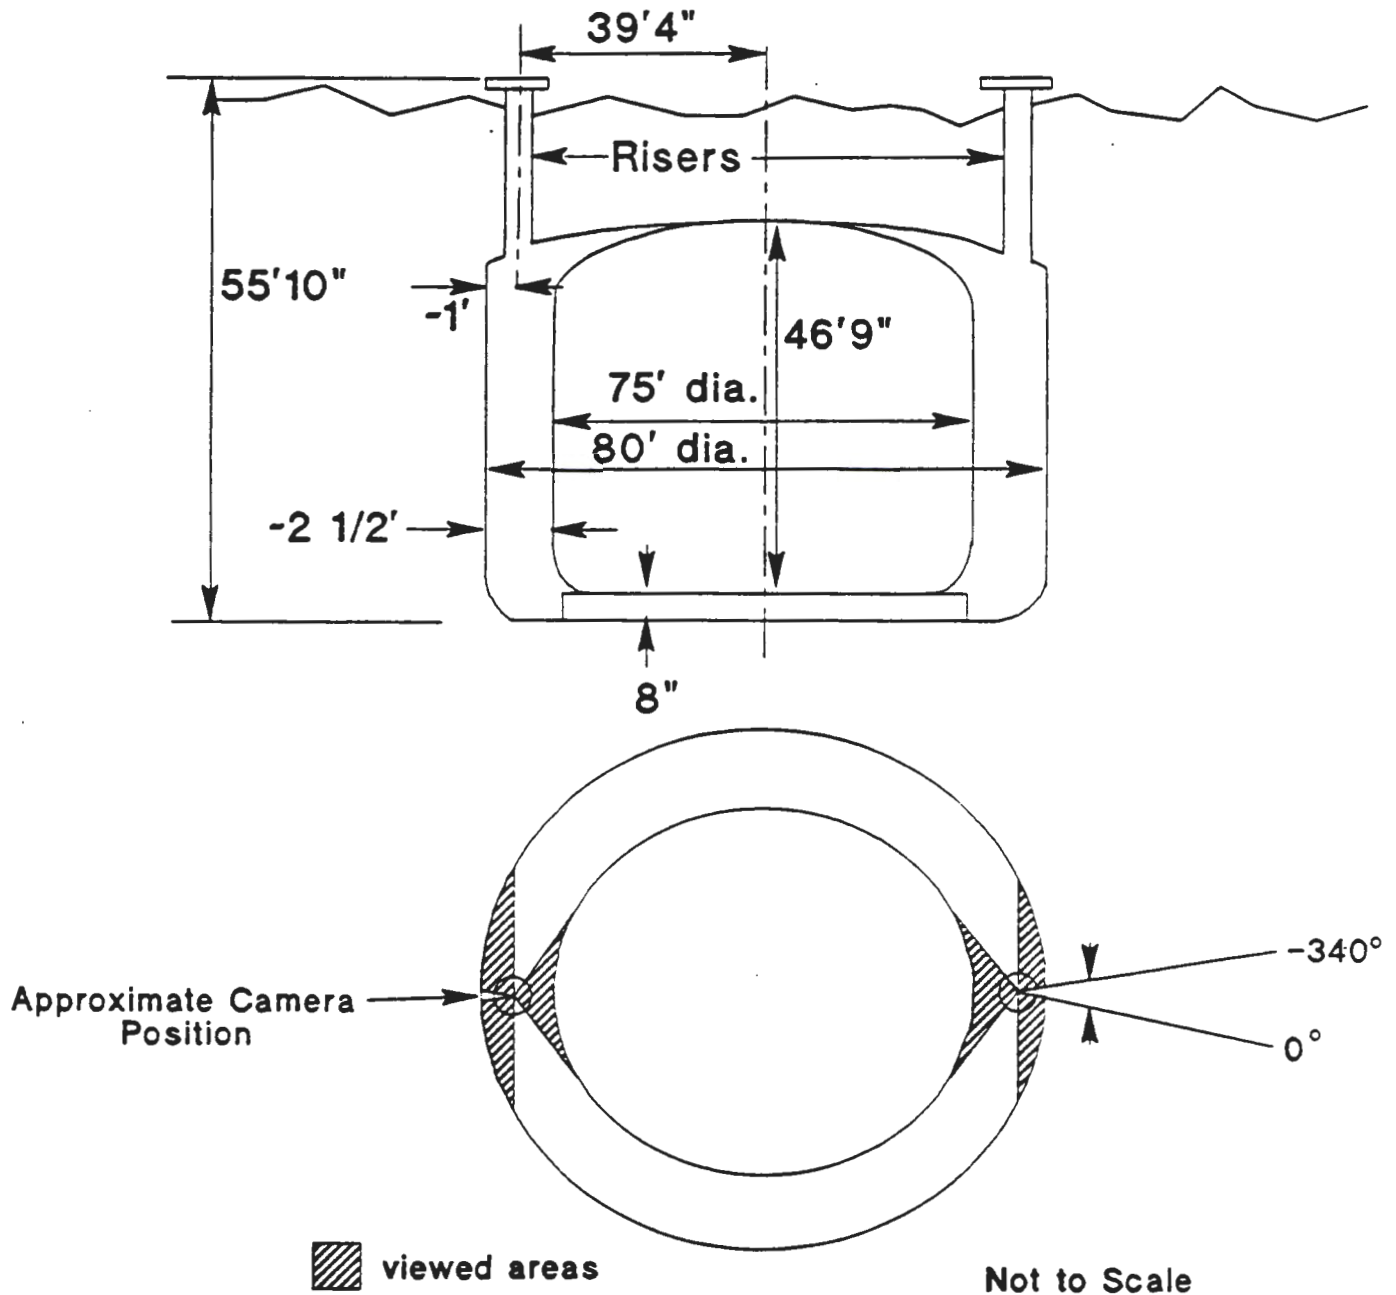
FIGURE A

the vessel and the location of the camera. The percent of the outer shell surface examined is limited by the range of the camera which is 20 feet (6.09m). Figure A, Typical Arrangement for Annulus Examination of the 241-AW Double Shell Tanks, is intended to depict viewing position of the camera in the annulus.

TYPICAL ARRANGEMENT FOR ANNULUS EXAMINATION  
OF THE 241-AW DOUBLE SHELL TANKS
