FACILITY STATUS CHANGE FORM

Date Submitted: 1/24/2017	Area: 200W	Control Number: D4-PFP-045
Originator: James Leary	Facility ID: 2727Z	Phone: 509 942-6675

2727Z, Supply Storage Building

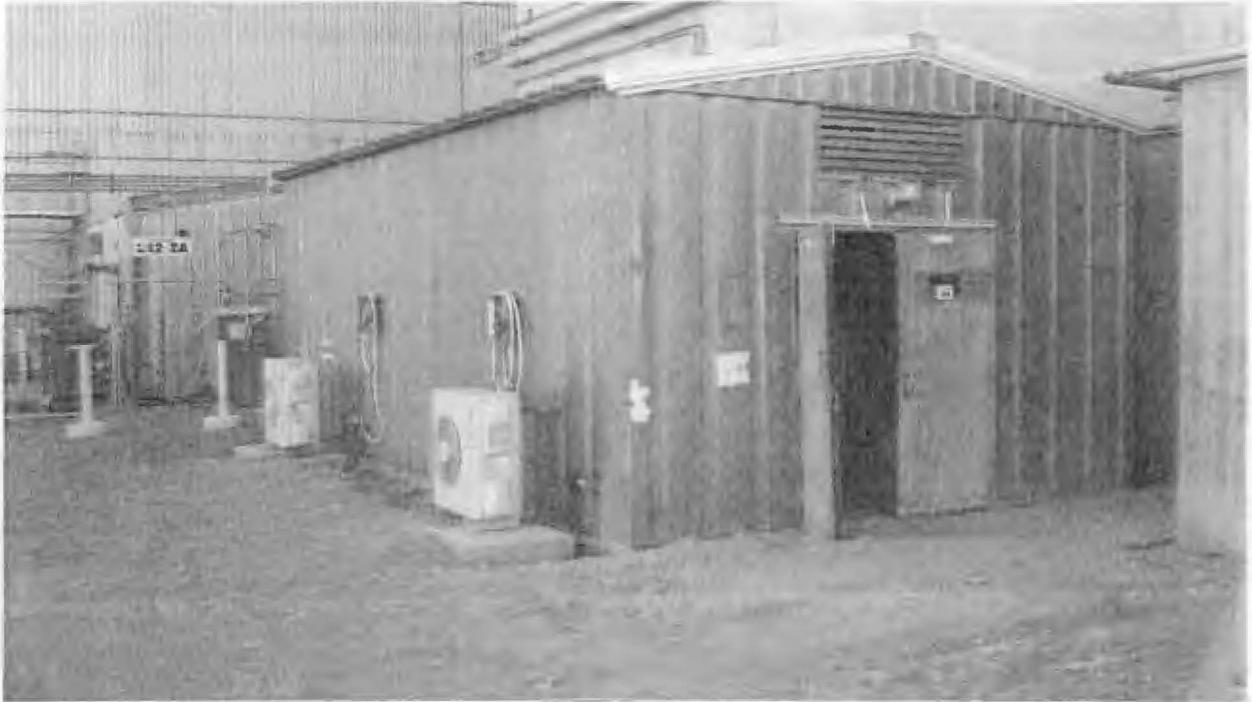
Figure 1. 2727Z Pre-demolition

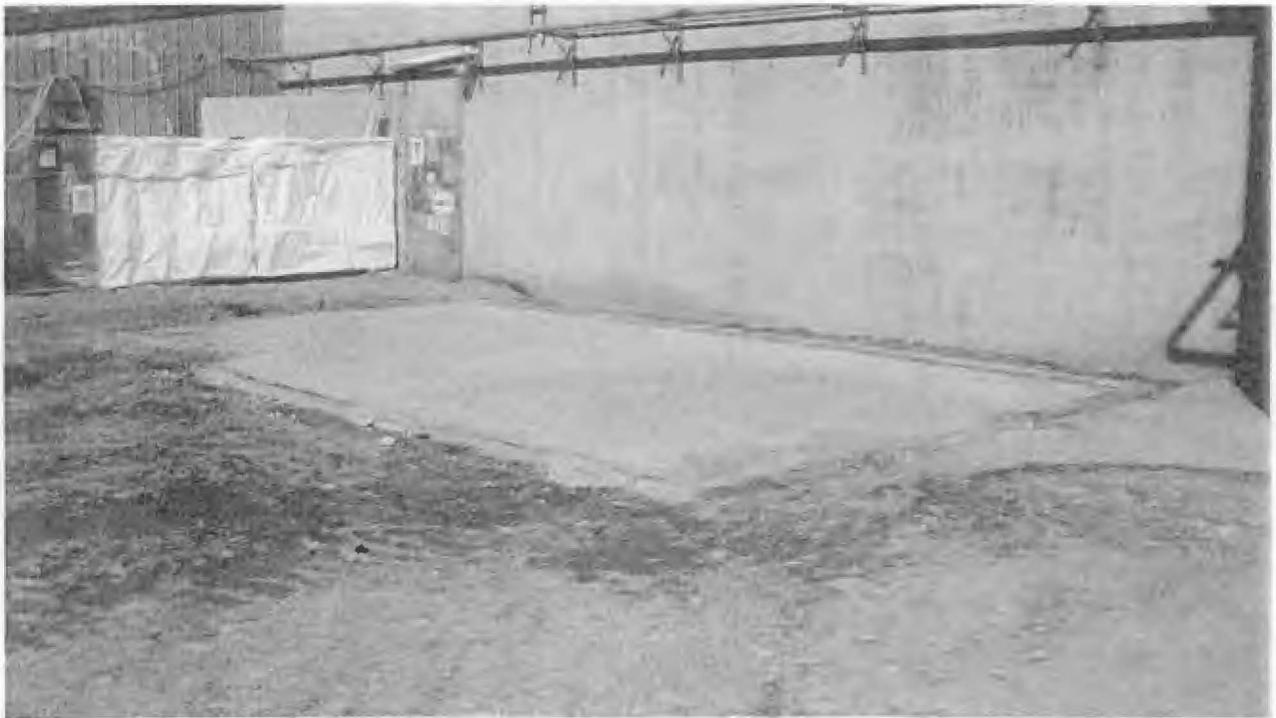
The 2727Z slab has been left in place, and a layer of gravel placed on top and contoured to provide a stabilized condition suitable for D4 activities to proceed in adjacent areas. A walkdown of the area where the structure previously stood has been conducted to confirm that demolition is complete, waste has been removed and the PFP area is appropriately posted in accordance with radiological and occupational safety requirements. Residual Category 1 ACM mastic material remains on the slab perimeter where it sealed the juncture between the slab and exterior walls. (See CWR-PFP-00008, Rev. 0, 2727Z and 2729Z Demolition Report).

Figure 2. 2727Z Post-demolition
