Asbestos NESHAP Thorough Inspection Report at
234-5ZA Change Room Addition Zone 1 of 234-5Z

Document Number: CWR-PFP-00021

Asbestos NESHAP Thorough Inspection Report at 234-5ZA Change Room Addition

Zone 1 of 234-5Z

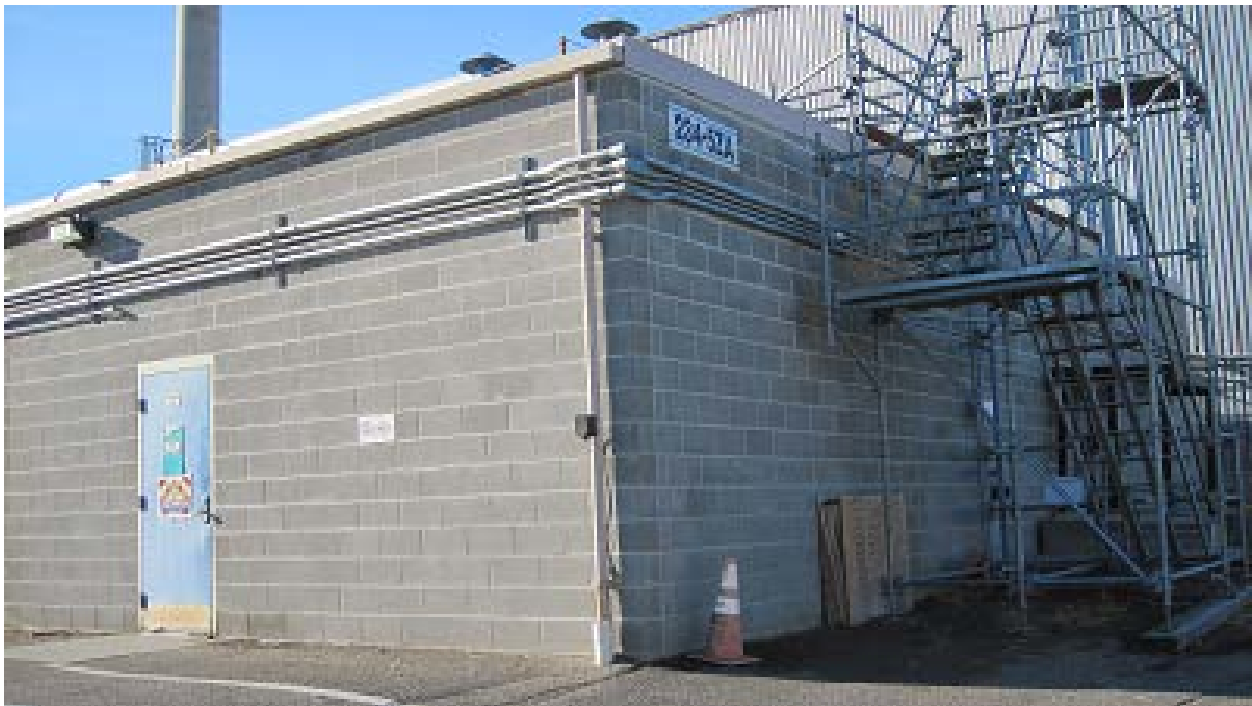
Figure 2. Northeast Corner of 234-5ZA Building Exterior (Cinderblock Construction)

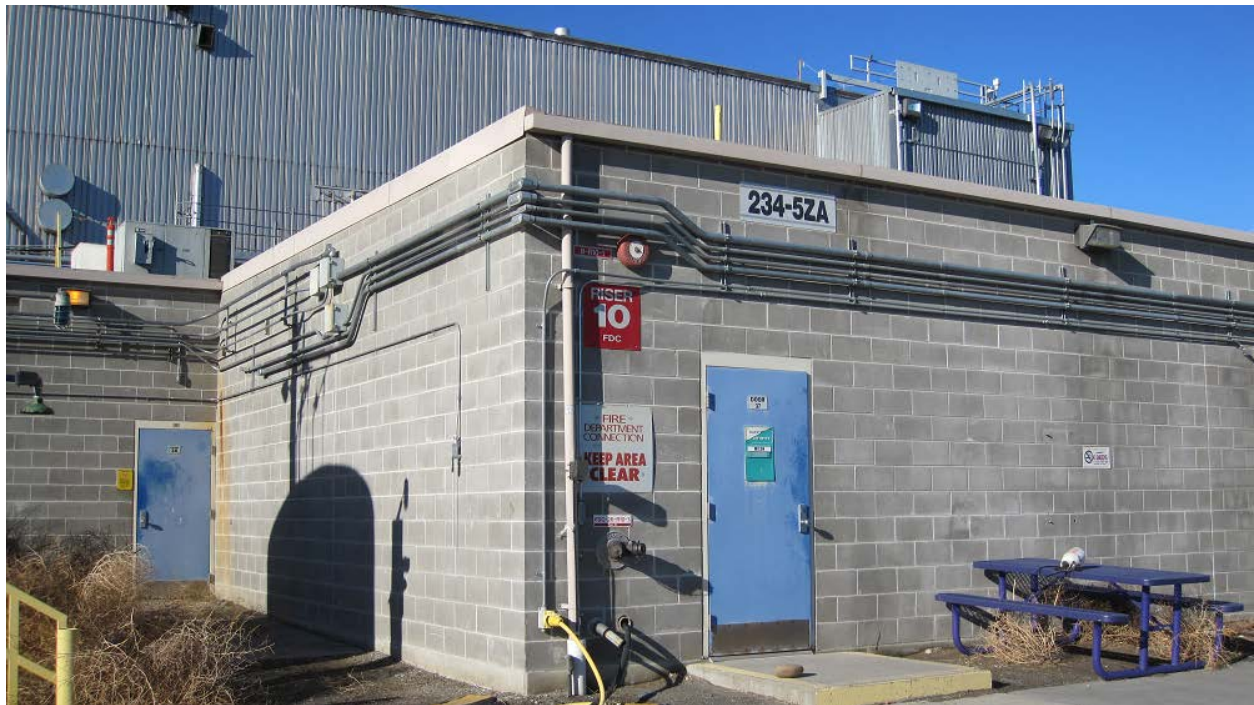
Figure 3. Southeast Corner of 234-5ZA (234-5Z in Foreground)

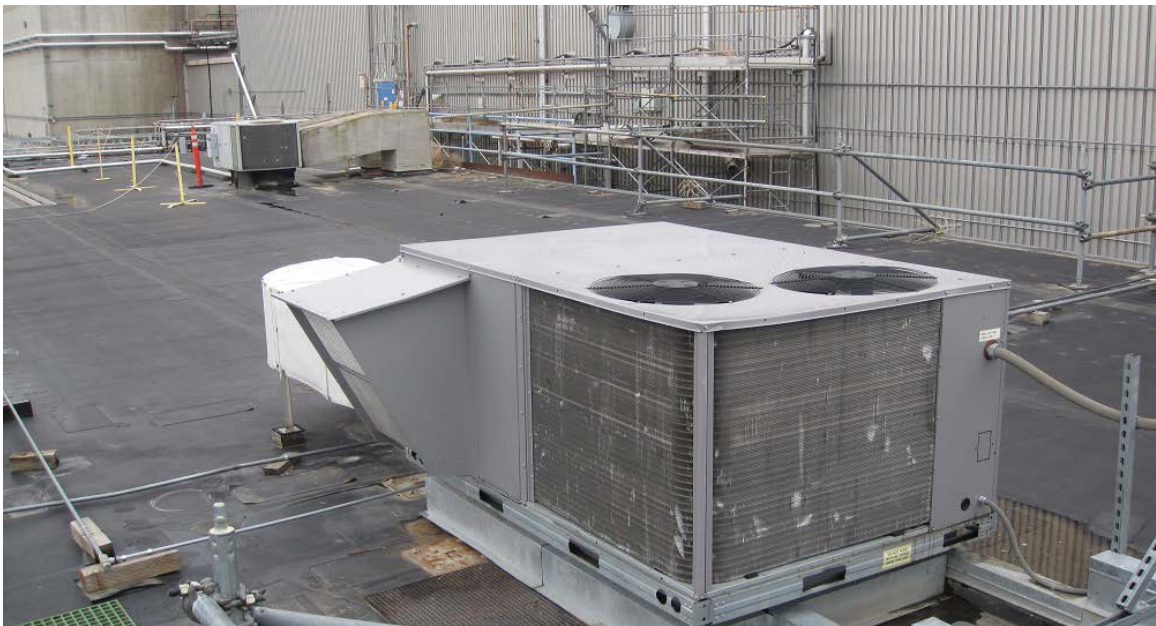
Figure 4. 234-5ZA Roof

EPDM membrane is a vulcanized/thermoset membrane that has been fully cured in the manufacturing process before shipment and delivery to the job site. With aging, EPDM membrane will not leech or emit hazardous chemicals. Its physical properties remain stable, which makes repairs much easier in the unlikely event of cuts or tears (Figure 4).

Based on the age of the roof, walkdown, records search, and as built drawings, the AHERA Building Inspector determined that no suspect ACM was present in the roof materials. Therefore, no samples were taken. The completed process knowledge characterization of the roof resulted in a determination of no asbestos detected (NAD).

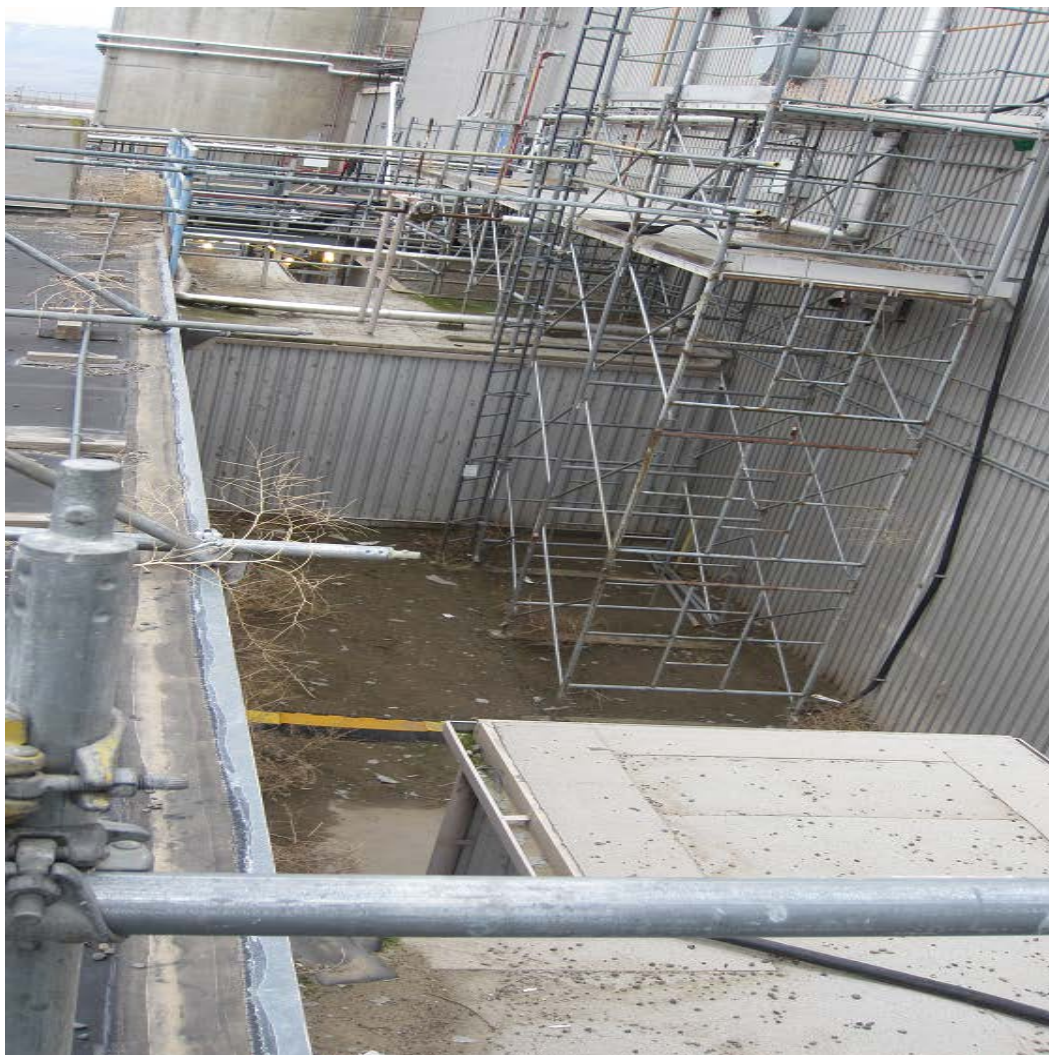
Figure 5. 234-5ZA Connection to 234-5Z (Taken from Roof along West Side)
