FACILITY STATUS CHANGE FORM (for DOE/RL-2010-34 Facilities)

Date Submitted: 4/12/2012 Originator: David Warren Phone: (509) 539-6040	Area: 100-N Facility ID: 1119-N (MO-403) Action Memorandum: General Hanford Site Decommissioning Activities	Control #: D4-100N-0029
--	---	-----------------------------------

This document provides information regarding the history, characterization, and final status at the completion of deactivation, decontamination, decommissioning, and demolition (D4) activities of the 1119-N Facility (MO-403 Mobile Office Trailer) at the 100-N area.

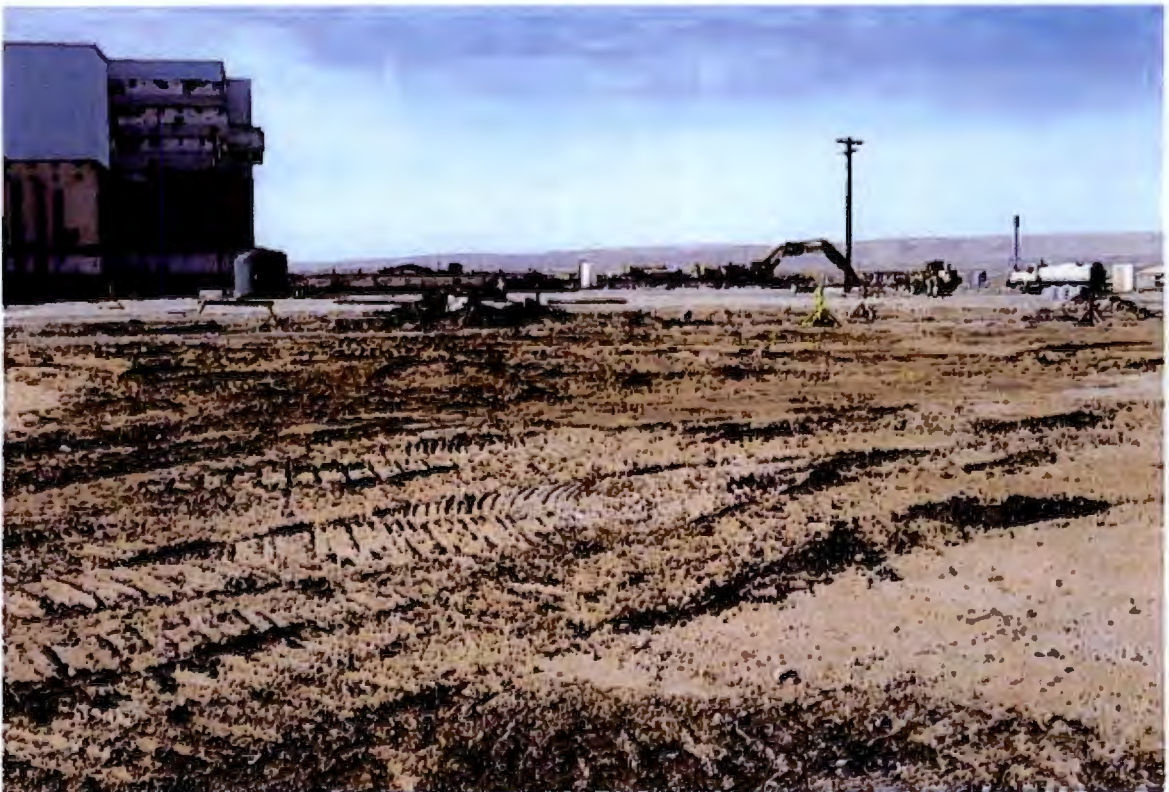
1119-N Facility site after Demolition

1119-N was demolished in place at the 100-N area and the waste generated was loaded out and disposed of at the ERDF. A minimal amount of soil was disturbed during the removal process. No backfill material was needed to re-grade the area. A Global Positioning Environmental Radiological Survey (GPERS) survey was performed at the site following D4 activities, see Attachment 3 for survey results. The previous building site is currently clear of Industrial Hygiene or Radiological postings.

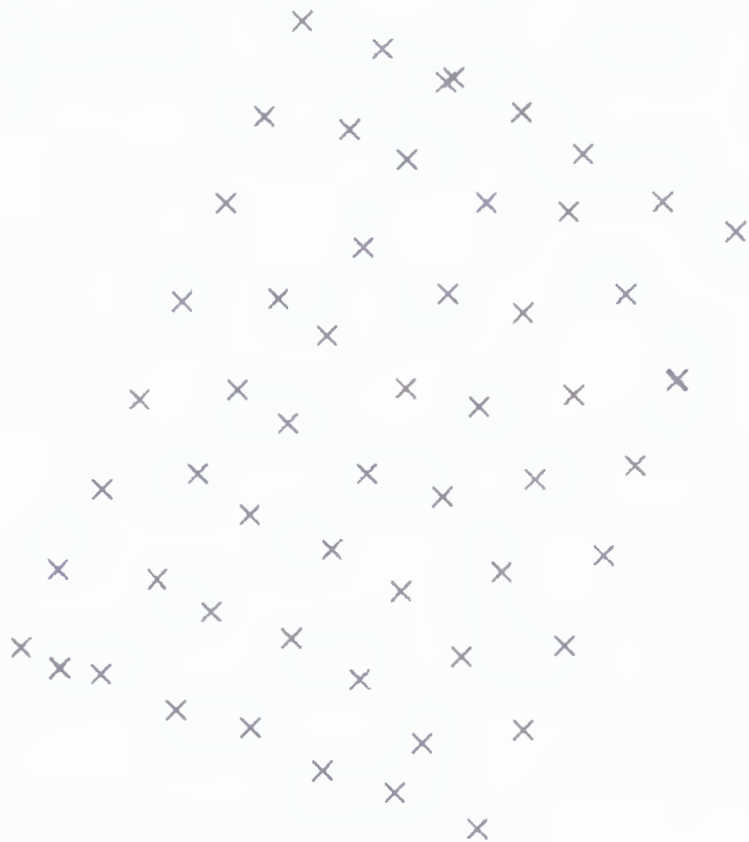
100N Field Remediation 1119-N GPERS Radiological Survey Beta Track Map

Coverage File: N074C
Number of Data Pnts: 58
Type of Survey: beta
Max GCPM: 775
Avg Bkg CPM: 410
Survey Date: 3/14/2012
Area Surveyed: 100 m²
Project File: ESRFRM120039B
Pdf File: ESRFRM120039BC

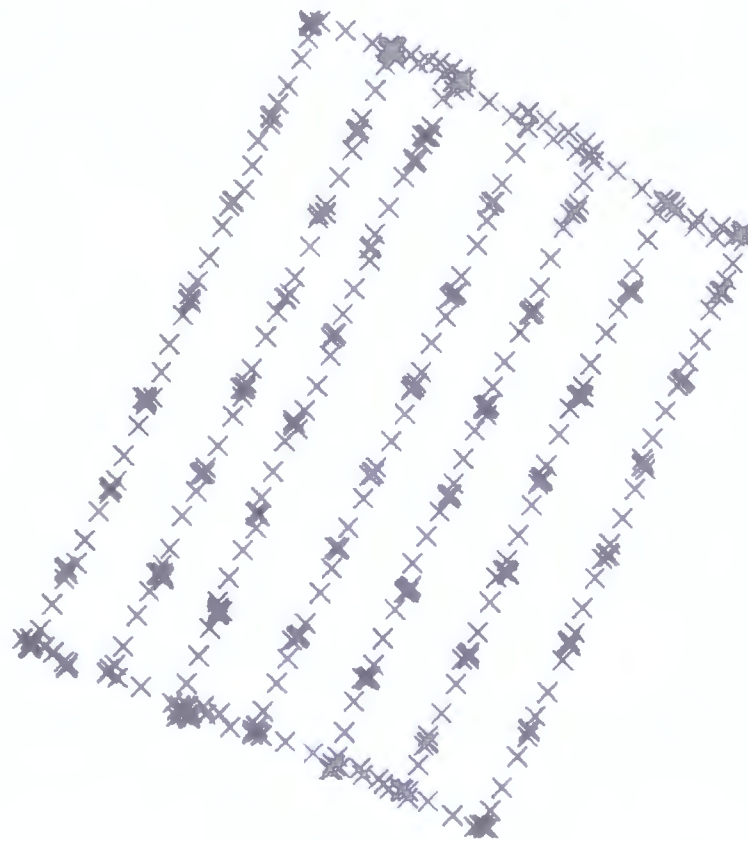
100N Field Remediation 1119-N GPERS Radiological Survey Gamma Track Map

Coverage File: N074C
Number of Data Pnts: 677
Type of Survey: gamma
Max GCPM: 2679
Avg Bkg CPM: 1332
Survey Date: 3/14/2012
Area Surveyed: 100 m²
Project File: ESRFRM120039G
Pdf File: ESRFRM120039GC
