DOE/RL-94-30
Rev. 0

Riverland Expedited Response Action Assessment

Date Published
June 1995

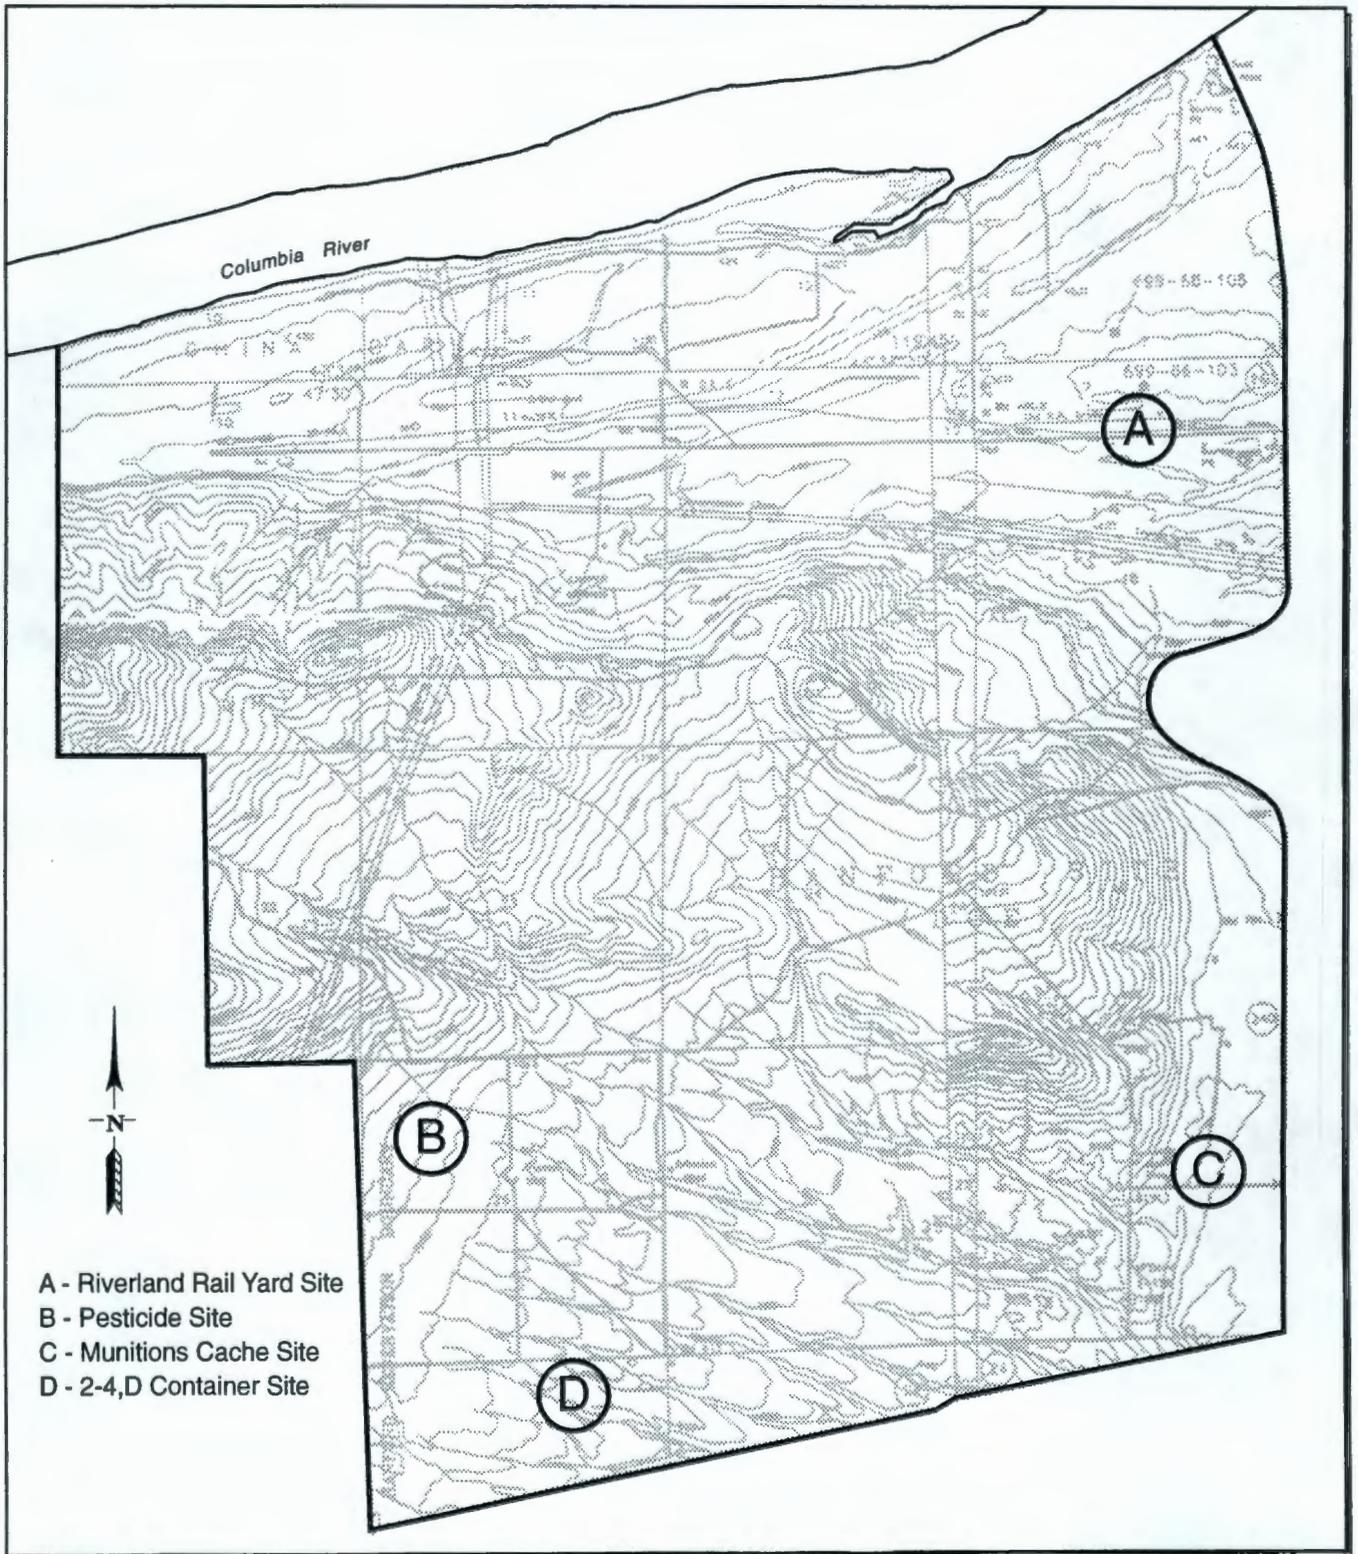
Figure 2. Waste Site Locations (USGS 1986).

An operable unit visual inspection found one homestead site containing a pile of empty pesticide containers (Figure 2, Location B). The condition of the containers suggest they were placed there after the Hanford Project was well underway. Characterization activities identified aldrin and dieldrin as contaminants of concern. Aldrin and dieldrin are carcinogenic and relatively immobile in soils. The chemicals were produced for about 10 years, from the early 1950s to early 1960s.

The munitions cache (Figure 2, Location C) received various military explosives in the 1970s. The explosives were remnants left from various military exercises in the area. The site consisted of a wooden box placed in a hole in the ground about 0.6 m by 0.9 m by 0.6 m (2 ft by 3 ft by 2 ft) deep. On May 22, 1986, the box with contents went to the Yakima Firing Range for destruction (DOE-RL 1992). The empty hole is all that remains at the site.

The 2-4,D Container Site (Figure 2, Location D) was discovered in July 1994 during an archaeological survey performed by Pacific Northwest Laboratories. Two 5-gal containers were found on the surface among some sage brush. In addition, nine 5-gallon containers, with just the pour spouts exposed, were found buried among the sage brush. Only one buried container contained liquid. Partial container markings indicate that the containers may have contained 2-4,D. The condition of the containers and surrounding vegetation indicate that the containers were buried after the Hanford Project was well underway.

The munitions cache hole was filled in on July 27, 1993.

The Pesticide Container Site cleanup activities started on July 6, 1993. On site immunoassay field screening was used to monitor cleanup activity success. Final excavated site dimensions were 2.1 m by 5.3 m (7 ft by 17.5 ft). The depth varied from 15.2 - 20.3 cm (6-8 in.) on the east end to 60 - 76.2 cm (24-30 in.) on the west end.

A total of 27 55-gal drums were filled with waste. Two drums contained 15 crushed pesticide containers. The remaining 25 drums contained aldrin and dieldrin contaminated soils. All drums were sent to the Hanford Central Landfill.

The site was backfilled on September 1, 1993 after offsite laboratory sample results confirmed that the soil contamination levels were below 2 parts per million (ppm) for dieldrin and aldrin.

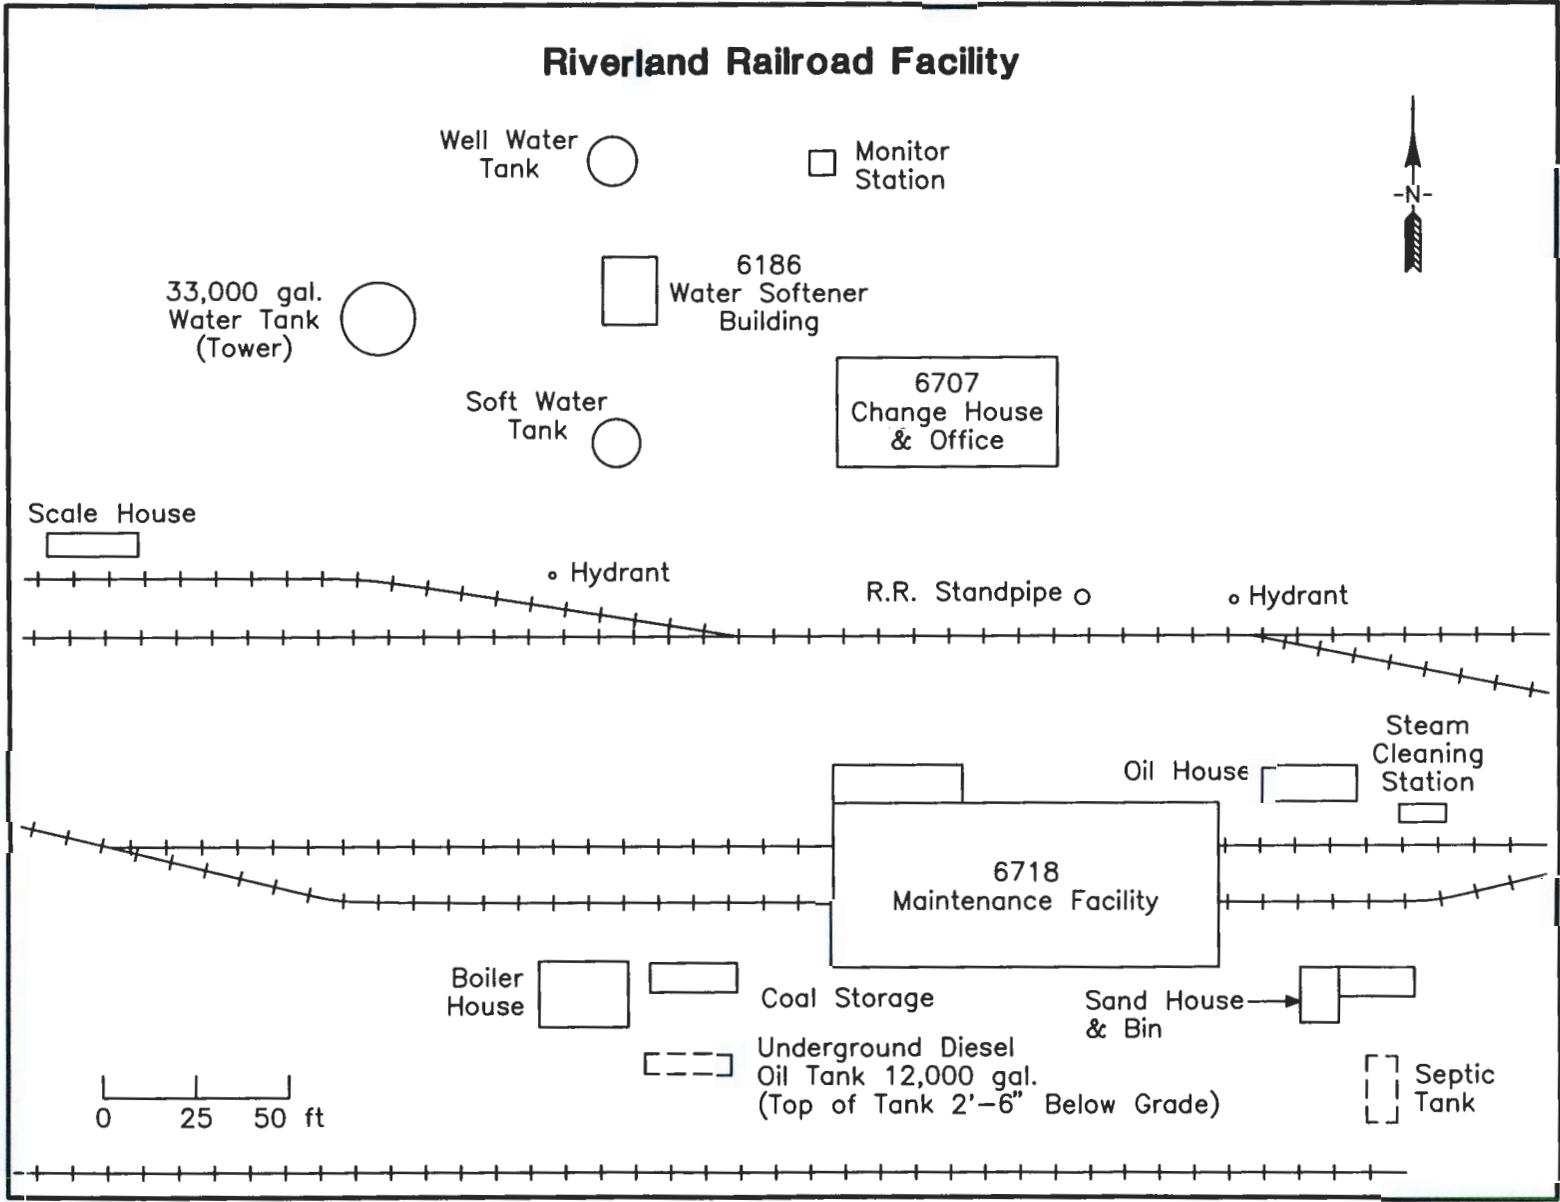
Figure 3. Riverland Rail Yard.

The Riverland Rail Yard Maintenance Facility (Building 6718, Figure 3) operated from 1943 until October 1954 when operations began in the 1100 Area 1171 Building railroad maintenance facility. Railcar decontamination continued in the two maintenance pits until 1956.

Radioactive decontamination was required before railroad maintenance personnel could work on the railcars and locomotives. Most decontamination activities concentrated on the wheels, axles, brake assemblies, bearing journal housings, and other rail vehicle undercarriage oil- or grease-coated parts. Diesel locomotives also had the engine compartment, radiators, and fan housings decontaminated.

The radioactive contamination levels were low and smearable. Contaminants common to the rail equipment are fission product particles (ruthenium, zirconium, niobium, iodine, etc.). These particles were dry, very light, and easily airborne. The contamination level was typically < 1 mr/hr with an occasional 200 mr/hr reading. Radiation monitoring personnel performed the decontamination to a nonsmearable level using acetone-soaked adsorbent pads. The bagged contaminated pads, gloves, and other materials were sent to the 200 West Area for burial.

The Riverland Railroad Maintenance Shop cleanup activities started on July 12, 1993 when the soil covering the shop concrete pad was removed. The entire cleanup action was monitored with immunoassay field screening kits that detected diesel (tph) concentrations at or above 200 ppm.

Abrasive blasting activities started on July 14, 1993. Blasting was stopped on July 16, 1993 because field screening results indicated that the concrete diesel contamination depth was greater than was consistent with economical abrasive blasting practice.

Additional concrete samples were collected with the use of a jack hammer. Onsite and offsite analysis confirmed that diesel contamination existed throughout the concrete. A hazardous identification analysis (Appendix B) determined the concrete contamination levels to be nonhazardous. Based on this designation, the decision was made to recycle the concrete.

Demolition of the concrete pad began on September 21, 1993. Thirty-four dump truck loads of concrete (10 yd³) were taken to the 100-B concrete stock pile. The concrete was recycled through a concrete crusher system.

Diesel contaminated soil removal started on September 27, 1993. The contaminated soil consisted of soils beneath the concrete pad, clay drain pipes and associated soils, and drainage ditch soils. A total of 43 dump truck loads of soil (10 yd³ each) were removed and hauled to a 100-C Area concrete pad for bioremediation.

All excavations were backfilled with existing onsite clean soils, and the pad site was leveled by October 19, 1993.

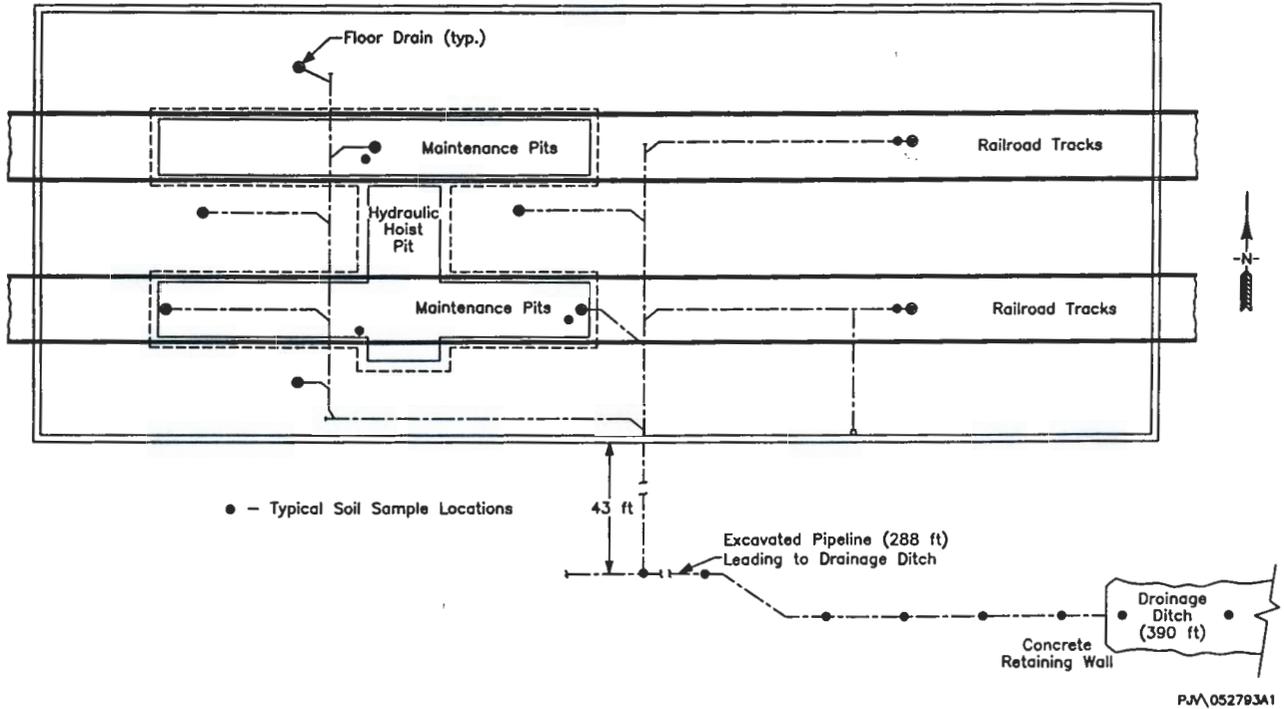
Figure 4. Riverland Rail Yard Maintenance Facility (Bldg. 6718) Floor Drain Plan.

Periodic maintenance floor pit cleaning consisted of brushing the walls with a broom and diesel fuel then rinsing with water. The rinse drained through the pit floor drains (Figure 4).

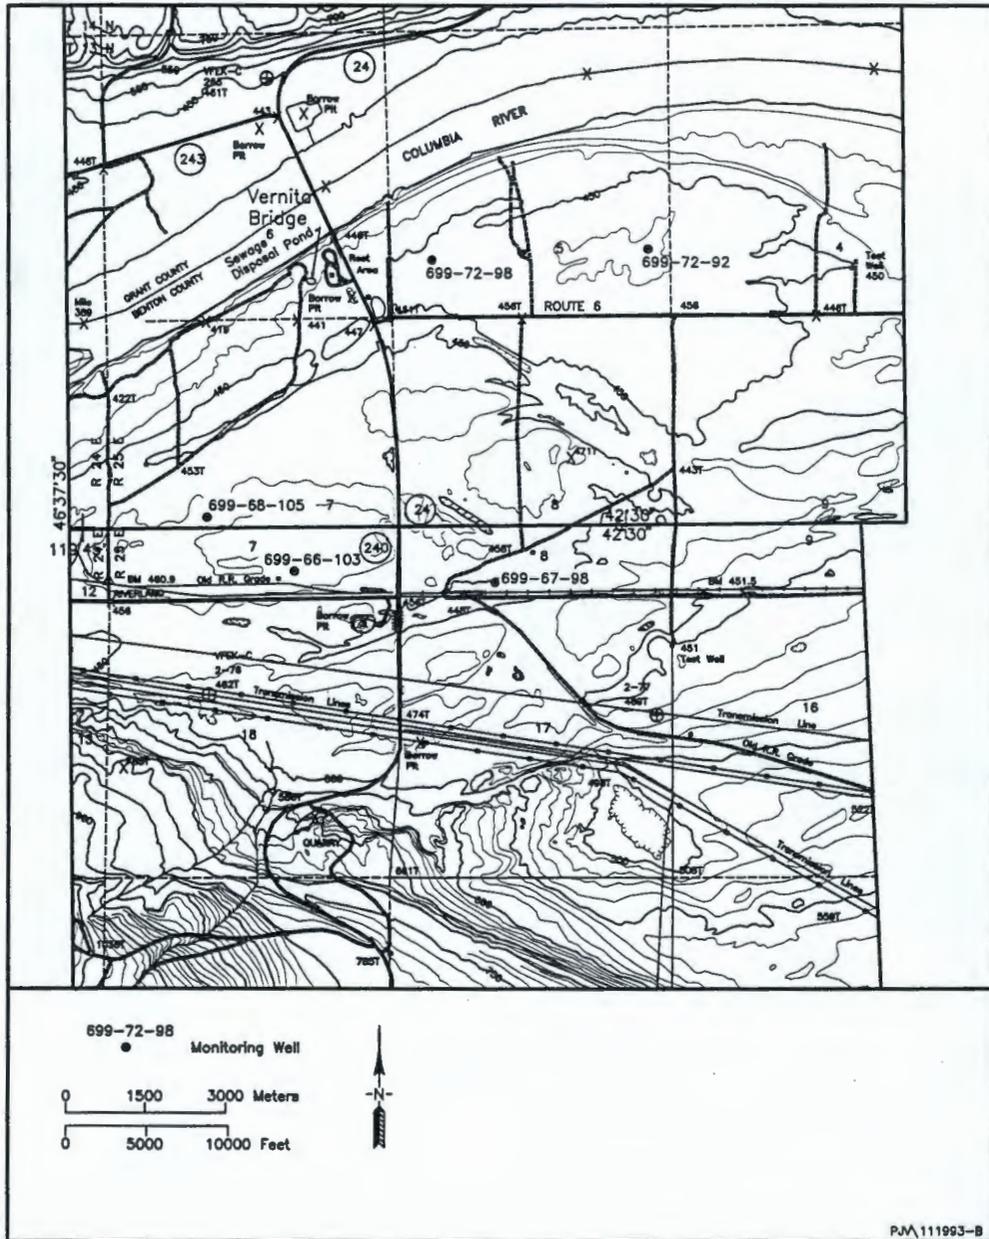
Figure 5. Groundwater Well Locations.

There is no known groundwater contamination associated with the 100-IU-1 Operable Unit. There are only two shallow depth groundwater monitoring wells (Figures 3 and 5) within the operable unit. The first, 699-66-103, is located down gradient of the Riverland Maintenance Shop site, and the second, 699-68-105, is located down gradient and to the northwest of

699-66-103. Sample analysis data from as far back as 1971 do not show groundwater contamination problems. Also, two additional groundwater monitoring wells, 699-67-98 and 699-72-92, (down gradient of the operable unit) do not indicate contamination.

The cleanup level for the Riverland Maintenance Shop diesel contaminated concrete and soil was 200 ppm (DOE-RL 1993). As shown in Table 2, diesel was not detected. Four existing groundwater monitoring wells were sampled for diesel fuel contamination. These groundwater samples did not show diesel contamination.
