Meeting Minutes
Interim Status Dangerous Waste Tank Systems
Hanford Federal Facility Agreement and Consent Order
Milestone M-32-00

PROJECT MANAGERS MEETING
January 23, 1997

Interim Status Dangerous Waste Tank System
Hanford Federal Facility Agreement and Consent Order
Milestone M-32-00 Project Managers Meeting minutes
January 23, 1997

Ultrasonic Nondestructive Examination of Double-Shell Tanks

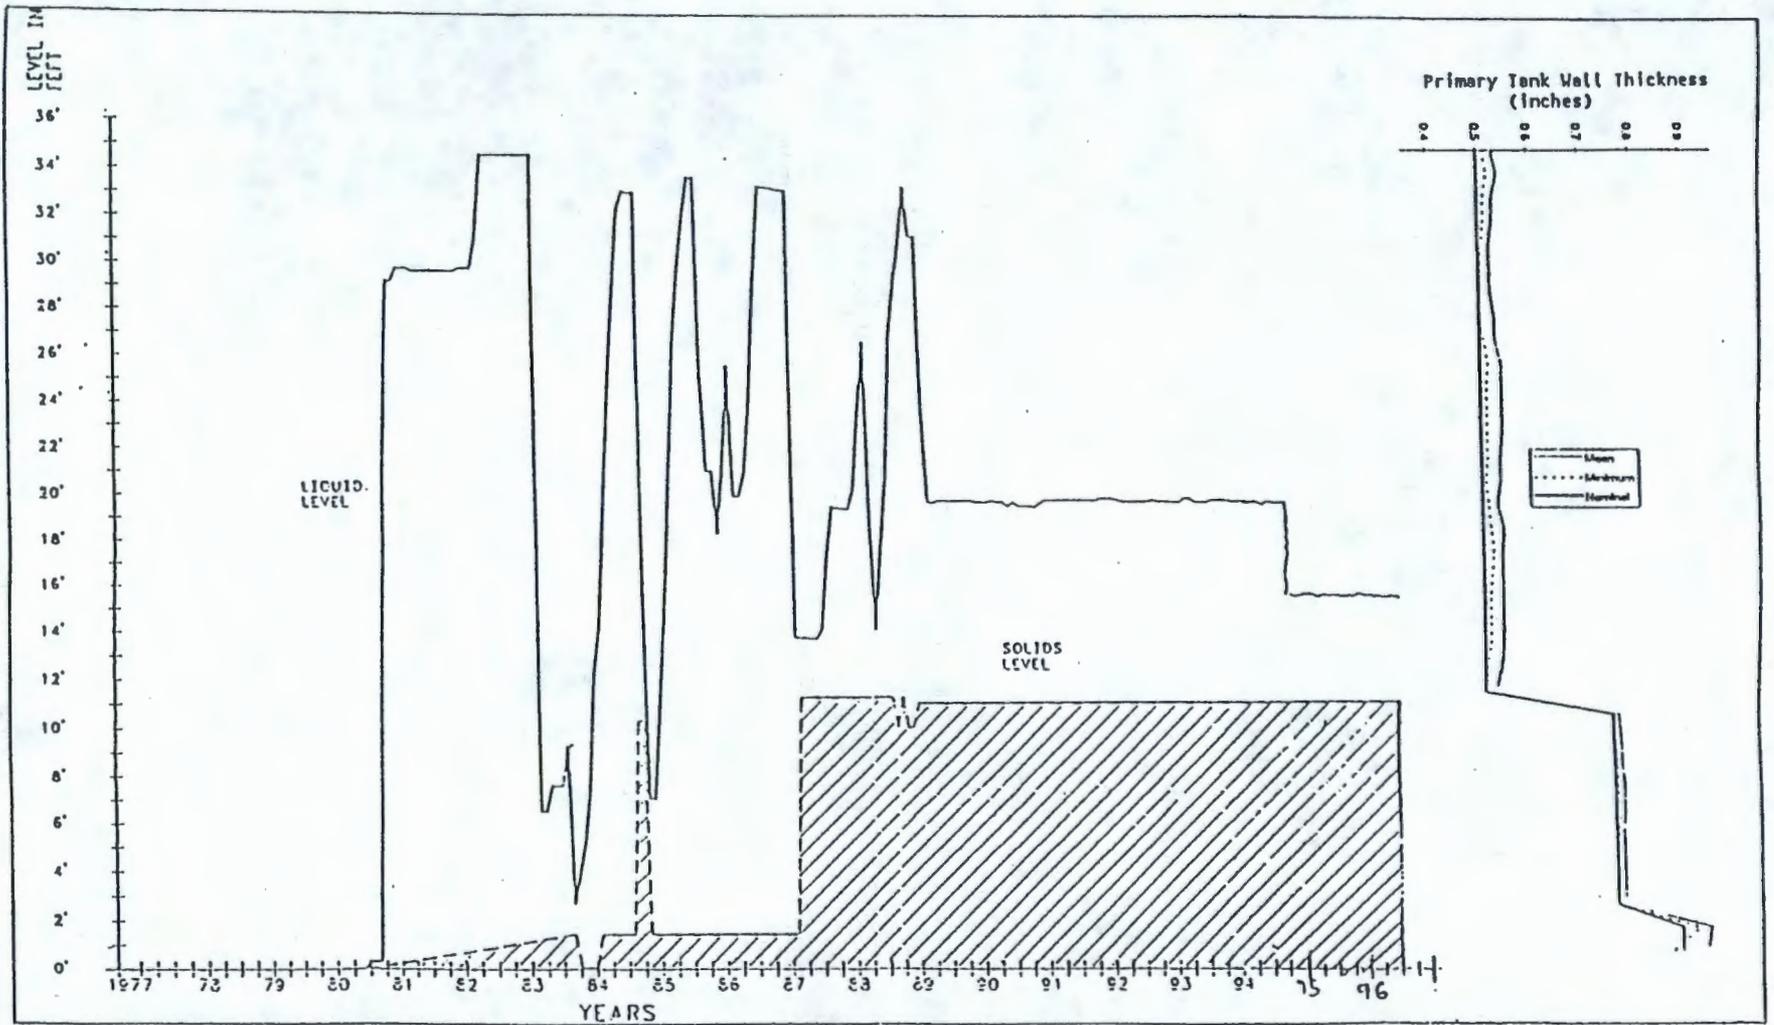
TANK AW-103 DATA REVIEW - Mr. Posakony showed a video of the AW tank UT test. Each 10" x 35' strip took 6-8 hours to complete once equipment was deployed. The primary wall was found to be within design tolerance. The secondary tank had more indications than the primary wall; there was no pitting, but inclusions were found. The secondary tank also had some stud indications due to construction activities (weld patch, scaffolding, rebar).

Comparison of As-Measured and ASTM-Specified Plate Thickness with Waste Level, DST 241-AW-103

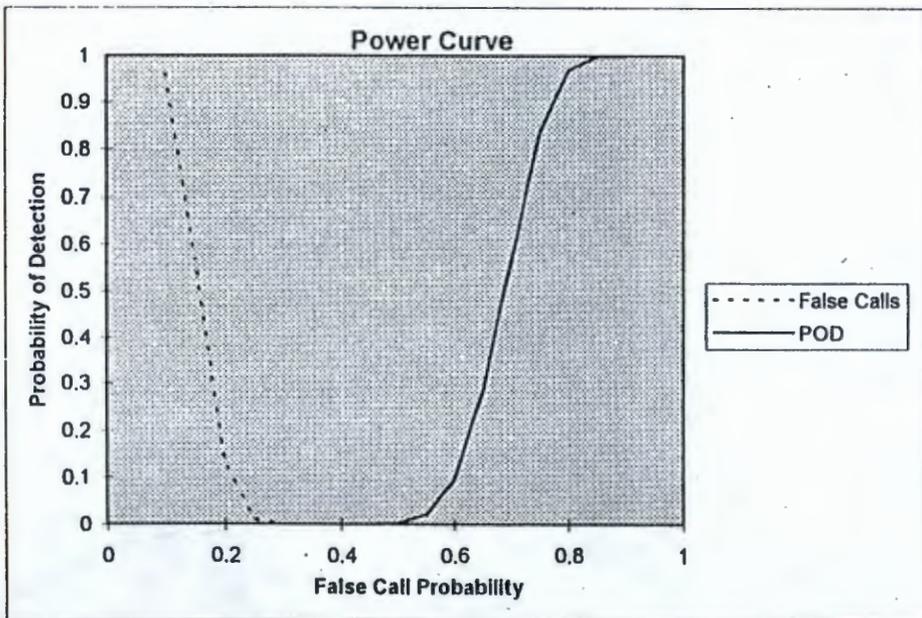
Figure No. 1 Example of ASME Power Curve, Calculation and Plot for a Test Involving 50 Defects (Flaw Grading Units) and 100 Blank Grading Units

If the inspection system had a 70% POD and a 20% FCP, the probability that the system could pass the test would be only 7% (0.569 X 0.128). If the system had a POD of 85% and a 10% FCP, the probability of passing the PDT would be 96% (0.998 X 0.96). This performance is typical of what is accepted in industry. The example illustrates the discrimination capability of the power curves used in developing the criteria for the PDT. Actual PDT results are given in Section 4.0.

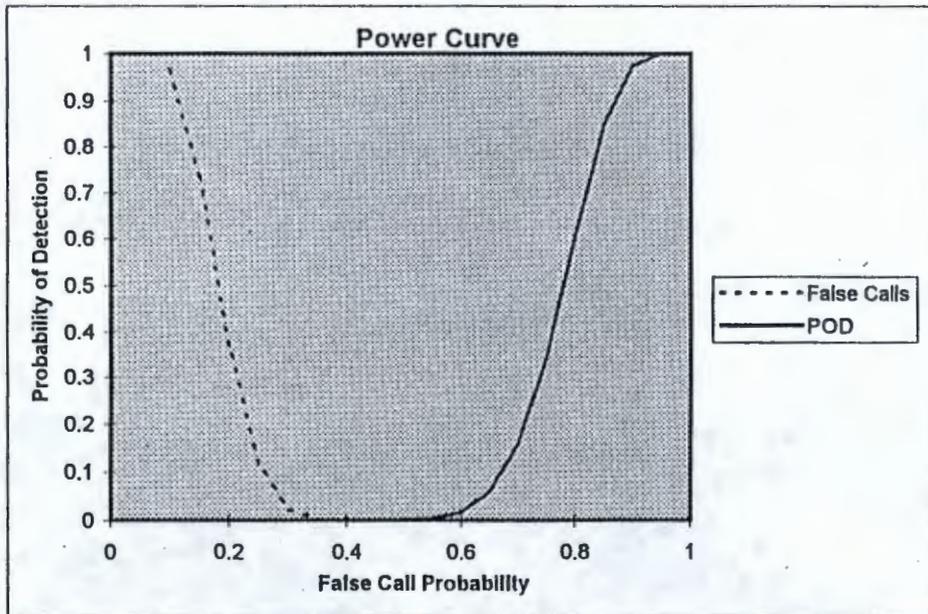
Figure No. 2 ASME Power Curve Developed for Performance Demonstration Tests

The system used by SAIC (P-Scan equipment, procedure and personnel) performed very well. The system POD was 90% with a 95.8% confidence bound. The error in pit/wastage sizing was 0.0028 RMS. The error in crack depth measurement was 0.0933 RMS. The crack depth measurement error, which is close to the limit defined in the specification, is the result of under sizing one of the six cracks in the test plates.

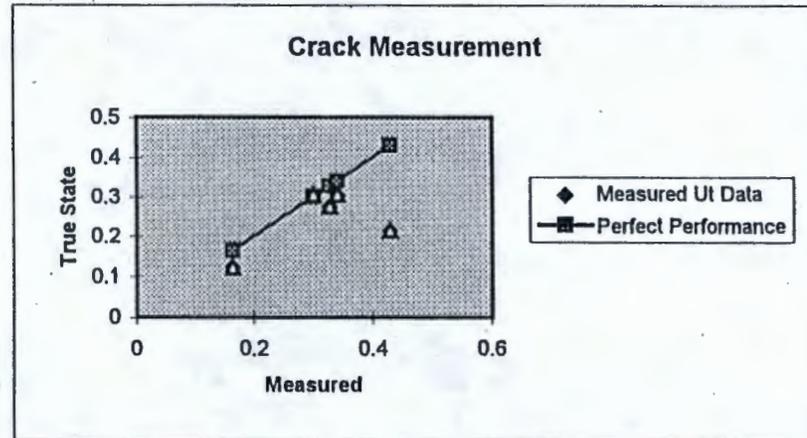
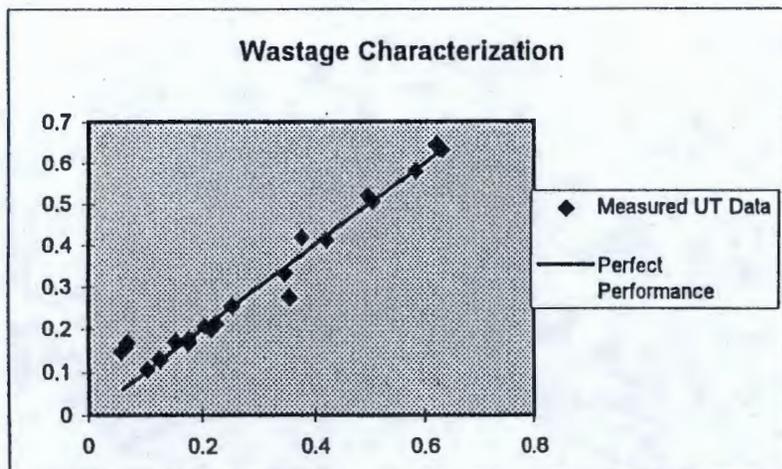
Figure No. 3 Comparison Between PNNL and SAIC Measurements and Graphs of Pit/Wastage and Crack Measurements

The individual data sheets provided by SAIC show that the system has a capability of measuring wastage within +/- 0.015 inches provided the remaining wall is more than 0.1 inches. The system did not accurately size simulated wastage in the test plate where the remaining wall was only 0.06 inches. Pits larger than 0.25-inch diameter and deeper than 0.1 inches were sized within +/- 0.04 inches which exceeded the specification of +/- 0.05 inches. Some smaller pits were detected, but 0.25-inch diameter was considered a minimum requirement. The system detected all cracks deeper than 20% of wall thickness and sized all but one quite accurately. This particular crack was undersized in depth but length was plotted accurately.
