Asbestos NESHAP Thorough Inspection Report at 291Z

Document Number: CWR-PFP-00027

The purpose of this report is to disclose the results of an asbestos thorough inspection of 291Z structure and associated 291Z001 stack located in the Plutonium Finishing Plant Complex. Note: Revision 0 was never issued.

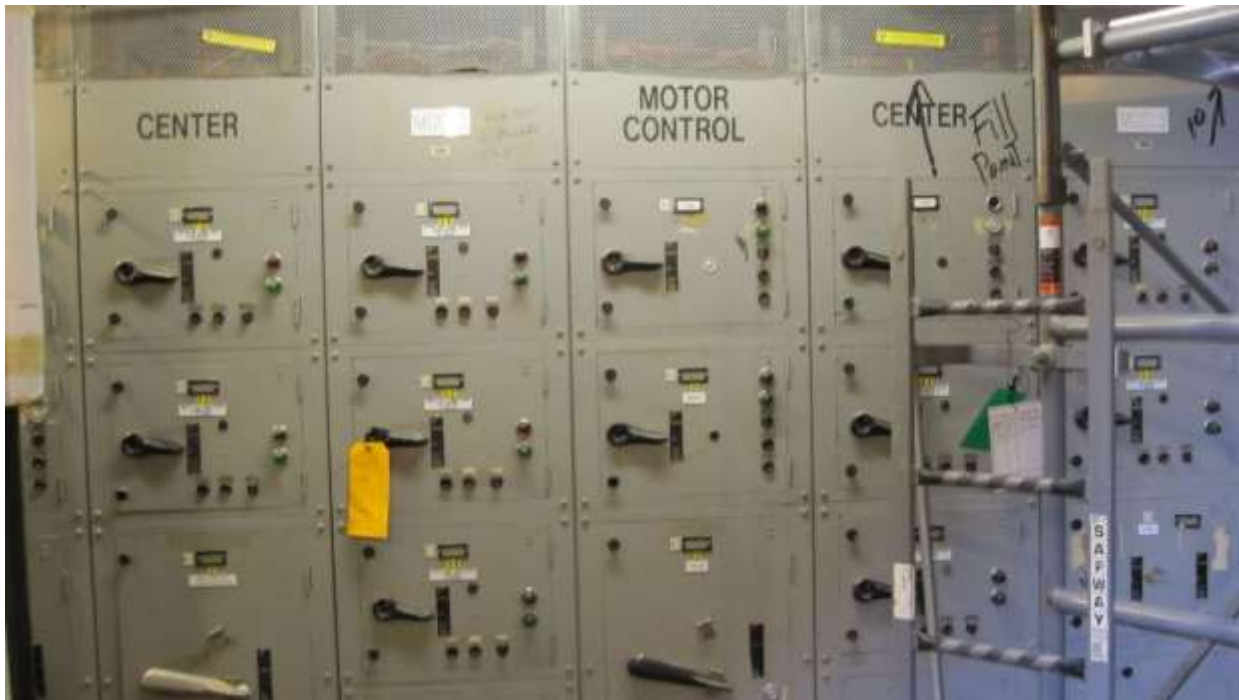
Figure 6. Room 501, Electrical Switchgear (21 Buckets)

- Gaskets/packings (Cat I) present throughout the building and in good condition.
- Doors 693, 694, and 695.
- The electrical switchgear in Room 501 was energized at the time of the inspection. As a result, the AHERA Inspector assumed the “21 electrical buckets” that made up the switchgear contained asbestos wiring and insulators (Figure 6). These buckets will be removed prior to demolition.

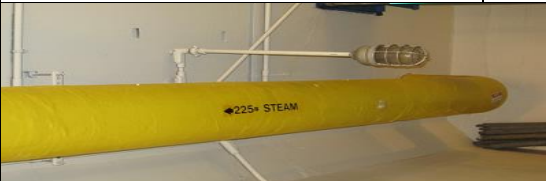
Figure 5: Aluminum clad TSI piping. Large straight runs (vertical/horizontal). Visual verification required to ensure that the horizontal and vertical runs are identical.

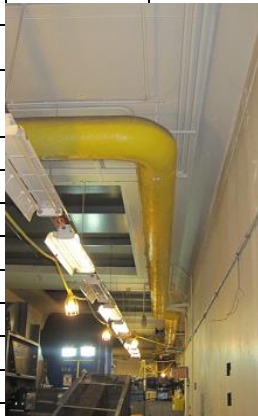
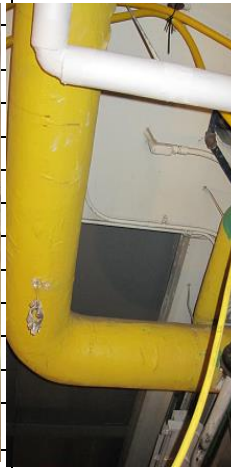
Straight run	TSI	Abated		
Elbows/ joints	TSI			
Figure 8: Small and large steam lines, valves, piping, etc.

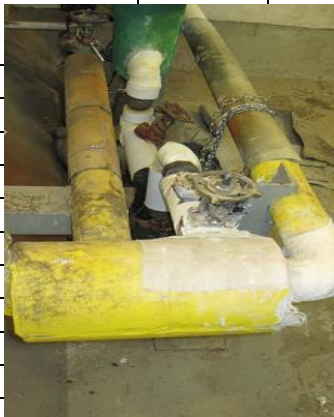
Green piping	Fiberglass	Abated		
Small pipe (A)	TSI			
Small pipe (B)	TSI			
Elbow	TSI			
Large valve body	TSI			
Figure 12: Miscellaneous piping (4). TSI suspect line on floor of 291Z. Assumption, large steam line already characterized. Sample small line, only.

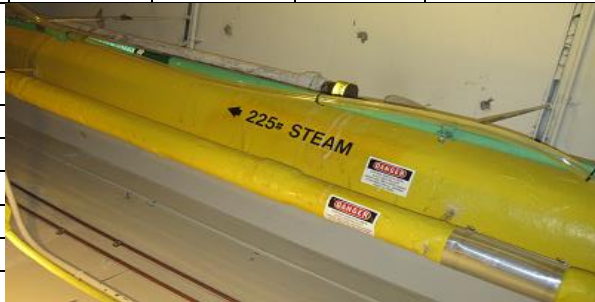
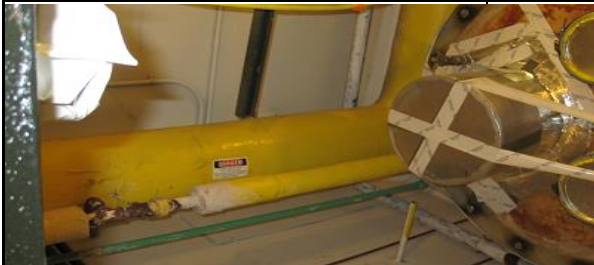
Figure 12: Miscellaneous piping (5)				
Small piping; horizontal run	TSI	Abated		
Small piping joints/elbows	TSI

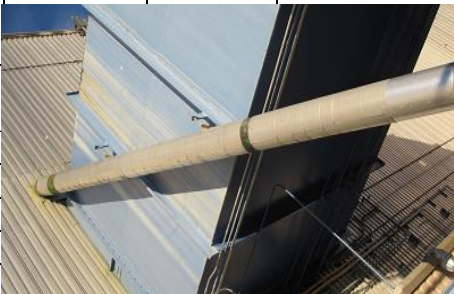
Straight runs	TSI	Abatement required	
Joints	TSI		
40 linear ft.			
Figure 16: NW corner exterior of 291Z. Note change in pipe size. Interview with insulators indicates that the smaller side is fiberglass and the large asbestos TSI. Conduct visual inspection.

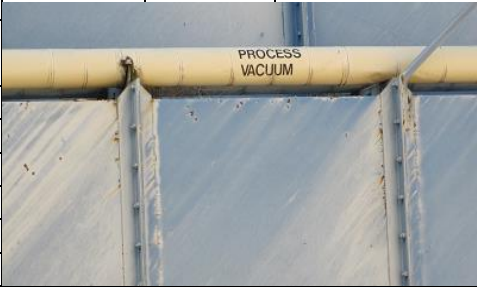
Straight runs	TSI	Abatement required			
Elbows/joints	TSI				
40 linear ft.					
Figure 18; Small pipe under main duct. Main steam line going from 291Z to 234-5Z.

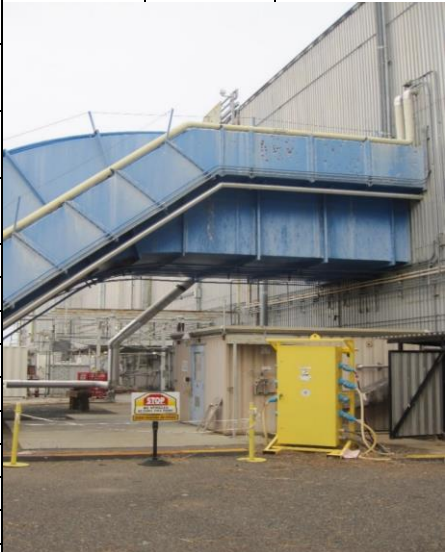
Main steam line; straight runs	TSI	Abatement required			
Ebows/ joints	TSI				
Small line straight runs (40 linear ft)	TSI	Abatement required			
Elbows/joints	TSI				
Medium lines; straight run (two pipe 80 linear ft)	TSI	Abatement required			
Elbows/joints	TSI				
Steam line running over the top of the black rhino liner duct. 70 linear ft	TSI	Abatement required
