Re: Department of Ecology (Ecology) Assessment Report for Field Monitoring Activities of the Waste Material near Riser 83 of the 241-AY-102 Double Shell Tank (DST)

ASSESSMENT REPORT

Field Monitoring Activities

Project: 241-AY-102 Field Monitoring, Riser 83 Video
 Project Contact: Jeremy Johnson (ORP) Phone: (509) 376-1866
 Review Date: 3/14/2013
 Reviewer: Michelle Hendrickson, CHMM, PE
 USDOE Project: US Department of Energy-Office of River Protection (USDOE-ORP)
 USDOE Contact: Tom Fletcher/Jeremy Johnson
 Prime Contractor: Washington River Protection Solutions (WRPS)
 Project Manager: Michael Hardesty Phone: (509) 373-4573
 Location: 241-AY-102, 200 East Area, Hanford
 Scheduled Start Date: 3/14/2013 Actual Start Date: 3/14/2013 Completion Date: 3/14/2013
 Contract Amount: Approximately \$75,000 for 4 Riser Visual Inspections
 Sub-Contractor: N/A
 Location: 200 East Area, Hanford Nuclear Reservation, Richland, WA

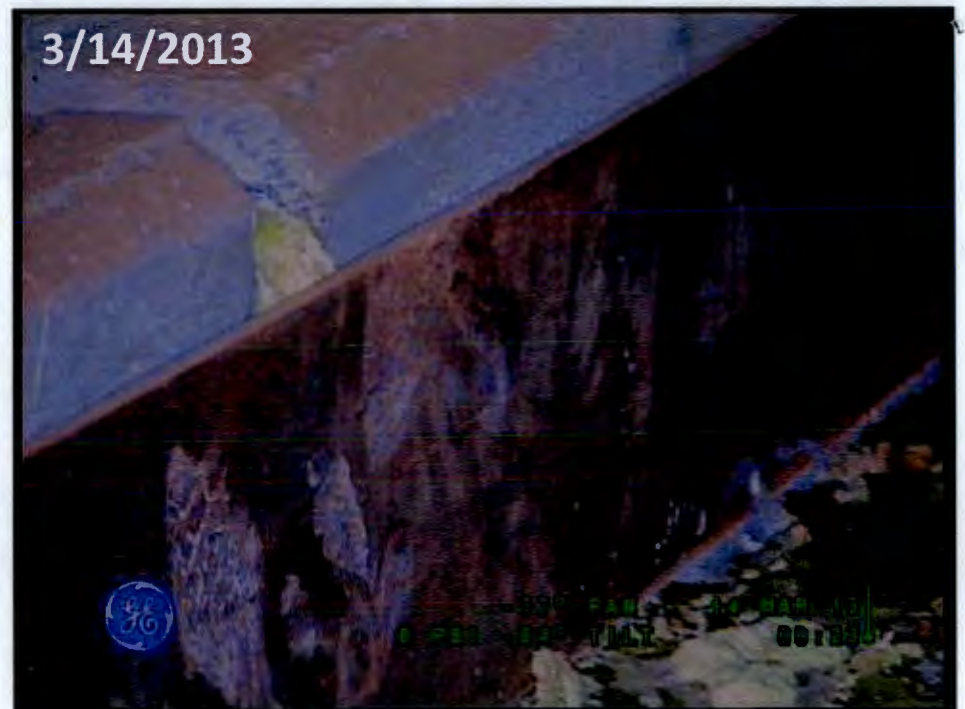
3/14/2013

- The camera viewed the waste in respect to the different in-annular space "landmarks" including the black dot or rock, two white pebbles, orange pieces of insulation/foam, and ventilation slots. It was noted by all witnessing the video that the area of the waste material did appear to have increased in size, near the upper portion of the leak. Ecology approximated that the increase was approximately 25% since late December 2012.

- Vertical and horizontal increase of the size of the leak was discovered where the waste material extends outward in "finger channels" and near the smaller piece of orange insulation/foam. The edges of the waste in this location appeared to be very wet. Further past the waste were salt streaks. It appeared that the horizontal extent was now past the center of the annulus for the salt streaks.

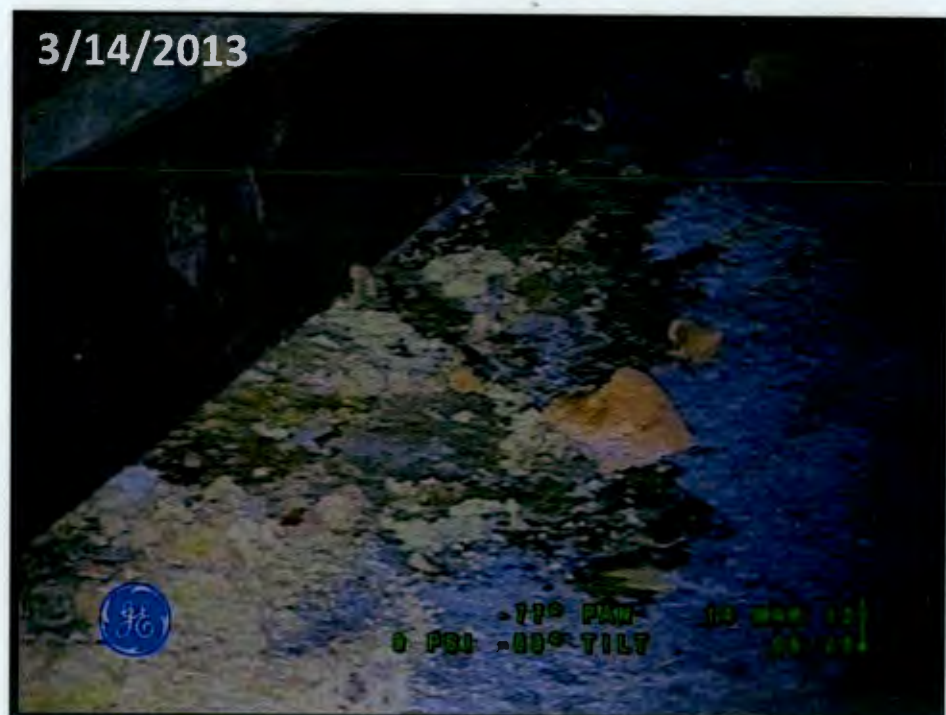
3/14/2013

- Ecology did not note a change in the size or condition of the waste material in the ventilation slot during this visual inspection. The top of the material appeared to have dried where it contacted the concrete. However, moisture streaks on either side of the waste material within the ventilation slot were again visible.
