WCH-551
Rev. 0

100 Area/400 Area D4 Project Building Completion Report

**January 1, 2012, to
December 31, 2012**

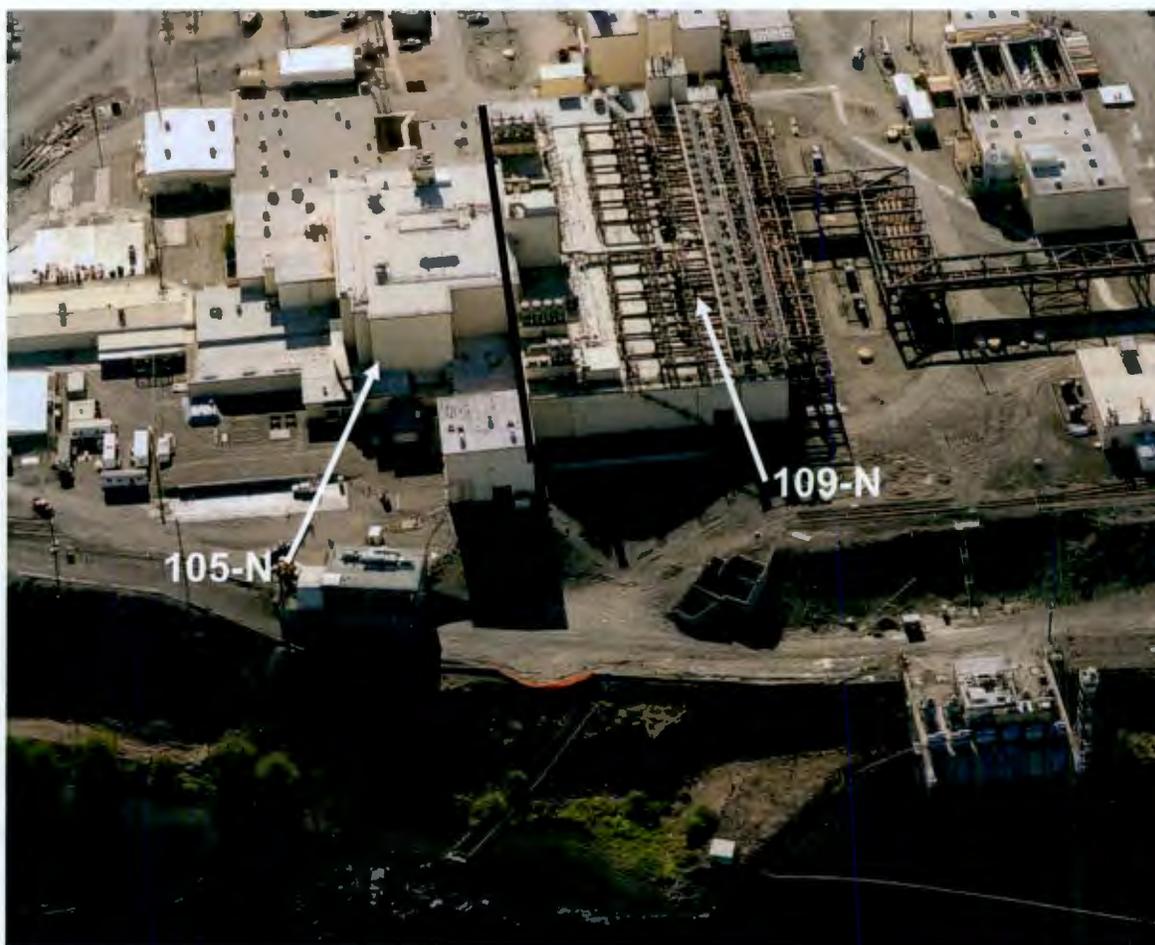
Figure 1. 105-N Reactor Building.

Numerous GPERS gamma/beta surveys and radiological down-posting surveys were conducted at the 105-N Building and some areas were found to be radiologically contaminated. Final radiological cleanup will be performed by Field Remediation (FR). A post-demolition GPS survey was performed on December 14, 2012, March 30, 2010, October 28, 2010, and July 14, 2010. Additional information is presented in CCN 165386, "Post-Demolition Summary Report for 105-N Reactor Building".

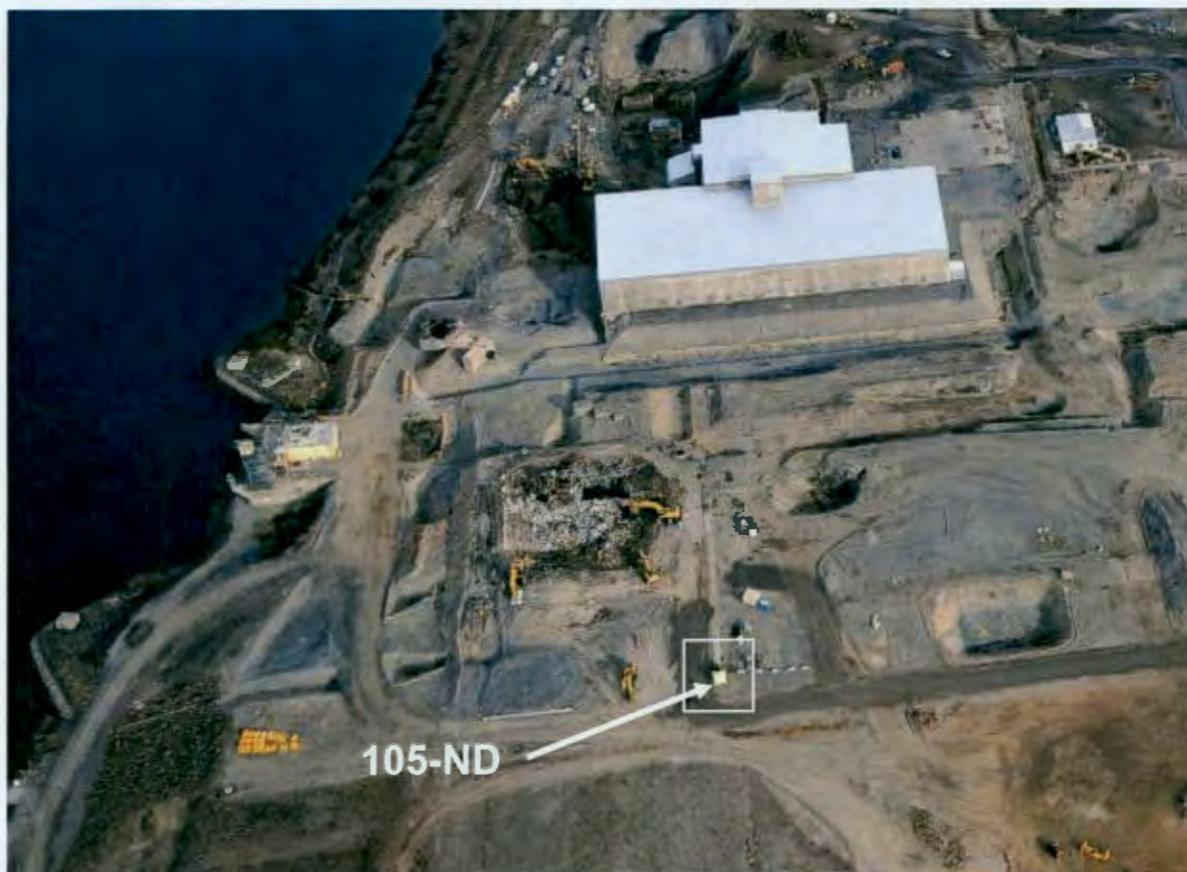
Figure 2. 105-ND Remote Air Intake.

Final D4 documentation includes a Global Positioning Environmental Radiological Surveyor (GPERS) survey, post-demolition global positioning system (GPS) survey, and sample data, all of which are included in CCN 165383, "Post-Demolition Summary Report for 105-ND Remote Air Intake."

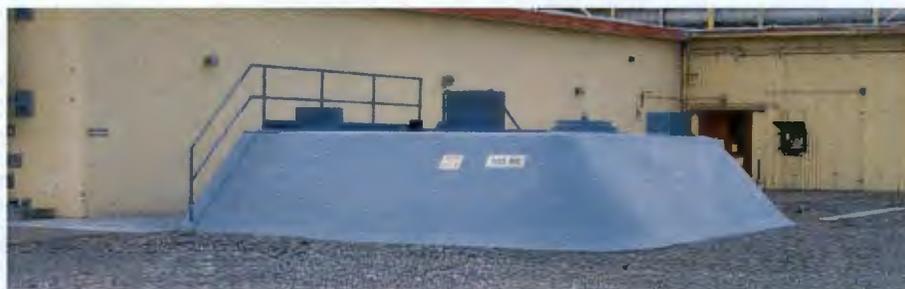
Figure 3. 105-NE Fission Products Trap.

A GPERS beta/gamma survey was conducted at 105-NE and was found to be still radiologically contaminated. All additional information including post-GPS survey is presented in CCN 165392, "Post Demolition Summary Report for the 1303-N Spacer Silos."

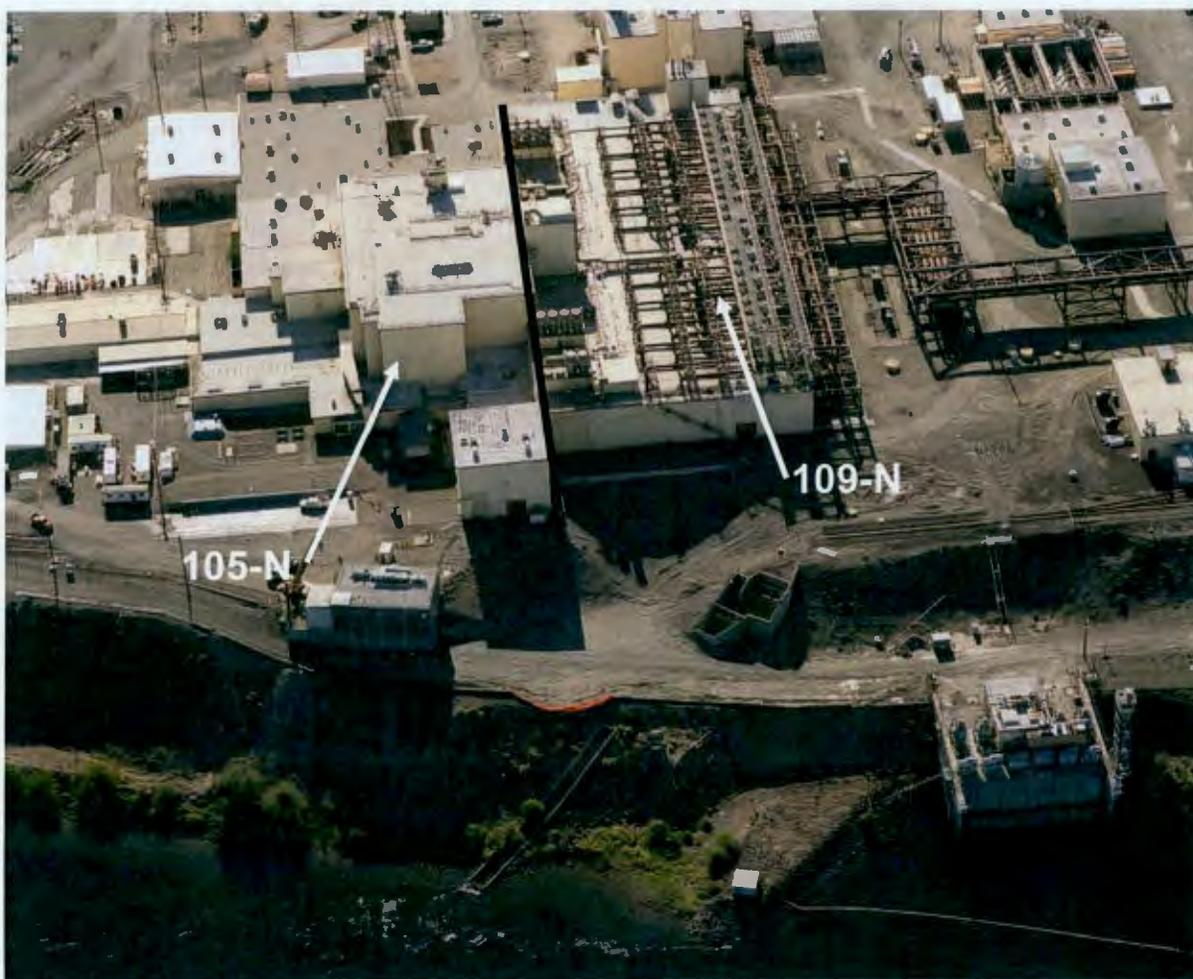
Figure 5. 109-N Heat Exchanger Building.

A GPERs gamma/beta survey and radiological down-posting survey was conducted at the 109-N Building and was found to be not radiologically contaminated. A post-demolition GPS survey was performed on September 10, 2009. Additional information is presented in CCN 165387, "Post-Demolition Summary Report for 109-N Turbine Building".

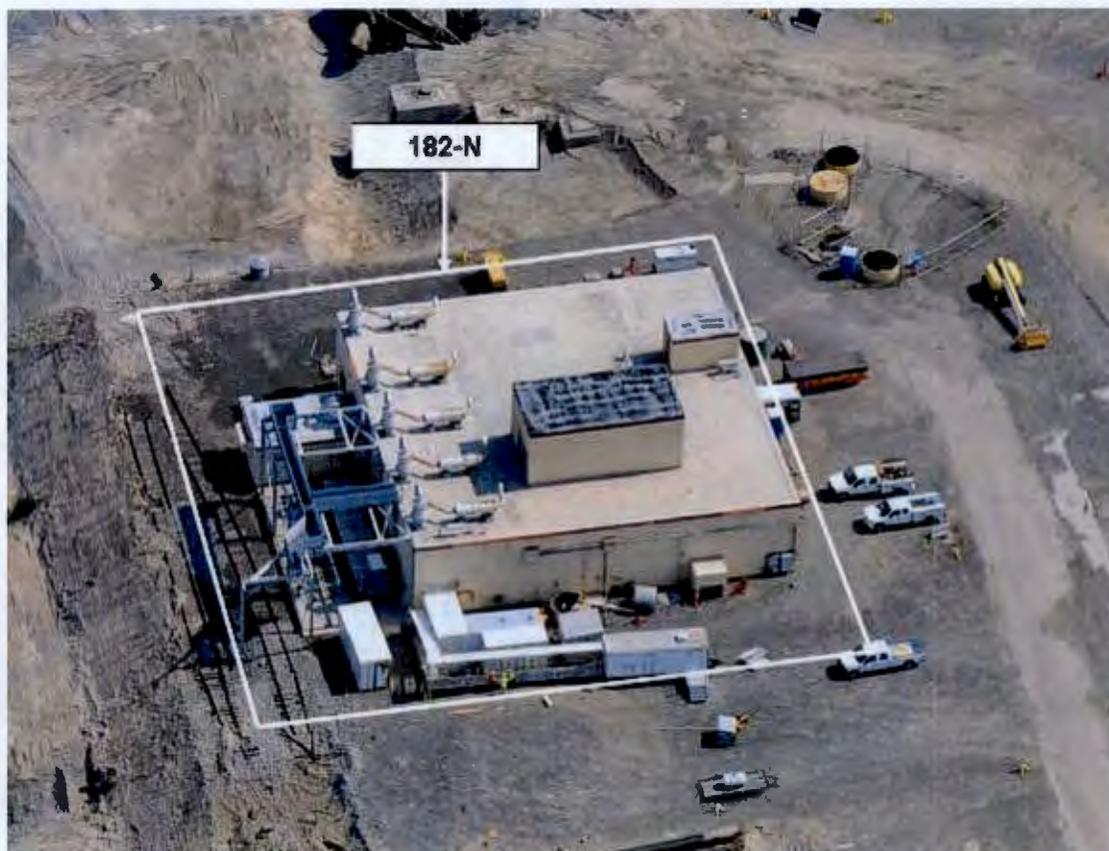
Figure 10. 182-N High-Lift Pump House.

A GPERS gamma survey and radiological down-posting survey was conducted at the 182-N Building and was found to be not radiologically contaminated. A post-demolition GPS survey was performed on June 19, 2012. Additional information is presented in CCN 165388, "Post-Demolition Summary Report for 182-N High-Lift Pump House."

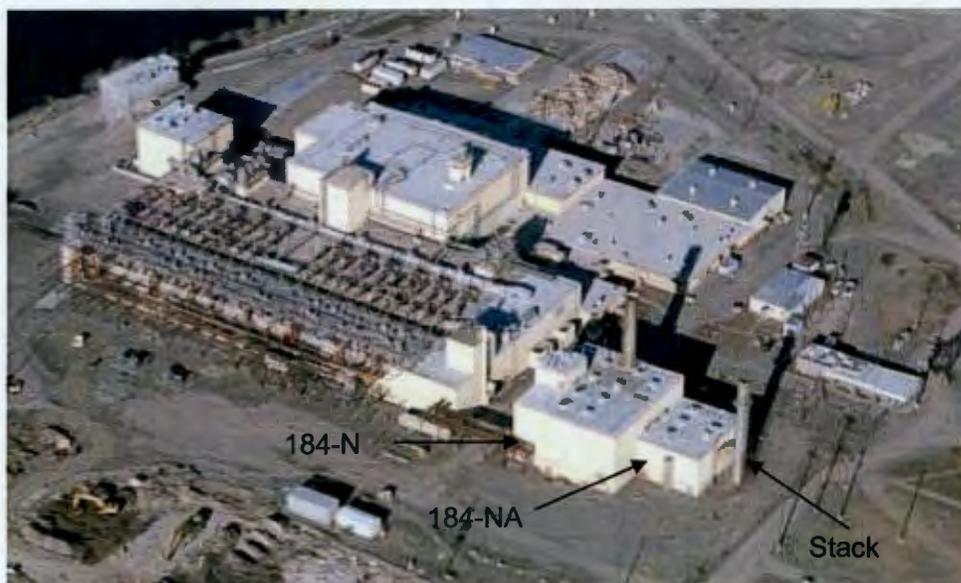
Figure 11. 184-NA Power House Annex Building.

A GPERS gamma/beta survey and radiological down-posting survey was conducted at the 184-NA Building and was found to be not radiologically contaminated. A post-demolition GPS survey was performed on May 1, 2012. Additional information is presented in CCN 167661, "Post-Demolition Summary Report for 184-NA Auxiliary Power Annex Stack."

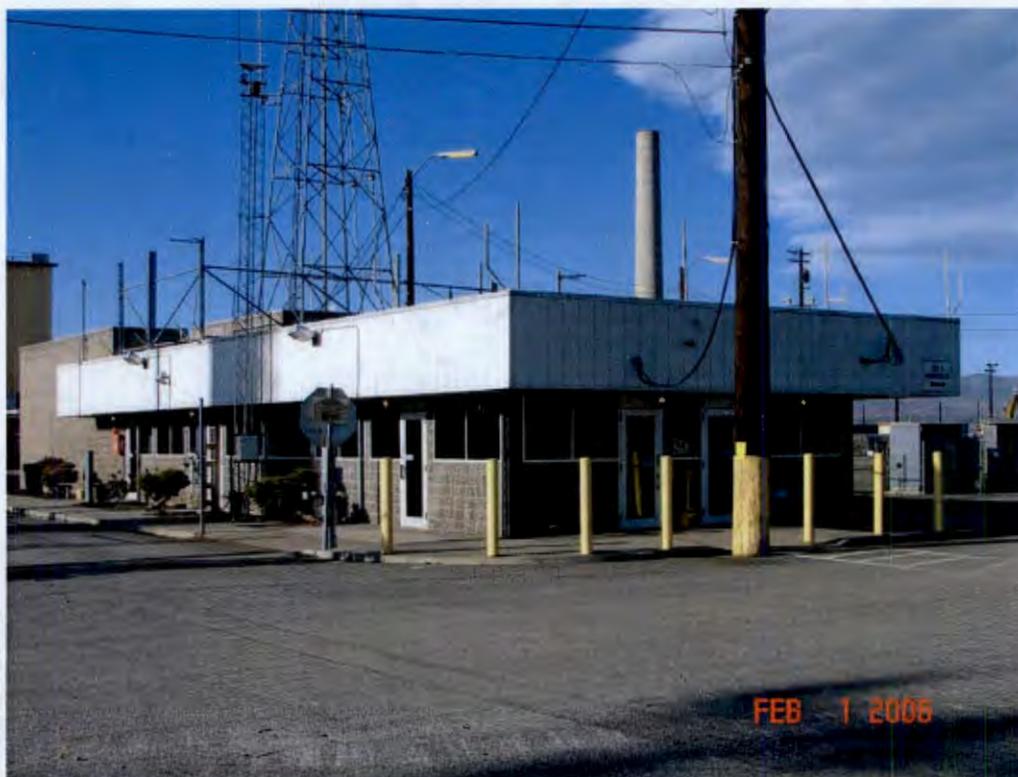
Figure 12. 1112-N Guard Station.

A GPERs gamma/beta survey and radiological down-posting survey was conducted at the 1112-N Building and was found to be not radiologically contaminated. A post-demolition GPS survey was performed on February 27, 2012. Additional information is presented in CCN 165376, "Post-Demolition Summary Report for 1112-N Document Control Building."

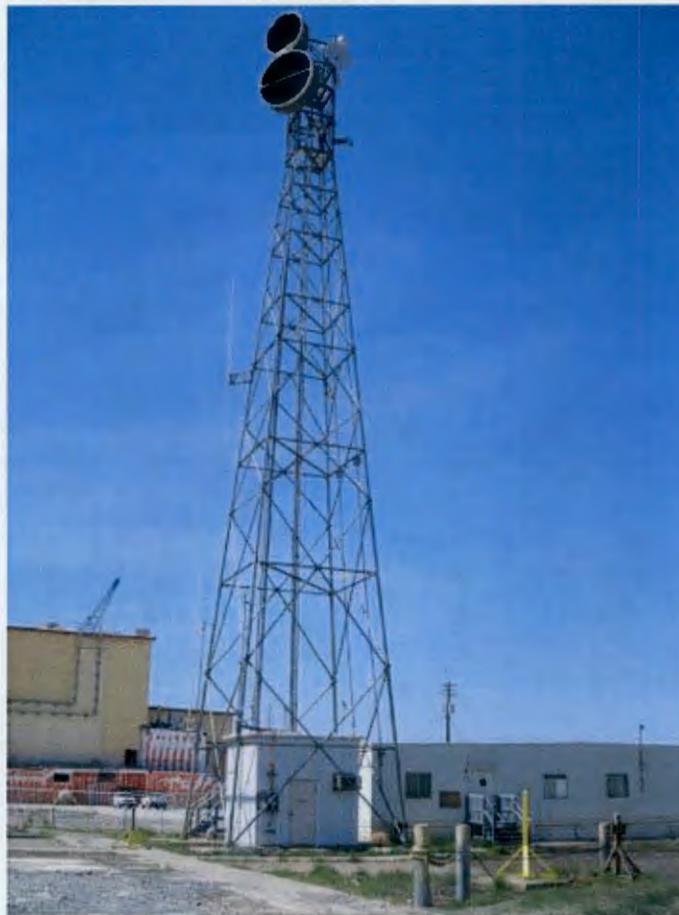
Figure 13. 1112-NA Microwave Tower Annex.

A GPERS gamma/beta survey and radiological down-posting survey was conducted at the 1112-NA Tower and was found to be not radiologically contaminated. A post-demolition GPS survey was performed on February 27, 2012. Additional information is presented in CCN 165377, "Post-Demolition Summary Report for 1112-NA Microwave Tower."

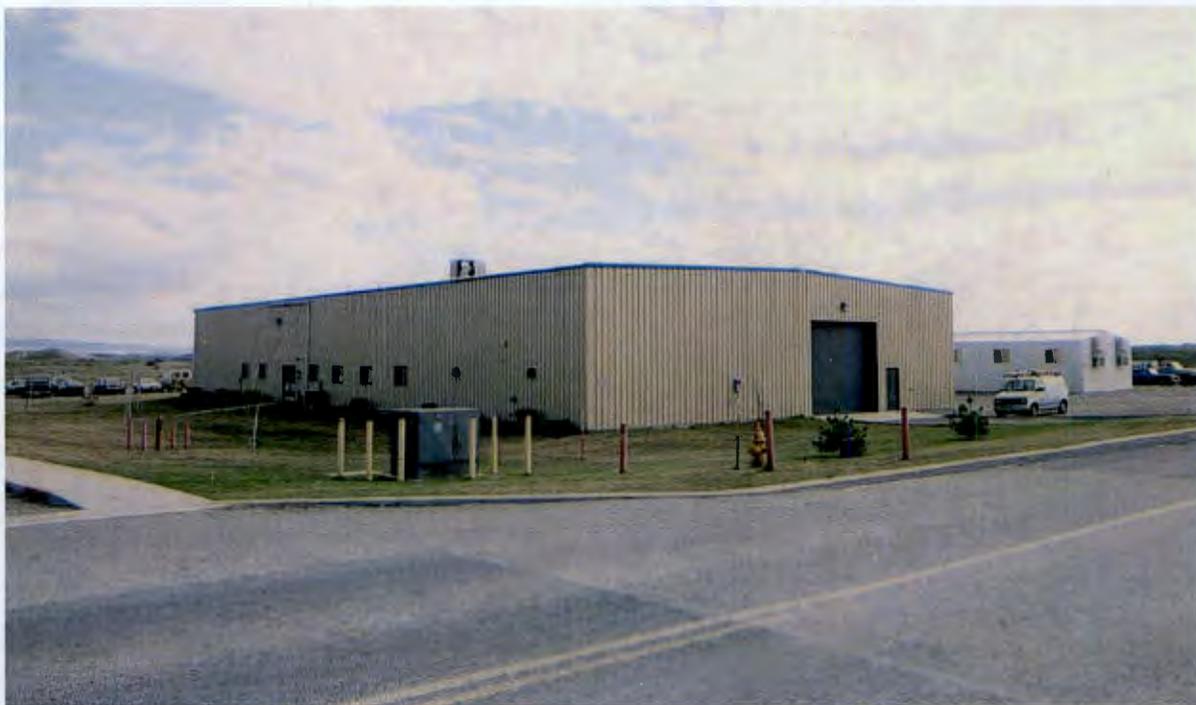
Figure 14. 1120-N Storage and Training Building.

A GPERS gamma survey and radiological down-posting survey was conducted at the 1120-N Building and was found to be not radiologically contaminated. A post-demolition GPS survey was performed on September 11, 2012. Additional information is presented in the PDSR (CCN 167663, "Post-Demolition Summary Report for 1120-N Storage and Training Building."

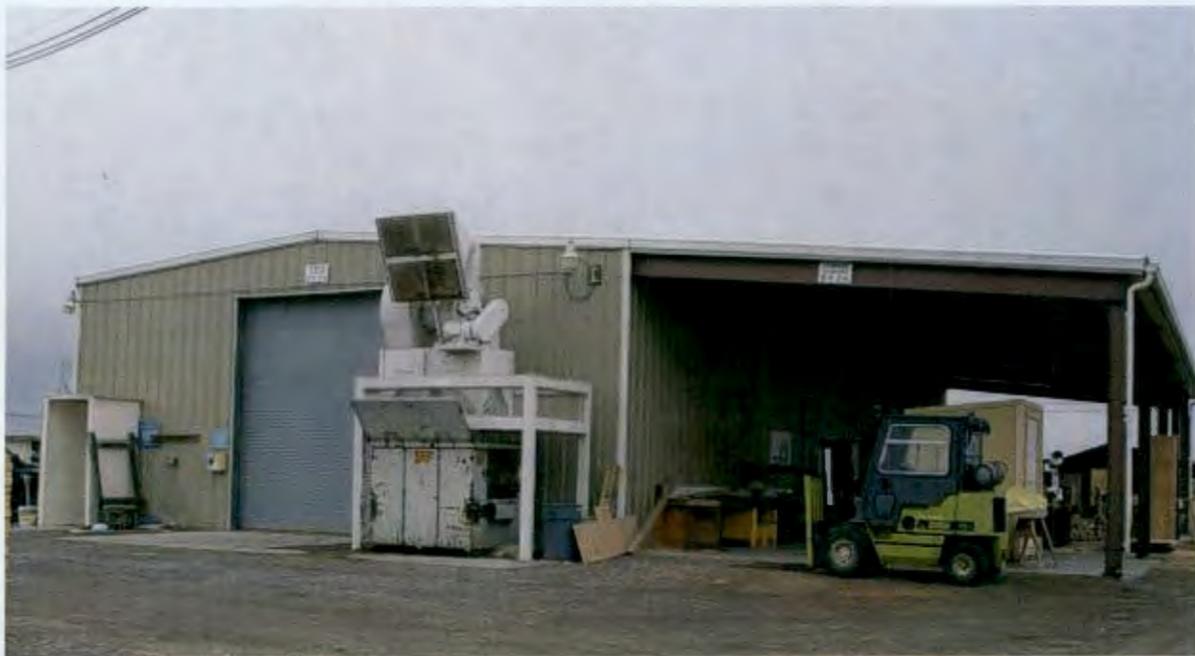
Figure 15. 1143-N Carpenter/Paint Shop.

A GPERS gamma/beta survey and radiological down-posting survey was conducted at the 1143-N Building and was found to be not radiologically contaminated. A post-demolition GPS survey was performed on March 22, 2012. Additional information is presented in CCN 165393, "Post-Demolition Summary Report for 1143-N Carpenter/Paint Shop."

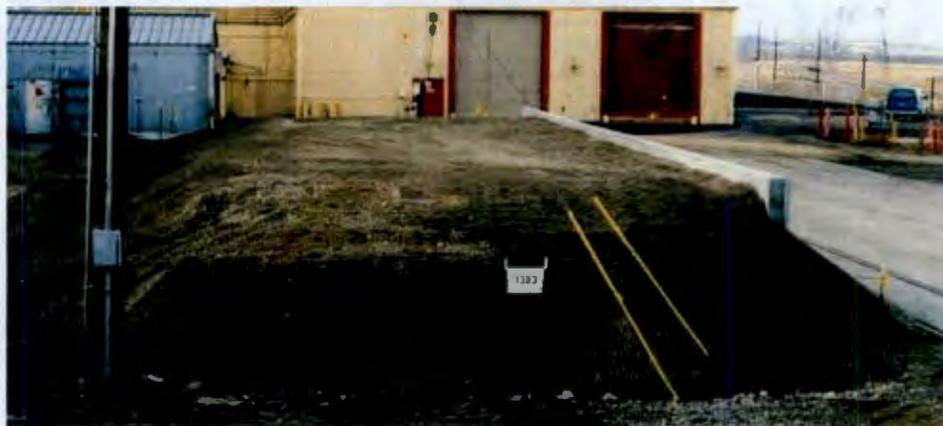
Figure 16. 1303-N Spacer Silos.

A GPERS beta/gamma survey was conducted at 1303-N and was found to be still radiologically contaminated. All additional information including post GPS survey is presented in CCN 169427, "Post Demolition Summary Report for the 1303-N Spacer Silos."

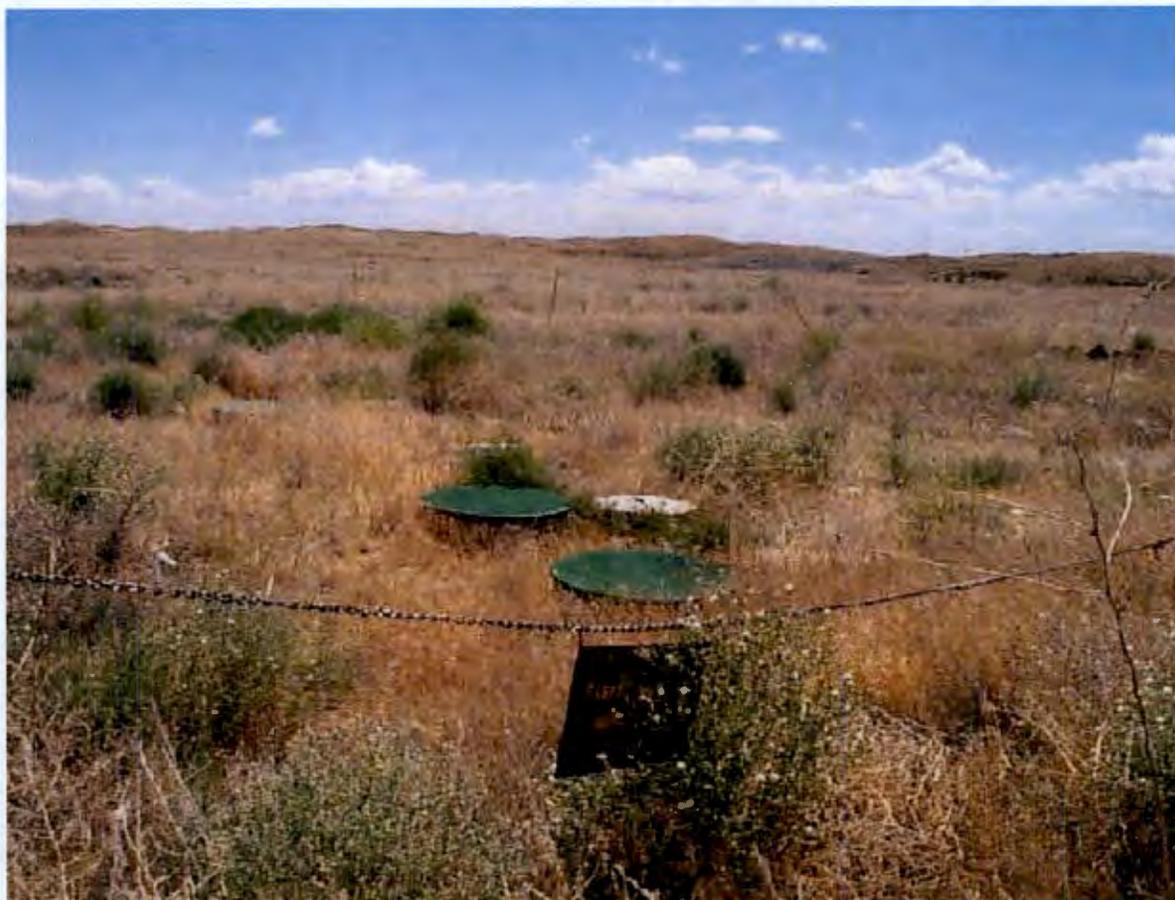
Figure 18. 1607-N9 100-N Sanitary Sewer System No. 9.

A GPERS gamma survey was conducted at the 1607-N9 system and was found to be not radiologically contaminated. A post-demolition GPS survey was performed on August 29, 2012. Additional information is presented in CCN 164009, "Post-Demolition Summary Report for 1903-N Septic System."

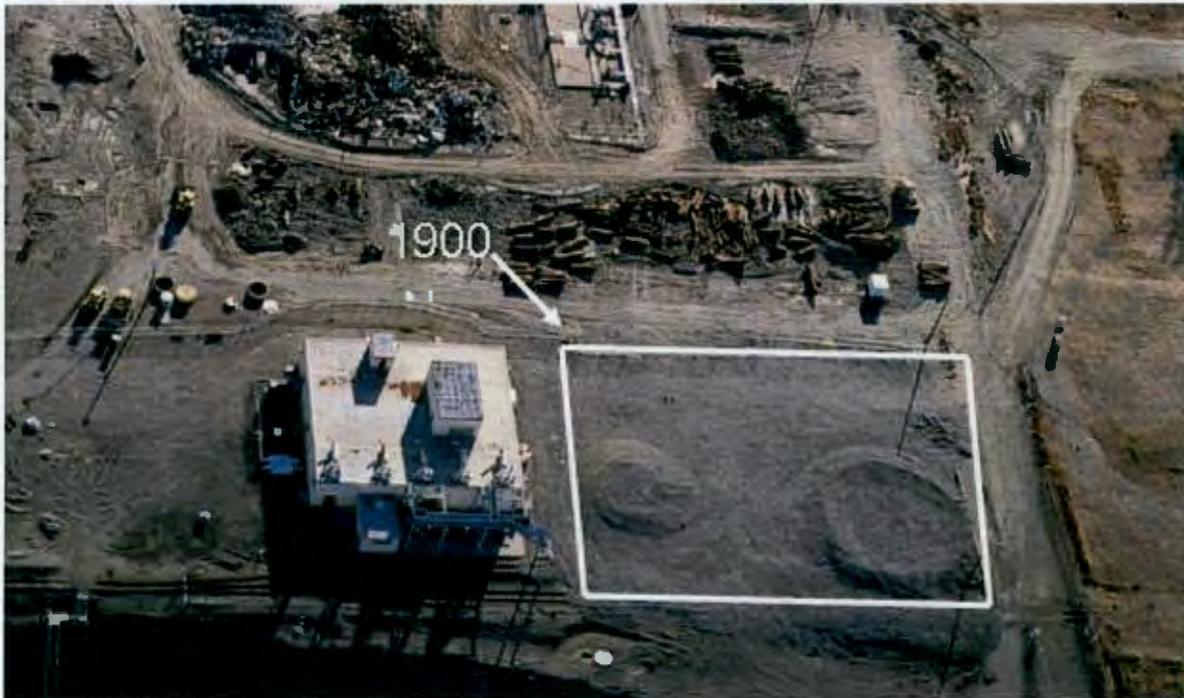
Figure 19. 1900-N Water Supply Tank Foundation Rings.

A GPERs gamma survey and radiological down-posting survey was conducted at the 1900-N Tank Rings and was found to be not radiologically contaminated. A post-demolition GPS survey was performed on July 18, 2012. Additional information is presented in CCN 165397, "Post-Demolition Summary Report for the 1900-N Water Supply Tank Foundation Rings."

The 1900-N Water Supply Tank Foundation Rings were demolished and loaded out under the RCCC by July 11, 2012. The 1900-N Tank Rings were backfilled to existing grade.

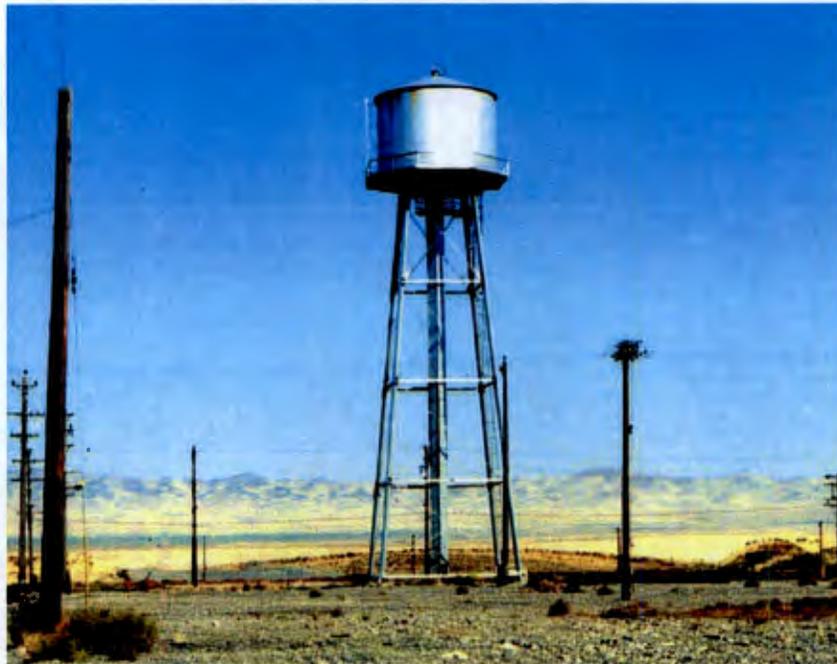
Figure 20. 1902-D Sanitary Water Tower.

A GPERS gamma survey and radiological down-posting survey was conducted at the 1902-D Tower and was found to be not radiologically contaminated. A post-demolition GPS survey was performed on September 27, 2012. Additional information is presented in CCN 167670, "Post-Demolition Summary Report for 1902-D Sanitary Water Tower."

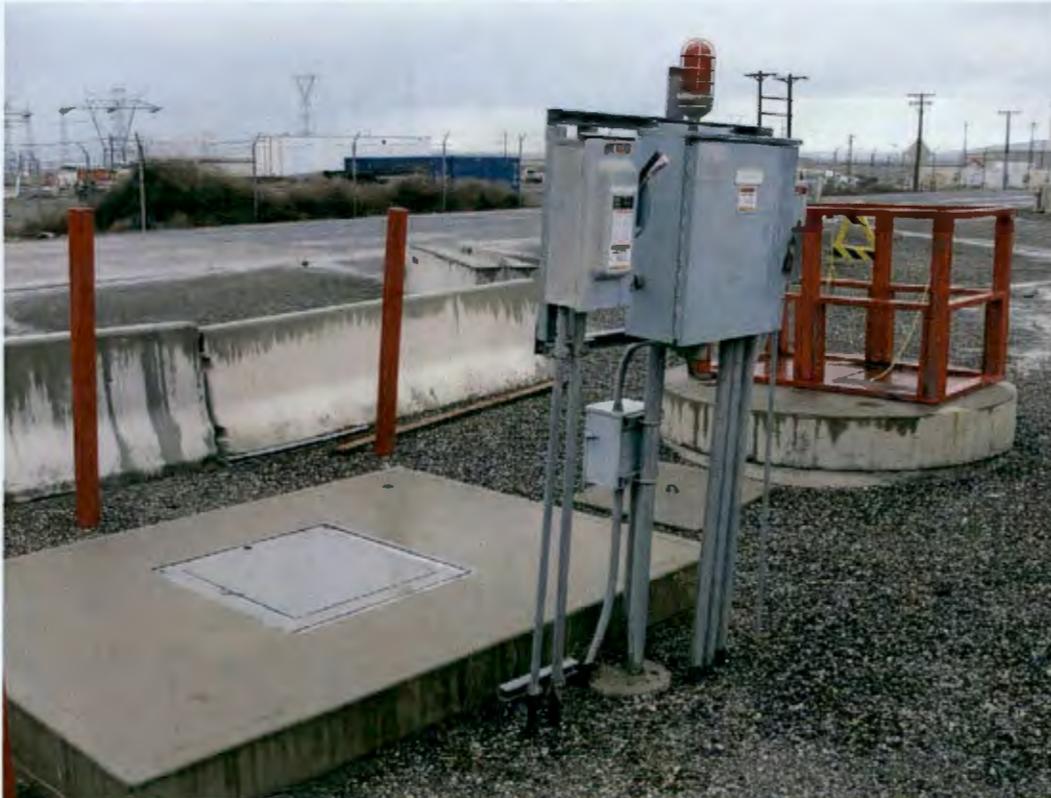
Figure 21. 1904-NB Sewage Lift Station #2.

A GPERS survey was not conducted, but a radiological down-posting survey was conducted at the 1904-NB utility and was found to be not radiologically contaminated. A post-demolition GPS survey was performed on December 12, 2012. Additional information is presented in CCN 167675, "Post Demolition Summary Report for 1904-NB Sewage Lift Station #2."

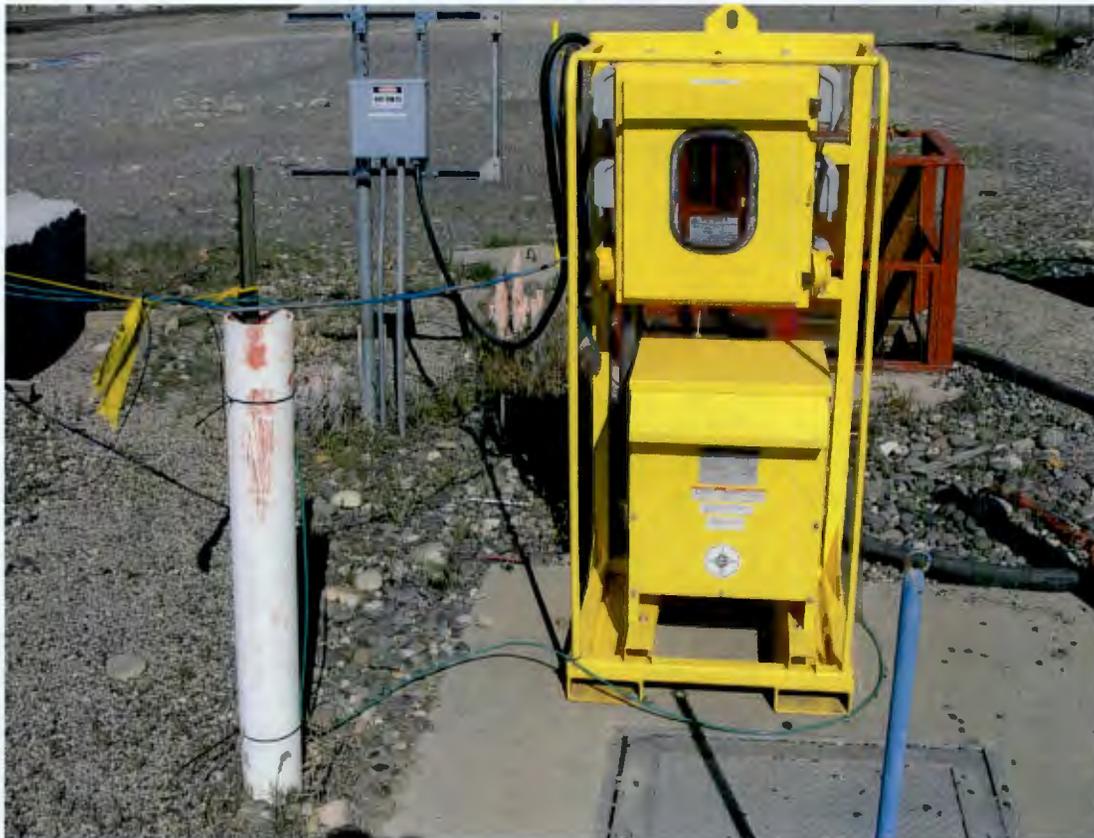
Figure 22. 1904-NC Sewage Lift Station #3.

A GPERS survey was not conducted, but a radiological down-posting survey was conducted at the 1904-NC utility and was found to be not radiologically contaminated. A post-demolition GPS survey was performed on December 12, 2012. Additional information is presented in CCN 169426, "Post Demolition Summary Report for 1904-NC Sewage Lift Station #3."
