FACILITY STATUS CHANGE FORM

Date Submitted:	Area: 200 East	Control Number: D4-B Plant-040
Originator: D. Turlington/E. Eberlein	Facility ID: 2716B	Phone: 509-373-0176

2716B was a ~240 ft² pre-engineered metal building on concrete slab on the east end of B Plant near the railroad cut into the tunnel. It was constructed in 1960 and first used as a Radiation Monitoring Checkout Station and later as a laundry change room for the B Plant railroad tunnel.

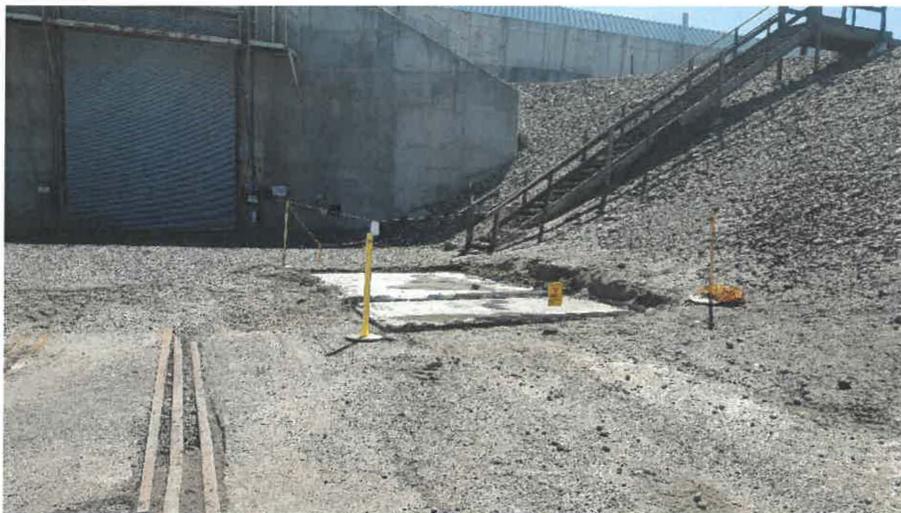
2716B After Demolition

Above Grade structure completely removed down to grade, the slab was left in place, all penetrations were grouted and plugged and a minimum 6" gravel (5/8 minus) cap was placed over and contoured.
