FACILITY STATUS CHANGE FORM

Date Submitted: 1/14/2013 Originator: David Warren Phone: 539-6040	Area: 100-N Facility ID: 108-N Chemical Unloading Facility Action Memorandum: 100-N Ancillary Facilities	Control #: D4-100N-0024
--	--	-----------------------------------

Attachment 1: Facility Information (10 pages)

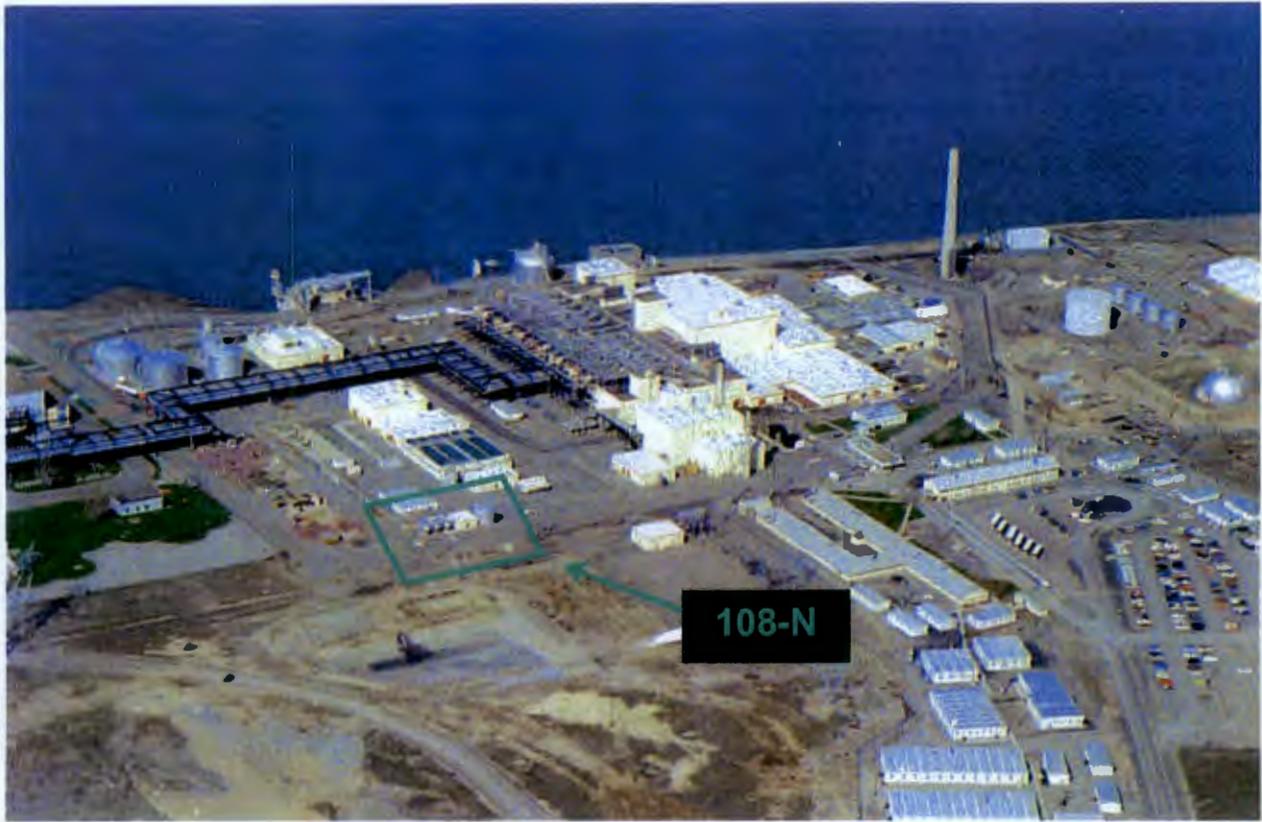
108-N Pre-Demolition

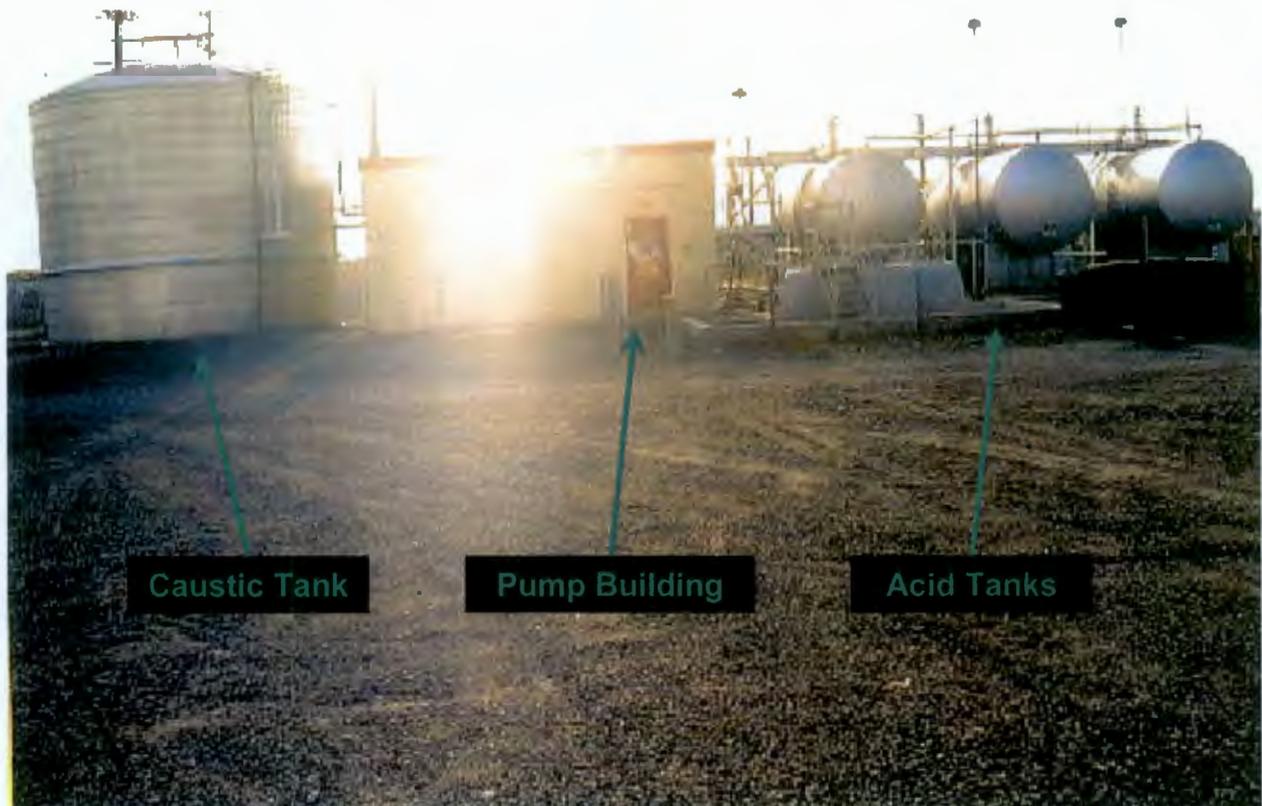
108-N Chemical Storage Tanks & Pump Building Pre-Demolition (Looking Southeast)

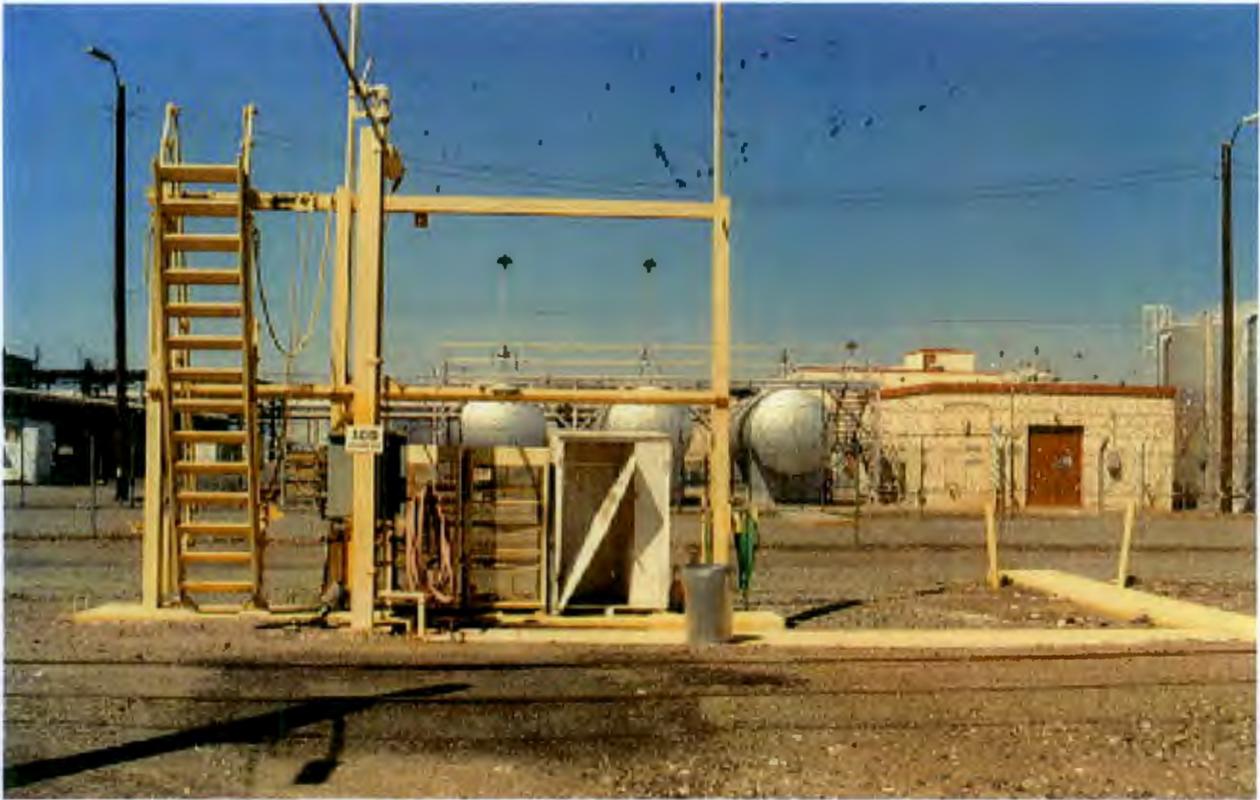
108-N Railcar Unloading Station (Looking Northwest)

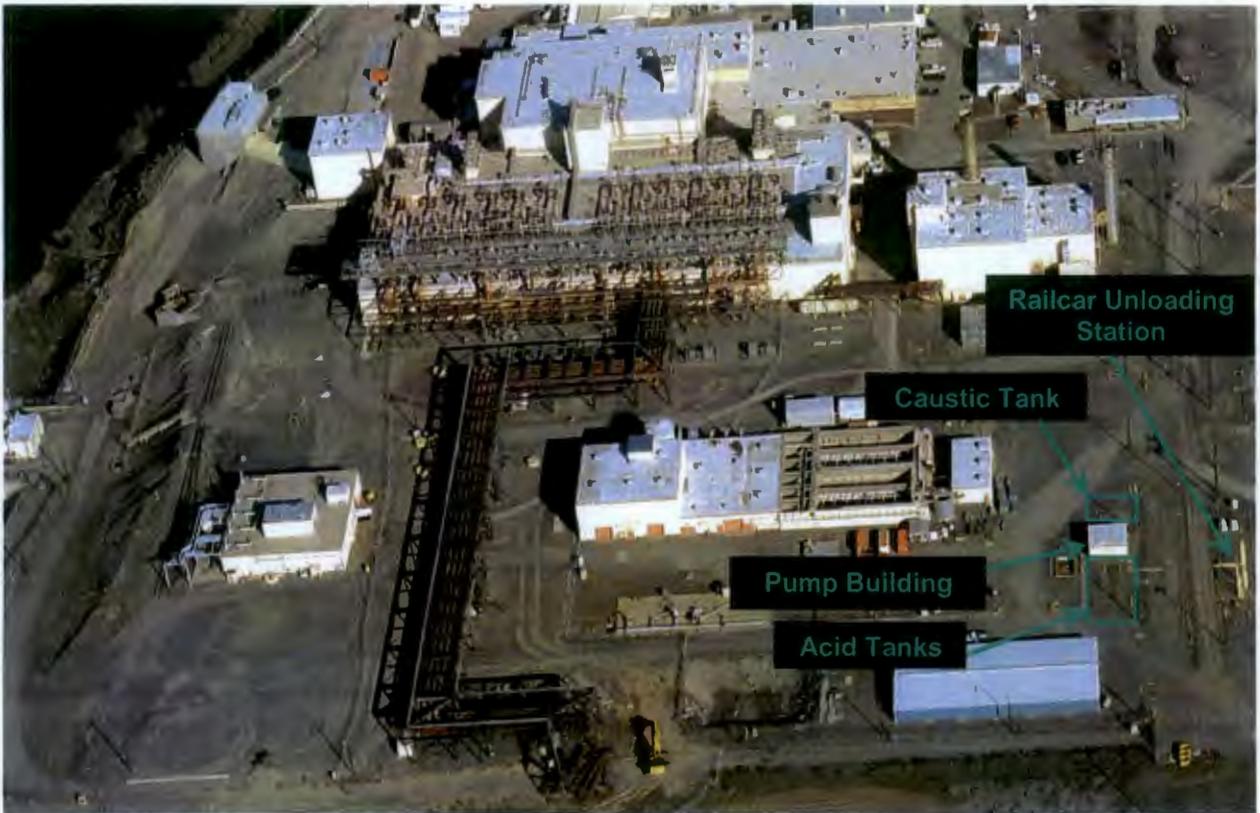
108-N After Removal of Chemical Storage Tanks

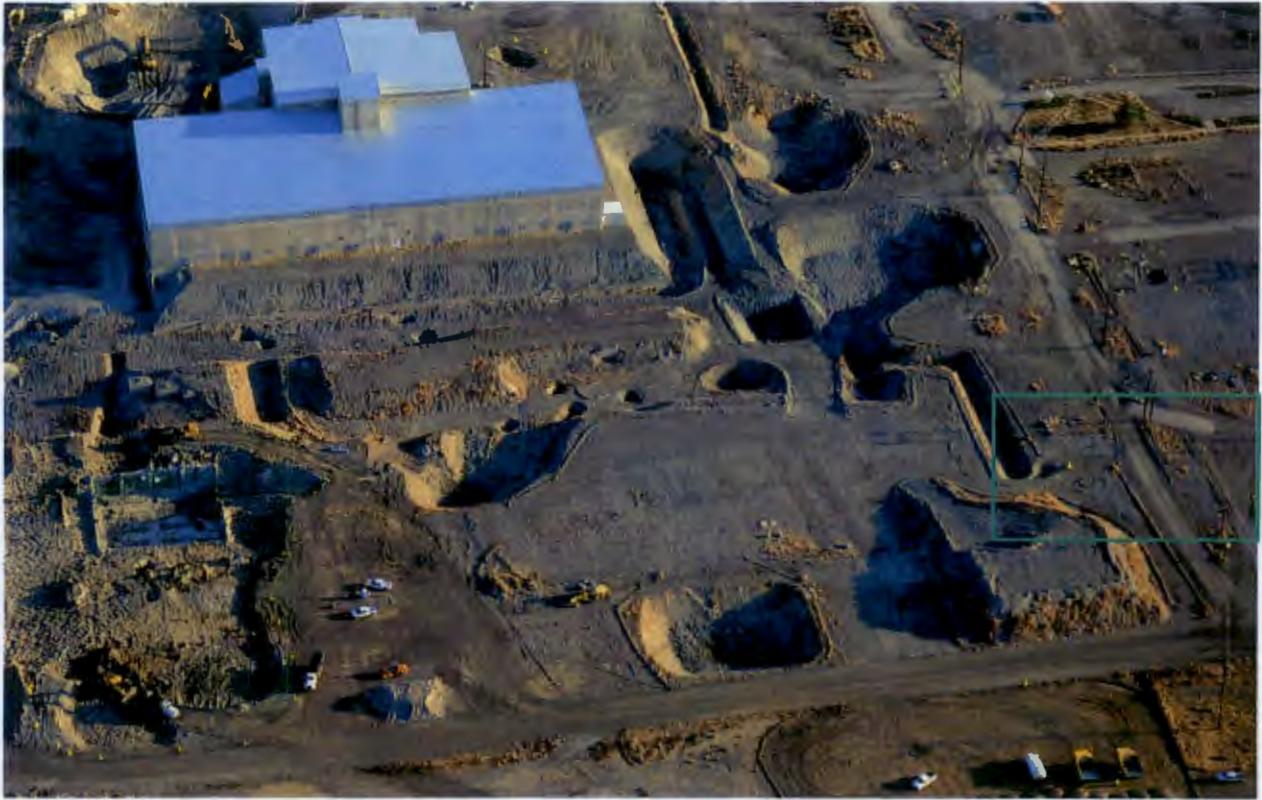
108-N After Demolition & Backfill

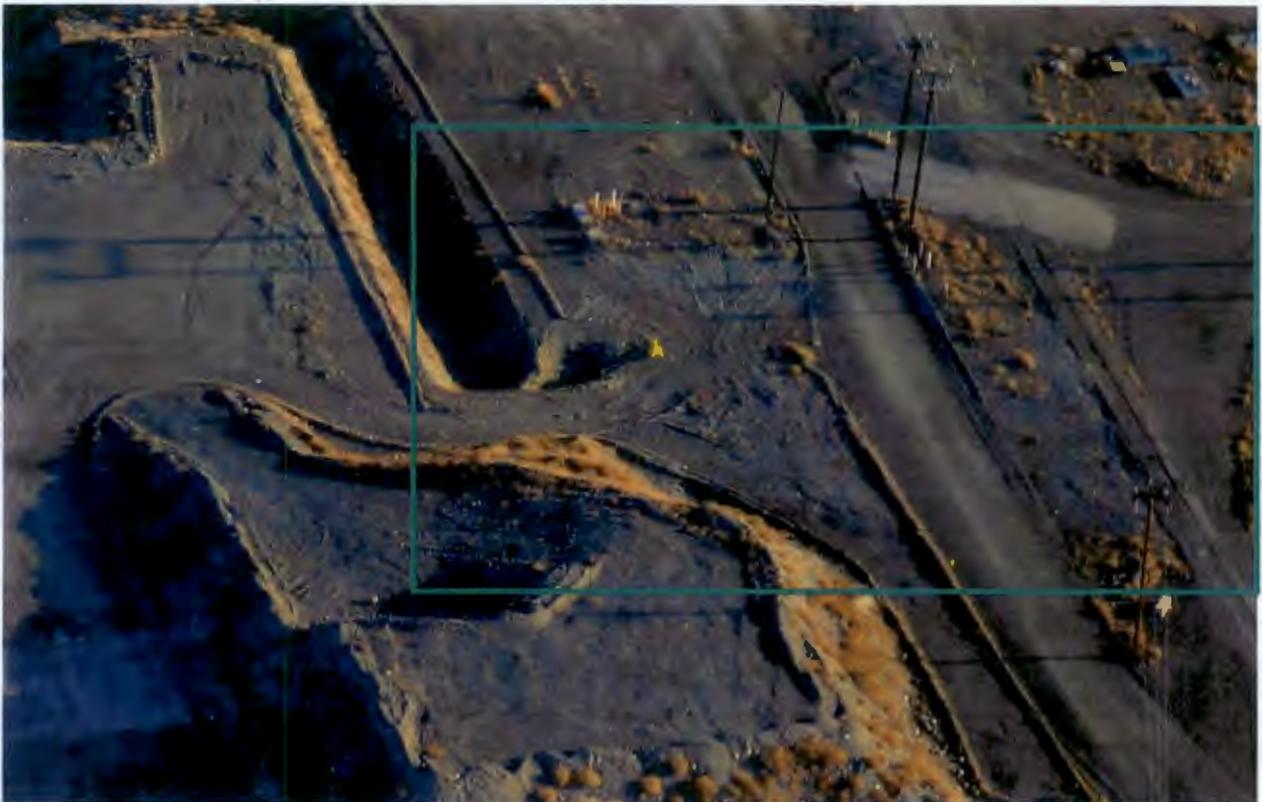
108-N After Demolition & Backfill

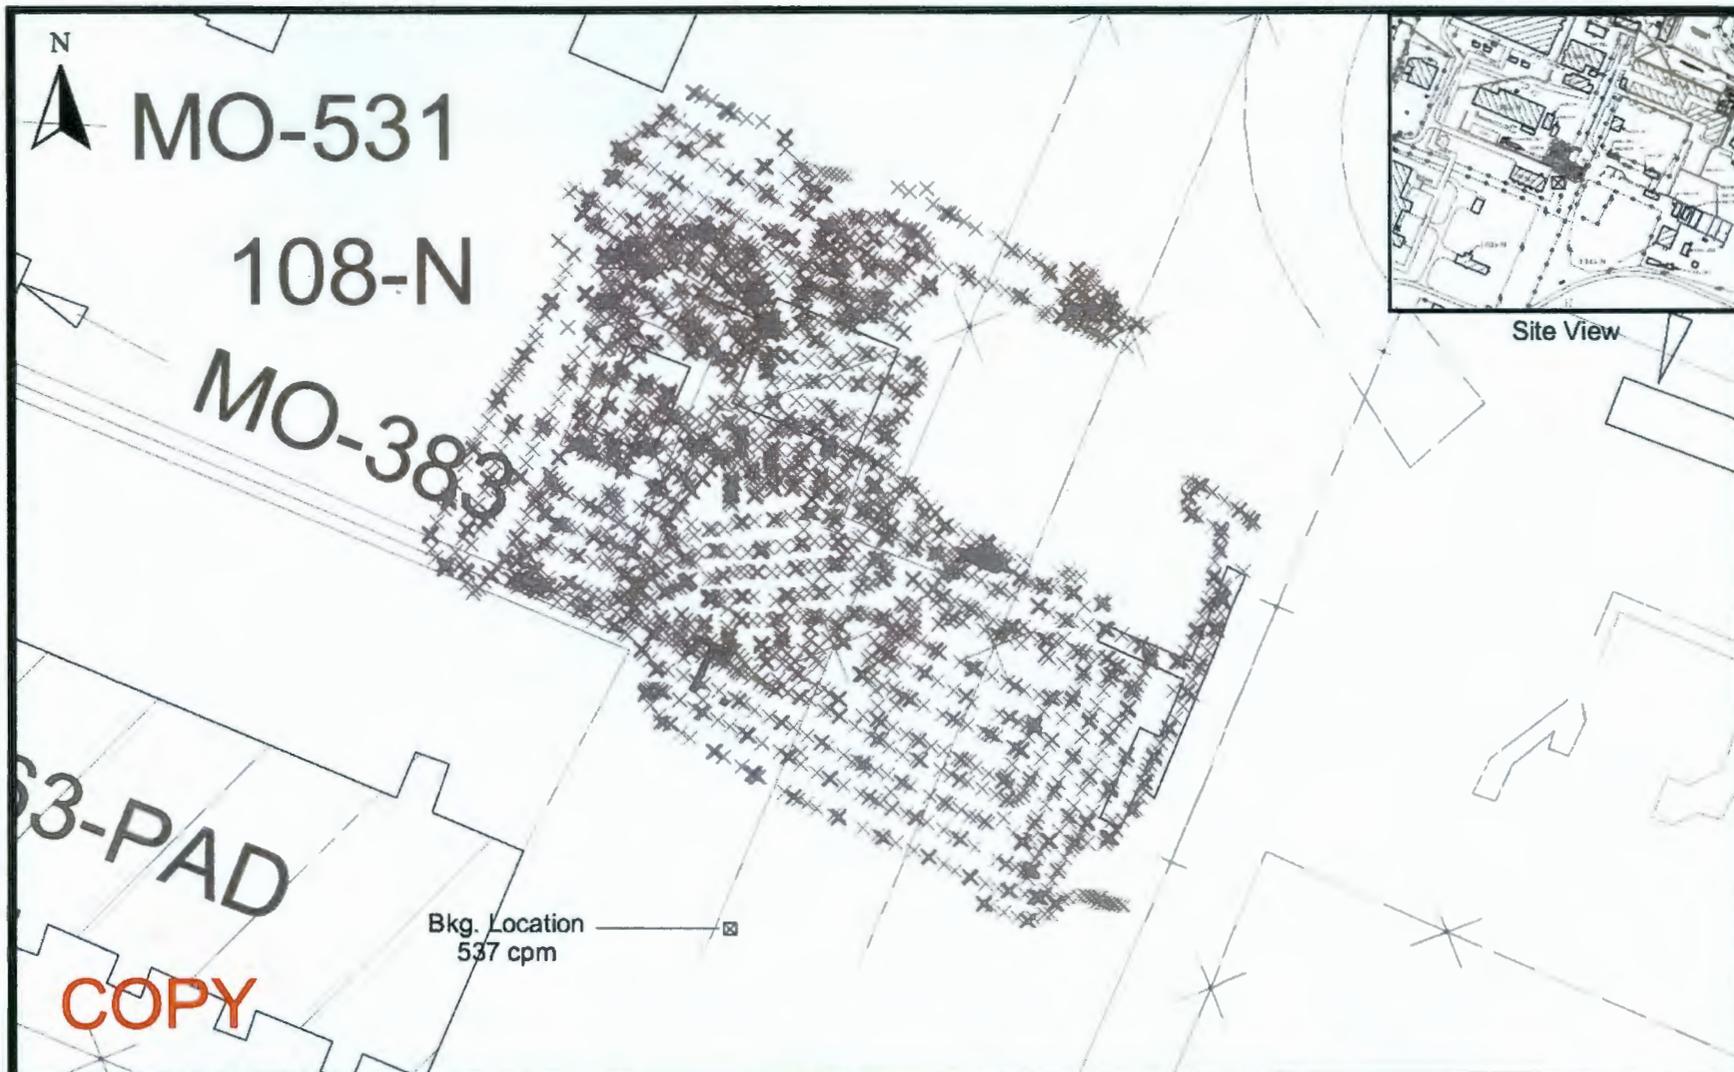
100N Field Remediation
108-N. Chem. Offload St.
GPERS Radiological Survey
Beta Track Map

Legend	Summary Statistics
NETCPM	Coverage File: N019_
	Number of Data Pnts: 5982
	Type of Survey: 'Beta'
	Max GCPM: 694
x < 800	Avg Bkg CPM: 537
● 800 - 1000	Survey Date: 01/19/2009
● 1000 - 1200	Area Surveyed: 1847 m2
● 1200 - 1400	Project File: N019_
● > 1400	Pdf File: ESRFRM090005_C

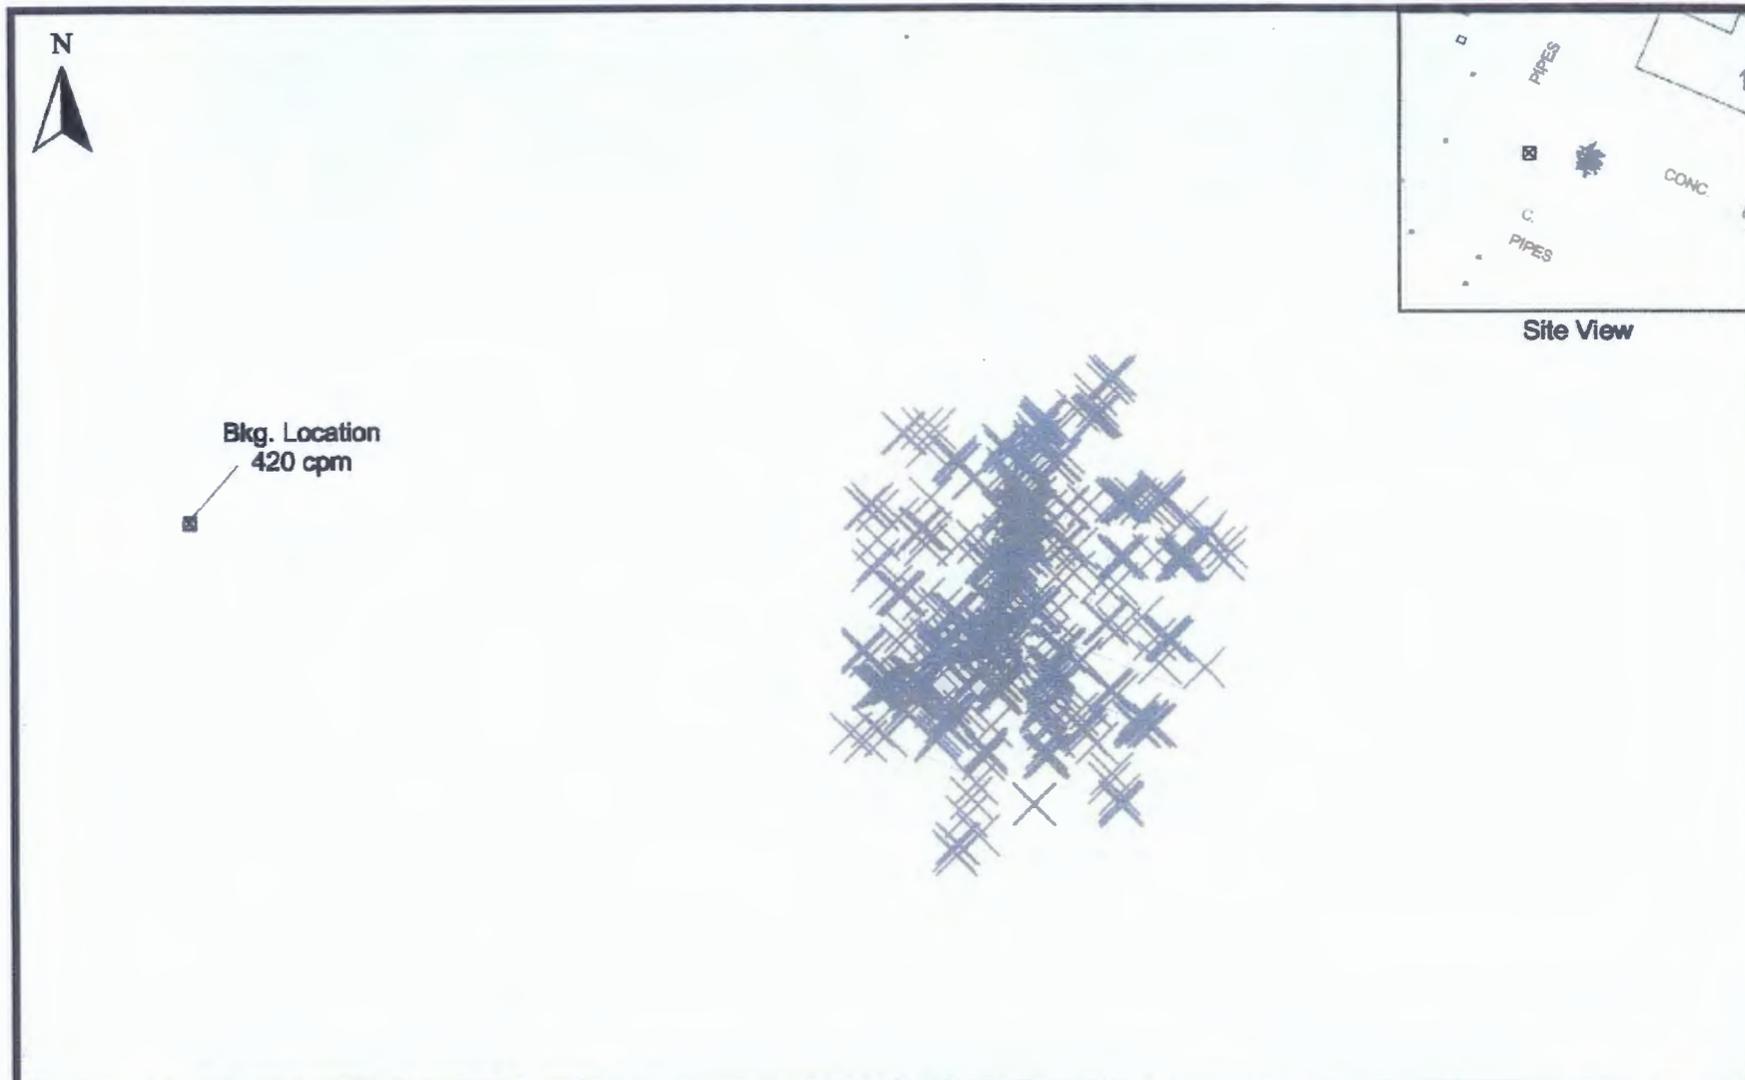
**100N Field Remediation
108-N Excavation
GPERS Radiological Survey
Beta Track Map**

Legend	Summary Statistics
NETCPM	Coverage File: N325_
	Number of Data Pnts: 748
	Type of Survey: 'Beta'
	Max GCPM: 723
× < 800	Avg Bkg CPM: 420
● 800 - 1000	Survey Date: 11/20/2008
● 1000 - 1200	Area Surveyed: 87 m2
● 1200 - 1400	Project File: N325
● > 1400	Pdf File: ESRFRM080170_
