BHI-01282

Hanford B Reactor Building Hazard Assessment Report

Title: Hanford B Reactor Building Hazard Assessment Report

June 1999

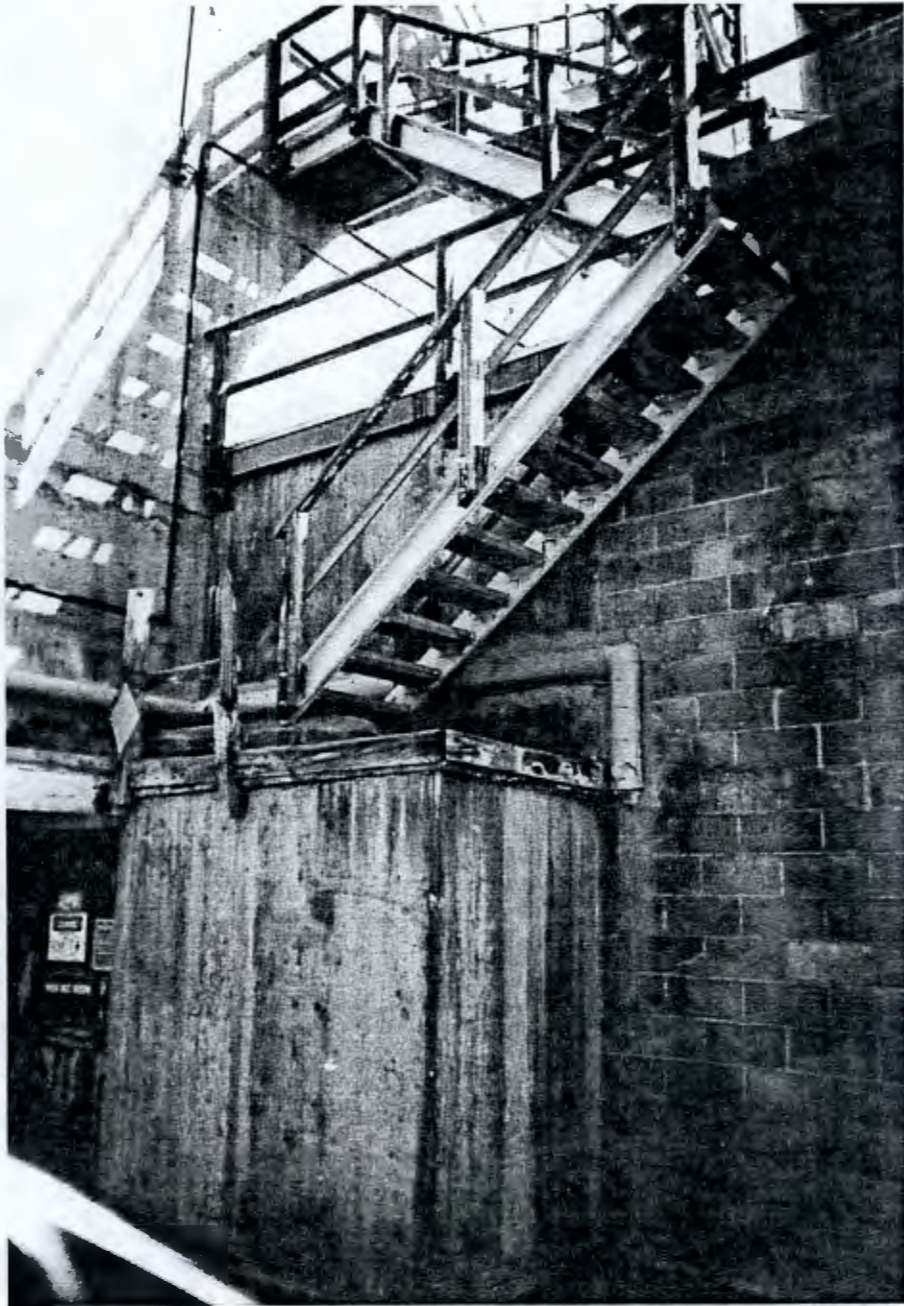
Photograph 1. Wood Stairway on South Side of the Reactor Building.

The wooden stairway (with concrete treads) up the south side of the reactor building has not been maintained and appears to be in poor condition. The wood has weathered, nails/bolts appear to be loose, and treads appear to have serious cracks.

It is recommended that the stairway be blocked and posted as dangerous at all access points. The stairway should not be used by anyone prior to a complete structural evaluation and completion of any necessary repairs.

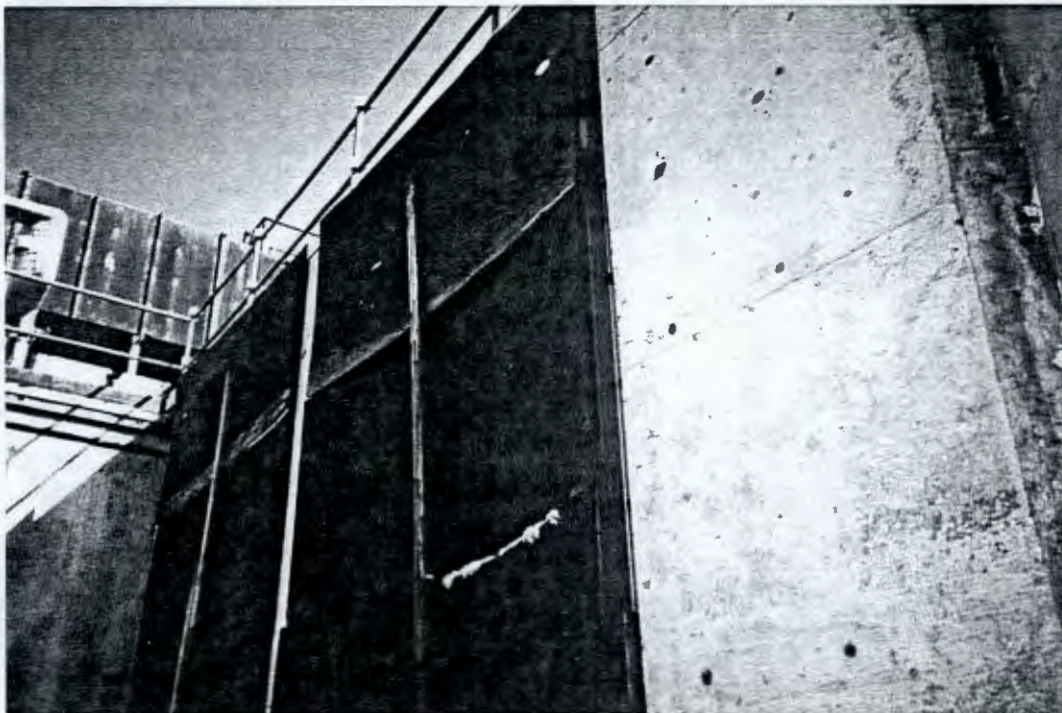
Photograph 3. Wood Covers Over the Stack Plenum Openings.

- Exterior stairway up south side of reactor: The wooden stairway (with concrete treads) up the south side of the reactor building has not been maintained and appears to be in poor condition. The wood has weathered, nails/bolts appear to be loose, and treads appear to have major cracks. *(Photograph 1)*
- Broken conduit with exposed electrical conductors. *(Photograph 2)*
- Covers (doors) missing from transformers.
- Peeling paint on both metal and wood surfaces may contain lead.
- Building penetrations need to be sealed to prevent animal intrusion.
- The wood roof over the tool/storage area on the north side shows signs of water damage.
- Wood covers over the stack plenum openings are weathered. *(Photograph 3)*

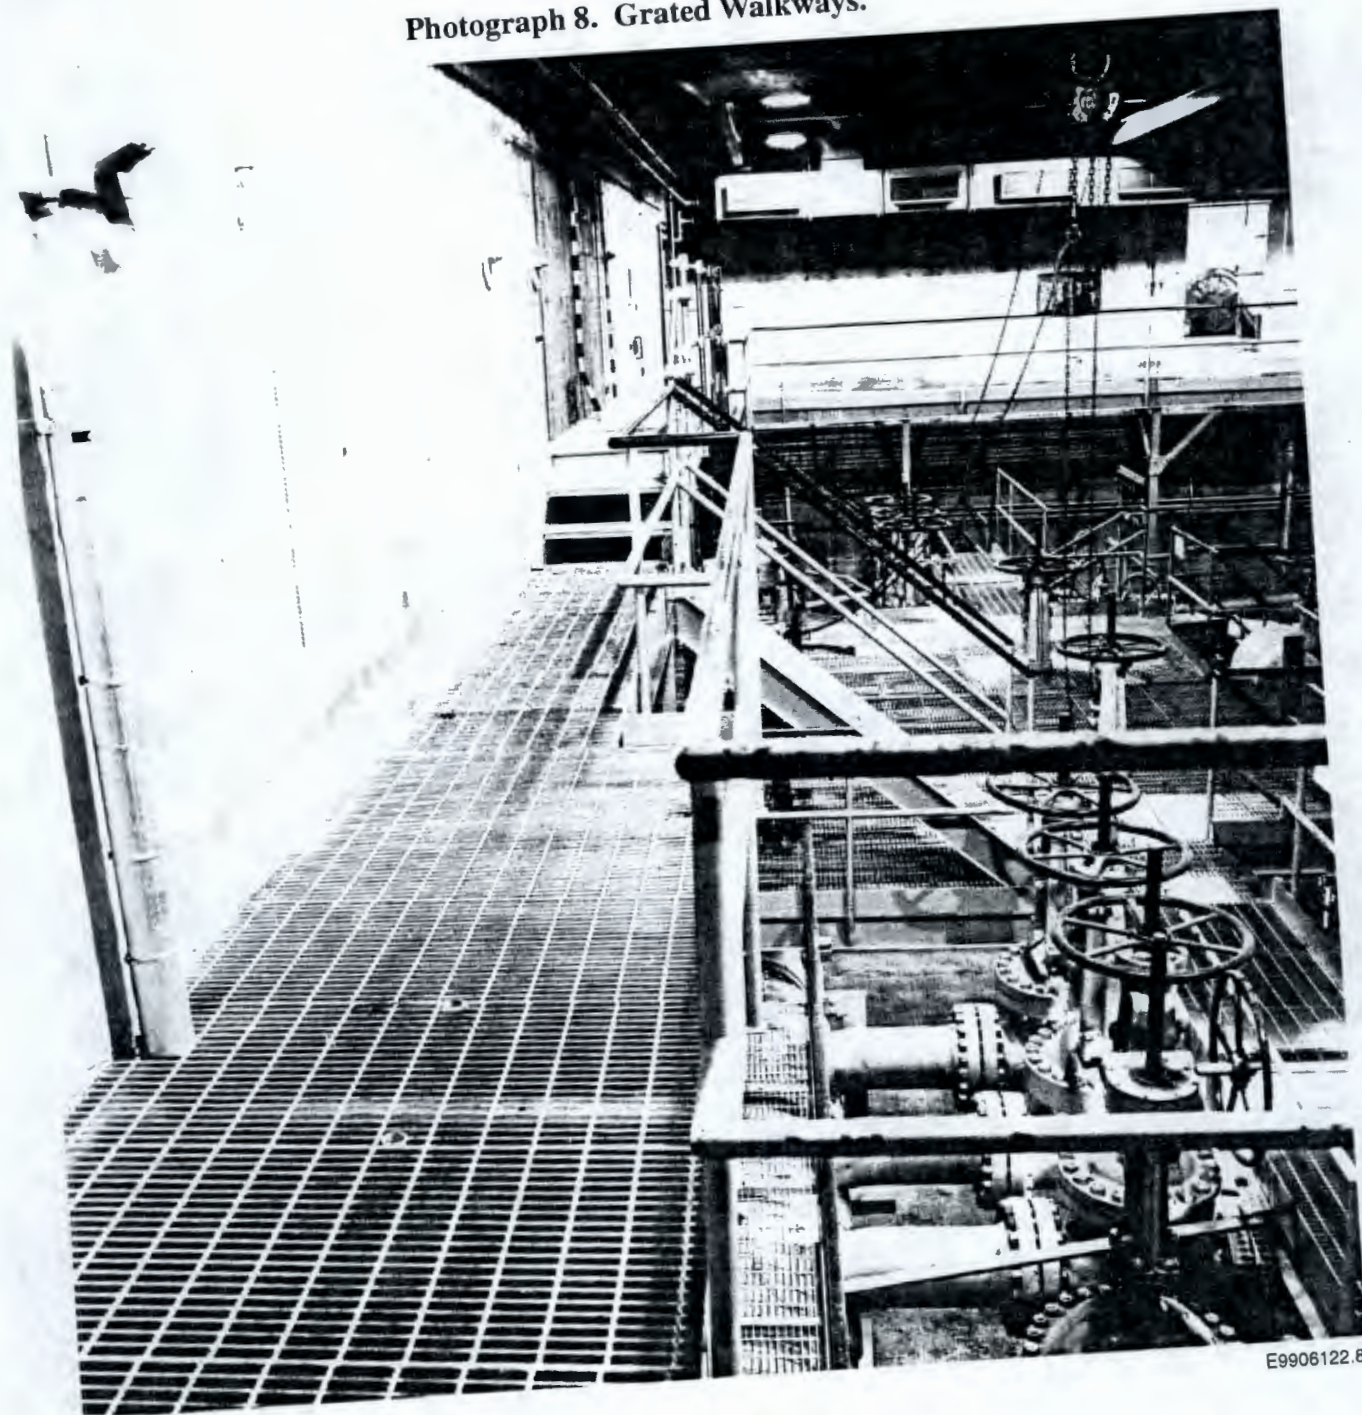
Photograph 8. Grated Walkways.

- Lunch room: Old fluorescent fixtures, possible PCBs.
- Room No. 5 (electrical equipment): Semi-volatile organics.
- Room No. 5: Batteries for the emergency lights.
- Fan rooms: Emergency lights and batteries.
- No. 8 fan supply room: Calcium chloride or similar desiccant in moisture absorbers on air lines.
- Fan room: Oil on casings of fan motors. (*Photograph 7*)
- Fan room: Dehydrator has oil in it and is dripping on the floor.
- Room No. 5 (electrical equipment): Oil in the seismometer.
- No. 8 fan supply room: Oil in air line accumulators.
- No. 9 fan cell: Oil in moisture separator.
- Basin viewing room: Oil separators on air line.
- Fan Rooms: Oil in motors and fans, hydraulic pistons on dampers, and hydraulic fluid in Kwik Srak fork truck.
- Supply fan room: No lighting.
- Grated walkways could create a tripping hazard to individuals with heeled footwear. (*Photograph 8*)

- Grated walkways could create a tripping hazard to individuals with heeled footwear.
- The elevation of the floor on both sides of a required exit door shall not vary by more than 0.5 in. At the present time this requirement is not being met.

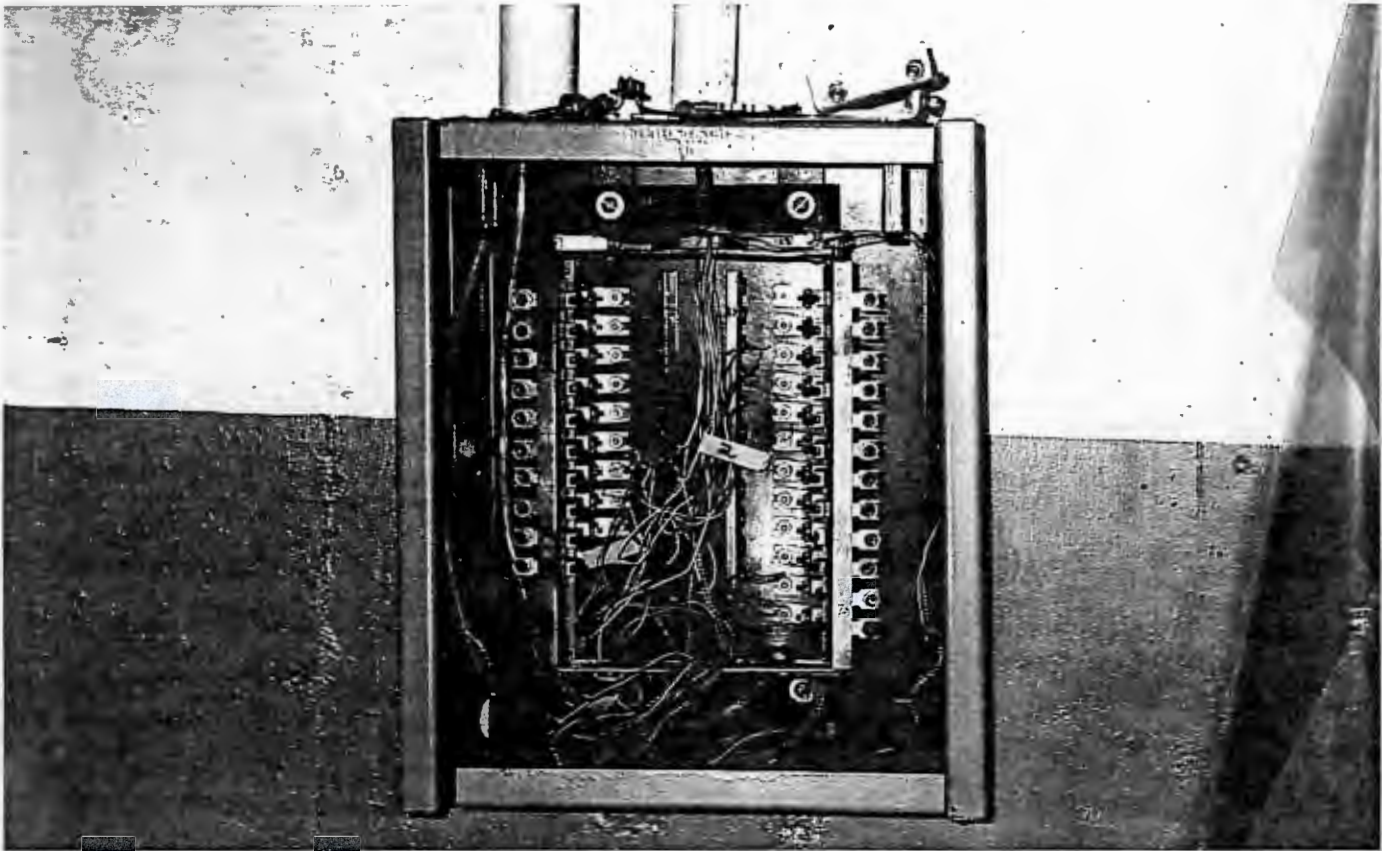
Photograph 9. Missing Electrical Covers.

- Electric equipment room: Missing covers on the wireway and gutters. Locate energized lines and isolate, label, or put barriers in place. Exposed wiring on the "C" platform should have "DO NOT TOUCH" signs on barriers. (*Photograph 9*)
- Electrical equipment room No. 35: Incandescent light fixtures missing lamps and globes. Fluorescent lighting fixtures need repair.
- Electrical switch gear room (Room 25): Wiring hanging from the wireway and sliding access doors are not secured from opening and may contain energized circuits.

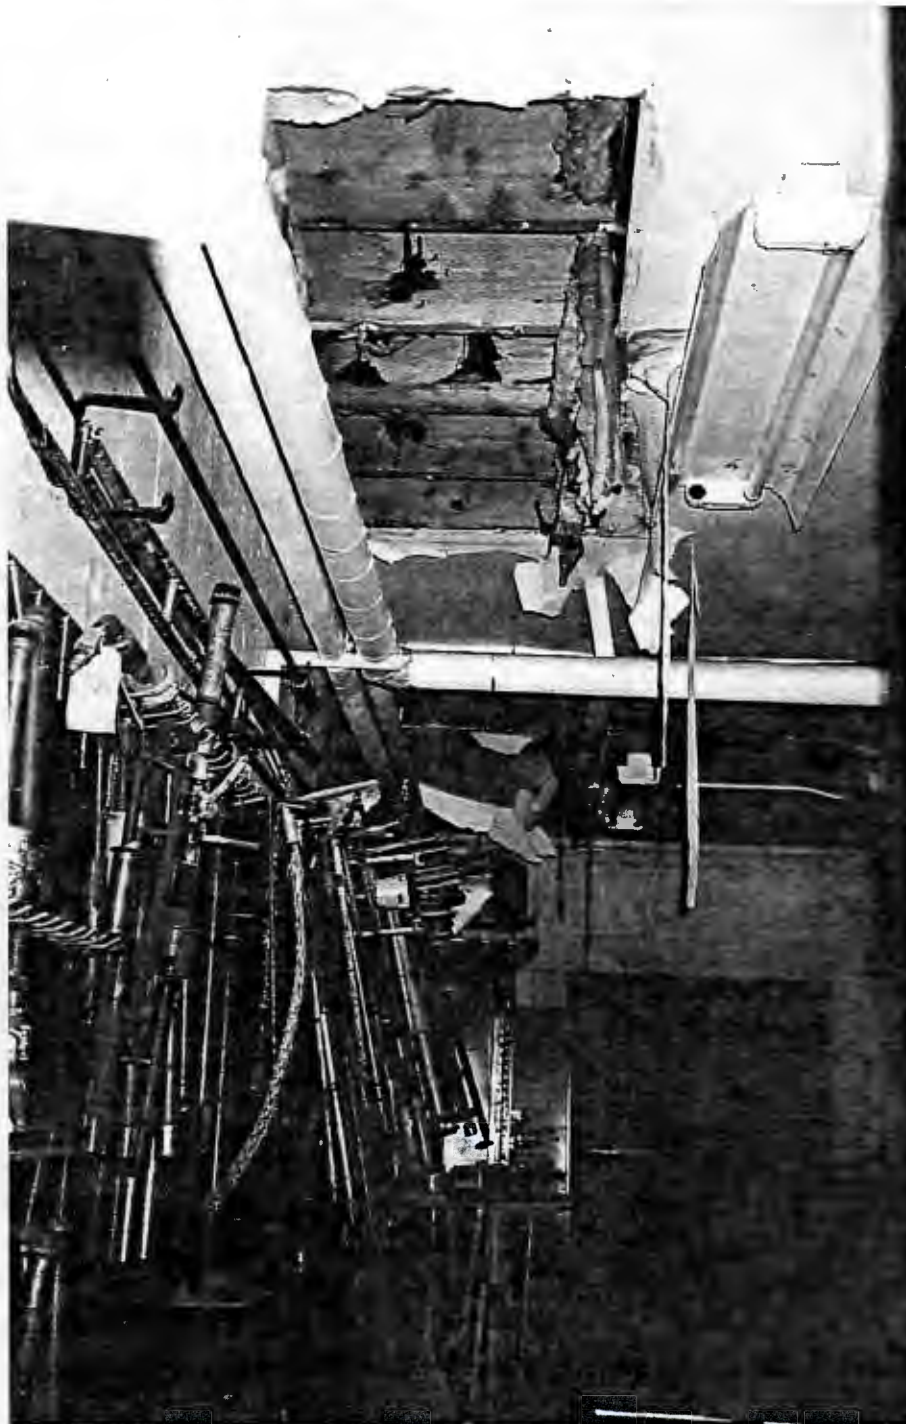
Photograph 10. Conditions in the Tool Storage Room.

The wooden roof over the Tool/Storage Area that extends outward on the north side of the reactor shows signs of water damage. The water-damaged wood could continue to deteriorate creating an unsafe condition in the near future.

- Tool/storage area: It is recommended that no tours be allowed in this area until proper repairs are made and that the current condition is monitored/inspected periodically (every six months, after heavy rains, or when there is snow build-up). (*Photograph 10*)

It is recommended that no tours are allowed in this area until proper repairs are made and that the current condition is monitored/inspected periodically (every six months, after heavy rains, or when there is snow build-up).
