Re: Entry of Site Visit Report to Administrative Record  
4843 Alkali Metal Storage Facility (S-4-1, M-20-14)

4843 Alkali Metal Storage Facility Unit  
(Group # S-4-1, Milestone M-20-14)  
July 9, 1993, Site Report by Alisa Huckaby

4843 ALKALI METAL STORAGE FACILITY SITE VISIT REPORT

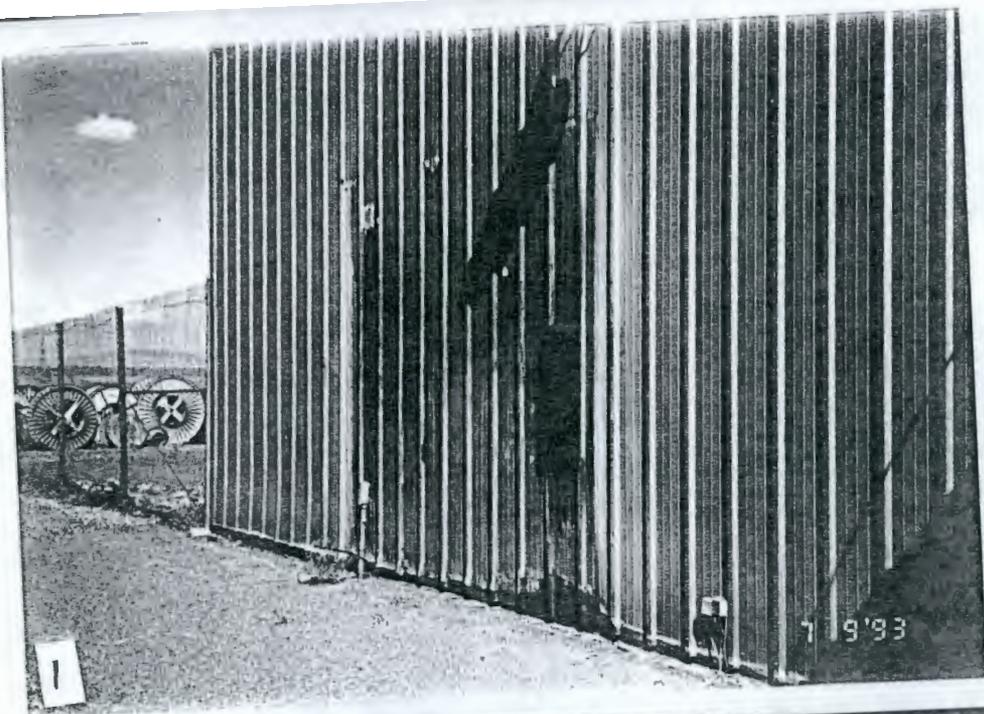
Photo 1

After the inventory discussions, the outside of the building (where fencing did not prevent access) was inspected. An area of discoloration was noted on the south end of the building of which upon closer inspection appeared to be rust discoloration (photo attached). Also noted within the rust discolored area, were what

appeared to be holes along the top edge of rust line which may represent bolt connection points.

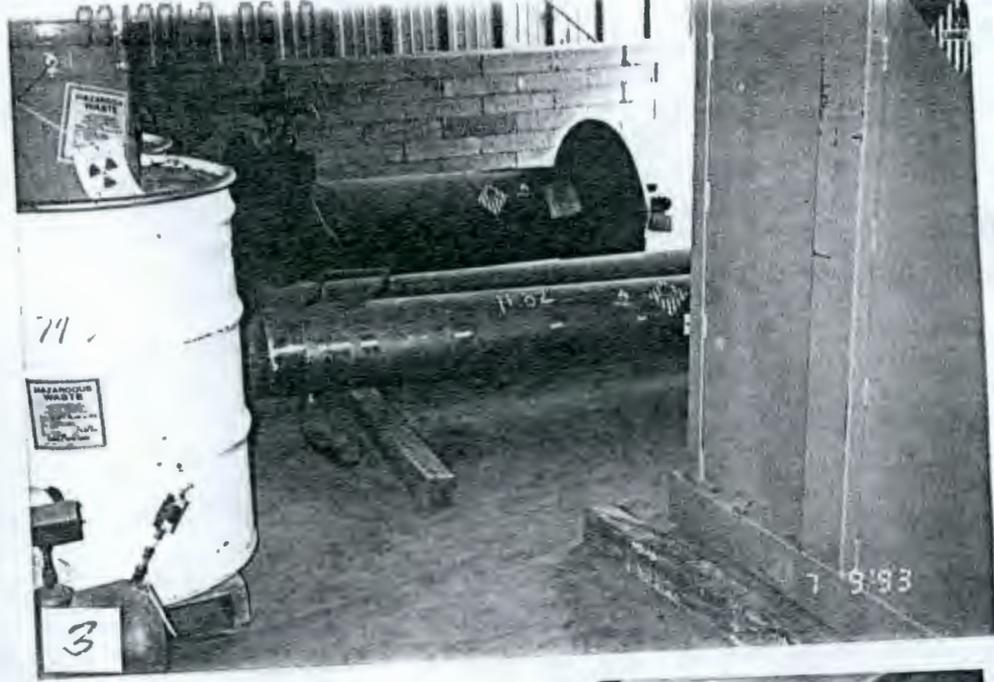
Photo 2

After inspecting the outside of the building, the inside of the building was revisited during which the additional photos were taken. Photos #2 and #3 show portions of the radioactive waste storage area located in the northern half of the building. Photo #4 was taken from near the south personnel door facing west and shows the southern and western walls of the building. Photo #4 shows the metal siding of the lower portion of the wall and the insulation of the upper portion of the wall and the ceiling. Photo #5 was taken from near the east roll up door facing north and shows the eastern end of the radioactive waste storage area. The large box/container shown on the left side of the photo represents waste inventory #80. Photo #6 was taken of the concrete floor and shows several stains. Photo #7 was taken facing south and shows the power panels located in the southwestern corner of the building. The torn insulation directly above the sheet metal wall may be noted in photo #7. Photo #8 was taken of a small crack within the concrete floor. Photo #9 was taken from near the center of the building within the radioactive waste storage area and shows a control joint in the concrete floor. The center of photo #9 shows damaged concrete along the control joint. Photo #10 also shows damaged concrete along the control joint. Photo #11 shows small cracks perpendicular to and intersecting the control joint. Photo #12 was also taken of the concrete floor and shows several stains. Photo #13 was taken of a section of the control joint in the dangerous waste storage side of the building (southern side). Prior to taking photo #13, the dirt in the control joint had been swept out of the control joint and the largest crack noted in the concrete during the visit was revealed.

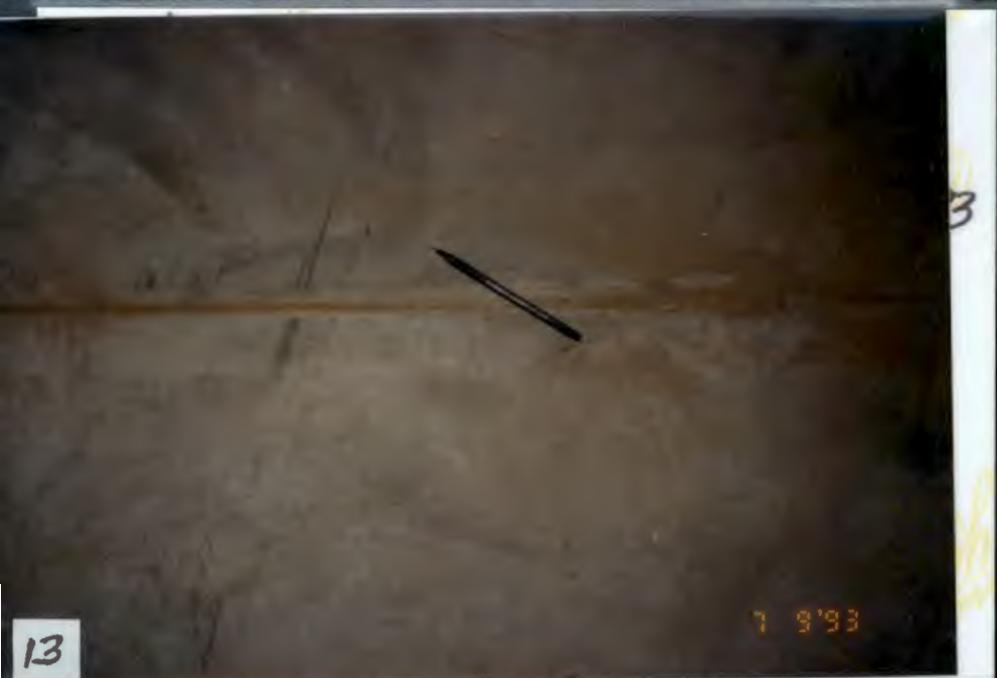
Photo 13

12	Photo of stain on concrete floor.
13	Photo of exposed crack in control joint of concrete floor
