FACILITY STATUS CHANGE FORM

Date Submitted:	Area: 200 East	Control Number: D4-B Plant-060
Originator: D. Turlington / E. Eberlein	Facility ID: 292B	Phone: 509-373-0176

292B is was a ~350 ft² building comprised of concrete masonry blocks and a wooden subframe. It was located on the south side of B Plant. It was constructed in 1944 and served as a stack exhaust monitoring station for B Plant.

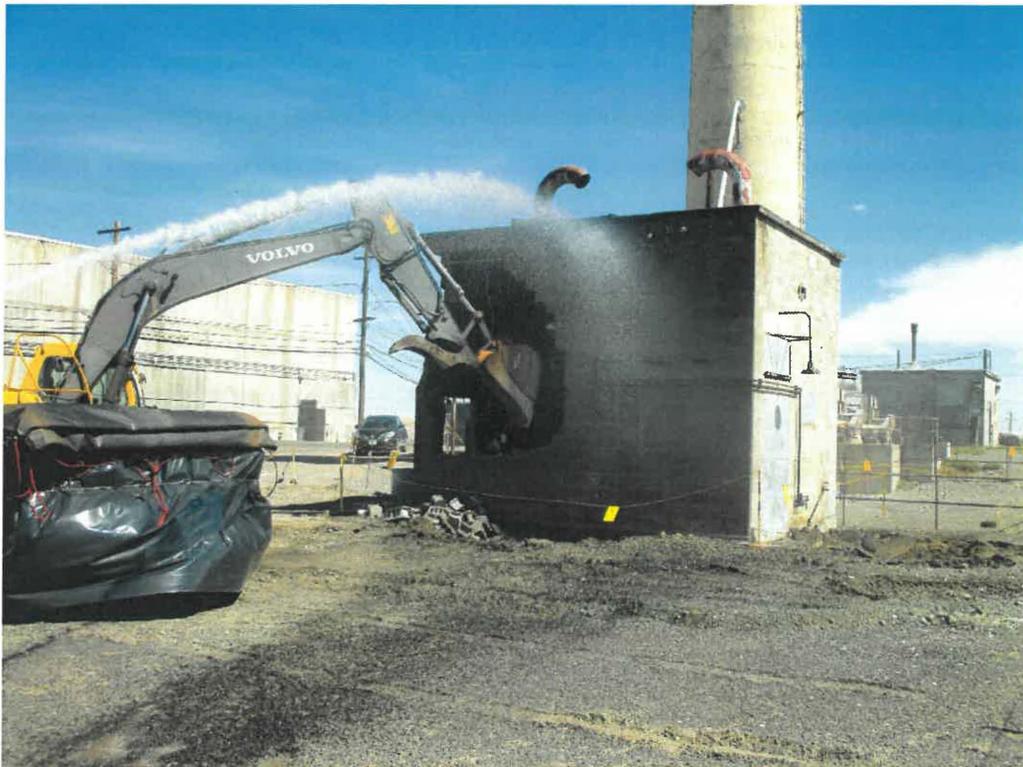
292B During Demolition

Building was electrically and mechanically isolated and concrete slab penetrations were plugged and grouted. Building was sampled for beryllium and cleared. Building was sampled for asbestos. Hazardous materials were removed prior to demolition, where required. Building was demolished to slab on grade. Slab was surveyed and a 6" gravel cap was placed on top of the slab and contoured to remove tripping hazards and aid water run-off.

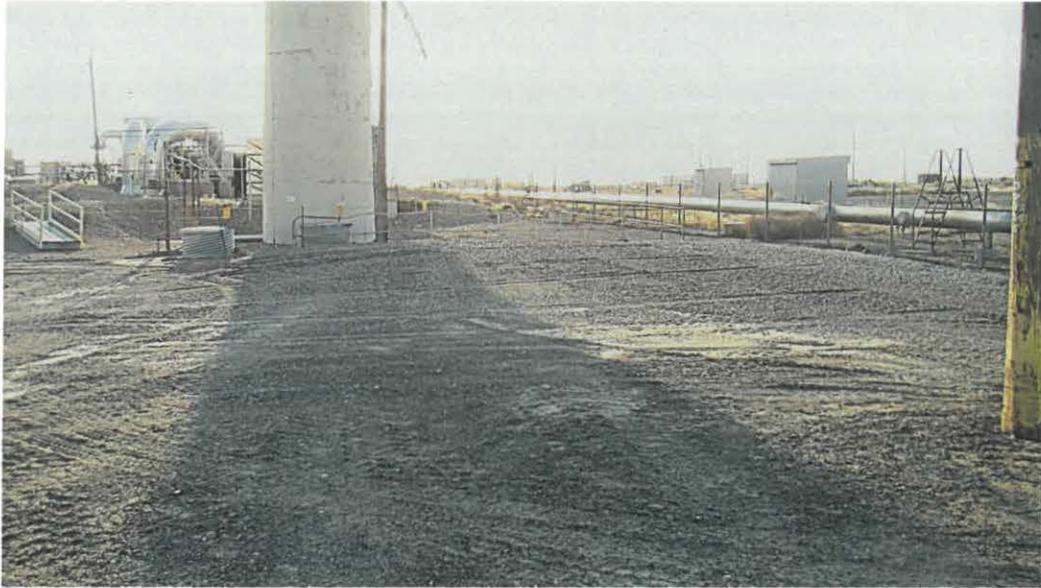
292B After Demolition

Above Grade structure completely removed down to grade, the slab was left in place, all penetrations were grouted and plugged and a minimum 6" gravel (5/8 minus) cap was placed over and contoured.

A Fixed Contamination Area (FCA) remains that will be covered by the gravel cap. Therefore, the area will be posted as an Underground Radioactive Material Area (URMA). Attachment 4 – WIDS Summary Report for New WIDS Site.

The direct radiological readings on the concrete slab ranged from 450 counts per minute to 5000 counts per minute. The foundation was then posted with Underground Radioactive Material Area signs.
