## FACILITY STATUS CHANGE FORM

| Date Submitted: | Area: 200 East | Control Number: D4-B Plant-007 |
| Originator: D. Turlington/E. Eberlein | Facility ID: 217B | Phone: 509-373-0176 |

Action Memorandum/Removal Action Work Plan:  
**Action Memorandum:** DOE/RL-2010-22, Rev. 1  
**Removal Action Work Plan:** DOE/RL-2010-33, Rev. 0

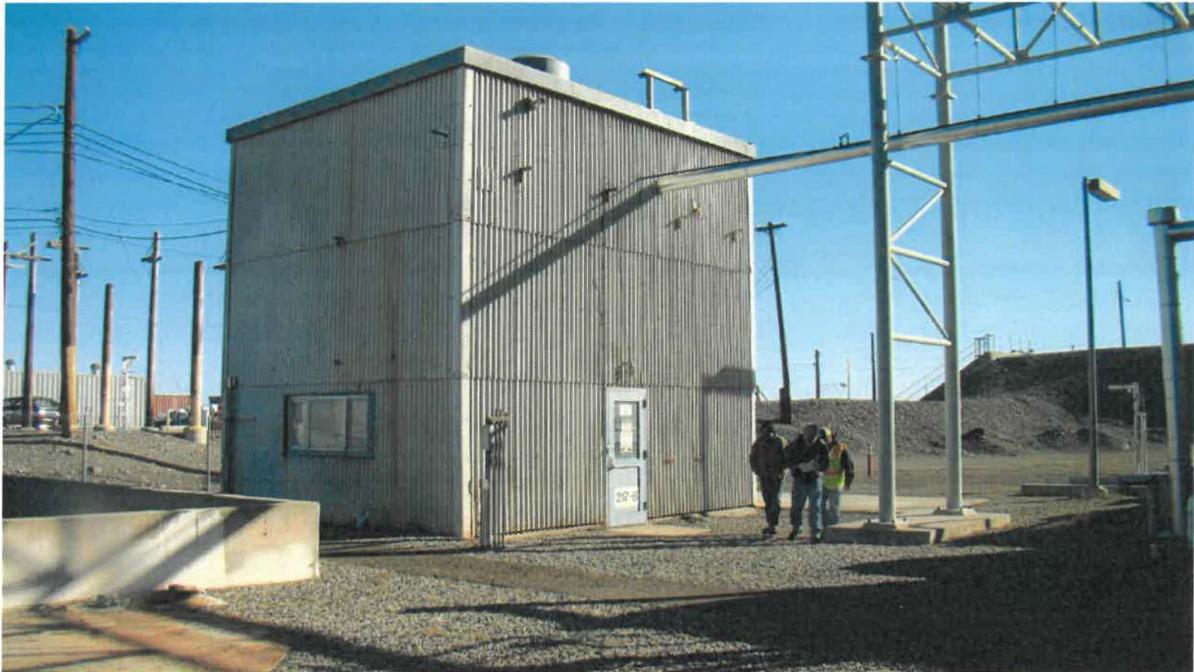
217B Before Demolition

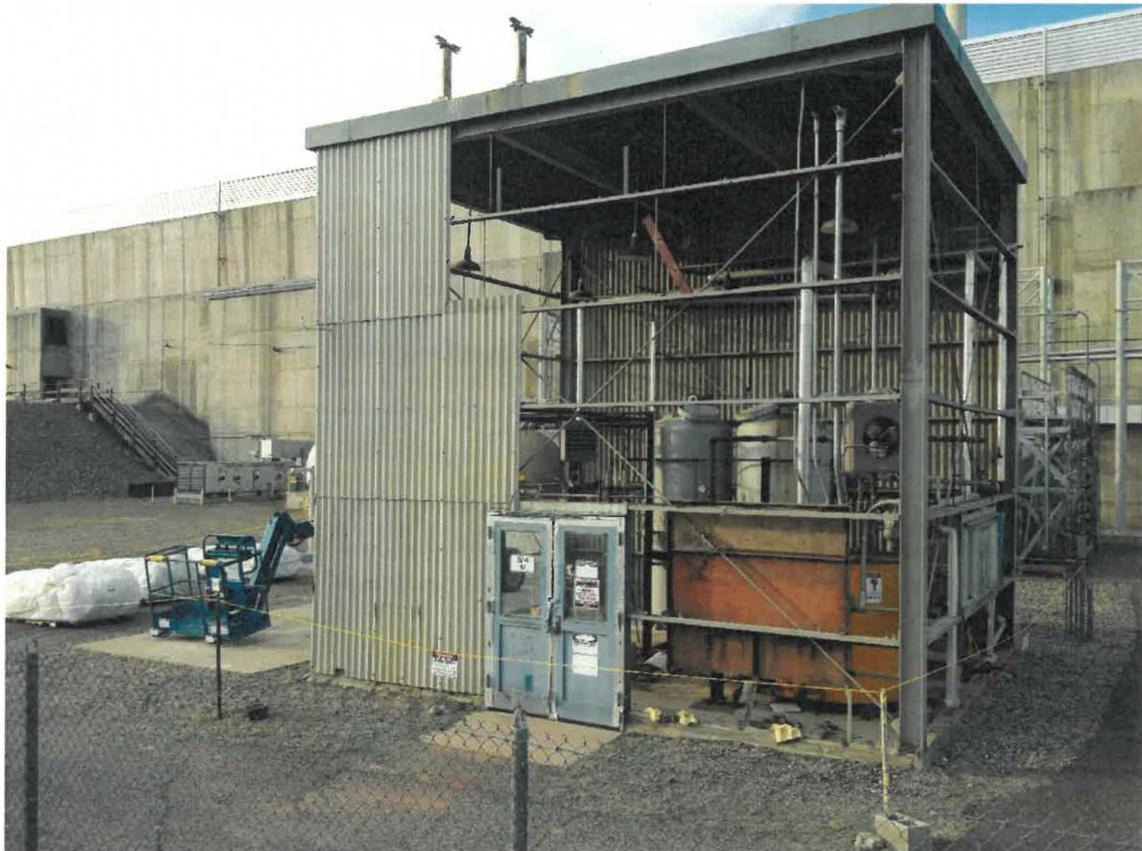
217B Transite removal prior to Demolition

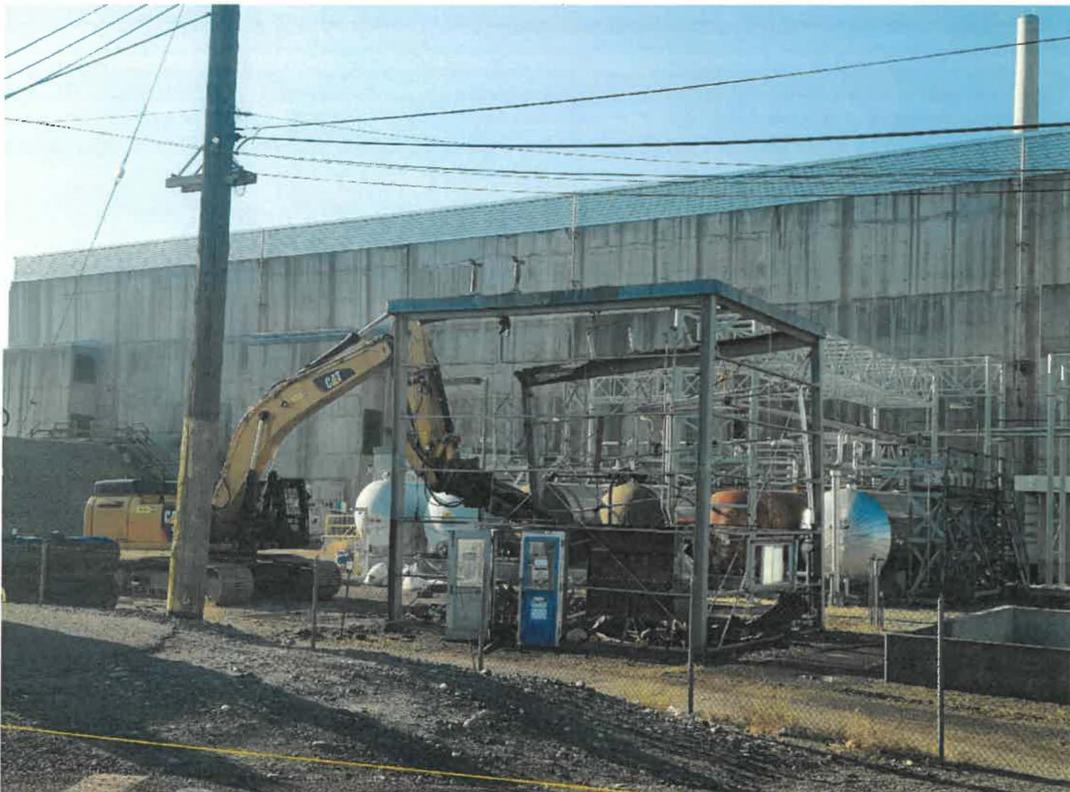
217B During Demolition

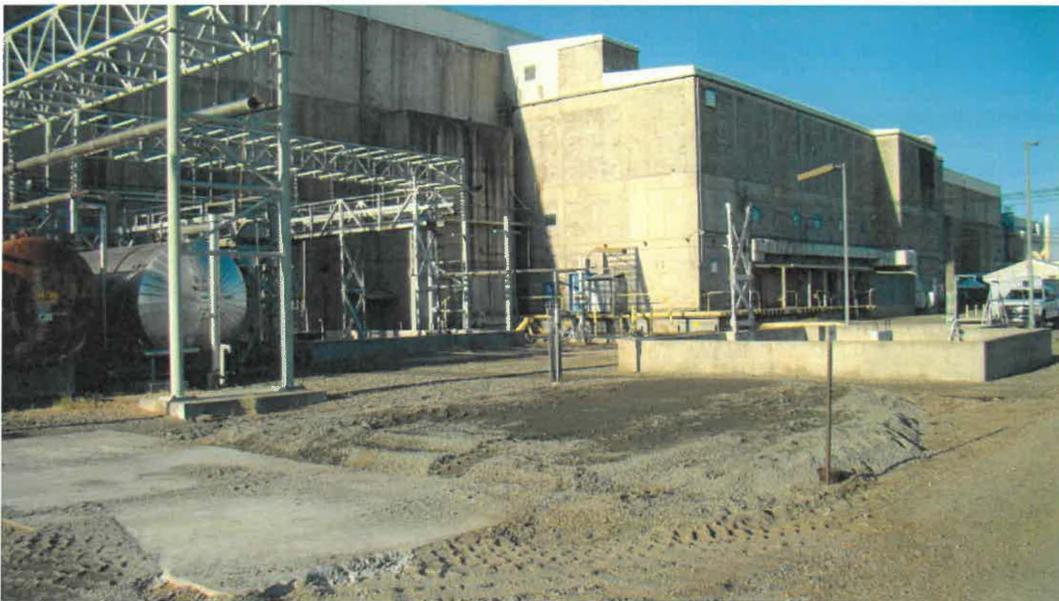
Above Grade structure completely removed down to grade, the slab was left in place, all penetrations in remaining slab were grouted and plugged and a minimum 6" gravel (5/8 minus) cap was placed over and contoured.

217B After Demolition
