Re: Washington State Department of Ecology (Ecology) Assessment Report for Field Monitoring Activities conducted November 12, 2012 of the waste material near Riser 83 of the 241-AY-102 Double Shell Tank (DST)

## ASSESSMENT REPORT

### Field Monitoring Activities

Project: 241-AY-102 Field Monitoring, Riser 83 Video

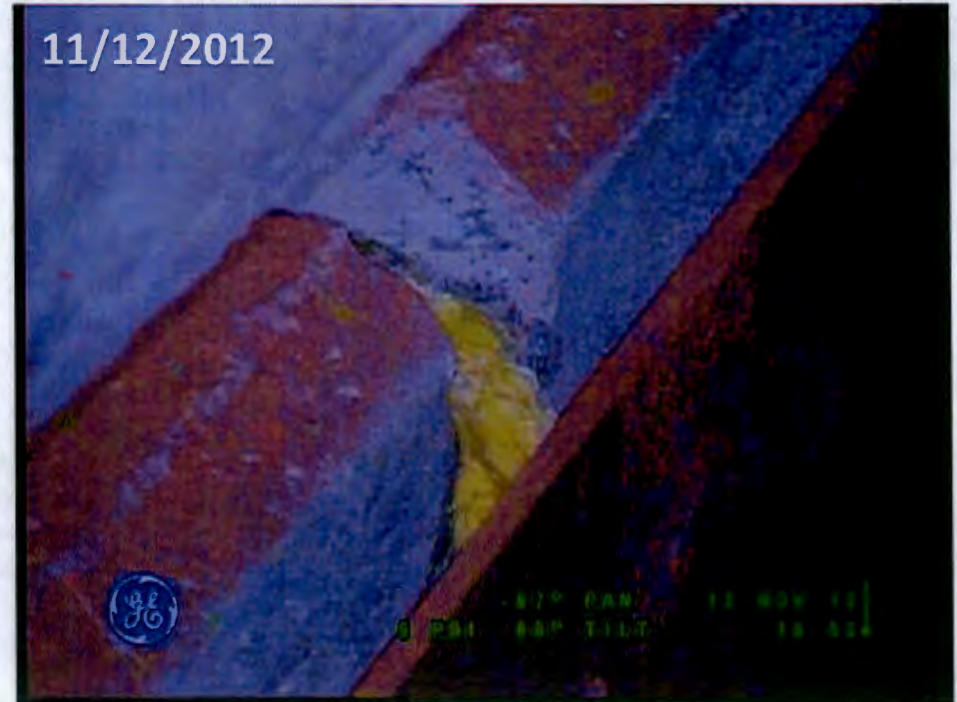
11/12/2012

- The camera viewed the waste in respect to the different in-annular space "landmarks" including the black dot or rock, two white pebbles and ventilation slots. It was noted by all witnessing the video that the size of the area of the waste material did appear to have slightly increased in size, especially in the ventilation slot landmark, as compared to the amount of waste material viewed during the visual inspection conducted on 10/25/12.

- All witnessing the video also noted that there appeared to be moisture streaks indicating that the concrete near the ventilation slot was wet on either side of the waste. This had been viewed during previous visual inspections.

- Ecology noted that there appeared to be an increased amount of white mineralization on the outside perimeter of the waste material in the annulus space.

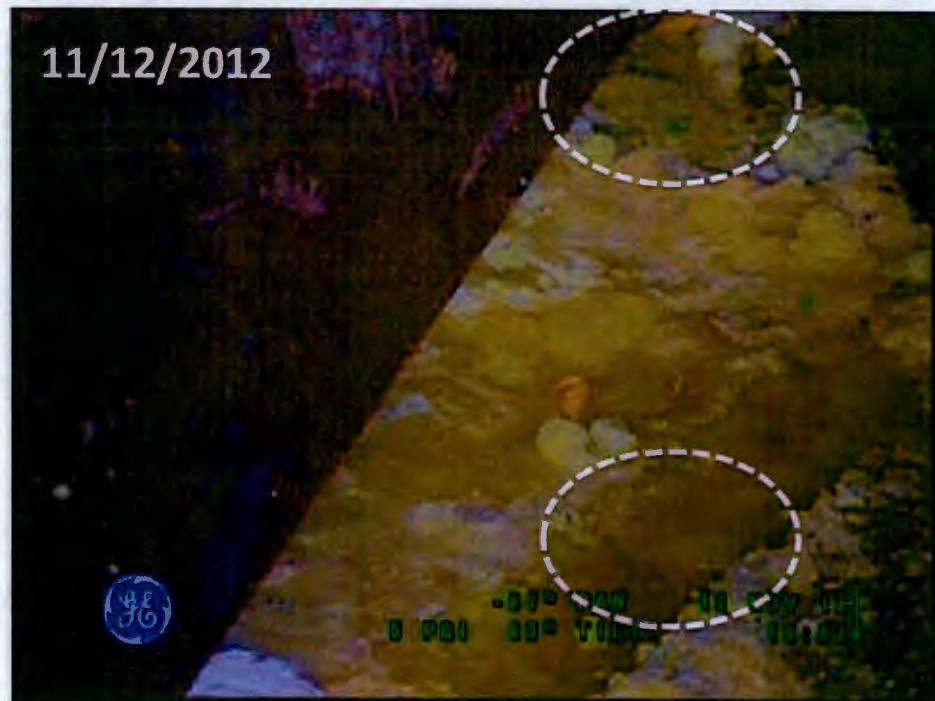
11/12/2012

- All witnessing the inspection noted that the color of the waste appeared to be changing. The dark green was changing to a lighter green in some locations. The lighter green was becoming a dark yellow. The darker yellow was changing to a lighter yellow. The lighter yellow was turning to a white color along the waste perimeter. This indicates that the waste material may be drying, most likely due to the ventilation.

- had turned from yellow to white and appeared to "grow" in height or crystalize. And as this white waste material appears to increase in height, the finger channels of waste or pools of waste (that are dark green, light green, and yellow) appear to look deeper and slightly extend in length.

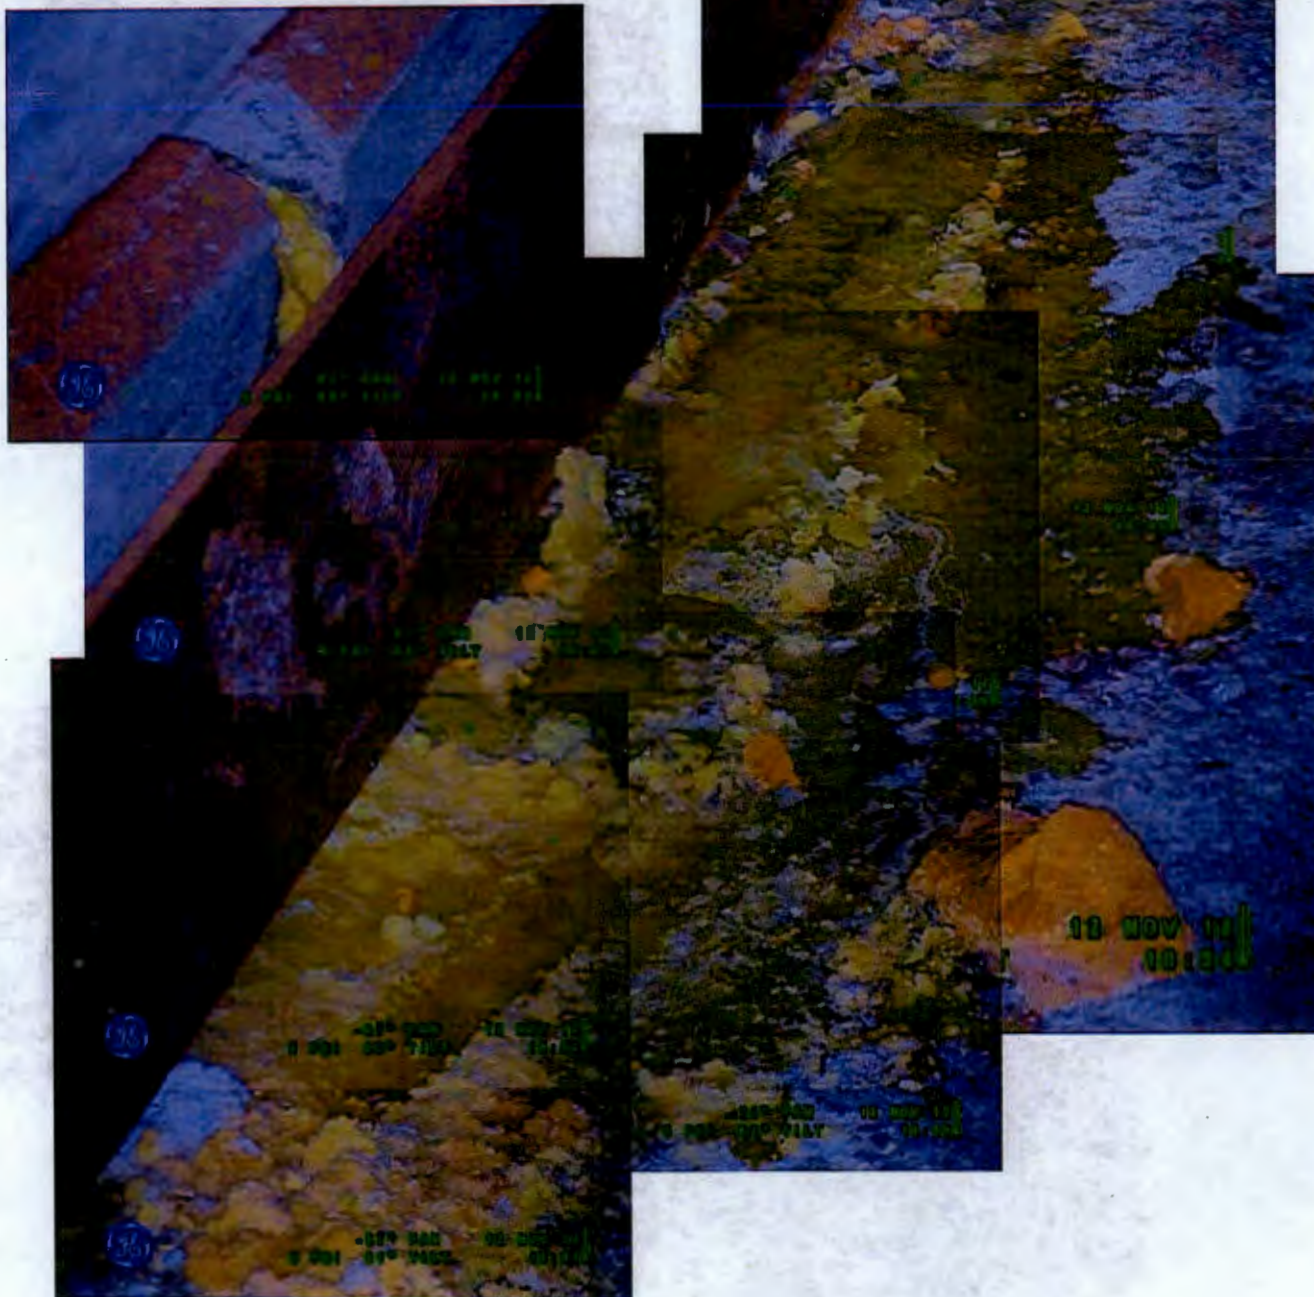
11/12/2012

- Ecology also noted some rust and pitting on the primary tank. It is unclear if this was previously identified or if it is a newer development.
- Ecology also noted that the waste material near the 6-inch refractory/connector ring

- Ecology could not visually distinguish if any visual damage indicators such as staining, cracking, pitting, etc. of the 6 inch wide carbon steel refractory ring, annulus floor, primary tank liner, or the refractory/concrete material where the waste was in direct contact with the tank structures. This lack of visual assessment is due to the increased growth of crystals, especially in the lower 2/3rds of the leak area and increased amount of deposition of mineralization around the perimeter of the leak area within the annulus. It is unknown at this time what influence the waste will have that is contacting the annulus floor and refractory/concrete pedestal.
