SUBJECT: **Post-Demolition Summary Report for the 183-B Water Treatment Plant Clearwells and Pump House**

Post-Demolition Summary Report for the 183-B Water Treatment Plant Clearwells and Pumphouse

May 2014

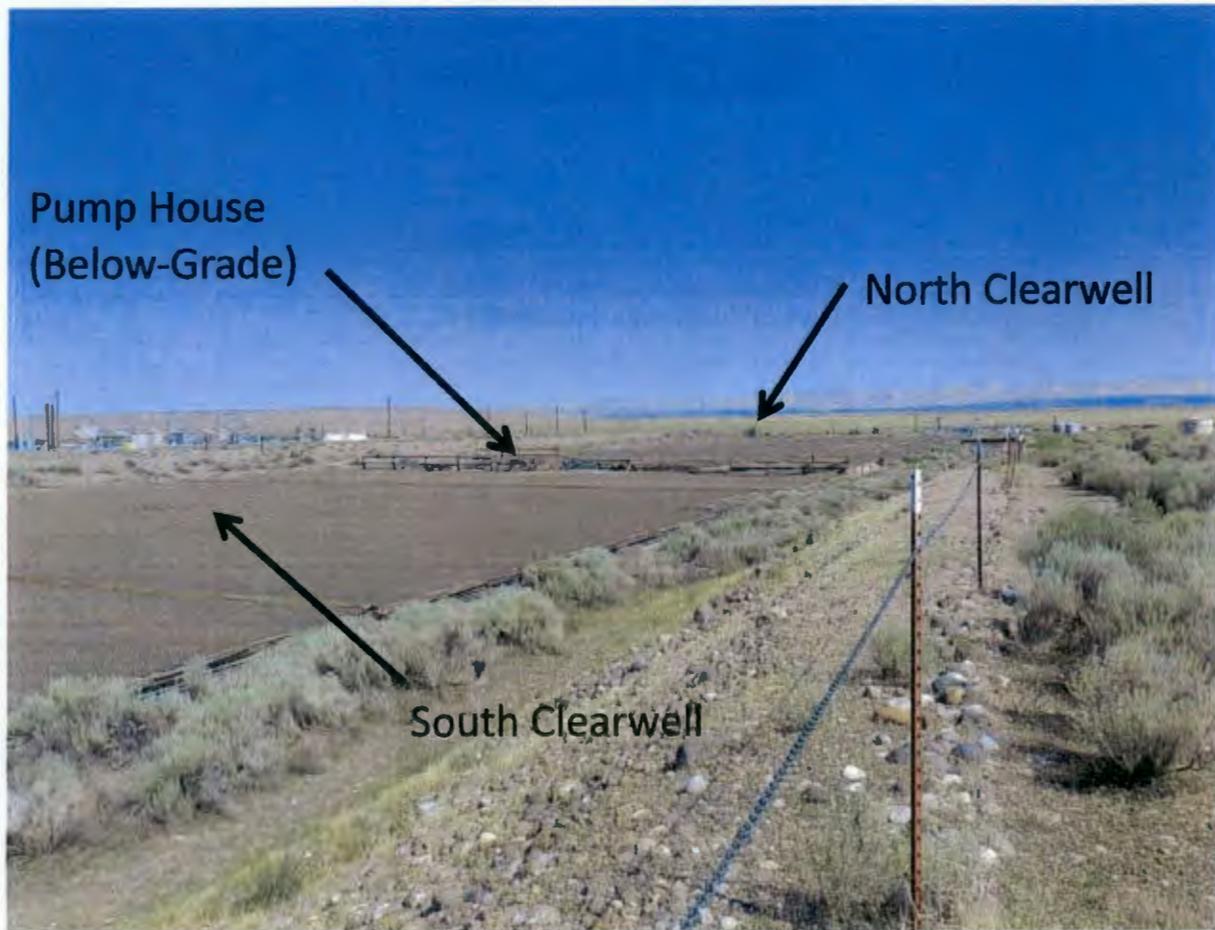
**Figure 1. 183-B Water Treatment Plant Clearwells and Pump House - Pre-Demolition
July 16, 2013 – Looking Northwest**

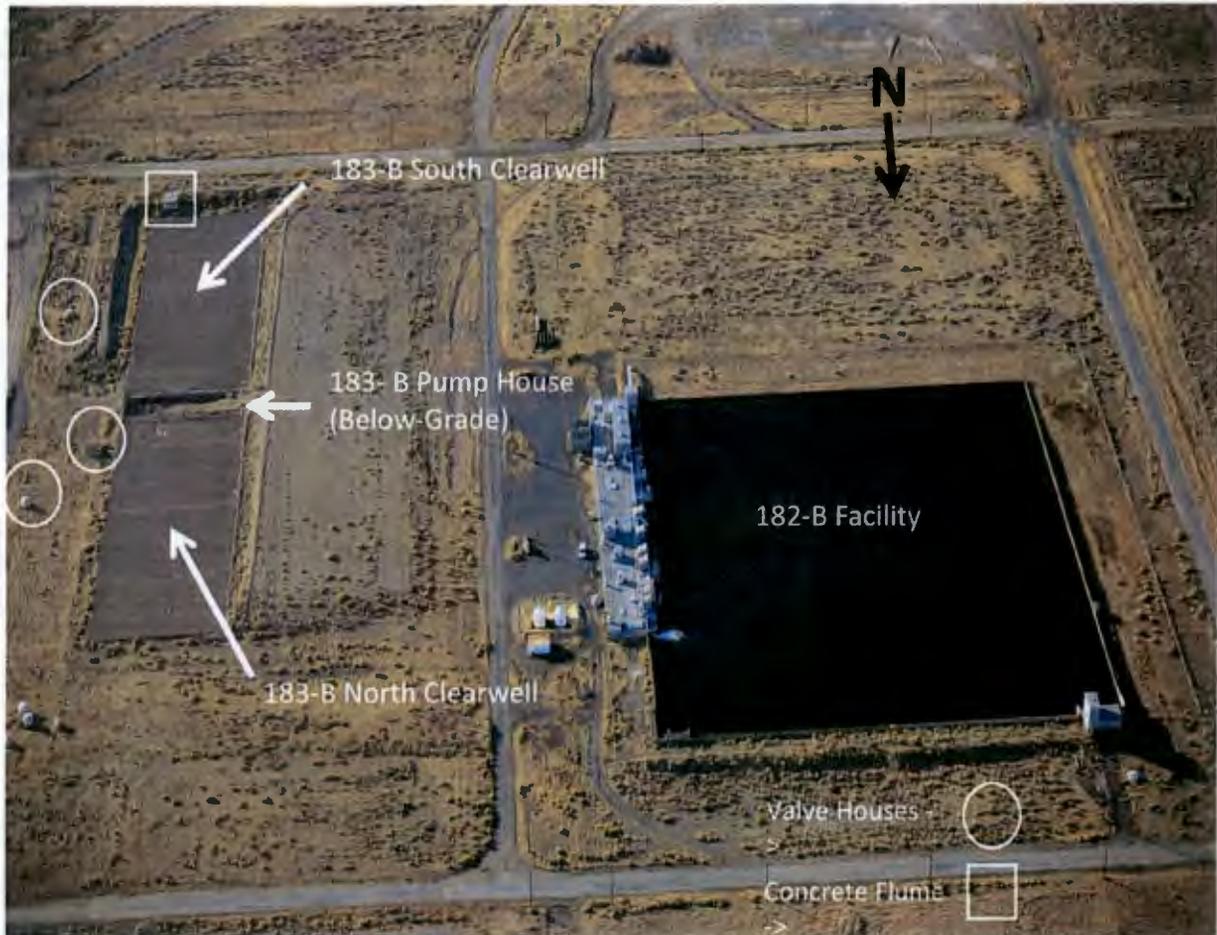
**Figure 2. Aerial View 183-B Water Treatment Plant Clearwells and Pump House – Pre-Demolition
October 17, 2012 – Looking South**

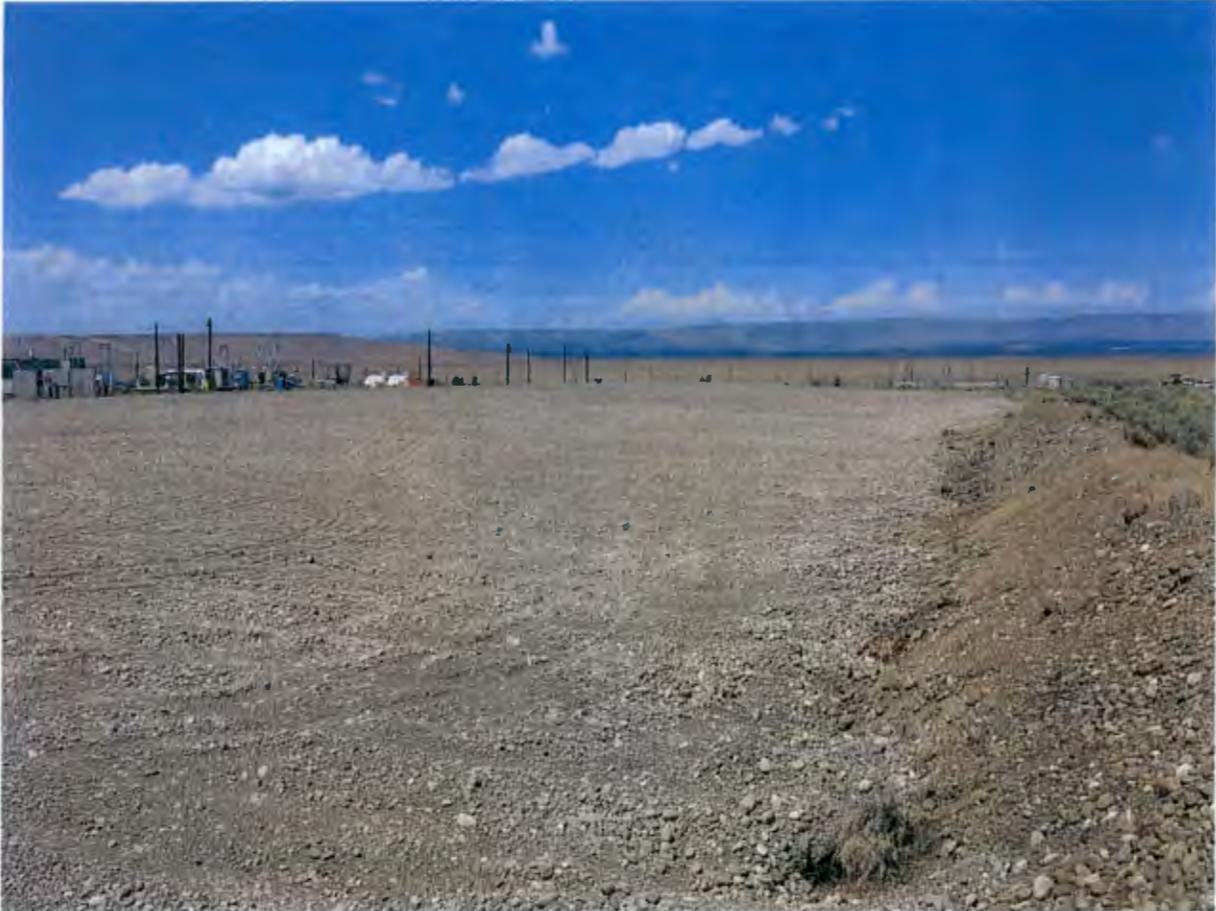
**Figure 3. 183-B Water Treatment Plant Clearwells and Pump House – Post-Demolition
June 2, 2014 – Looking Northwest**

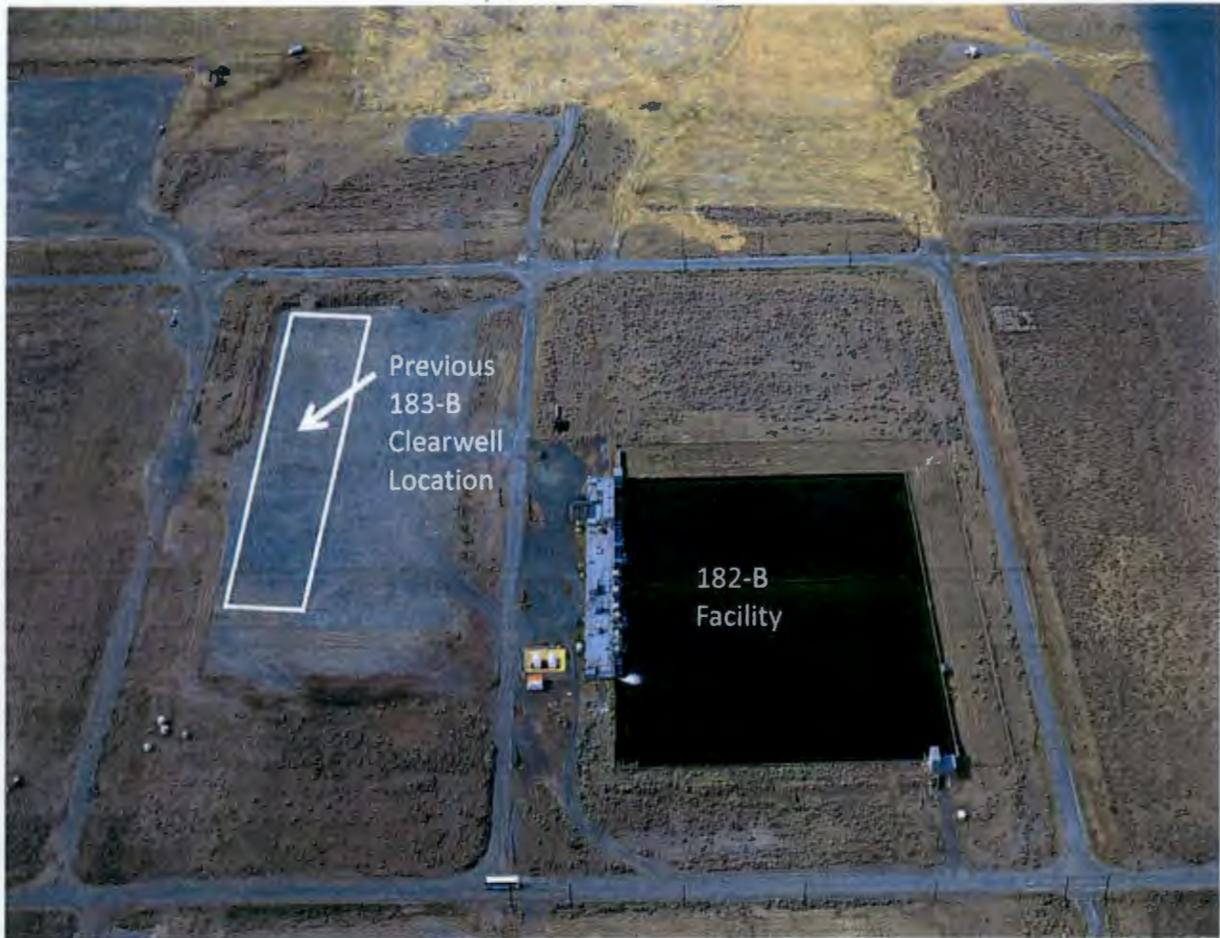
**Figure 4. Aerial View 183-B Water Treatment Plant Clearwells and Pump House – Post Demolition
June 12, 2014 – Looking South**
