INTEROFFICE MEMORANDUM

7G410-MEJ-07-004

Subject: INFORMATION ON PROCESS WASTE PIPELINE FAILURES DUE TO CORROSION

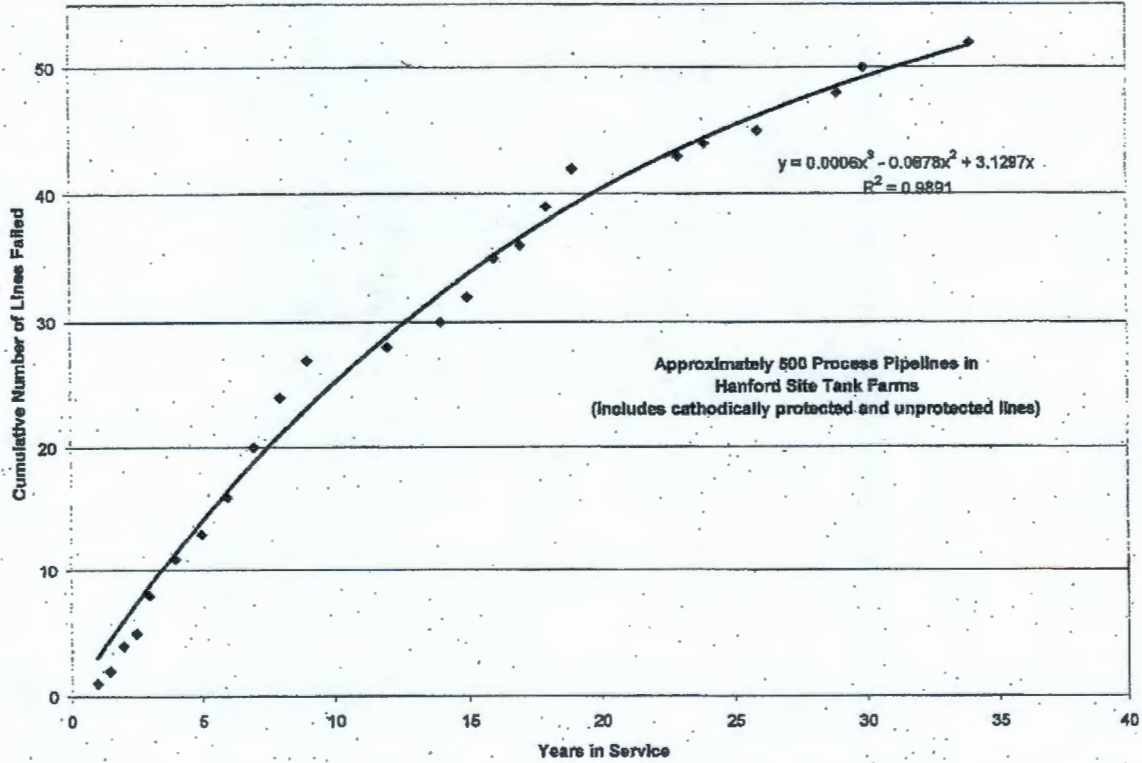
Figure 1 Failure Frequency of Hanford Tank Farm Process Pipelines

The cumulative number of pipelines failed versus the number of years in service is presented in Table 2 (Enclosure 1), excluding the pipelines that have unknown years in service. The failure frequency of process waste pipelines is plotted in Figure 1 (Enclosure 1).
