Asbestos NESHAP Thorough Inspection Report at
MO2308, MO2501 and MO2502

Document Number: CWR-PFP-00030

The purpose of this report is to disclose the results of an asbestos thorough inspection of MO2308, MO2501 and MO2502 at the Plutonium Finishing Plant Complex.

Document Type: RPT Program/Project: PFP Closure

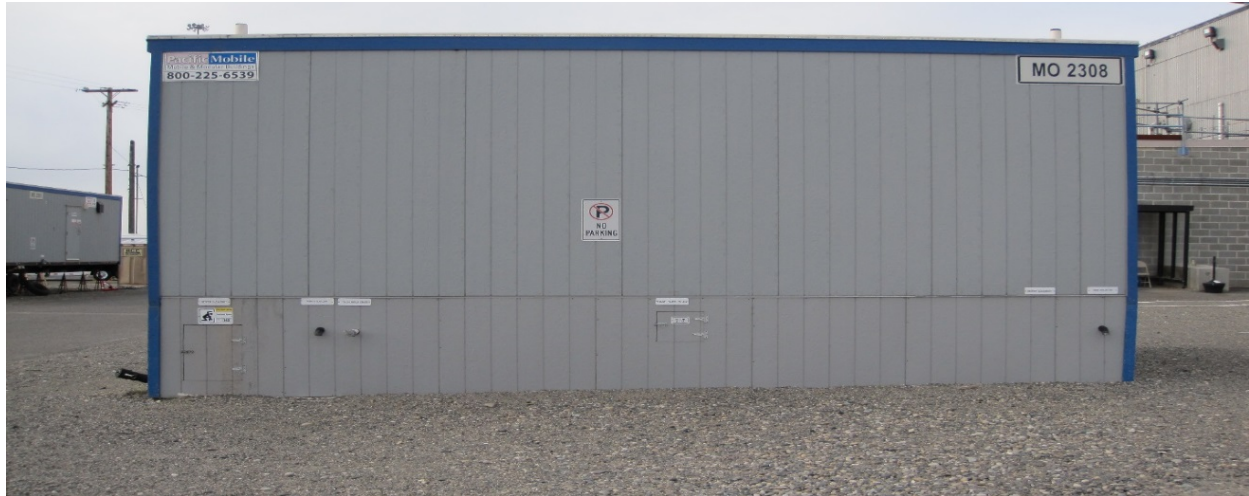
Figure 2. MO2308 Exterior, North Side

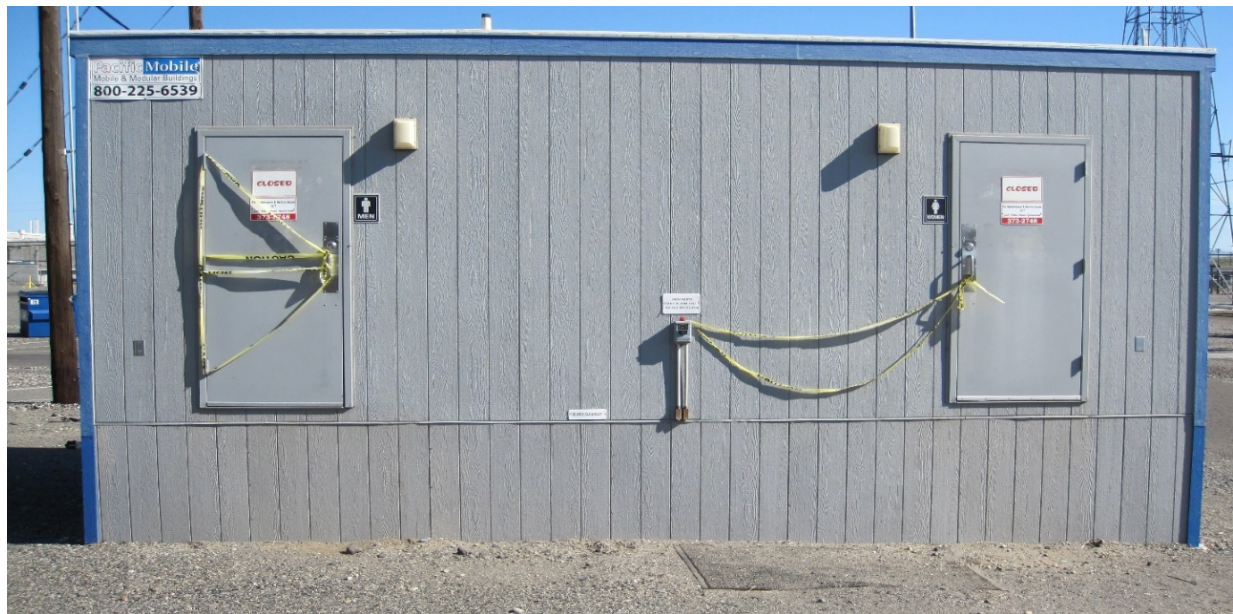
Figure 3. MO2308, South Side

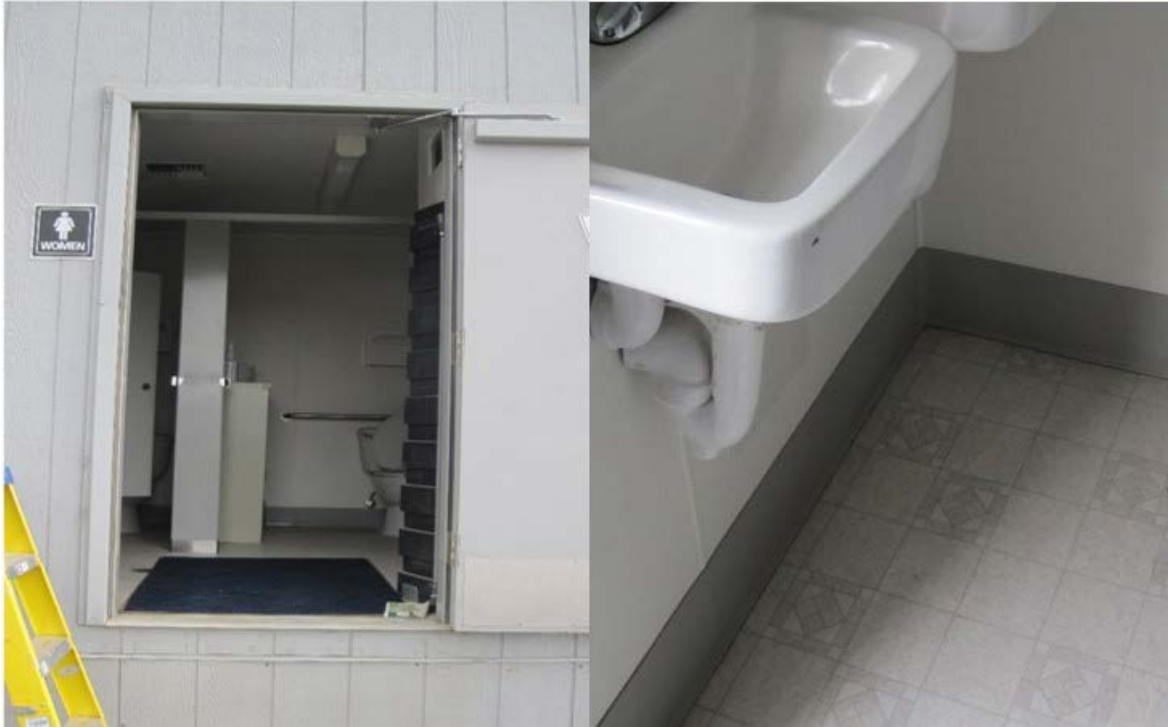
Figure 4. MO2308 Interior Women's Side

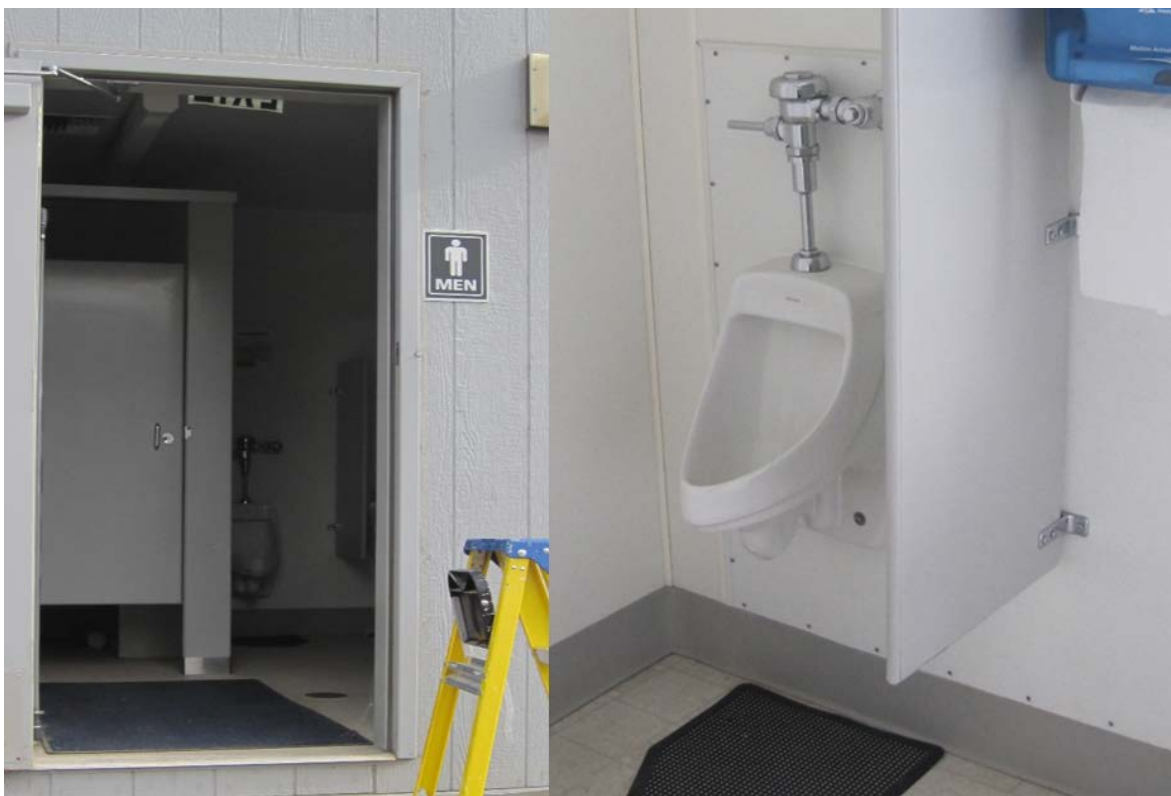
Figure 5. MO2308 Interior, Men's Side

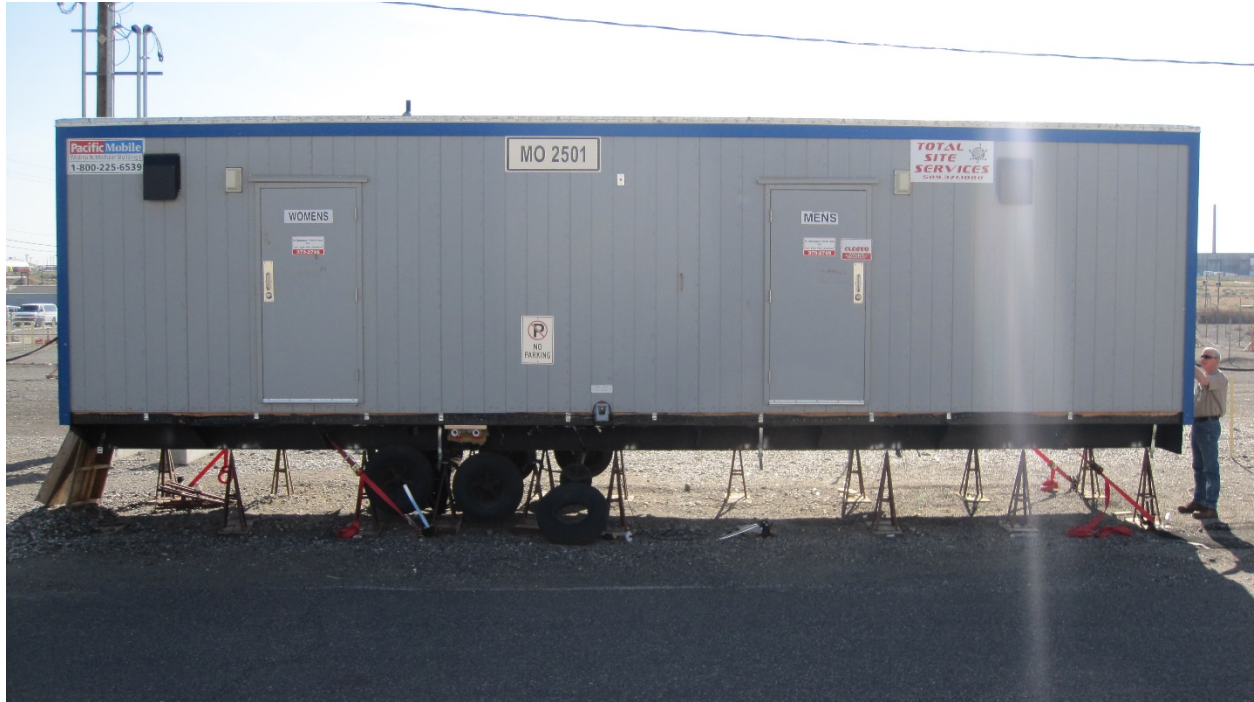
Figure 6. MO2501 Shower Facility, Exterior South Side

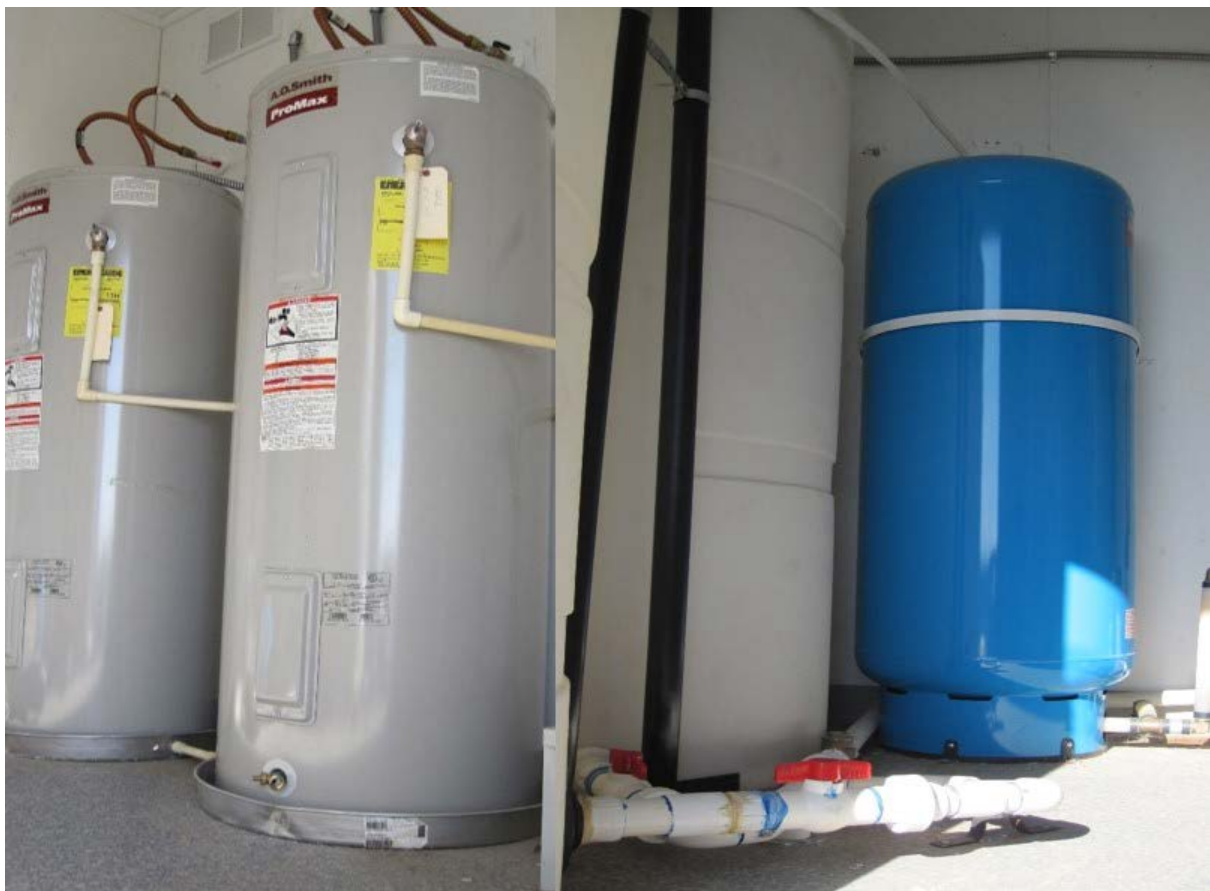
Figure 7. MO2501 Interior, Hot Water Heater and Water Supply Tank Room

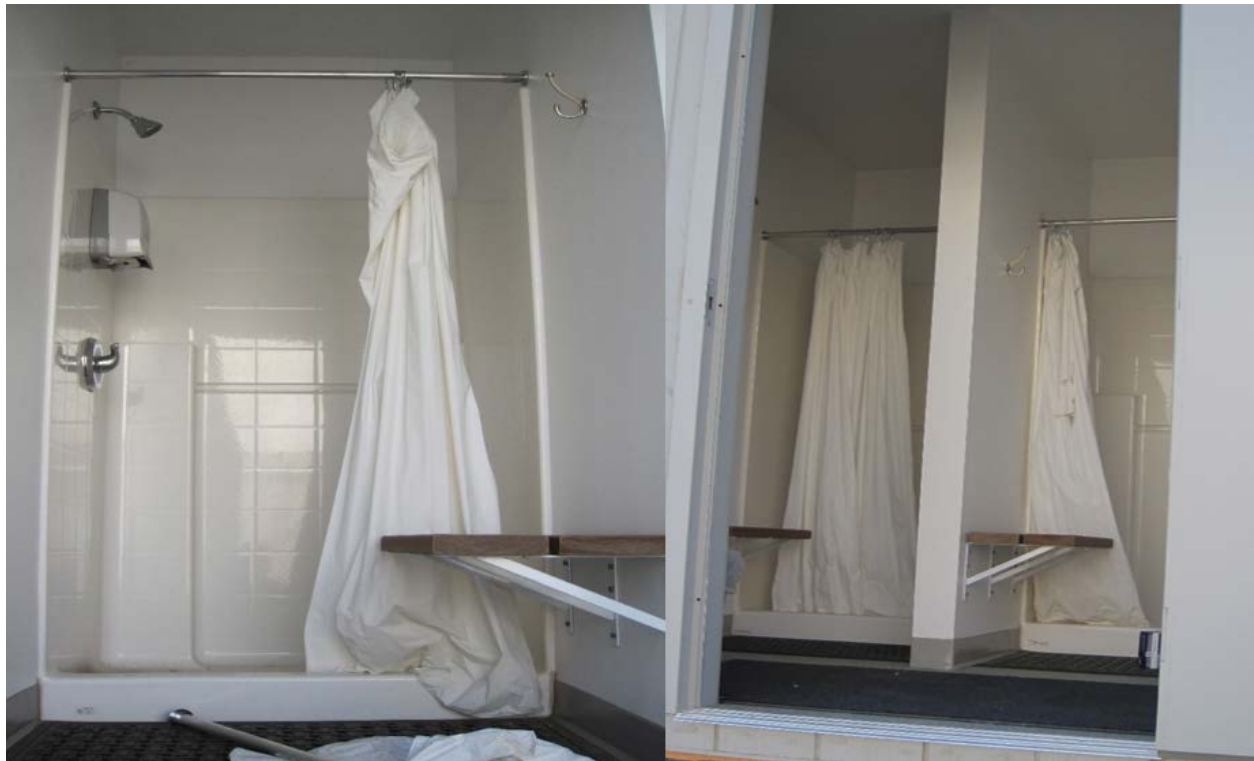
Figure 8. MO2501 Interior View of Shower Rooms

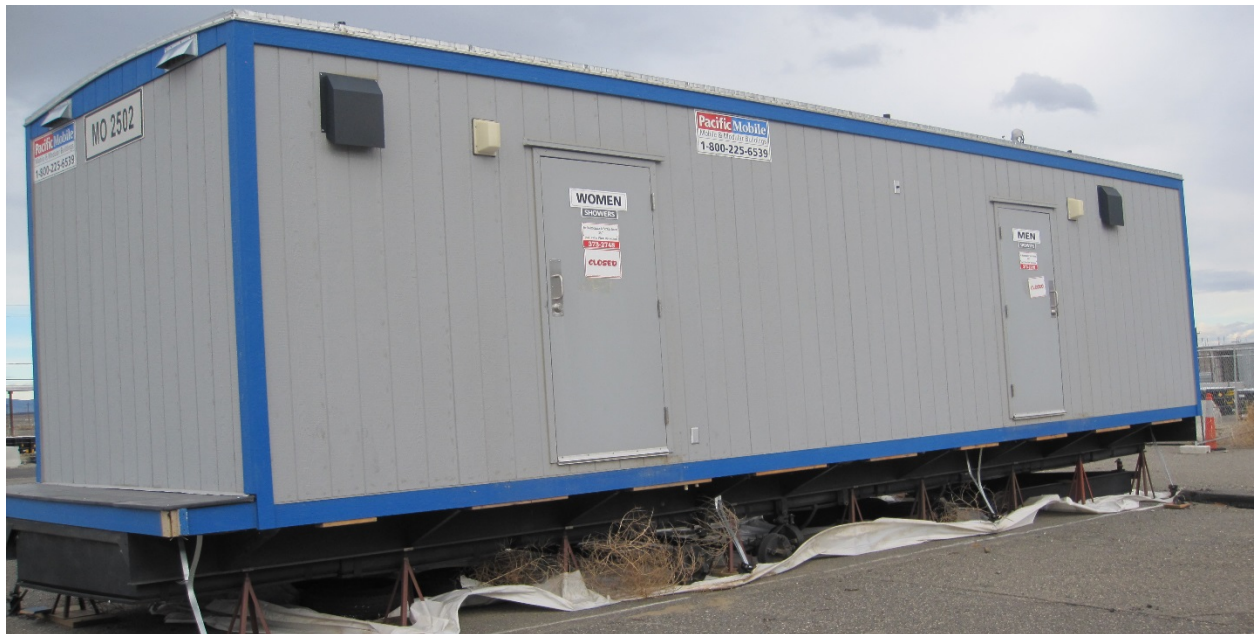
Figure 9. MO2502, Shower Facility, Exterior View South Side

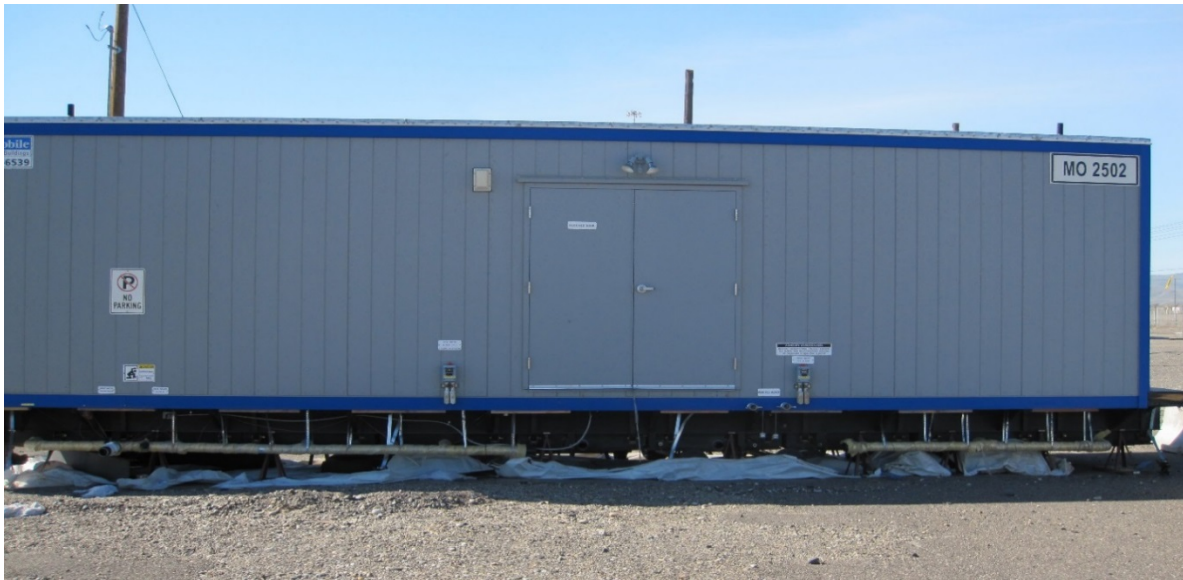
Figure 10. MO2502 Exterior View, North Side; Doors to Hot Water Heater/Supply Tank Room

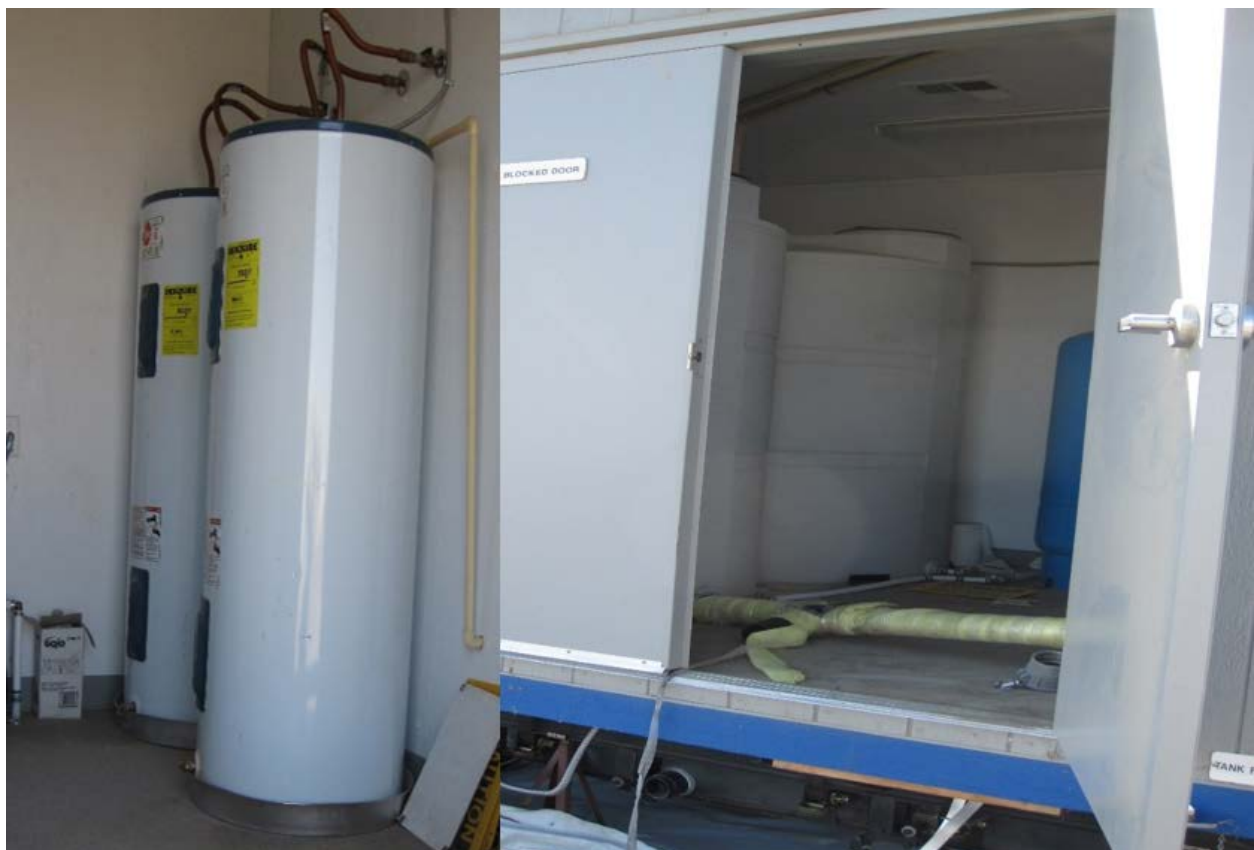
Figure 11. MO2502 Hot Water Tank and Water Supply Tank Room, North Side

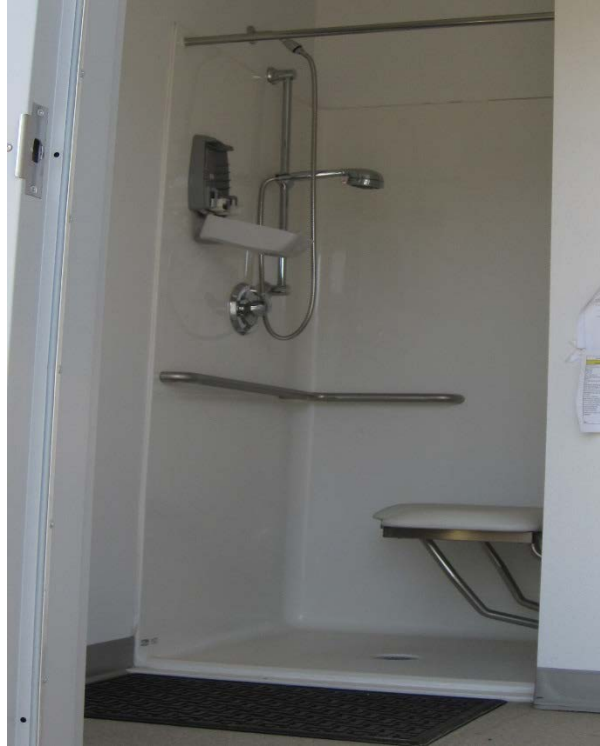
Figure 12. MO2502, Shower Stall
