Re: Washington State Department of Ecology (Ecology) Assessment Report for Field Monitoring Activities Conducted December 27, 2012, of the Waste Material Near Riser 83 of the 241-AY-102 Double Shell Tank (DST)

## ASSESSMENT REPORT

### Field Monitoring Activities

Project: 241-AY-102 Field Monitoring, Riser 83 Video  
 Project Contact: Jeremy Johnson (ORP) Phone: (509) 376-1866  
 Review Date: 12/27/2012  
 Reviewer: Michelle Hendrickson, CHMM, PE  
 USDOE Project: US Department of Energy-Office of River Protection (USDOE-ORP)  
 USDOE Contact: Tom Fletcher/Jeremy Johnson  
 Prime Contractor: Washington River Protection Solutions (WRPS)  
 Project Manager: Michael Hardesty Phone: (509) 373-4573  
 Location: 241-AY-102, 200 East Area, Hanford  
 Scheduled Start Date: 12/27/2012 Actual Start Date: 12/27/2012 Completion Date: 12/27/2012  
 Contract Amount: Approximately \$75,000 for 4 Riser Visual Inspections  
 Sub-Contractor: N/A  
 Location: 200 East Area, Hanford Nuclear Reservation, Richland, WA

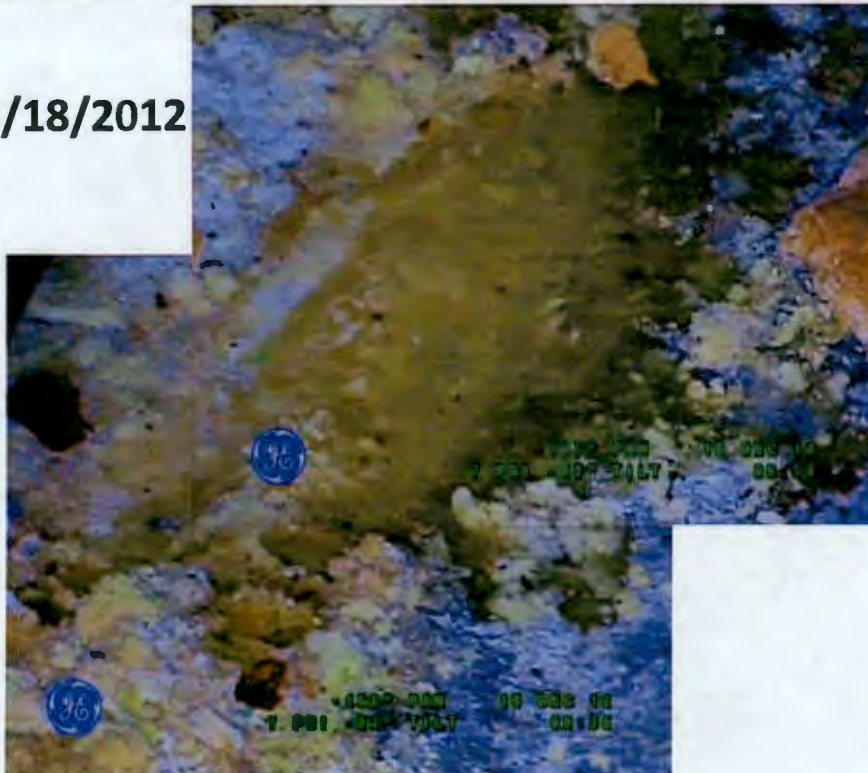
12/27/2012

- The camera viewed the waste in respect to the different in-annular space "landmarks" including the black dot or rock, two white pebbles, orange pieces of insulation/foam, and ventilation slots. It was noted by all witnessing the video that the size of the area of the waste material did appear to have slightly increased in size, near the upper portion of the leak where the waste material extends outward in "finger channels" and near the smaller piece of orange insulation/foam. The extent of the leak seemed to slowly expand as compared to the amount of waste material viewed during the visual inspection conducted on 10/25/12 and 11/12/2012.

- Ecology noted that the increase in the extent of the waste material present within the annulus may be due to an increase in material or as a result of the draining of the

deeper pools of waste material outward onto the annulus floor. Many of these "deeper pools" of waste material as indicated by a darker green color of material, appeared to be lighter green in nature and not as thick, which may indicate they are draining.

- Ecology noted that the waste material in the ventilation slot appeared to be wider and thicker, especially on the base near the 6 ½ inch ring. The top of the material appeared to have dried where it contacted the concrete. However, moisture streaks on either side of the waste material within the ventilation slot were again visible.

- Ecology also noted that the waste material the finger channels of the waste or pools of waste (that are dark green, light green, and yellow) appear to look deeper, extend in length, and had split to flow toward another direction creating an additional finger channel.
