WCH-292

River Corridor Closure Contract

105-C Safe Storage Enclosure, Five-Year Surveillance in July 2008

December 2008

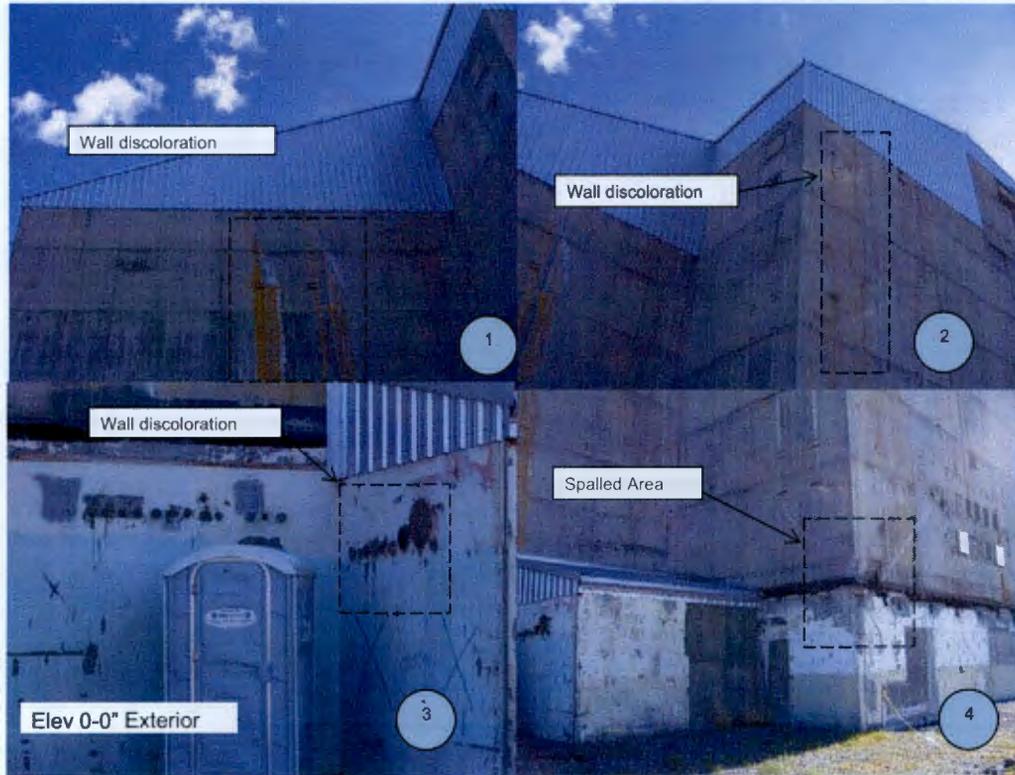
Figure 2. Exterior Building Details - Grade Level, SW Wall Areas.

- Item 1 – Wall Discoloration at SW Wall of Building Exterior, Elev 0'-0", minor corrosion
- Item 2 – Wall Discoloration at SW Corner of Building Exterior, Elev 0'-0", minor corrosion
- Item 3 – Exposed ISS Closure Details SW Wall of Building Exterior, Elev 0'-0", minor corrosion
- Item 4 – Exposed Aggregate & Rebar at SW Wall Corner of Building Exterior, Elev 0'-0", spalling

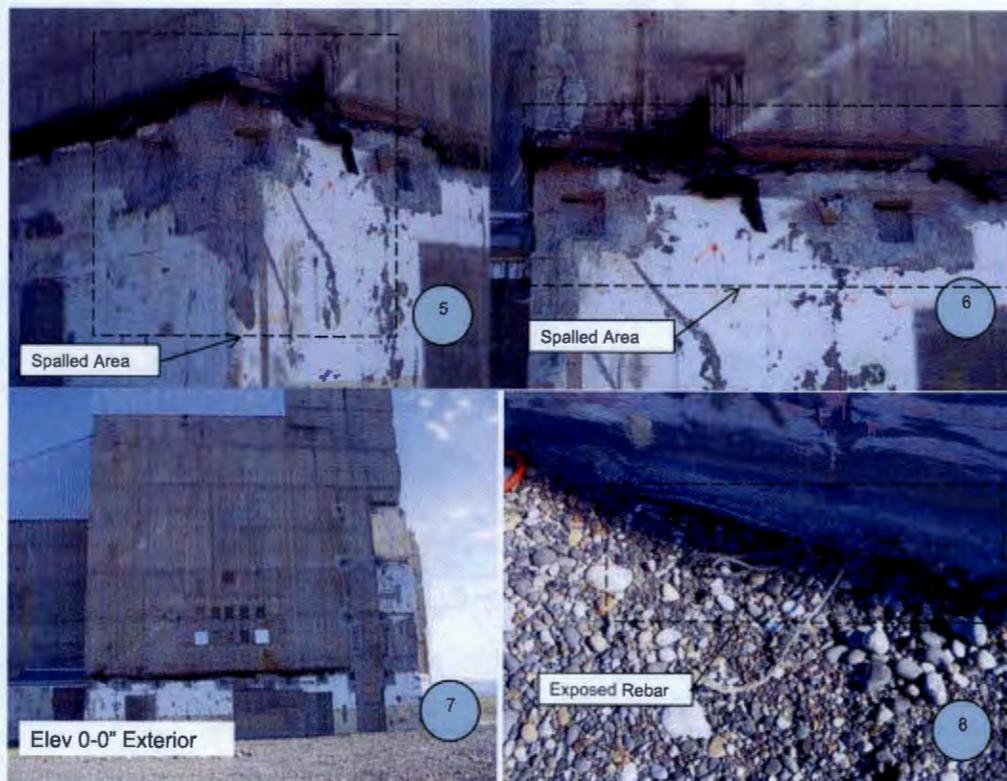
Figure 3. Exterior Building Details - Grade Level, South Wall Areas.

- Item 5 – Exposed Aggregate and Rebar at S Wall of Building Exterior, Elev 0'-0", minor corrosion, and spalling
- Item 6 – Exposed Aggregate at S Wall of Building Exterior, Elev 0'-0", spalling
- Item 7 – View of South Wall, Elevation 0'-0"
- Item 8 – Exposed Foundation/Floor Rebar at S Wall of Building Exterior, Elev 0'-0", recommend soil removal

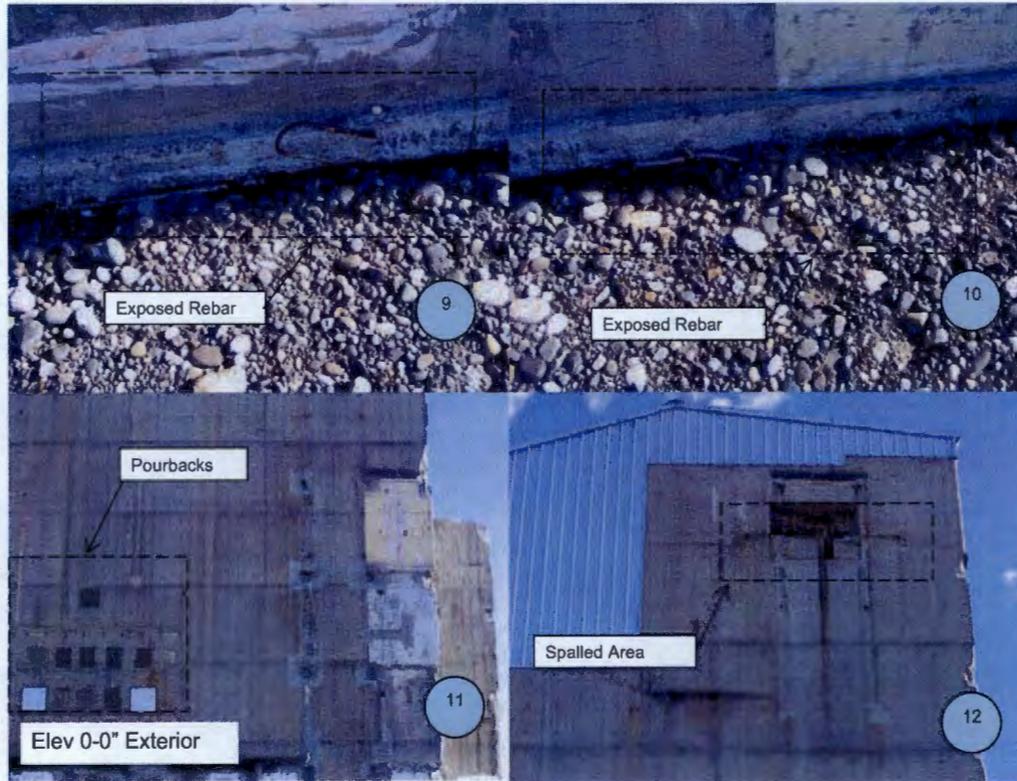
Figure 4. Exterior Building Grade Level Details, South Wall.

- Item 9 – Exposed Foundation/Floor Rebar at S Wall of Building Exterior, Elev 0'-0", recommend soil removal.
- Item 10 – Exposed Foundation/Floor Rebar at S Wall of Building Exterior, Elev 0'-0", recommend soil removal
- Item 11 – Pourback ISS Detail at S Wall of Building Exterior, as seen from Elev 0'-0", no visible defect
- Item 12 – Exposed Aggregate Detail at S Wall of Building Exterior, as seen from Elev 0'-0", no visible defect

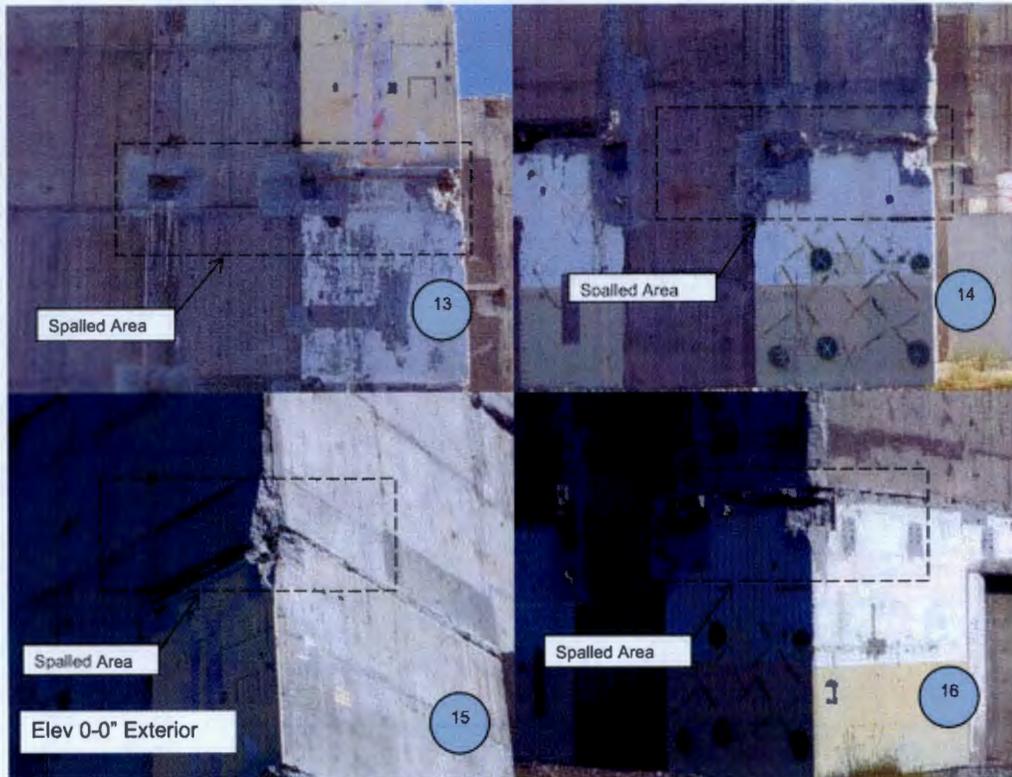
Figure 5. Exterior Building Grade Level Details, SE Wall.

- Item 13 – Exposed Aggregate at SE Wall Corner of Building Exterior, Elev 0'-0", spalling
- Item 14 – Exposed Aggregate at SE Wall Corner of Building Exterior, Elev 0'-0", spalling
- Item 15 – Exposed Aggregate at SE Wall Corner of Building Exterior, Elev 0'-0", spalling
- Item 16 – Exposed Aggregate at SE Wall Corner of Building Exterior, Elev 0'-0", spalling

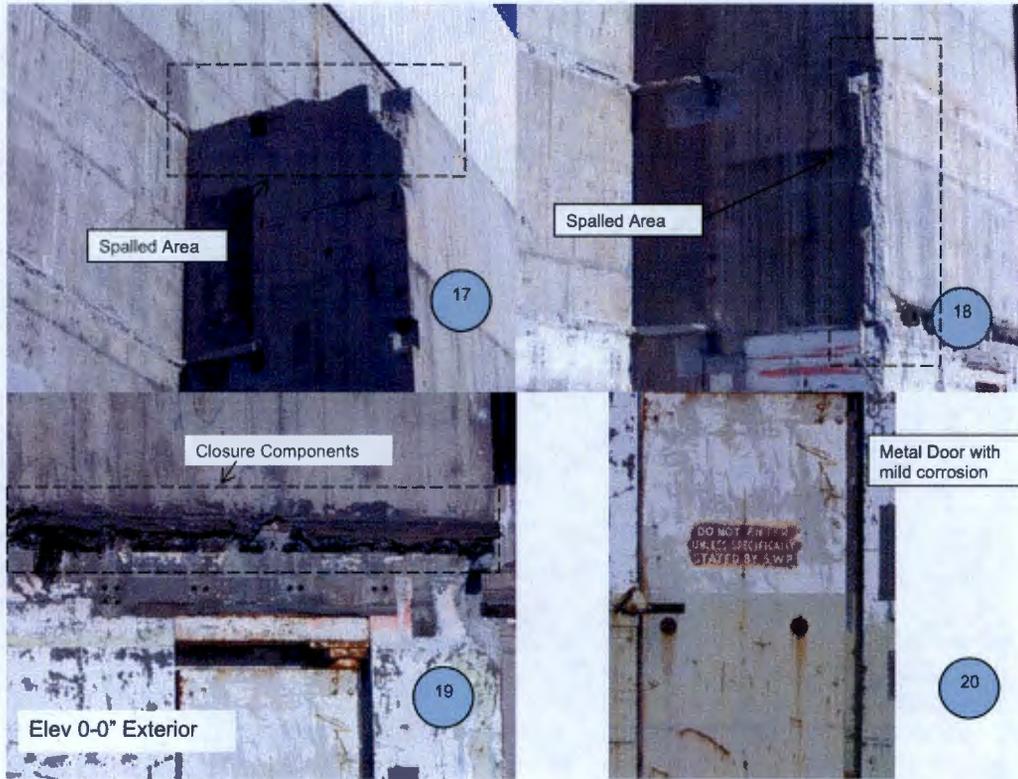
Figure 6. Exterior Building Grade Level Details – SE wall.

- Item 17 – Exposed Aggregate at SE Corner Wall of Exterior Building, Elev 0'-0", spalling
- Item 18 – Exposed Aggregate at SE Corner Wall of Exterior Building, Elev 0'-0", spalling
- Item 19 – Exposed ISS Detail at SE Wall of Exterior Building, Elev 0'-0", discoloration
- Item 20 – Existing Metal Door at SE of Exterior Building, Elev 0'-0", minor corrosion

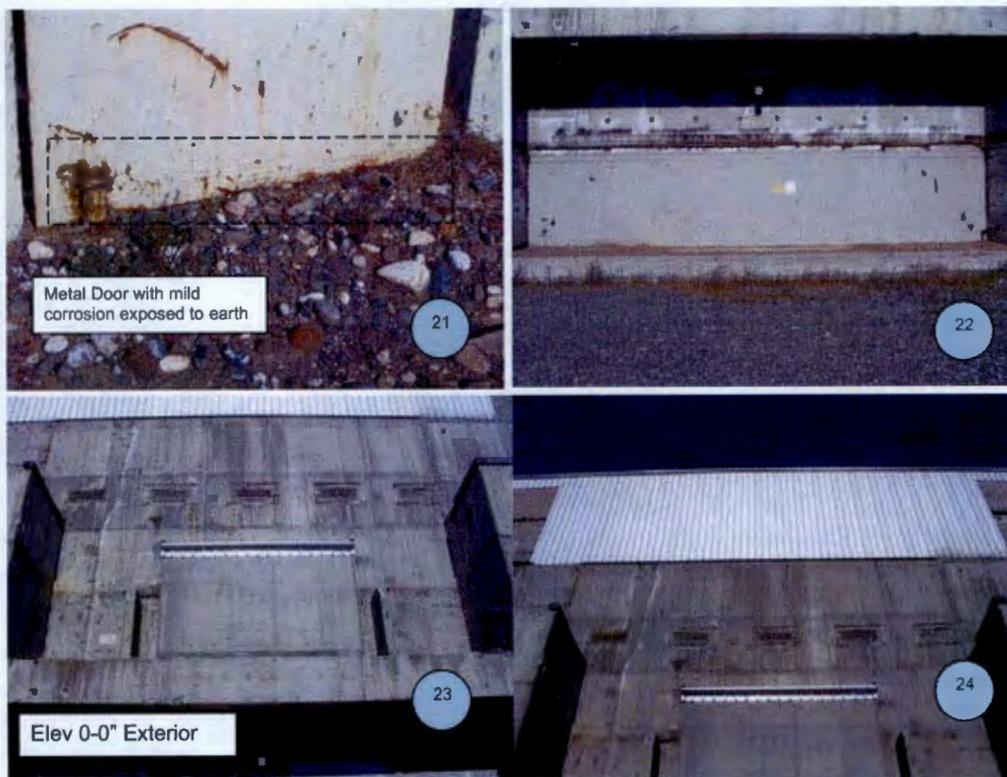
Figure 7. Exterior Building Grade Level Details – East Wall.

- Item 21 – Existing Reactor Metal Door at SE of Exterior Building Area , Elev 0'-0", minor corrosion, soil removal recommended
- Item 22 – ISS Closure Detail , Elev 0'-0", no visible defect
- Item 23 – ISS Closure Detail, as seen from Elev 0'-0", no visible defect
- Item 24 – ISS Closure Detail, as seen from Elev 0'-0", no visible defect

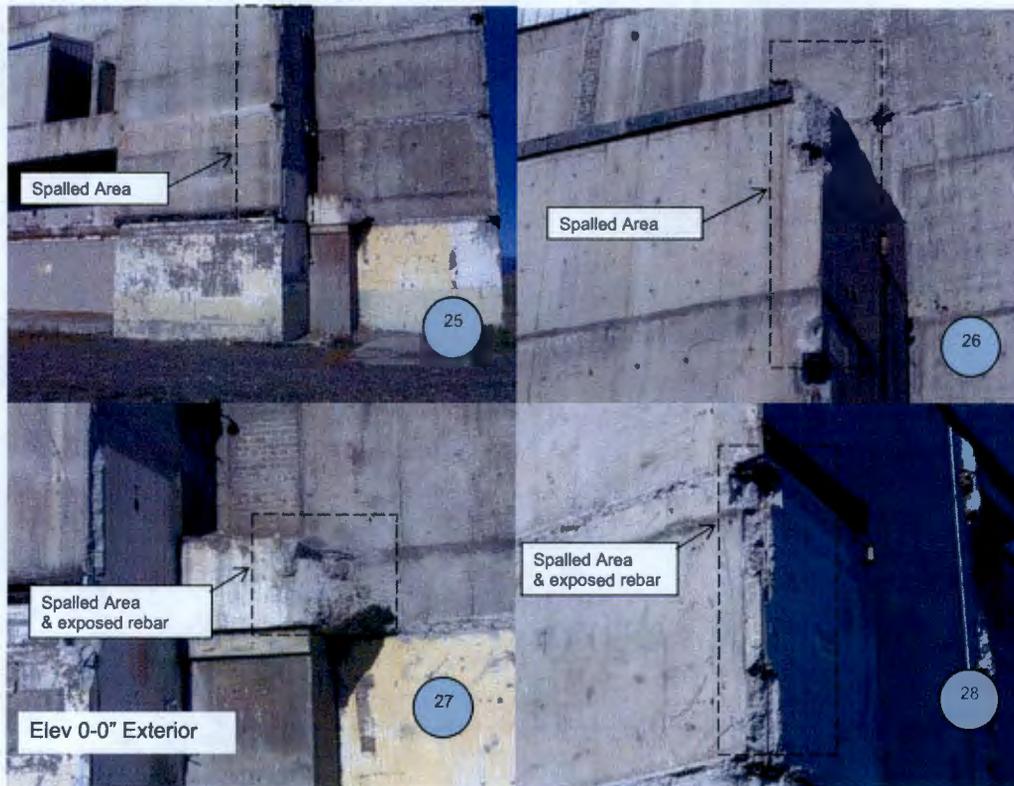
Figure 8. Exterior Building Grade Level Details, East Wall.

- Item 25 – Exposed Aggregate at E Corner Wall of Building Area , Elev 0'-0", spalling
- Item 26 – Exposed Aggregate at E Corner Wall of Building, Elev 0'-0", spalling
- Item 27 – Exposed Aggregate at E Corner Wall of Building, Elev 0'-0", spalling
- Item 28 – Exposed Aggregate at E Corner Wall of Building, Elev 0'-0", spalling

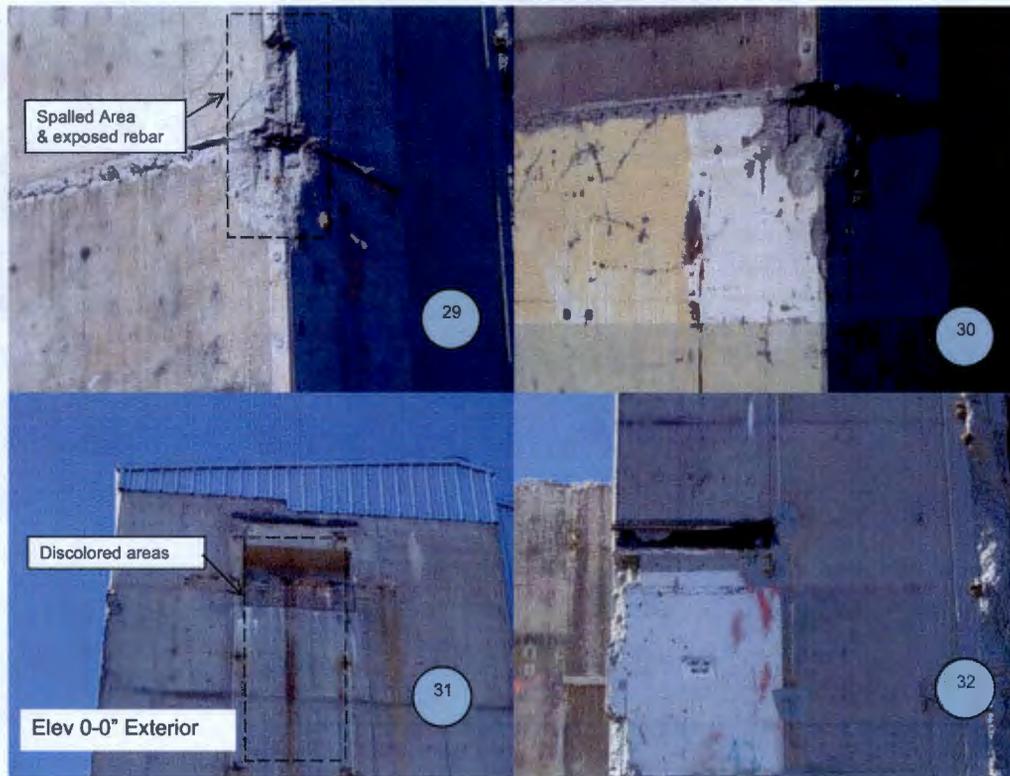
Figure 9. Exterior Building Details, NE Wall.

- Item 29 – Exposed Aggregate at NE Corner Wall of Building Exterior, Elev 0'-0", spalling.
- Item 30 – Exposed Aggregate at NE Corner Wall of Building Exterior, Elev 0'-0", spalling
- Item 31 – Pourback ISS Detail at NE Wall of Building Exterior, as seen from Elev 0'-0", discoloration
- Item 32 – Exposed Aggregate from ISS detail at Wall of Building Exterior, as seen from Elev 0'-0", no further visible defect

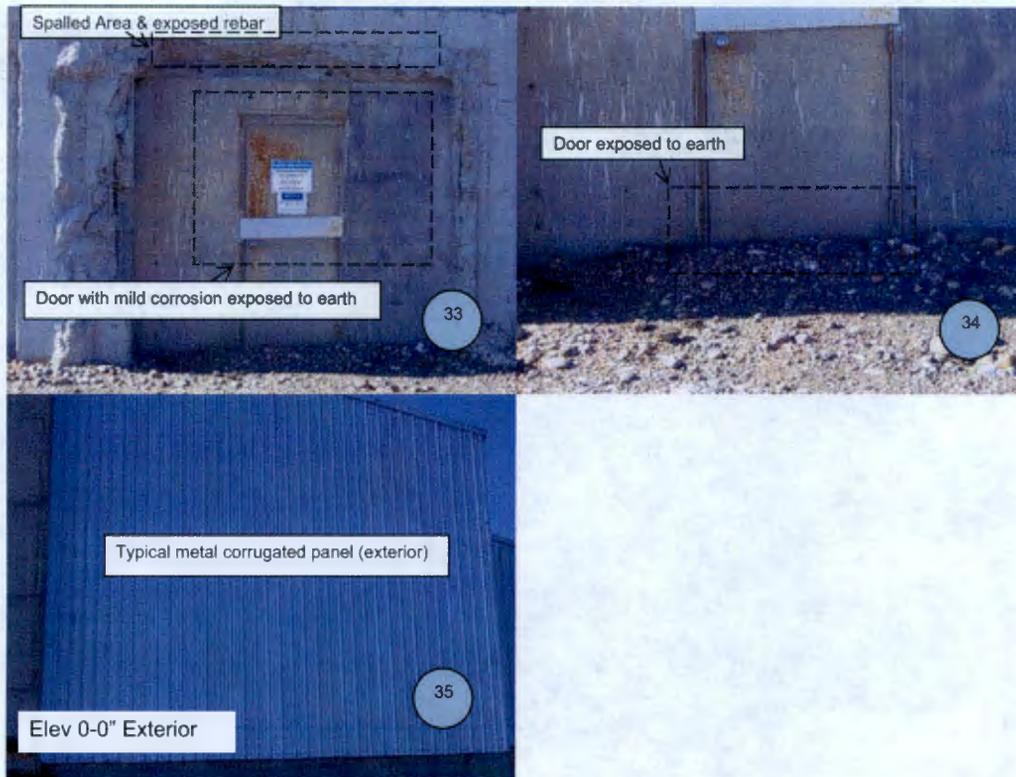
Figure 10. Exterior Building Details, North Wall .

- Item 33 - Metal Door at N Wall of Building Exterior, Elev 0'-0", mild corrosion.
- Item 34 - Metal Door Detail Exposed to Earth at N Wall of Building Exterior, Elev 0'-0", recommended soil removal
- Item 35 - Pourback ISS Detail at N Wall of Building Exterior, as seen from Elev 0'-0", no visible defect

- In several locations, exterior metal was found in contact with the soil. The aggregate that is in contact with the metal door common to the northeast side of the building should be removed.

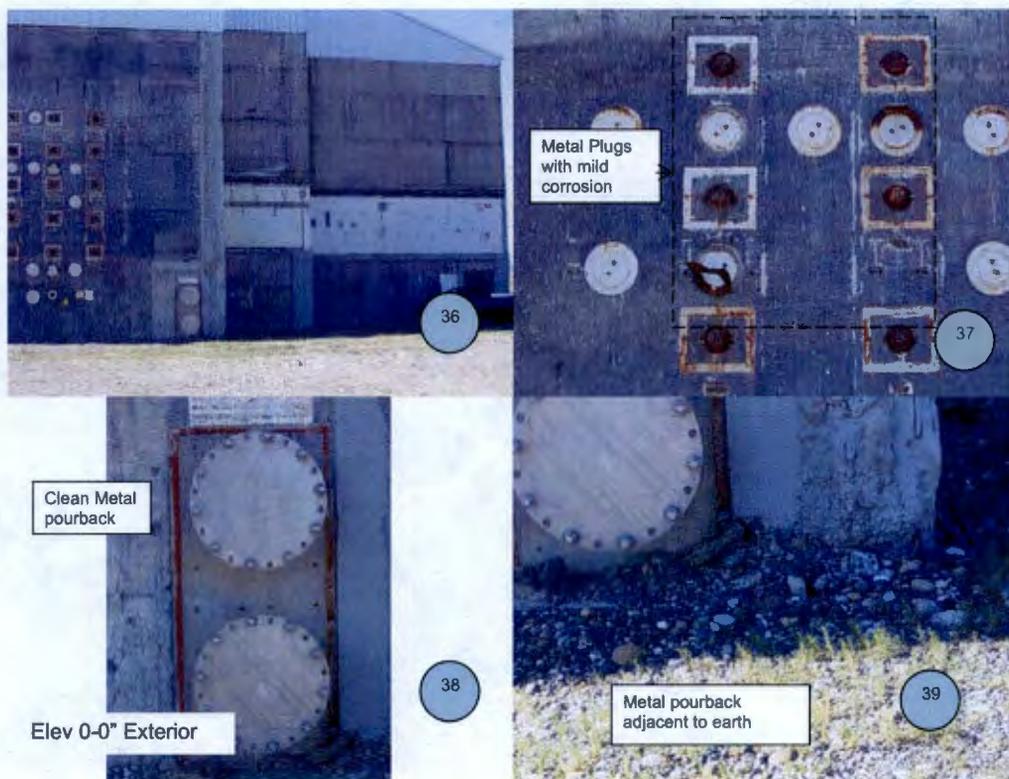
Figure 11. Exterior Building Details, North Wall.

Item 36 – North Wall View of Exterior Building I, from Elev 0'-0"

Item 39 – Pourback ISS detail at N Wall of Building Exterior, Elev 0'-0", recommend soil removal

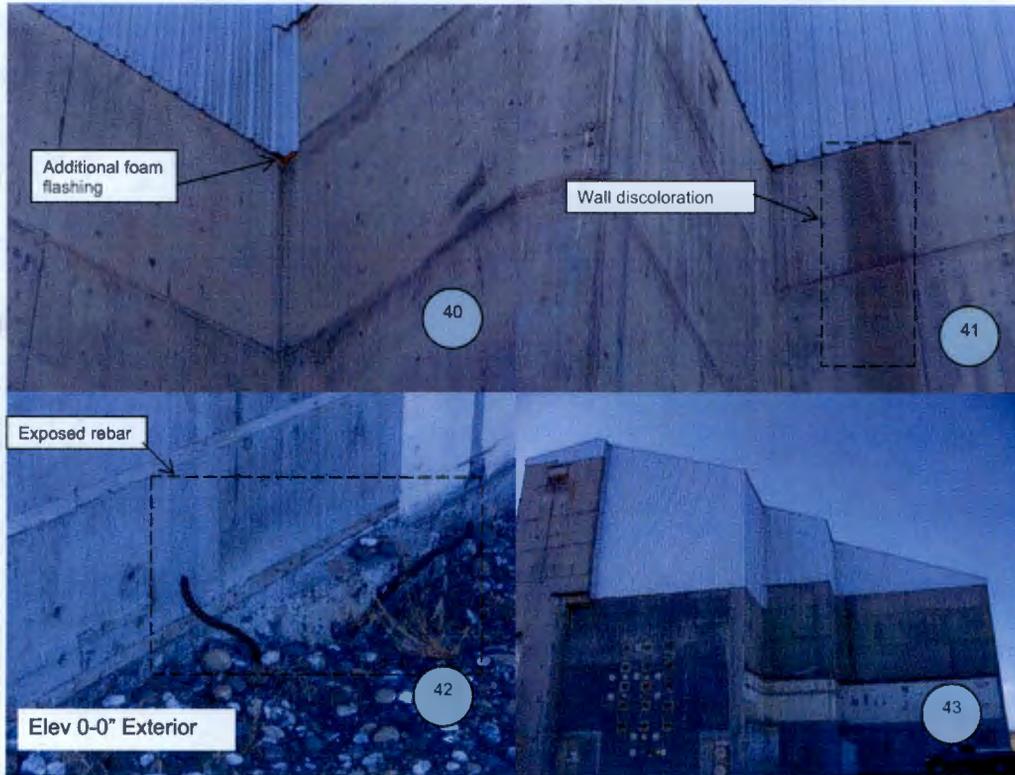
Figure 12. Exterior Building Details, NW Wall.

- Item 40 – ISS Detail at NW Wall, from Elev 0'-0", flashing exposed, no visible structural defect
- Item 41 - Discoloration at NW Wall of Building Exterior, from Elev 0'-0", unknown substance, no visible structural degradation
- Item 42 – Exposed Aggregate & Rebar at NW Wall of Building Exterior, Elev 0'-0", moderate corrosion
- Item 43 – Pourback ISS details at NW Wall of Building Exterior, from Elev 0'-0"

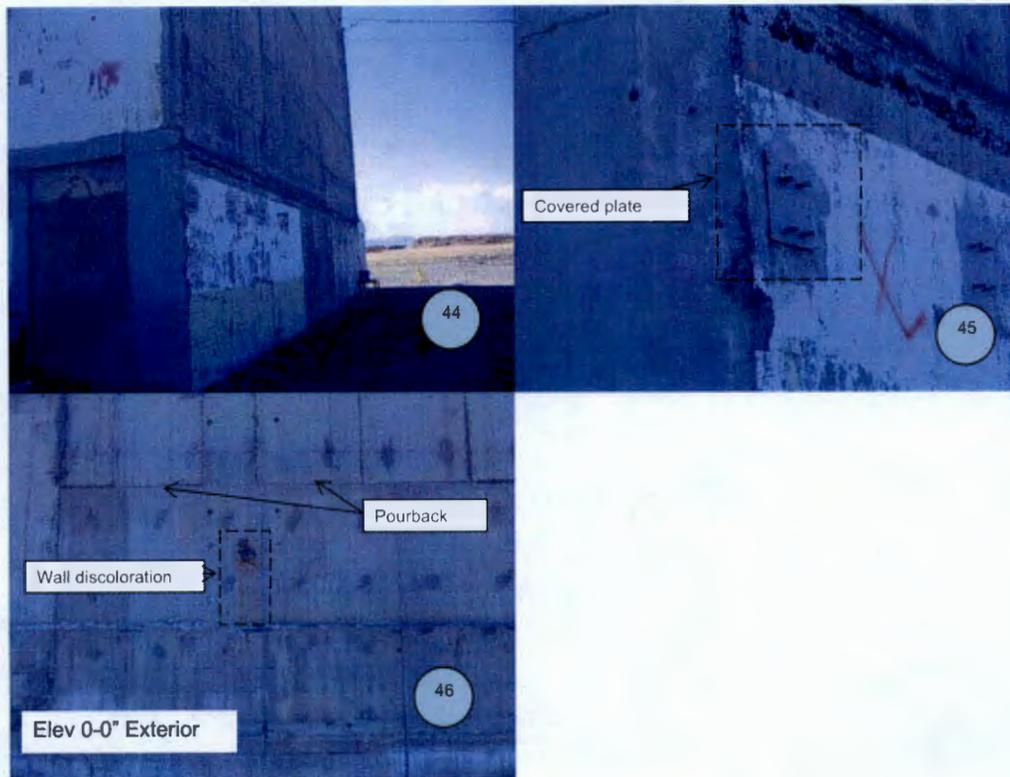
Figure 13. Exterior Building Details, North Wall.

Item 44 – View of NW Wall of Building Exterior, from Elev 0'-0"

Item 46 – Exposed ISS details at NW Wall of Building Exterior, Elev 0'-0", minor corrosion

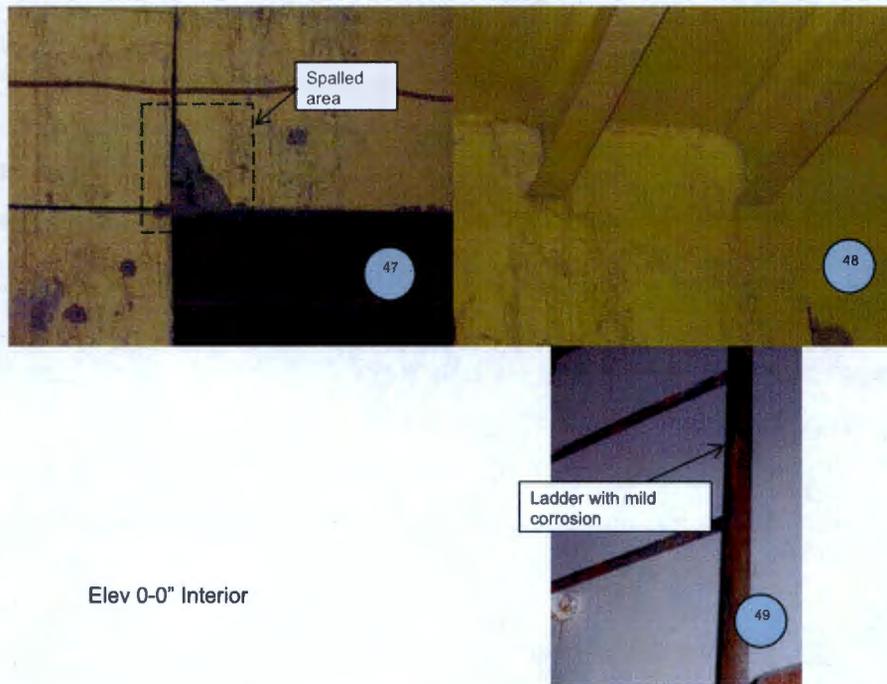
Figure 15. Interior Building Details, Connections Beams, Walls, Elevation 0'-0".

- Item 47 – Exposed Aggregate Detail at Building Interior, Elev 0'-0", spalling.
- Item 48 – Original Building Beam Details at Building Interior, Elev 0'-0", no visible defect
- Item 49 – Original Building Ladder at Building Interior, Elev 0'-0", minor corrosion

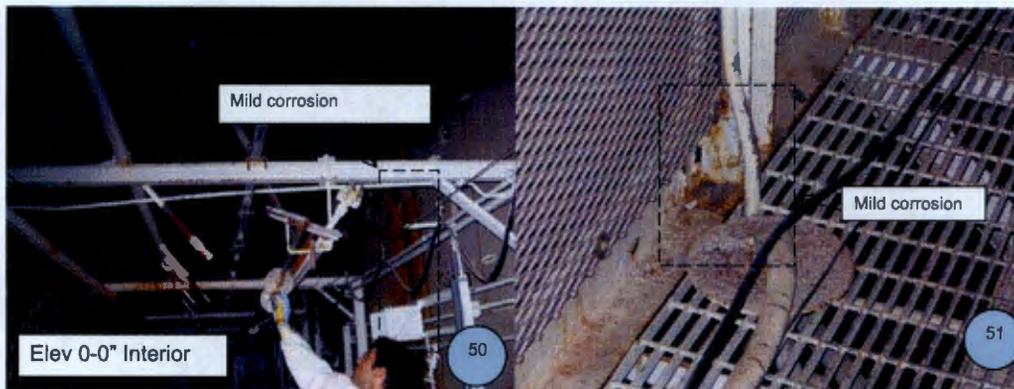
Figure 16 - Original Building Details, Elev. 0'-0".

Item 50 -- Original Building Structural Details at Building Interior, Elev 0'-0", minor corrosion.

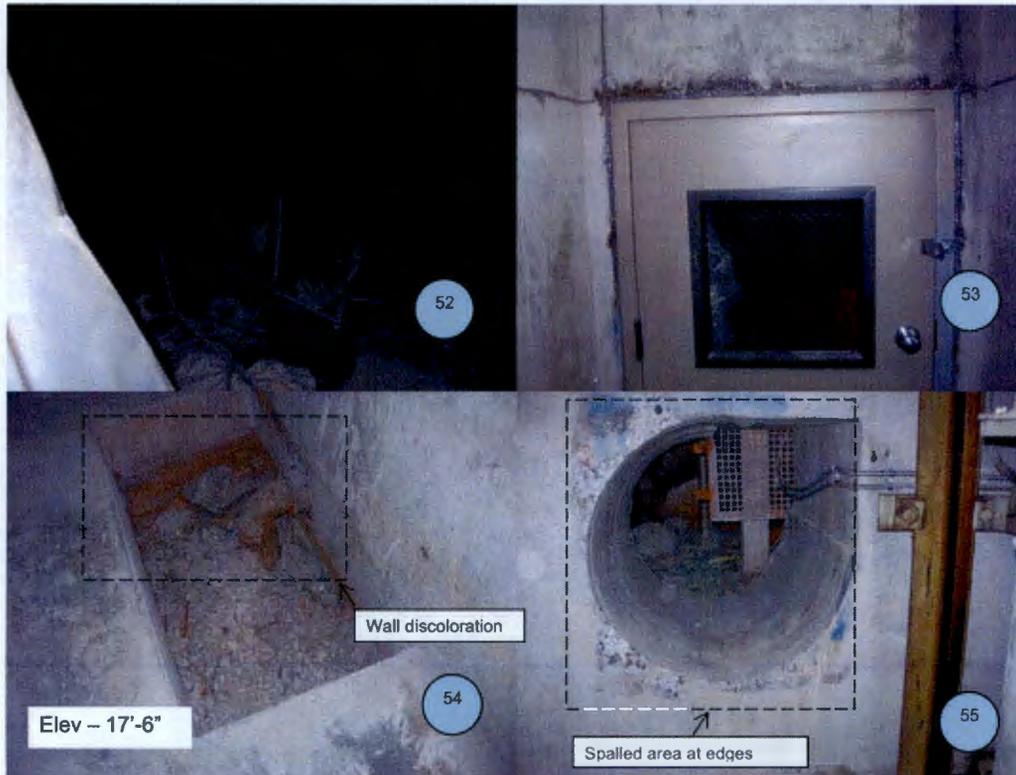
Figure 18. Interior Building Inspection Map, Elevation -17'-6".

- Item 52 – ISS Details rebar and pourback, Elev -17'-6", no visible structural defects
- Item 53 – ISS Door Detail, Elev -17'-6", no visible structural degradation
- Item 54 – Original Building Structure Floor Detail, Elev -17'-6", moderate corrosion
- Item 55 – Original Building Building Exterior, Elev 17'-6", spalling

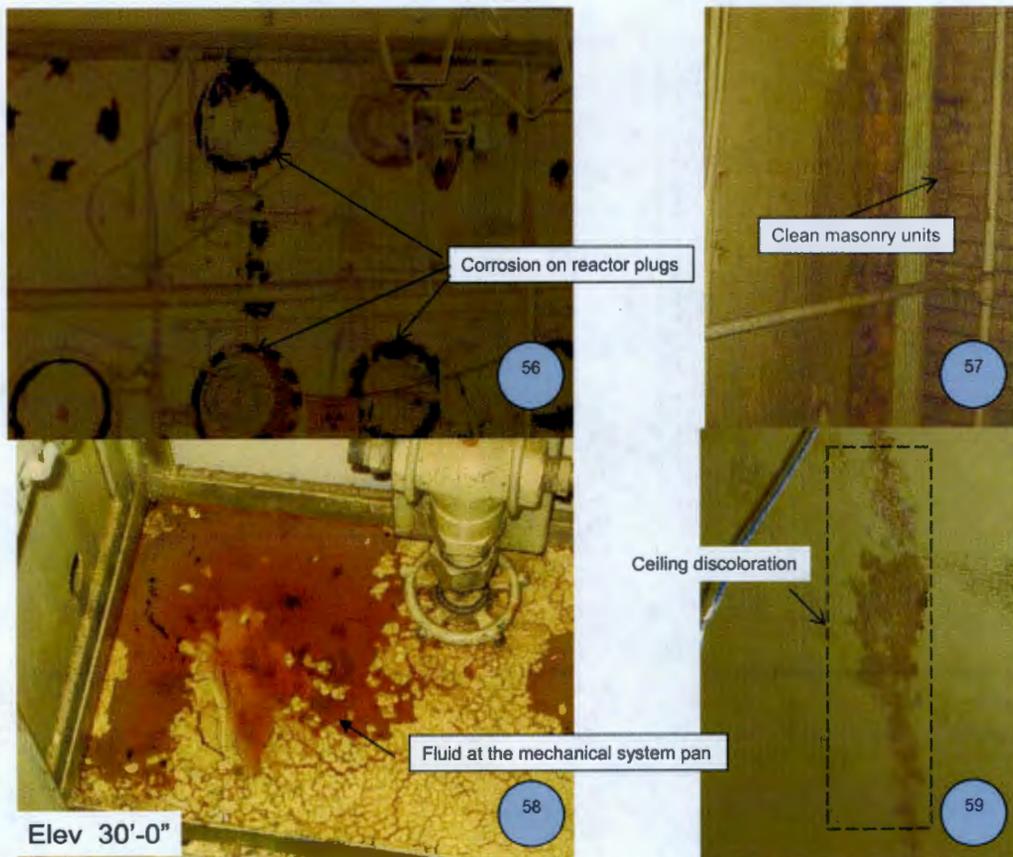
Figure 20. Interior Building ISS Details, Roof, Beams, Columns and Connections, Elevation 30'-0".

- Item 56 – Existing Reactor Block Wall, Elev 30'-0", moderate corrosion
- Item 57 – Existing Reactor masonry and flashing at Building Interior, Elev 30'-0", no visible cracking
- Item 58 – Unknown Liquid at a Mechanical System Component, Elev 30'-0", recommend cleanup
- Item 59 – Wall Discoloration at Building Interior, Elev 30'-0", no visible structural defect

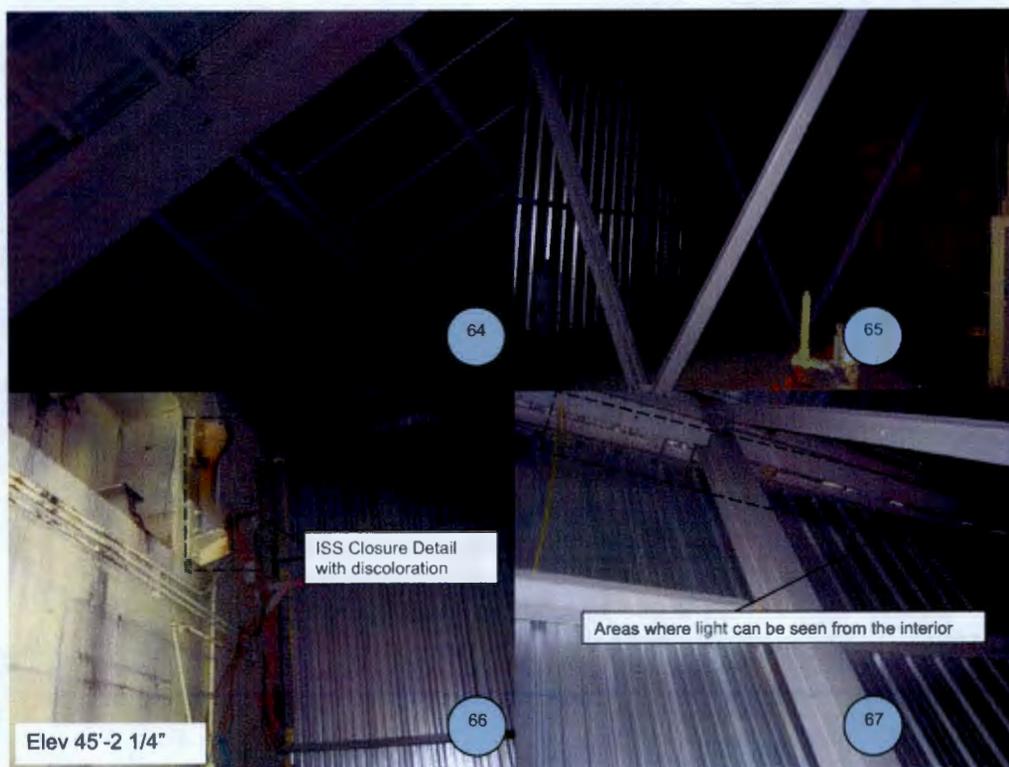
Figure 23 - ISS Details, Elevation 45'-2 1/4".

- Item 64 – ISS Details, rafters, Elev 45'-2 1/4", no visible structural defects
- Item 65 – ISS Details, trusses, Elev 45'- 2 1/4", no visible structural defects
- Item 66 – ISS Details, Original Beam, Elev 45'-2 1/4", no further structural degradation
- Item 67 – ISS Details, Soffit area between wall and roof, Elev 45'-2 1/4", visible light thru gaps, recommend to leave as is

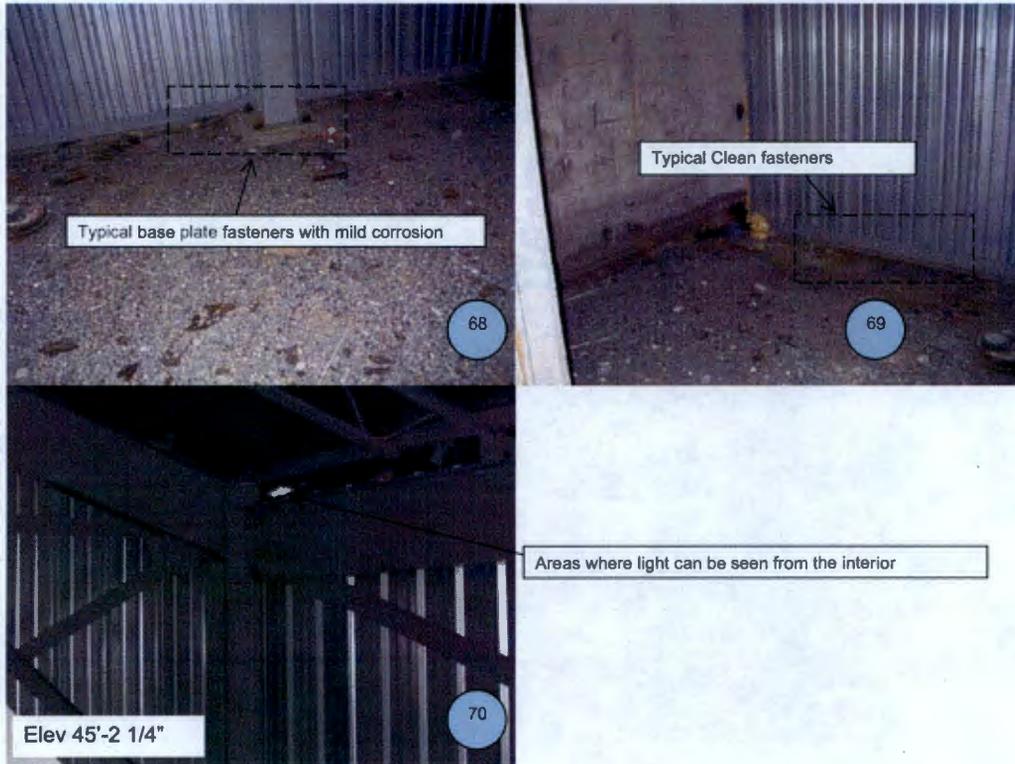
Figure 24 - ISS Details, Elevation 45'- 2 1/4".

- Item 68 – ISS Details, column base plates & bolts, Elev 45'-2 1/4", no visible structural defects
- Item 69 – ISS Details, fasteners, Elev 45'- 2 1/4", no visible structural defects
- Item 70 – ISS Details, Soffit area between wall and roof, Elev 45'-2 1/4", visible light thru gaps, recommend to leave as is

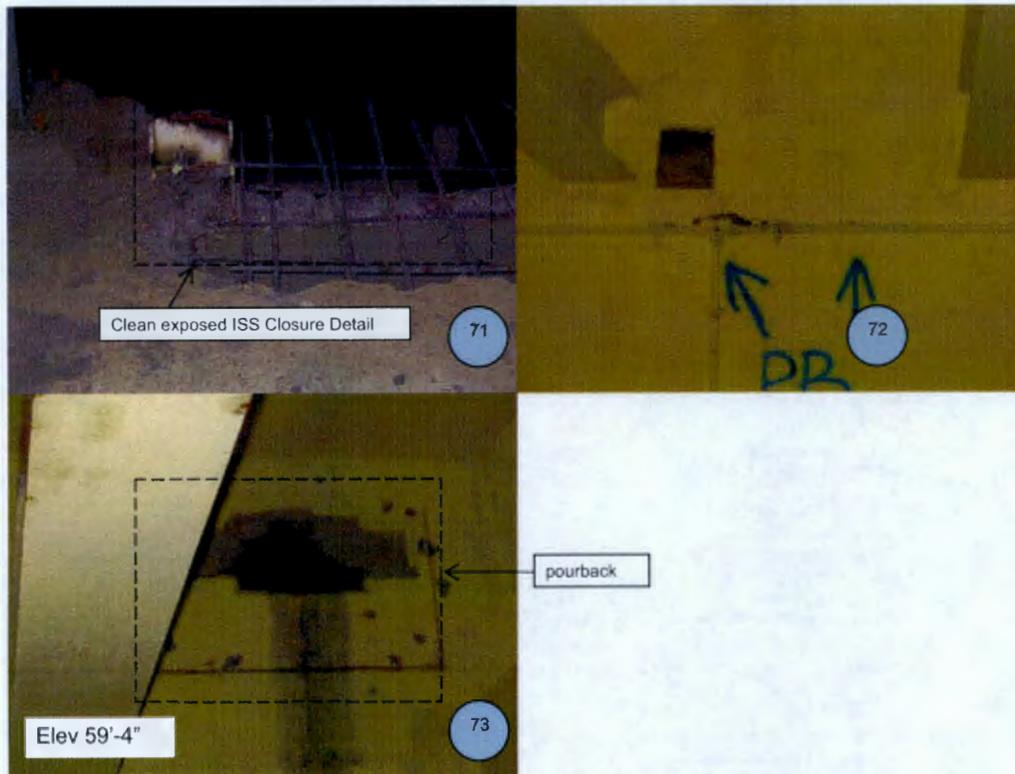
Figure 26 - ISS & Original Building Details - Elev. 59'-4".

- Item 71 – ISS Details, removed original structure, Elev 59'-4", no further structural damage
- Item 72 – ISS Details, pourbacks, Elev 59'- 4", no visible structural defects
- Item 73 – ISS Details, pourback, Elev 59'-4", no visible structural defects

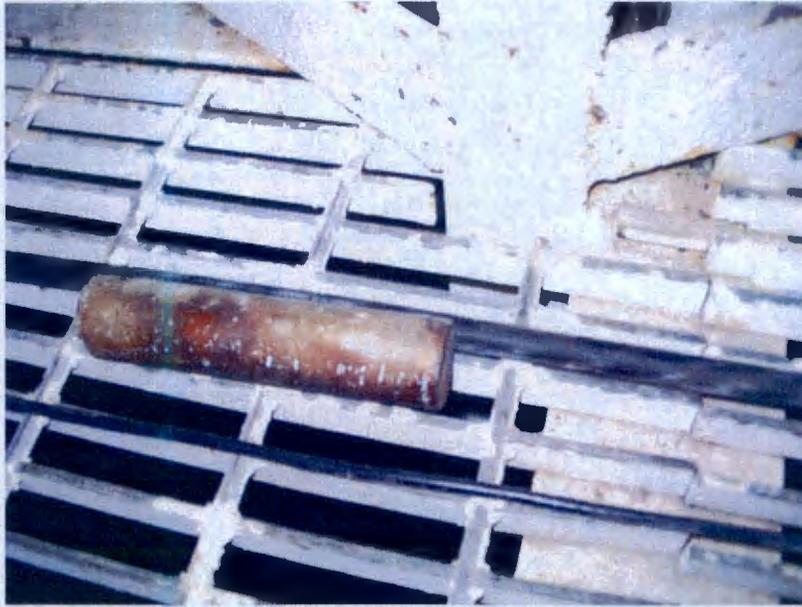
0ft
Lead plug

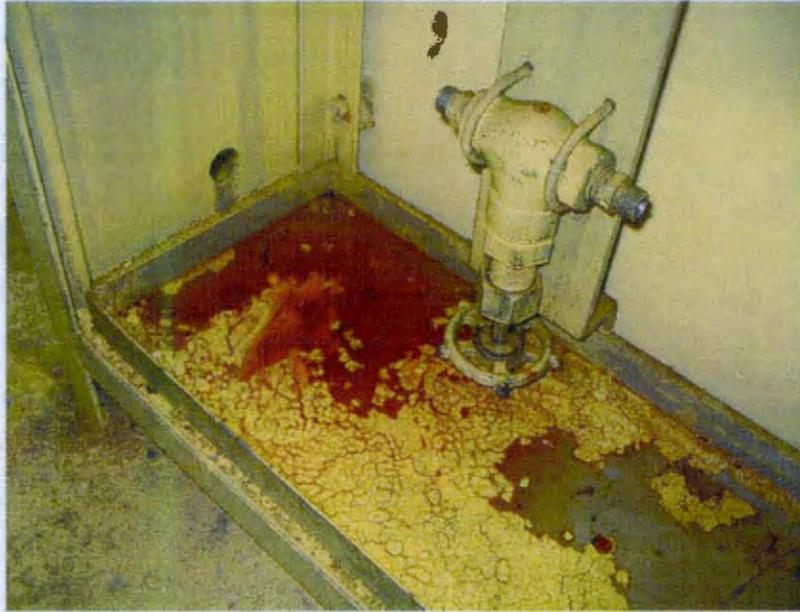
30ft oil in pan

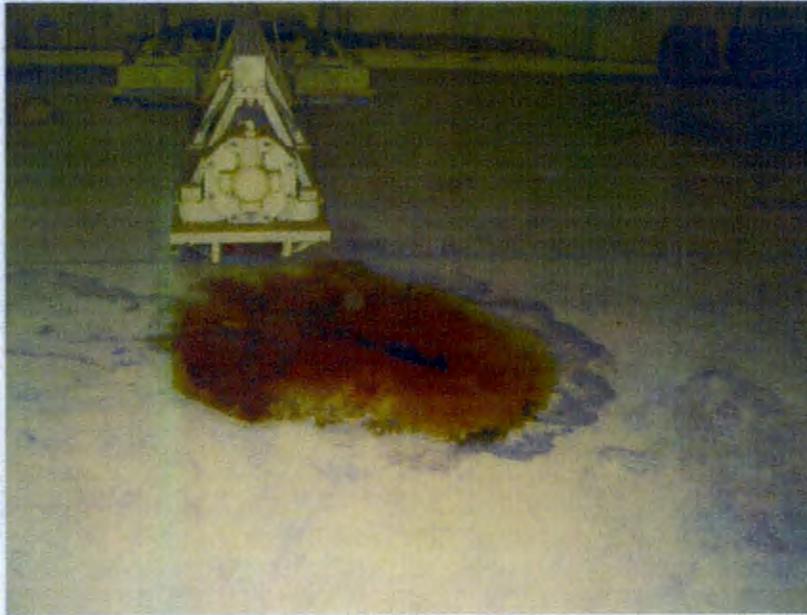
2.3.6 REMOVAL OF HAZARDOUS SUBSTANCES – Some minor amounts of mouse feces and bate guano were located and removed as part of this effort. There were also two discoveries regarding small amounts of oil on the 30' 0" level. One was located in a catch pan directly under a valve system, and the other was located directly under a small overhead hoist. The oil leaks were small in volumes (less than 6 to 8 ounces) and resulted from leakage/seepage from left in-place equipment. The oil leaks were cleaned up and small absorbent pads placed in these areas.

30ft
Oil on floor

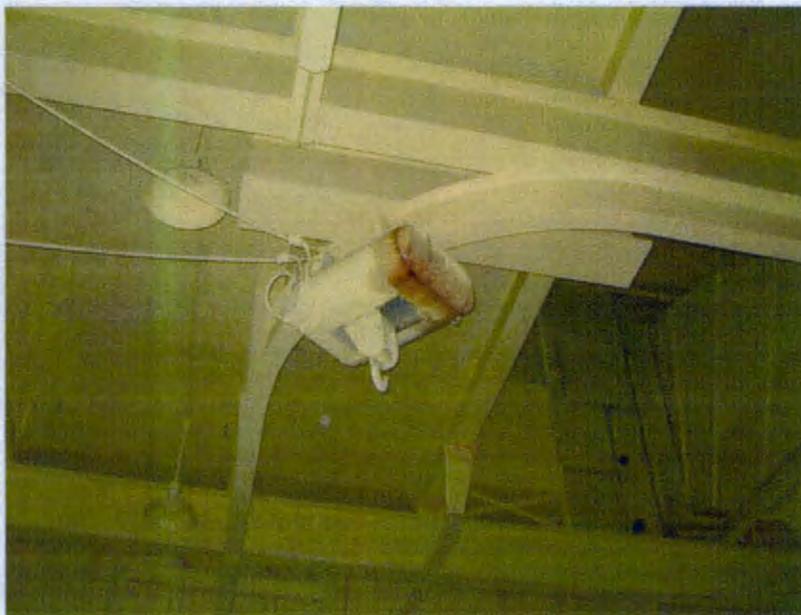
30ft
Source of oil on floor

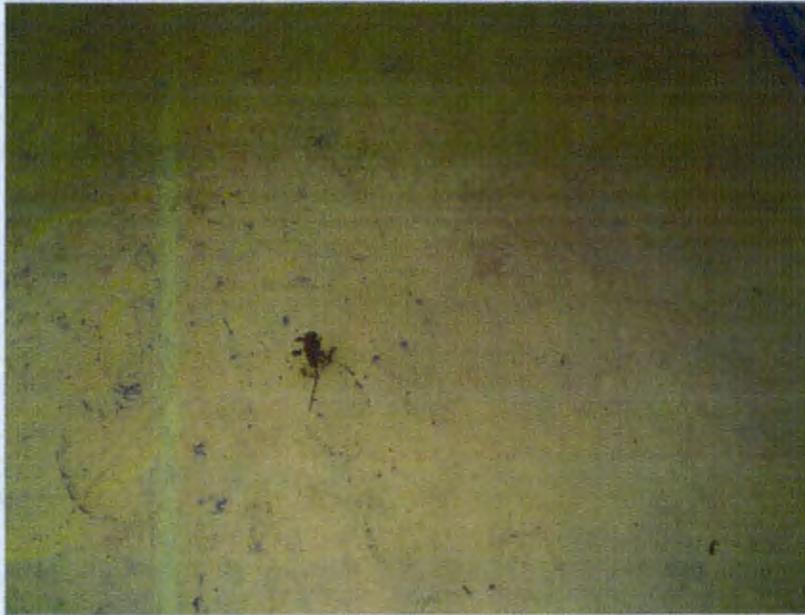
30ft
Dead mouse

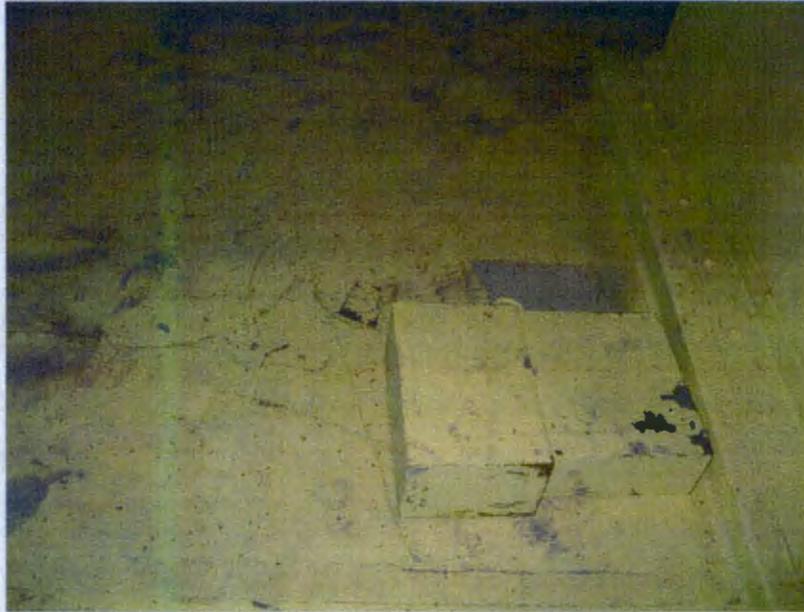
30ft
Lead

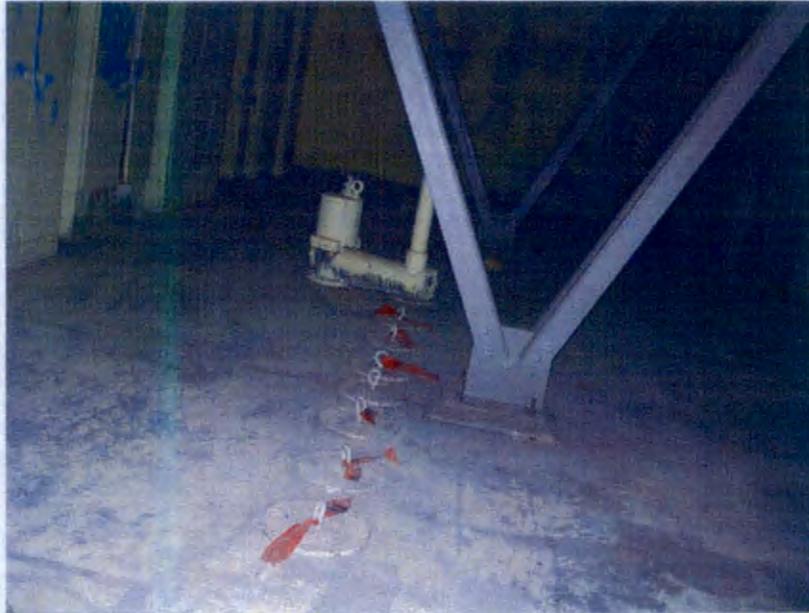
60ft
D machine room
Tripping hazards

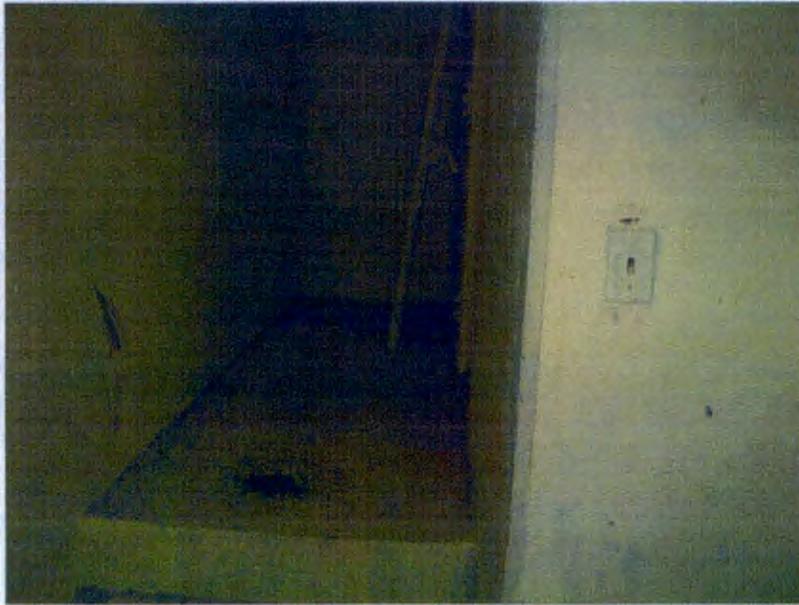
60 ft
Bat guano
