FACILITY STATUS CHANGE FORM

Date Submitted: Feb 9, 2011 Originator: David Warren Phone: 539-6040	Area: 100-N Area Facility ID: 153-N Electrical Substation Action Memorandum: 100-N Ancillary Facilities	Control #: D4-100-N-0008 rev.1
--	---	--

SUBJECT: **POST DEMOLITION SUMMARY REPORT FOR THE 153-N ELECTRICAL
SUBSTATION**

Post Demolition Summary Report for the 153-N Electrical Substation

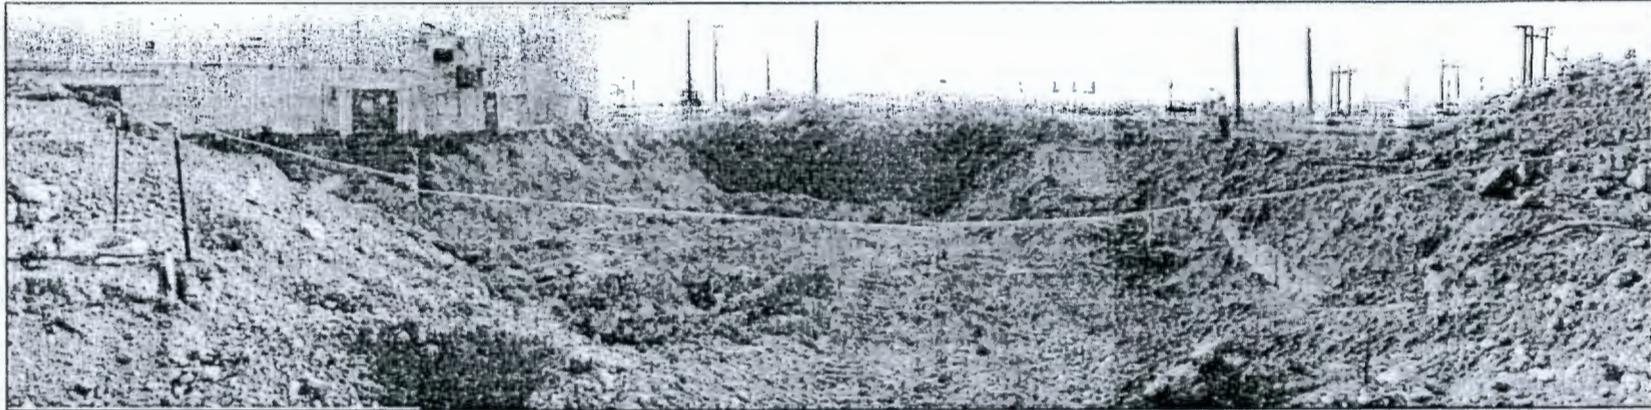
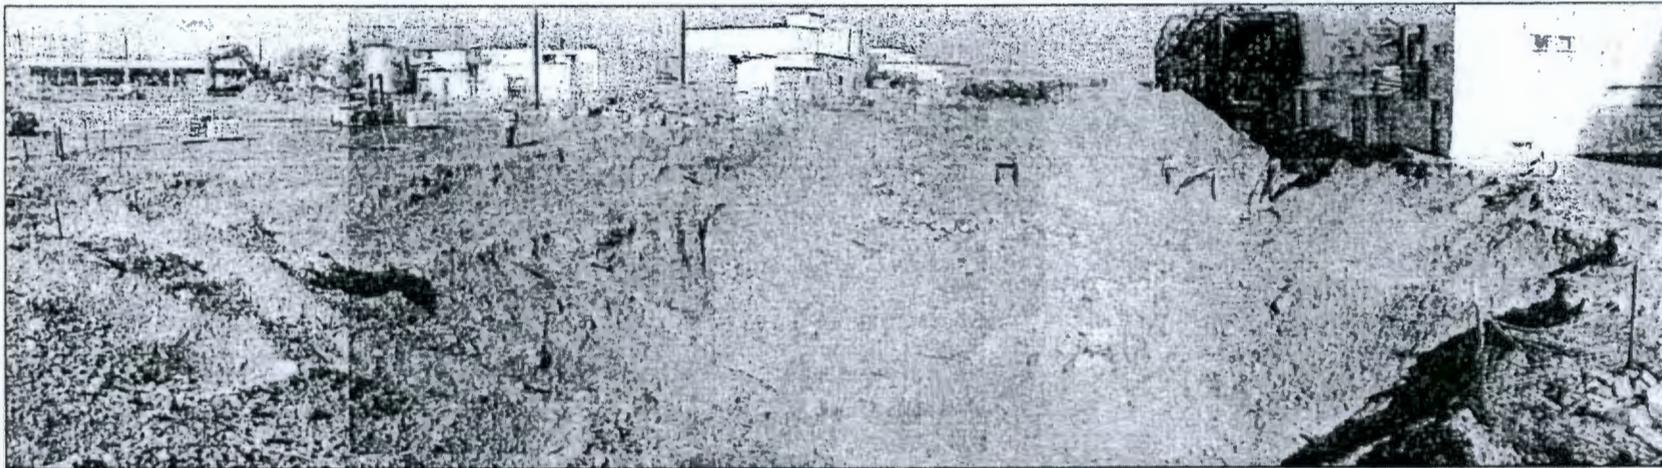
Figure 2 - 153-N Electrical Substation Excavation

UPR-100-N-36, Diesel Generator Area – this inactive WIDS site is in an area used to work on compressor parts and had oil spills during this work. The WIDS description indicates that the most recent spills were cleaned up. The 153-N demolition excavation came up to the southern edge of this WIDS site, and may have intersected the WIDS site. During D4 demolition activities, the excavation was visually inspected for signs of staining. No staining was identified, and no indication of soil contamination could be found. Pictures of the facility excavation are provided as Figure 2.

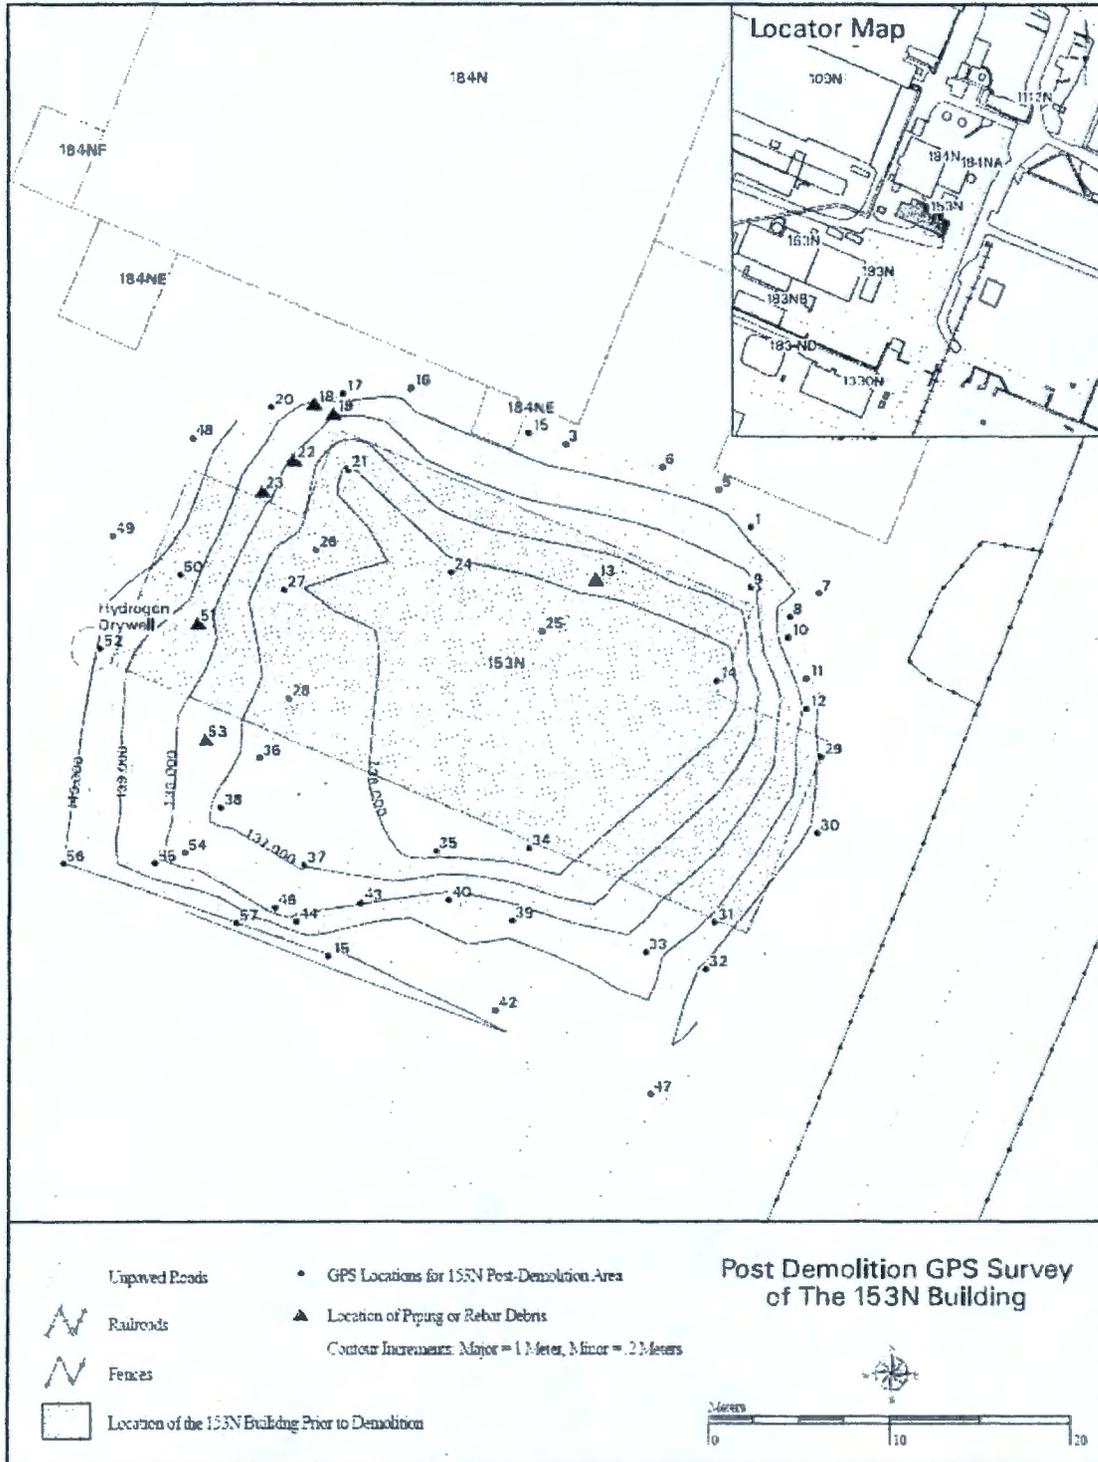
Attachment 4 – Post-Demo Civil Survey

A GPS civil survey was performed on the 153-N prior to demolition. This survey located the corners of the building and the corners and extents of near-by structures. A post demolition civil survey was performed. This survey documented the extent of the excavation (footprint and depth) as well as remaining structures (electrical conduits and concrete structures) extending into the excavation. It should be noted, that these remaining concrete structures are not from the 153-N facility but rather footings from adjacent structures.

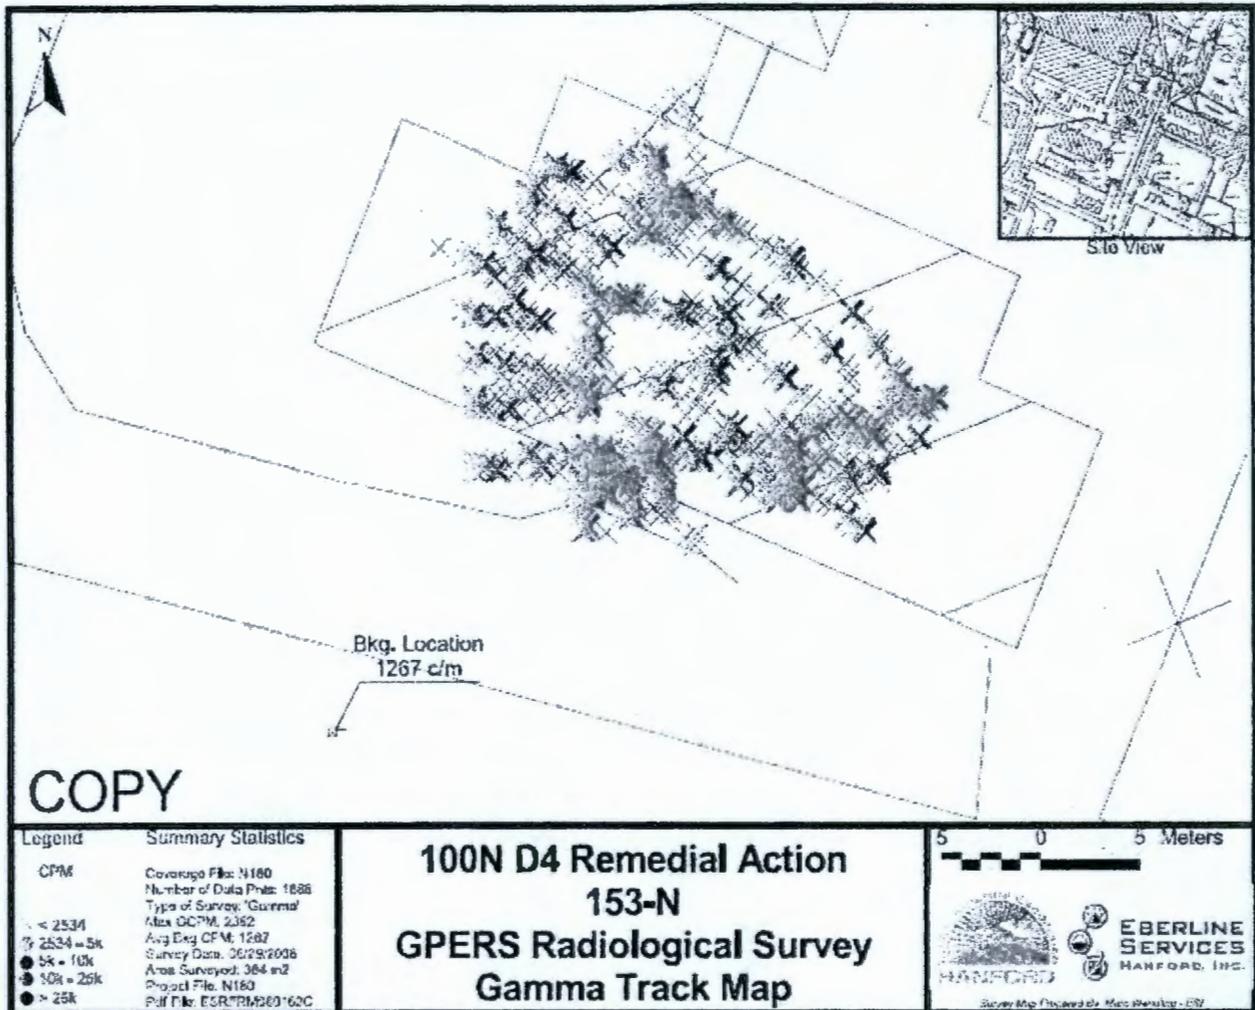
Attachment 4 - GPERS Survey of 153-N Excavation, Gamma Track

This down posting survey included tech smears of the excavation equipment and the 153-N demo site, except for the excavation. A GPERS survey was performed in the excavation (see Attachments 4 and 5). No contamination was detected during the demolition of 153-N, and is documented in these surveys.
